Mosley Street

### Proposed Elevation - Lightwell C & D - Repairs

PROJECT REF. 1995  
DRWG NO. P(241)  
REVISION A  
SCALE 1:100 @ A3  
DATE 1st August 24  
DRAWN RG

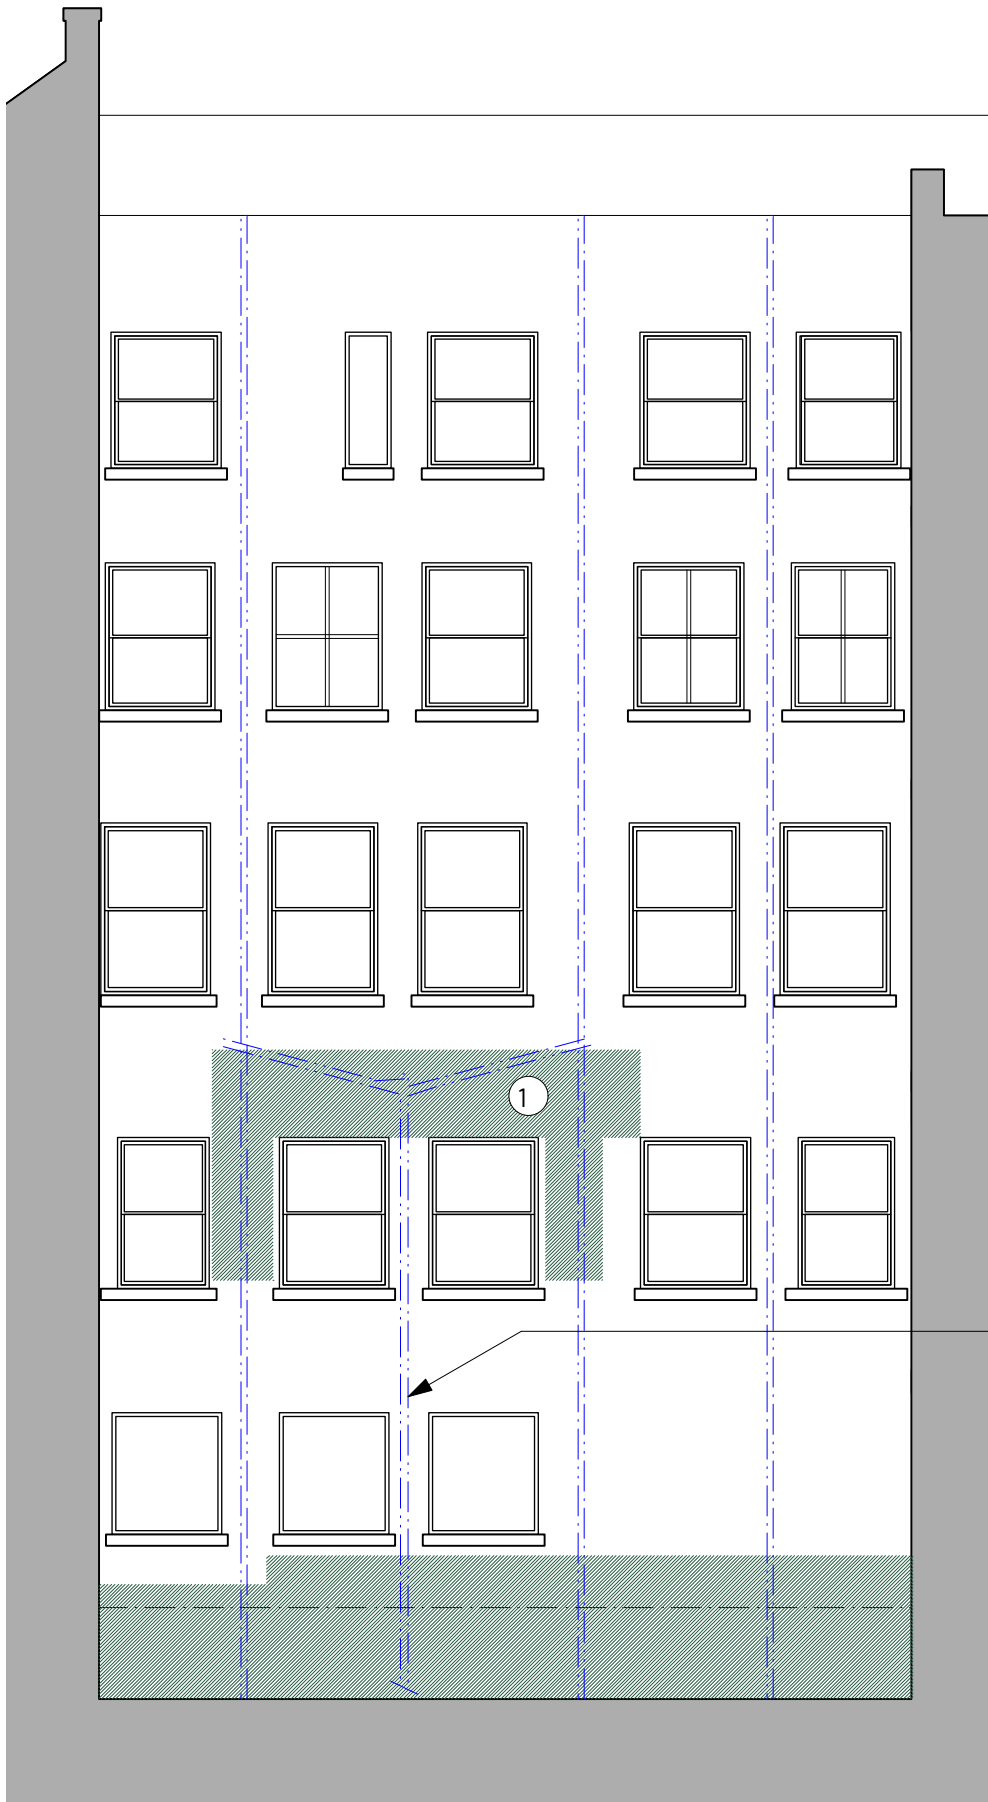
1

Lightwell Elevation C

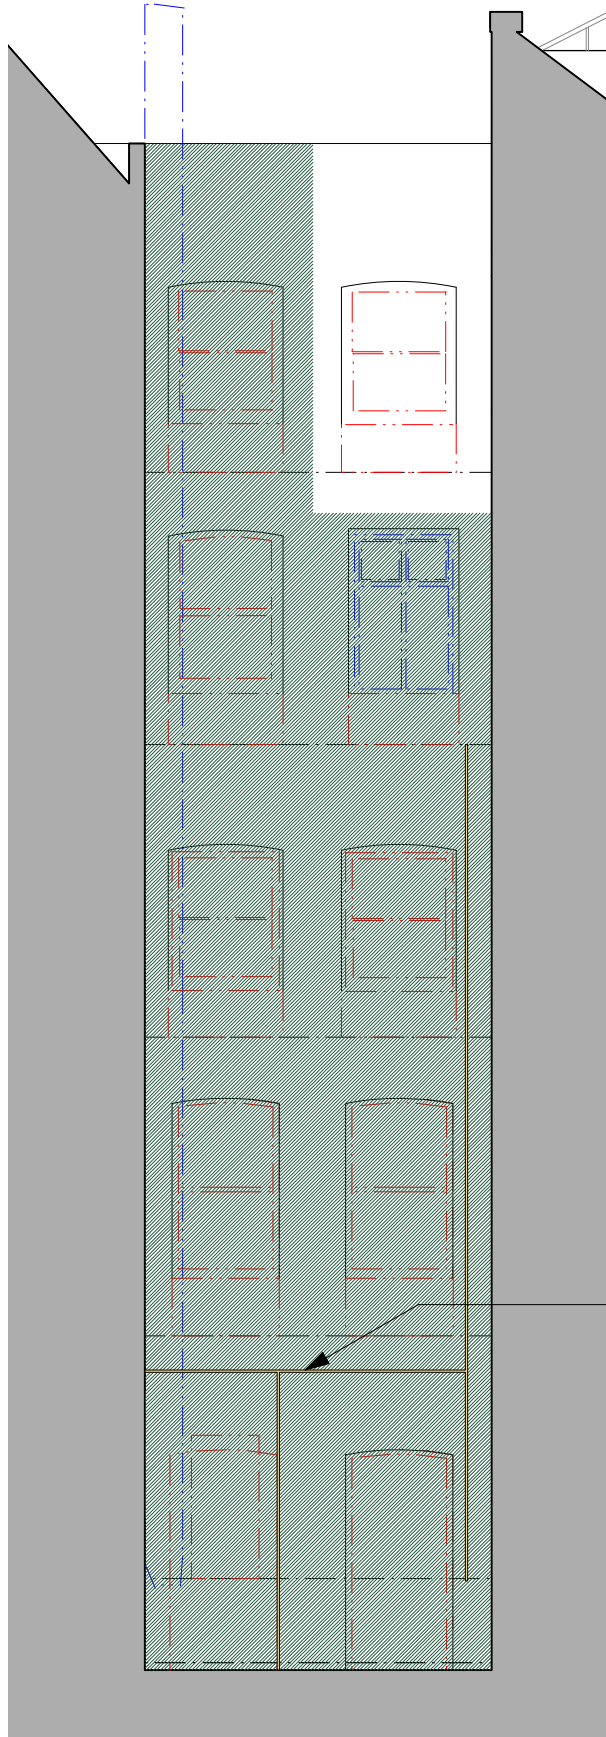
2

Lightwell Elevation D
