# Contamination Risk Assessment Report

**Site:** 262 Ryebank Road, Chorlton  
**Planning Ref:** 140430/FO/2024  
**Date:** 21<sup>st</sup> January 2025

LK Consult (LKC) has been commissioned by Mr E. Malley to provide a contamination risk assessment report for the site. The current house is to be demolished and redevelopment as 2no. semi-detached houses (appended).

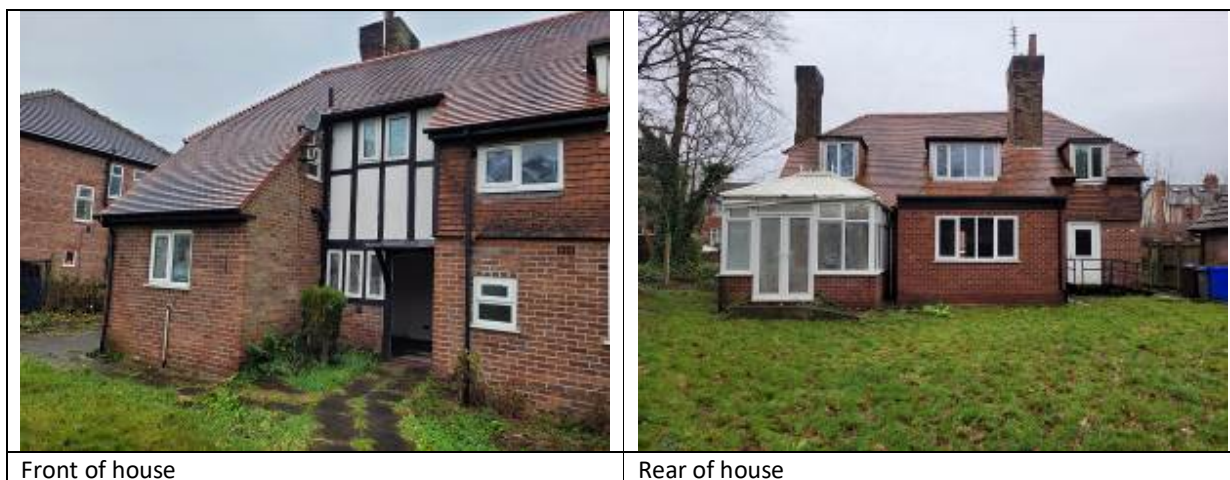
From publicly available historical mapping the site was undeveloped until 1937 mapping where potential terraced housing was present at the front of the site (this configuration maybe due to the use of 1:25,000 scale) because the 1:250 mapping from 1944-1974 clearly show a detached house as per current configuration. Photographs of rear and front of the house presented below.

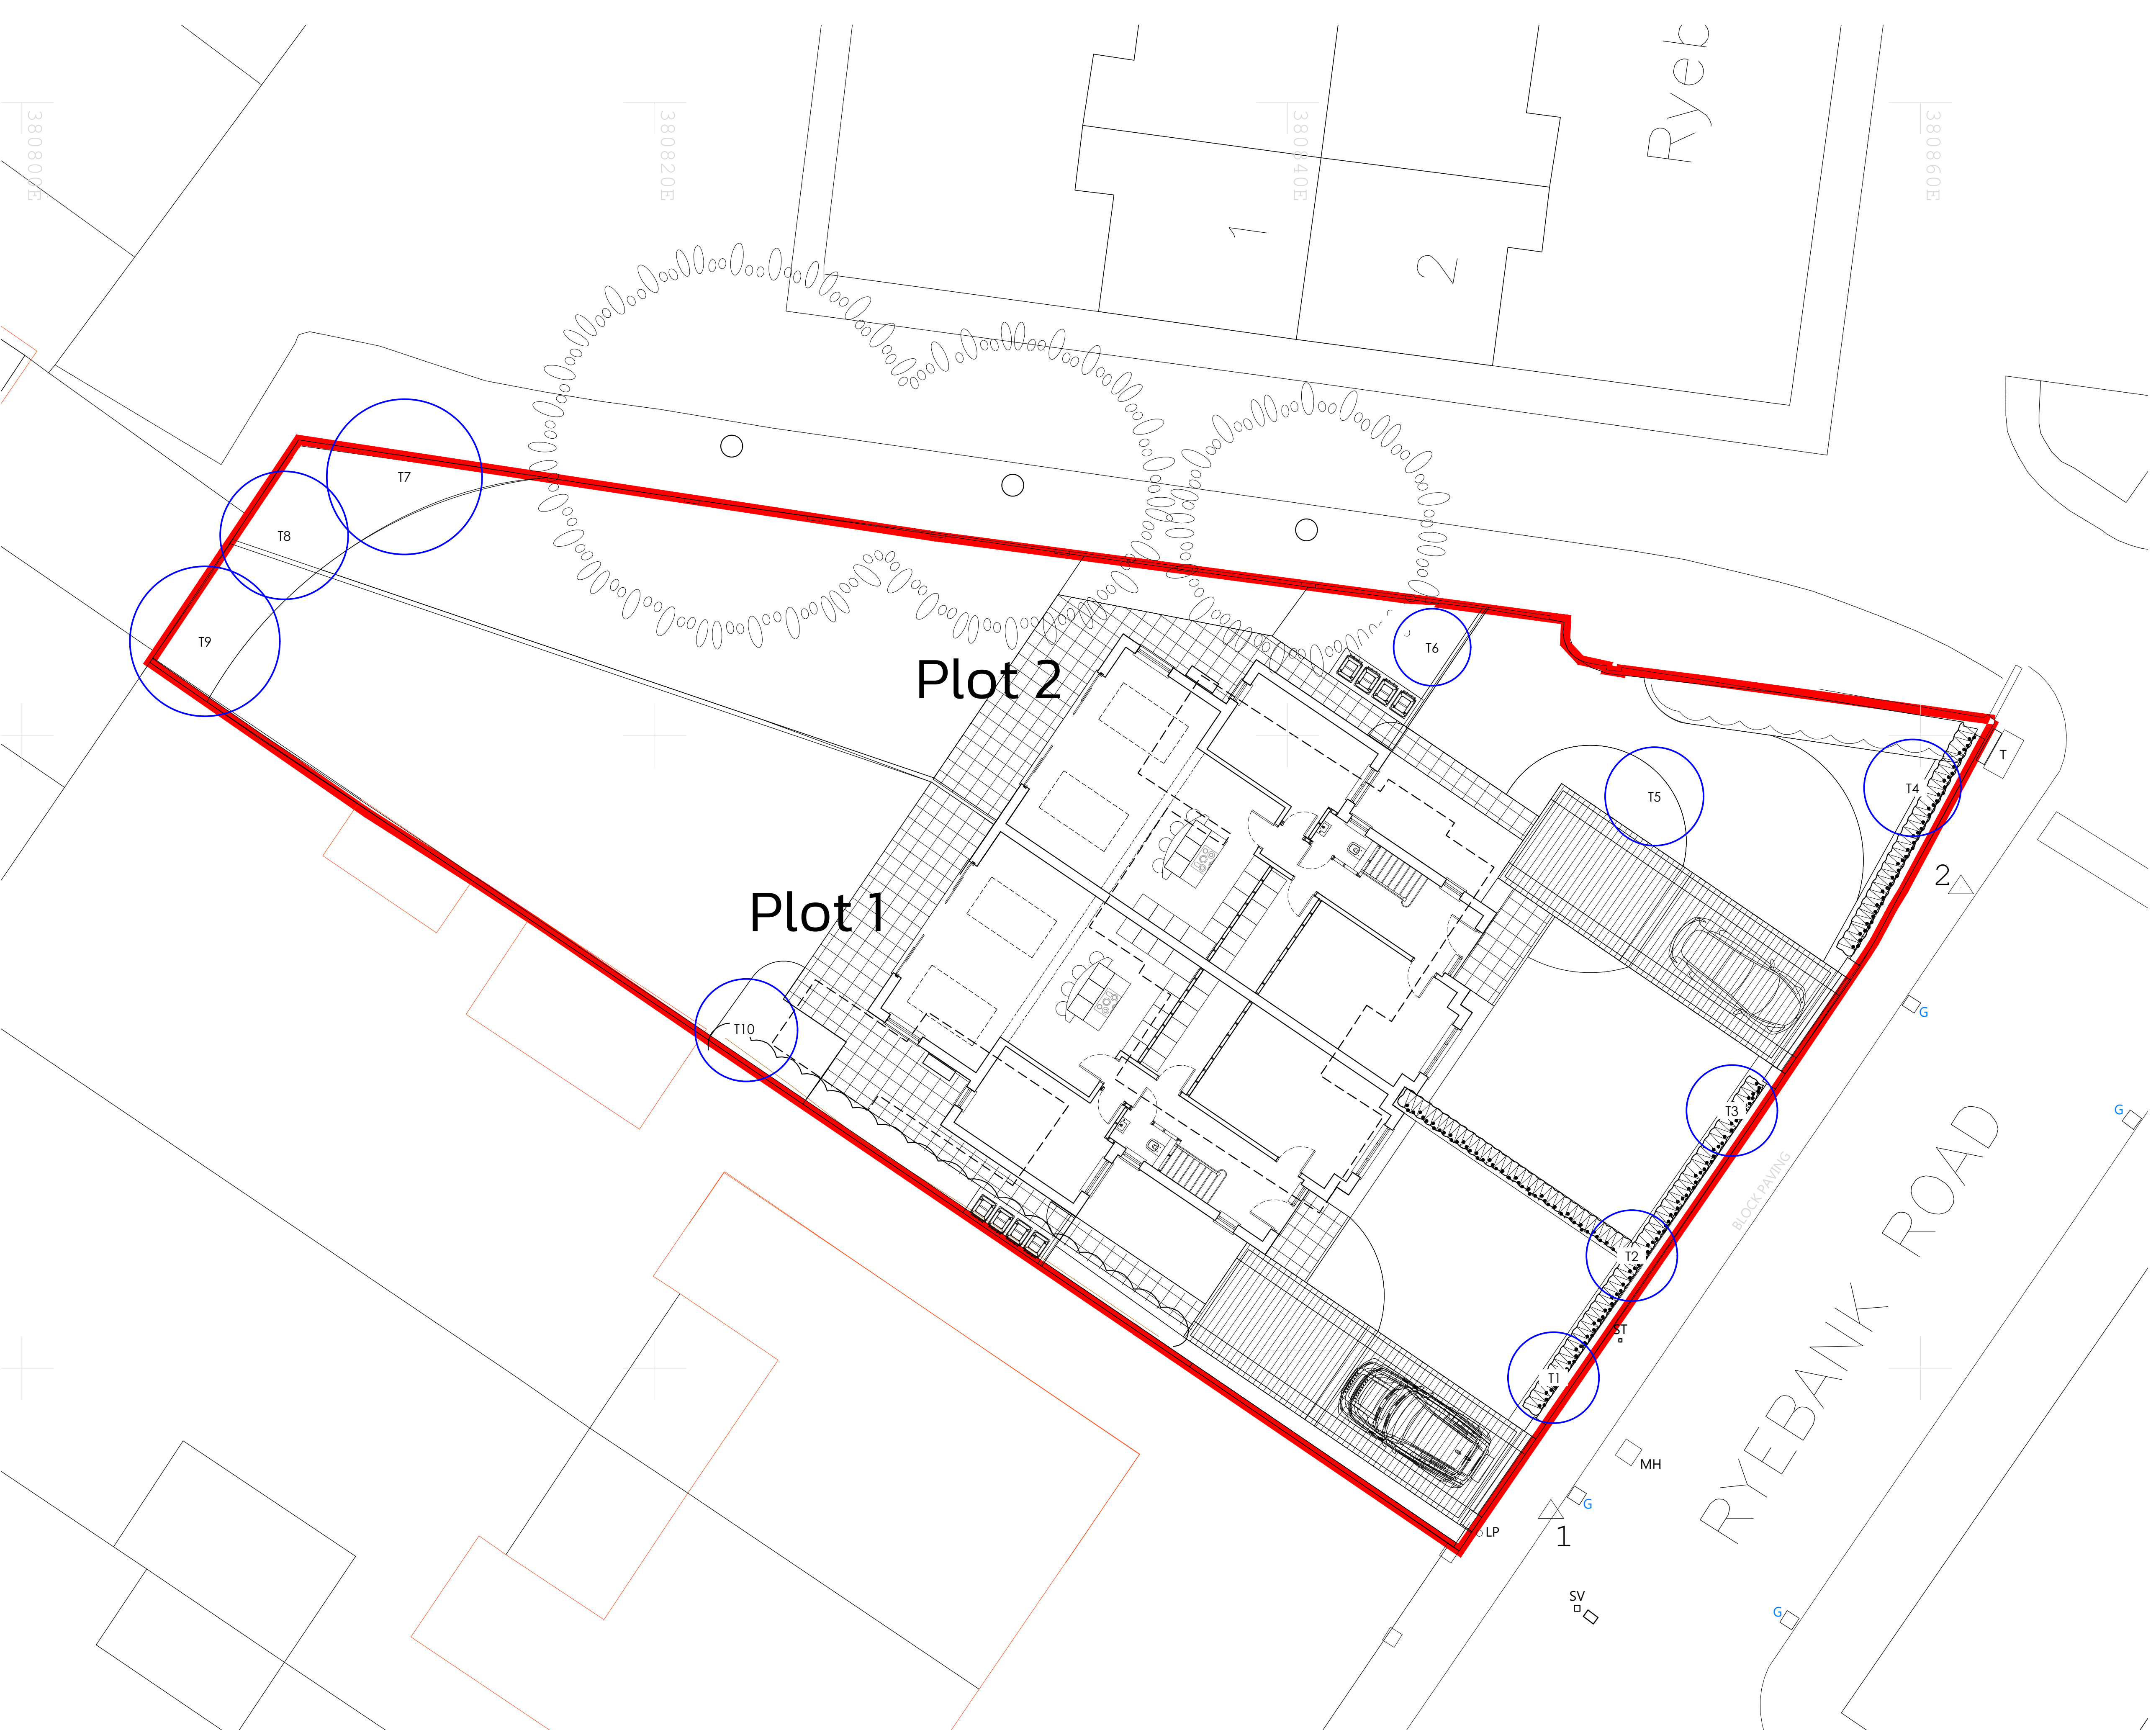
Proposed Site Plan

| 20.09.24. | Front Gable windows re-design inline with Planners comments. | PA. | A. |

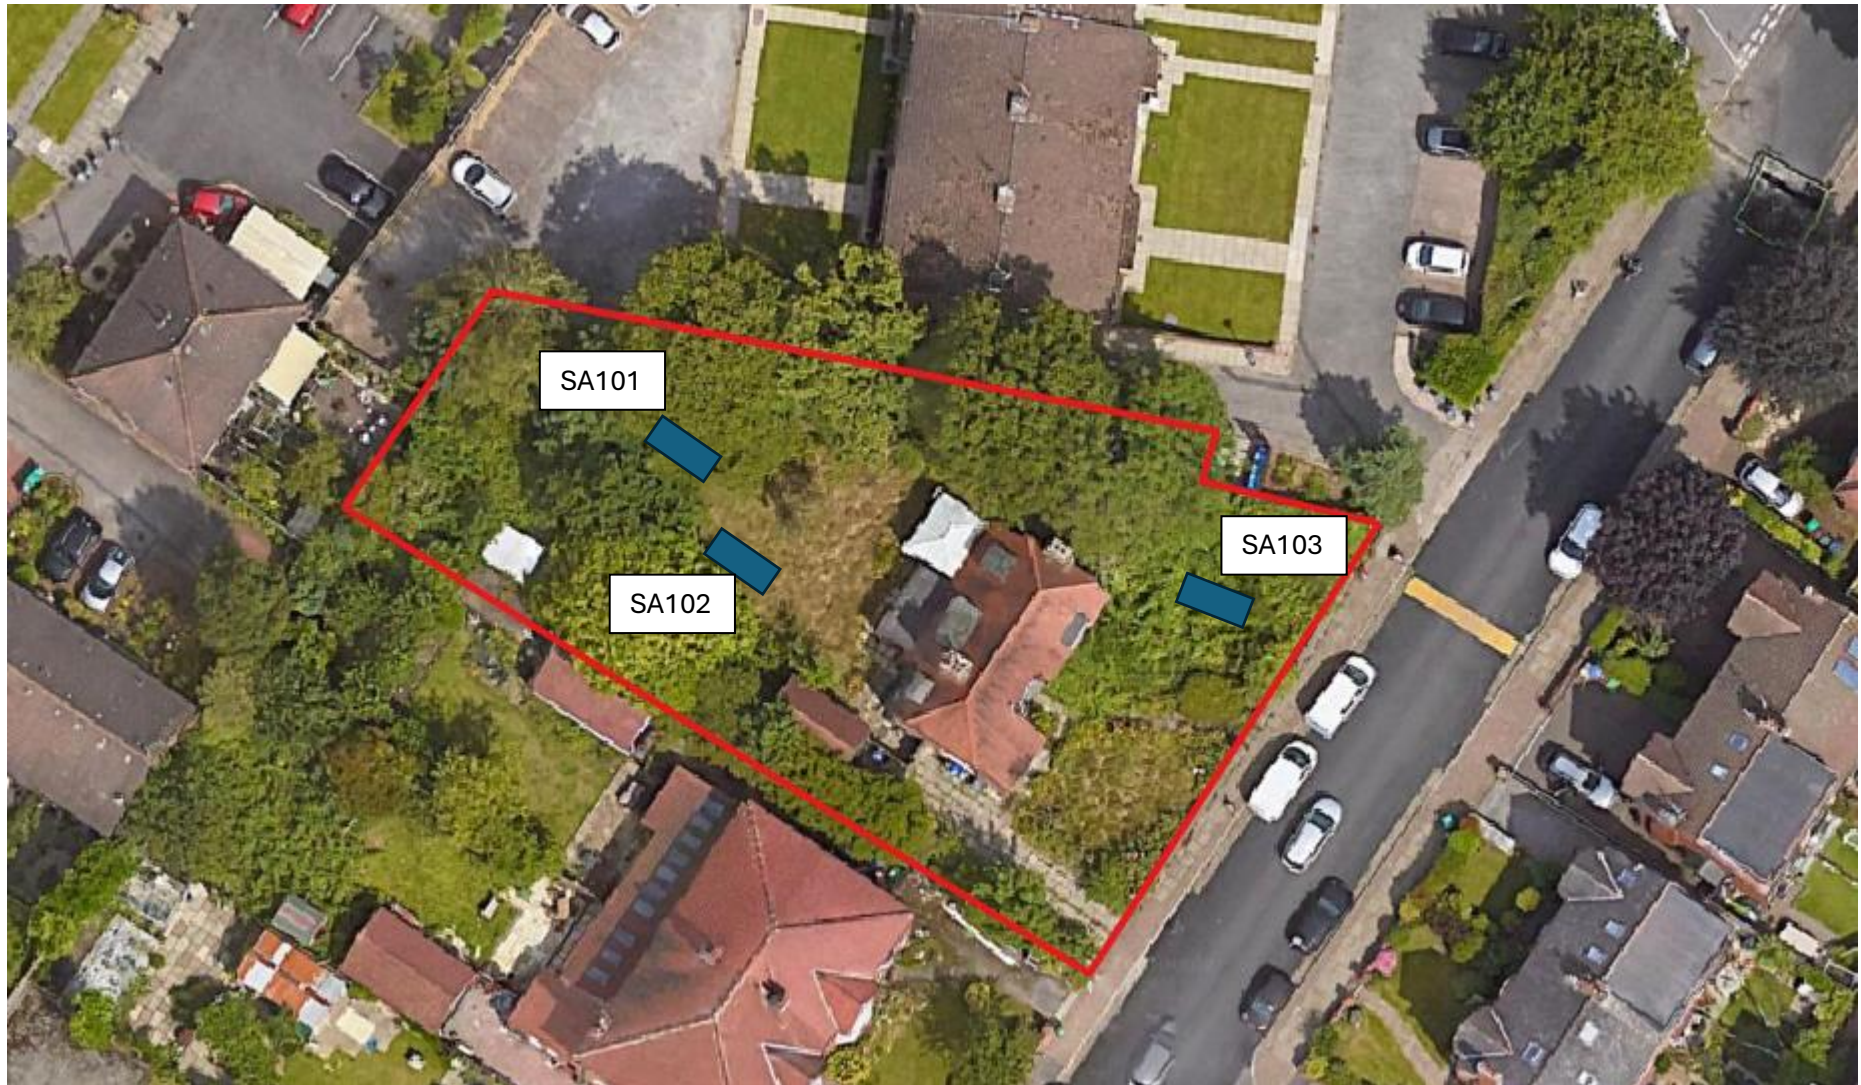
**SOAKAWAY TRIAL PIT LOCATIONS AND PROFILE LOGS**

Soakaway testing was conducted by LKC on the 29<sup>th</sup> May 2024. Trial pit logs (appended) noted topsoil over natural sand and clay in the rear of the property (SA101-102). Made ground was noted in the front of the property (SA103) to a maximum of 0.7mbgl. The composition of the made ground taken from the front of the property appeared to be of reworked natural composition with a single whole brick. A band of oyster shells was encountered at 0.6-0.7mbgl.

Soakaway location.
