## Road Safety Audit Designers Response for: Highway Improvement Works Associated with Residential Development Talbot Road, Burnage

AMA Project Number: 21894

## Highway Improvement Works Associated with Residential Development Talbot Road Burnage

### Updated Road Safety Audit: Stage 1

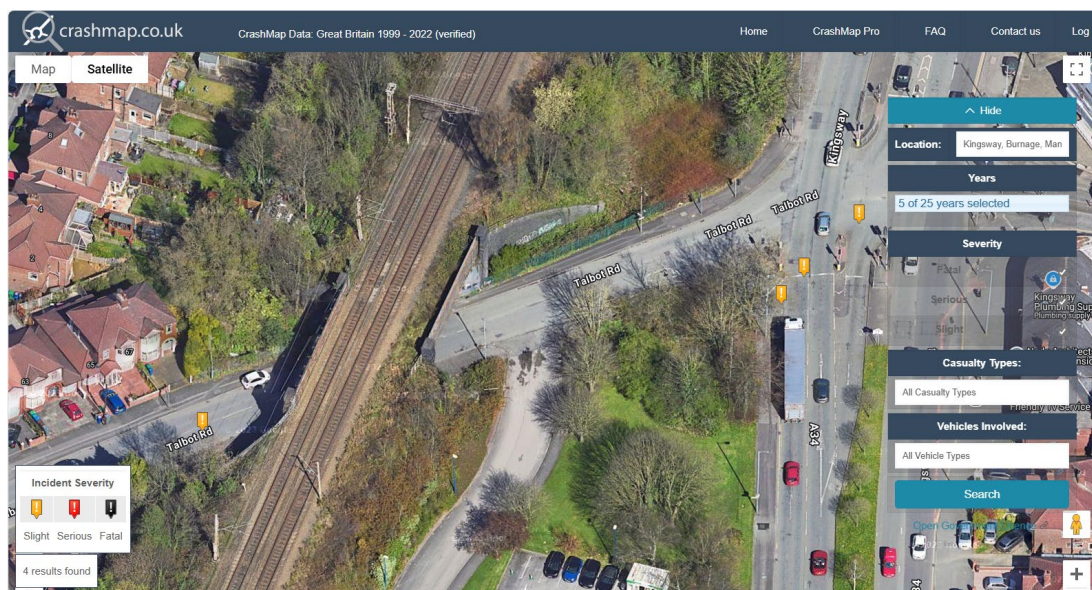
**Figure 1: CrashMap Data 2018 -2022**

Collision data was available as part of the Brief. The data covered a much wider area than that associated with the improvement works and as such data from the Crash map website was used. A plan of the most recent 5 years of data 2018-2022 is provided in Figure 1 below.

Examination of the data shows that there have been four collisions in close proximity to the proposed works. Three at the Kingsway traffic signal junction and one to the west of the works on Talbot Road. No collisions have occurred at the existing junction.

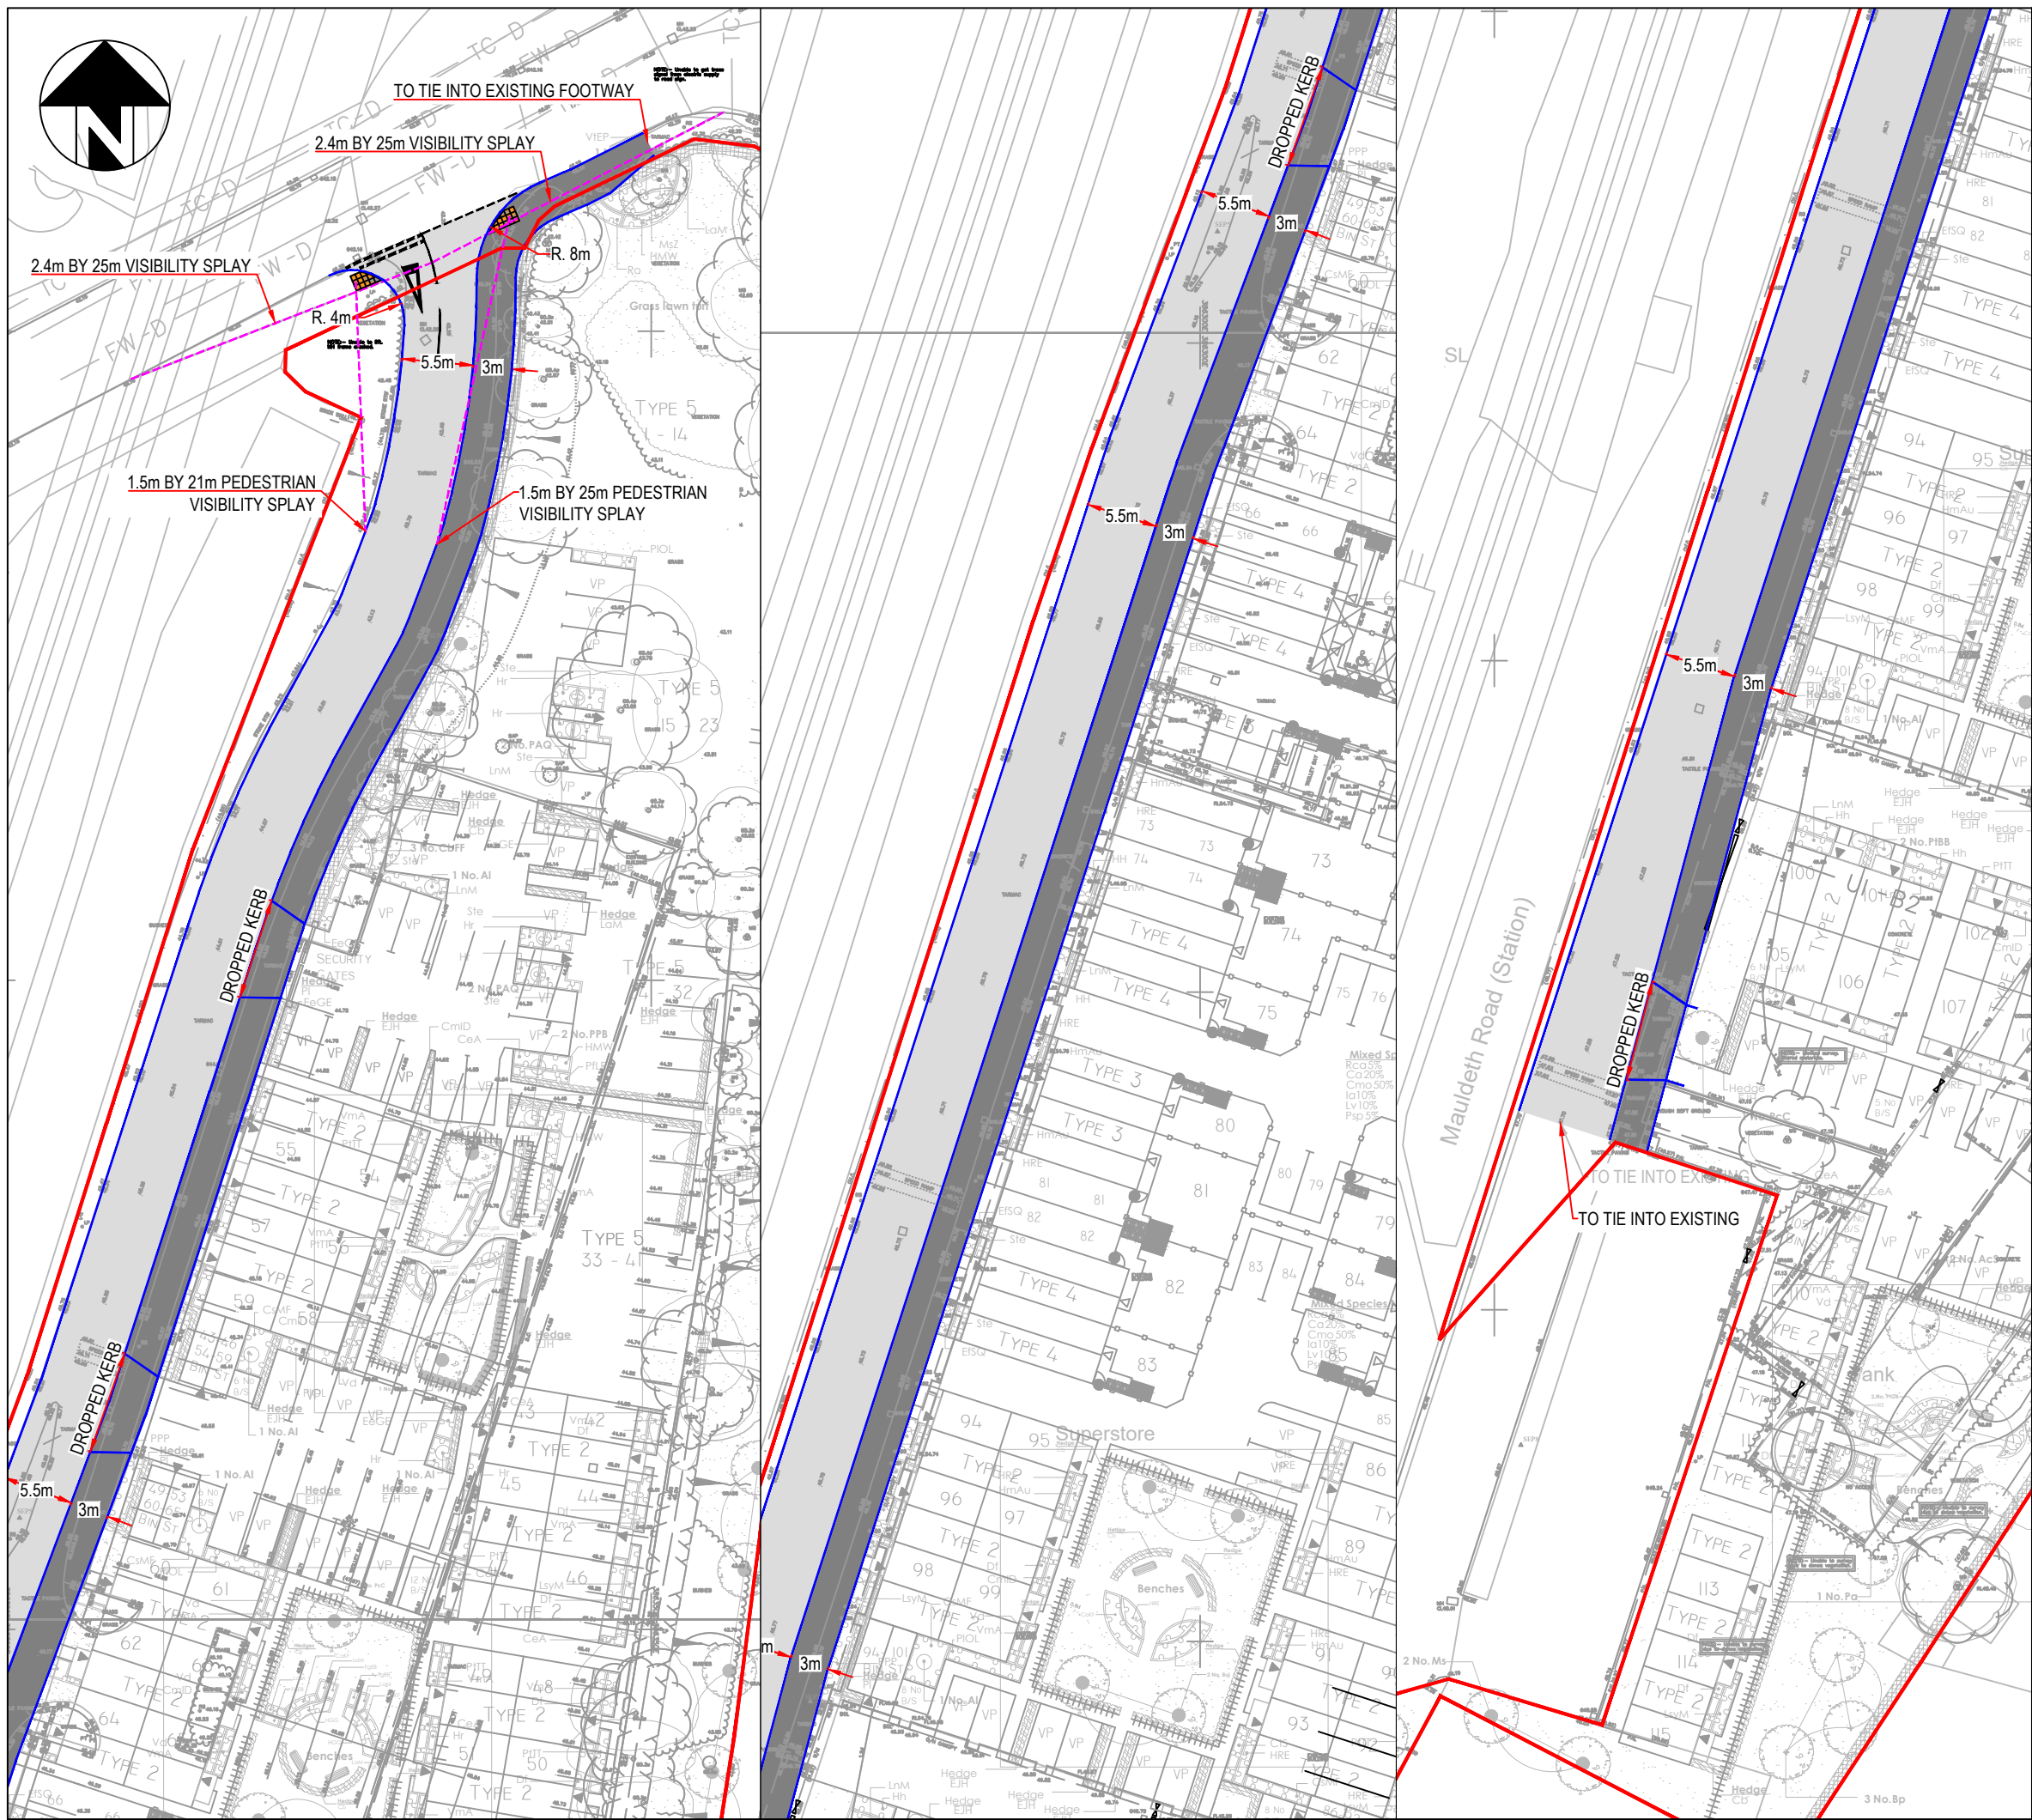
| Drawing No. | AMA/21894/SK007 | | Paper size:<br>A3 |

| P03 | Amended to include pedestrian visibility splays | 24/01/25 | ECT |

| RSA Problem | RSA Recommendation | Design Organisation Response | Overseeing Organisation Response | Agreed RSA Action |
|---|---|---|---|---|
| | | Overall, it is considered that as this is an improvement to an existing uncontrolled crossing and it will not cause any additional highway safety risks. | | |
