## Phase II Interpretative Ground Assessment

Grey Mare Lane  
Manchester

Client: Great Places

Reference: 34338-SUT-ZZ-00-RP-G-7201

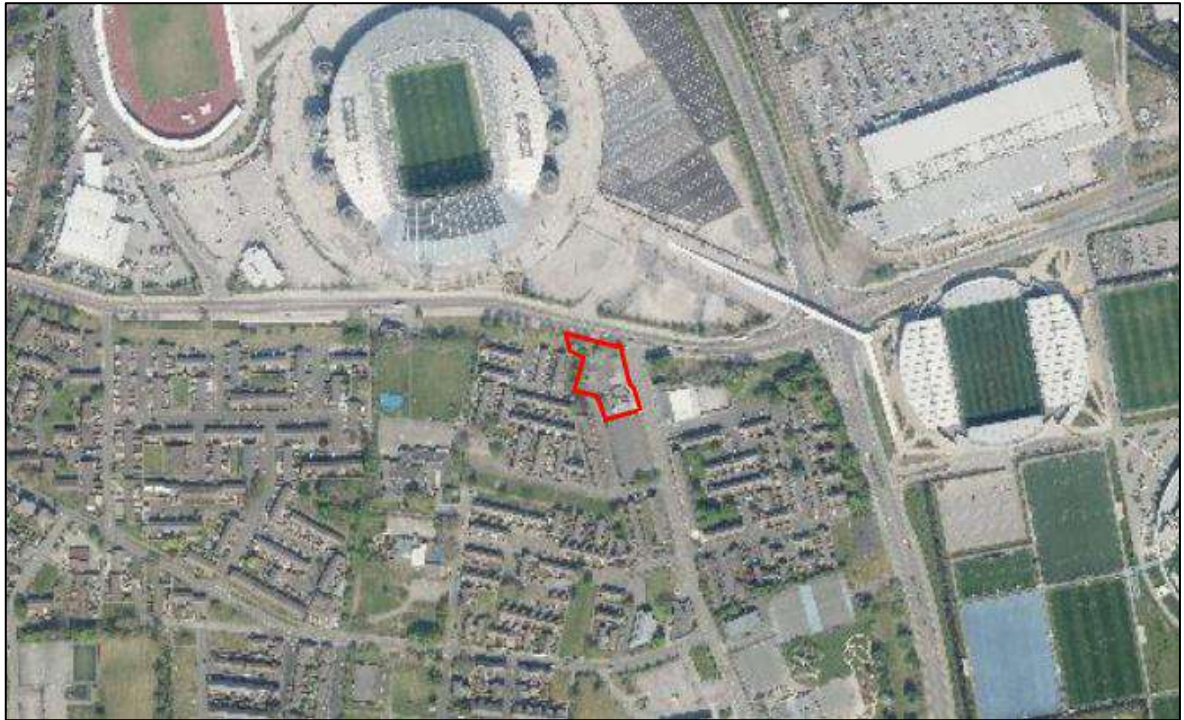
Figure 2: Aerial Photograph of the Site

The site is irregular in shape, 0.47ha and can be accessed via Grey Mare Lane along the south-eastern boundary of the site. The northern part of the site is currently covered with grass soft standing with a line of mature trees along the northern boundary. The southern portion of the site is currently unoccupied and covered with asphalt hardstanding. The central portion of the site used to contain the former public house however since its demolition, the area has been left as concrete hardstanding. An area of the central section is currently used as car parking for local residents with street lighting also noted. Curbs and street furniture are prevalent through this area along highway access to the former pub and car park.

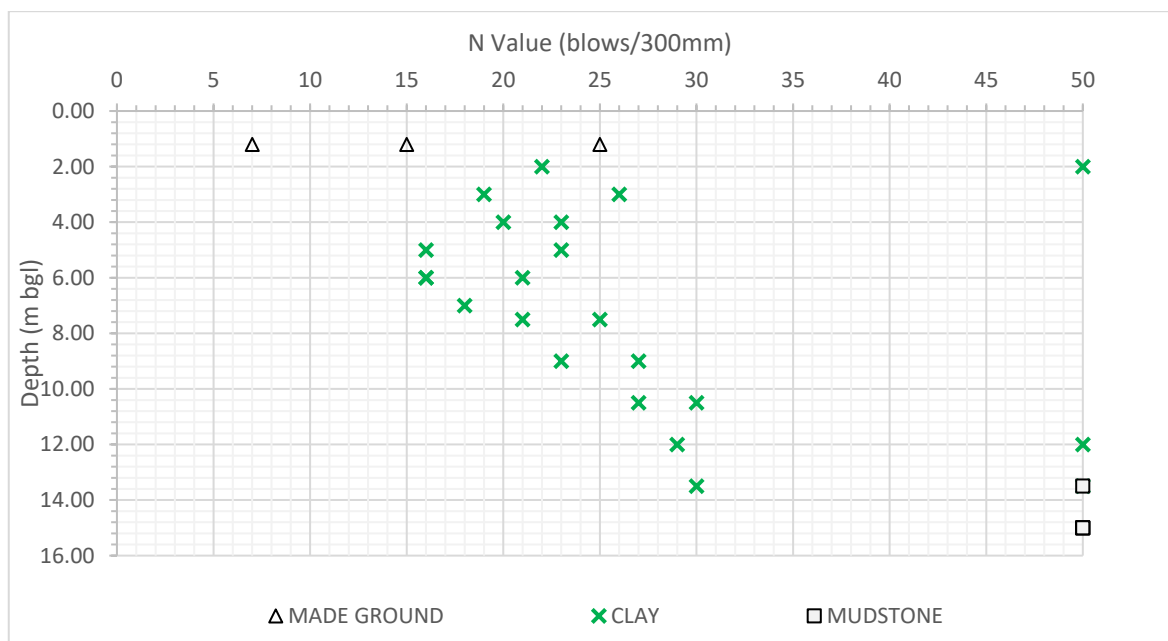
Figure 3: SPT Results

The standard penetration test (SPT) is used to provide geotechnical engineering properties for foundation design purposes. The results can be used to determine the relative density, bearing capacity, and settlement of granular soil. The results can also be used to correlate the approximate strength of cohesive soil.

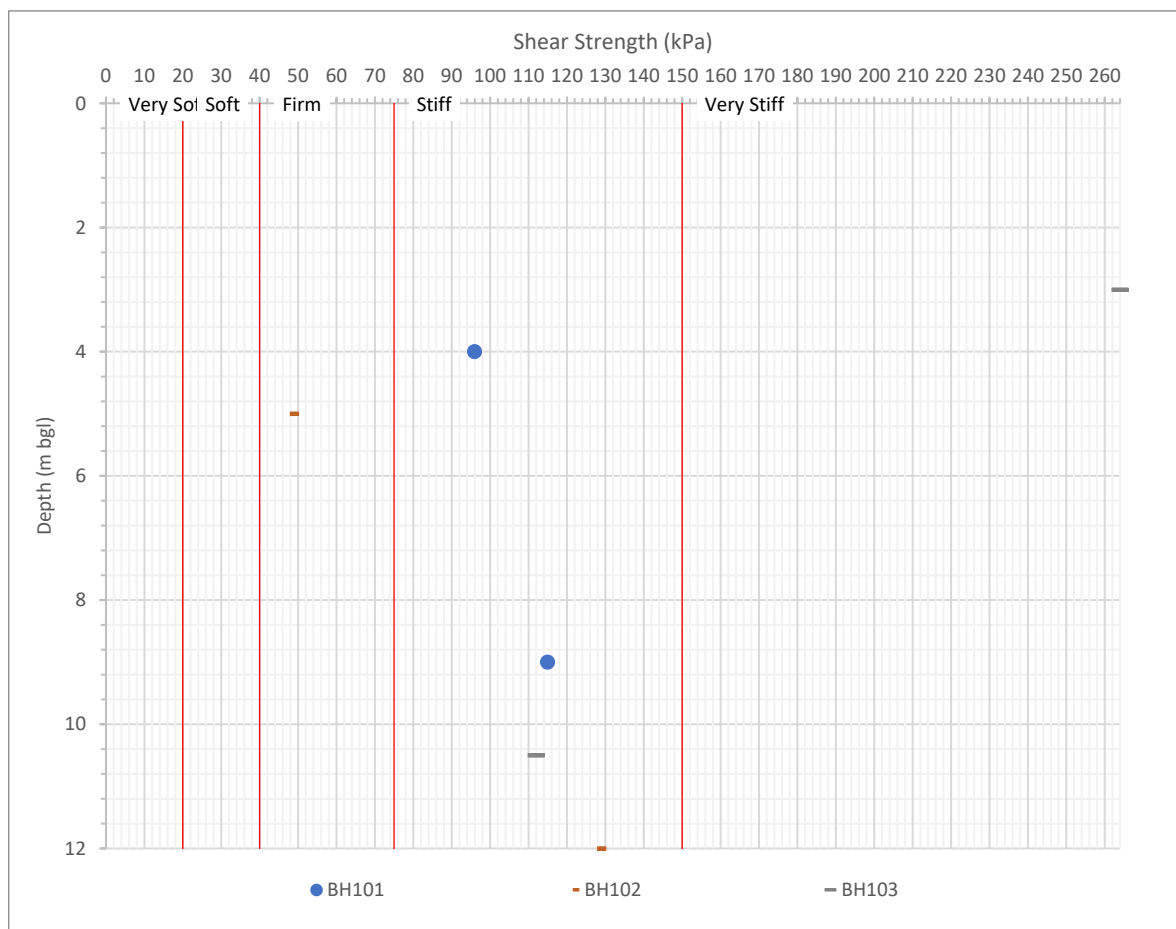
Figure 5: Shear Strength Test Results

A summary of the Shear Strength Testing including Triaxial Testing is presented in Figure 5.

The results of this testing indicate that the shear strength of the clay classifies as firm to very stiff, with the strength of the clay generally increasing with depth with the exception of material in BH103.

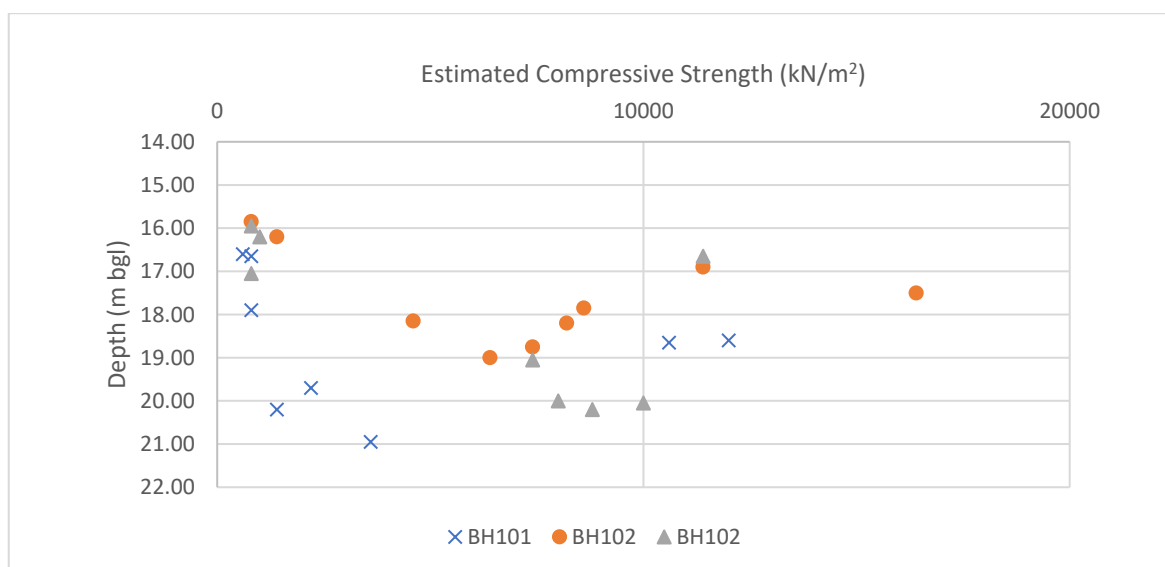
Figure 6: Point Load Results

Point Load Test Results are included within Appendix E.

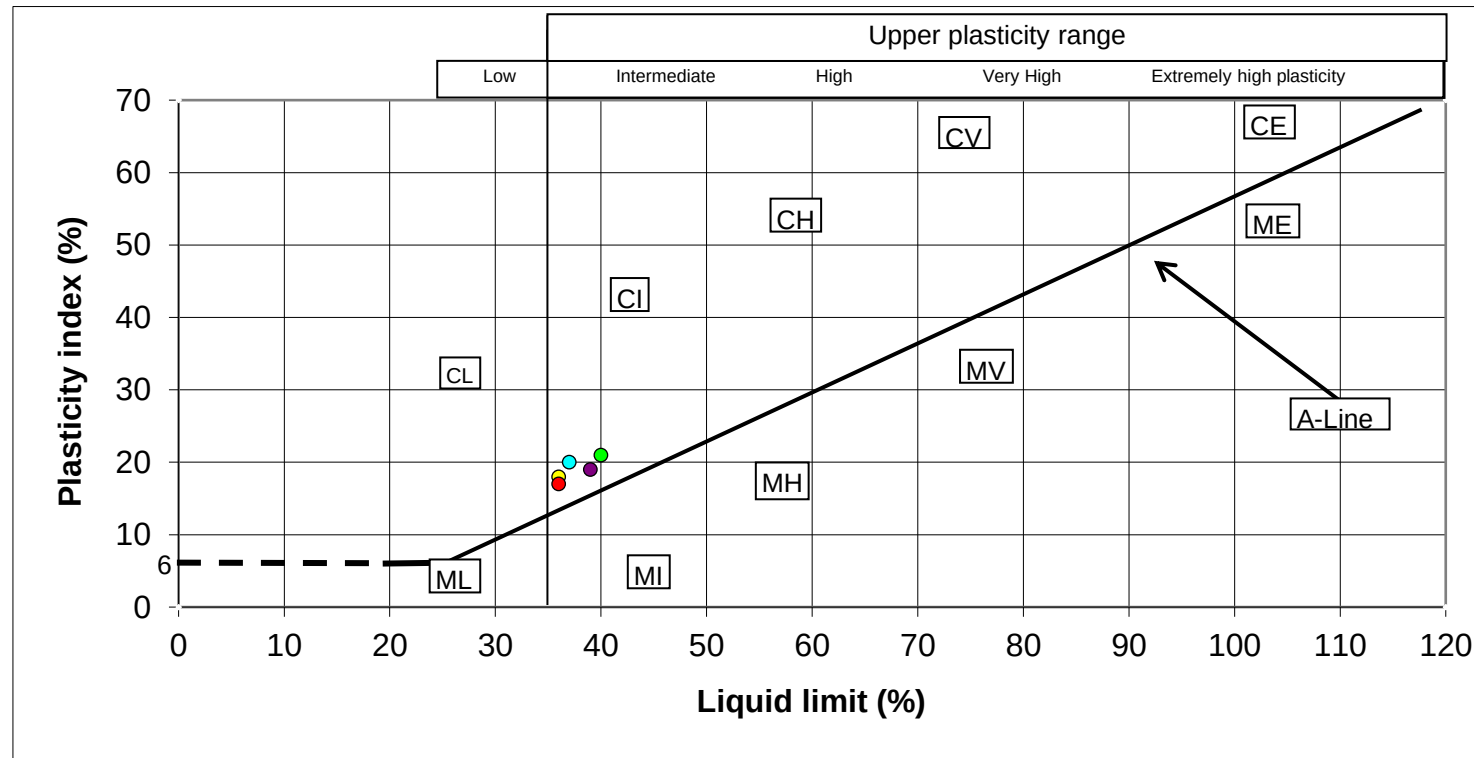
SILT (M-SOIL), M plots below A-Line , CLAY,C, plots above A-Line, M and C may be combined as FINE SOIL, F.

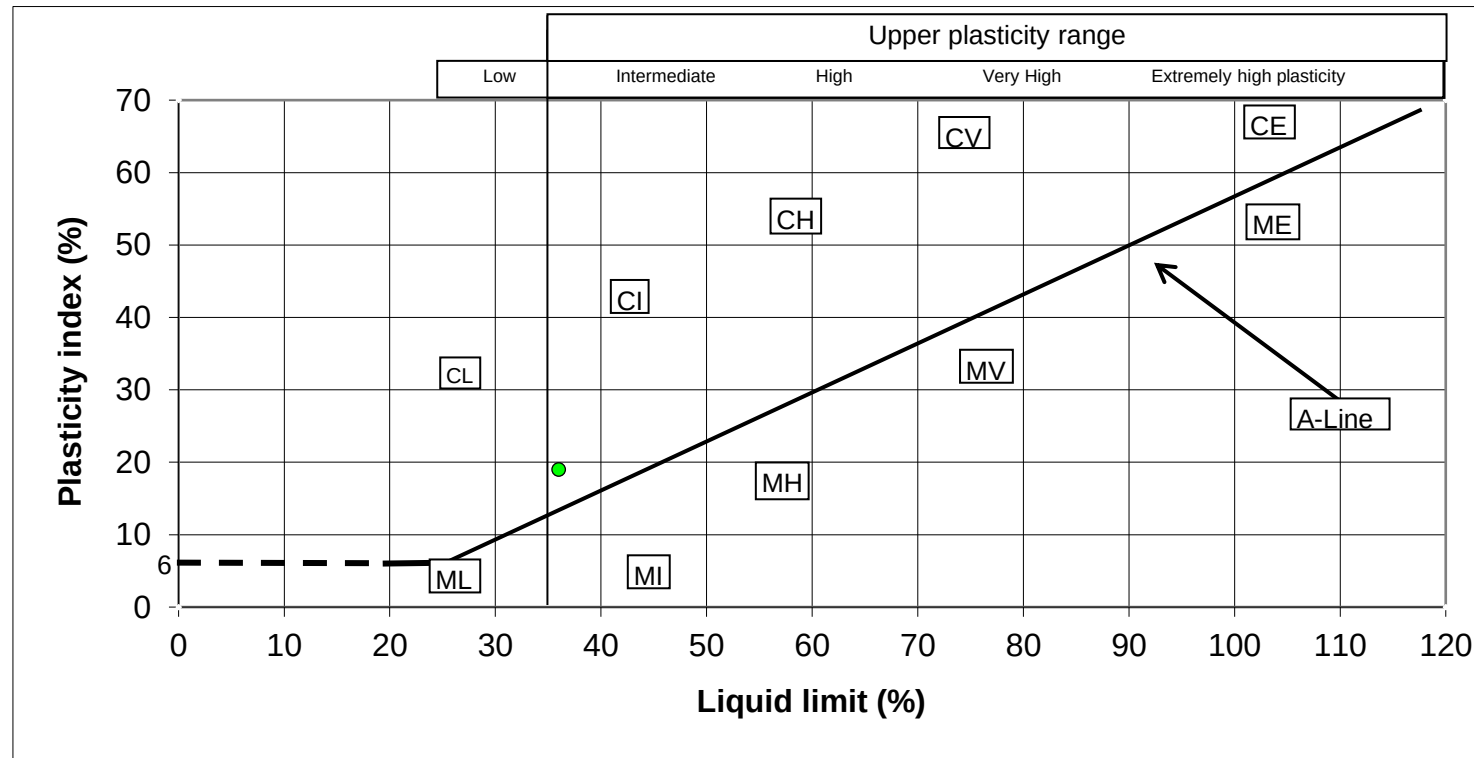
SILT (M-SOIL), M plots below A-Line , CLAY,C, plots above A-Line, M and C may be combined as FINE SOIL, F.

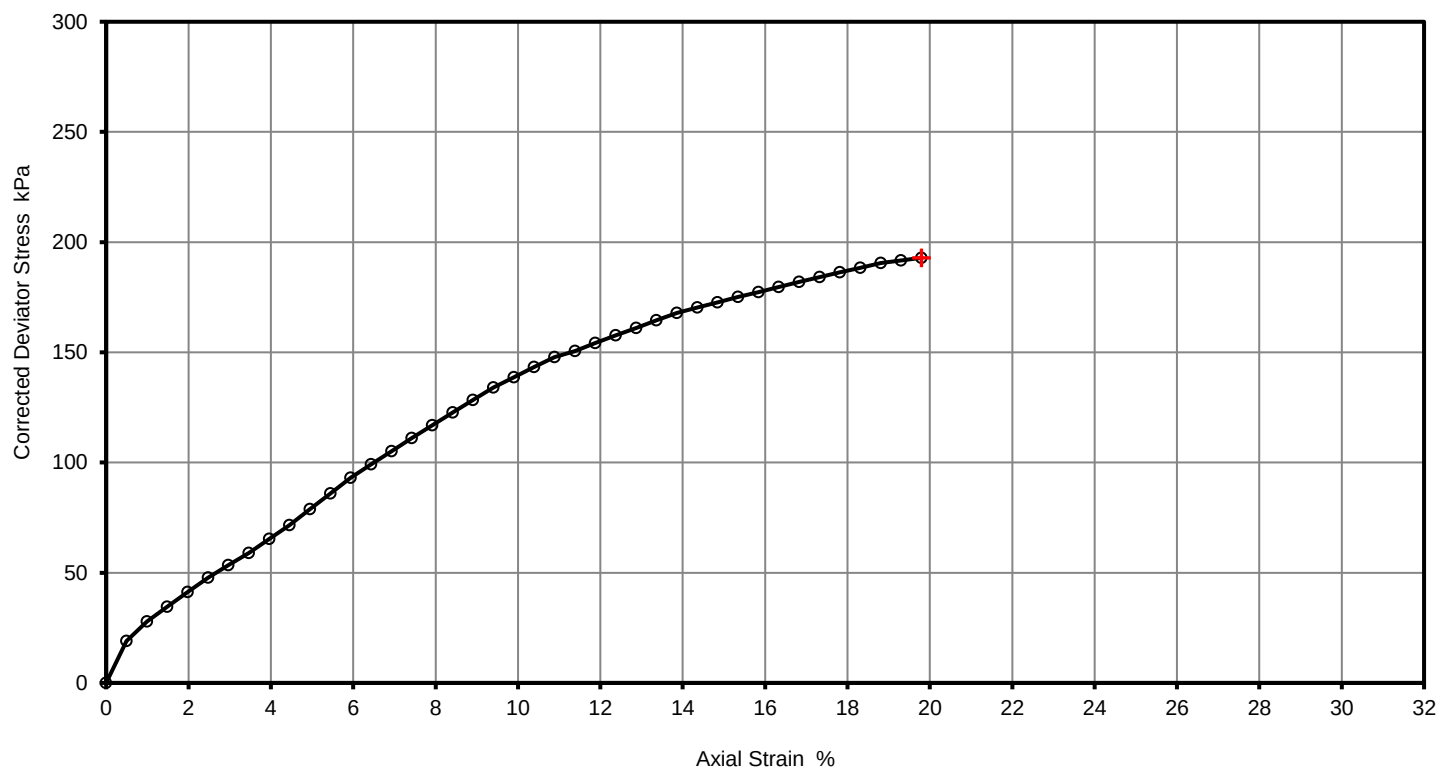
## Deviator Stress v Axial Strain

0.5mm membrane, correction factor = 1.88

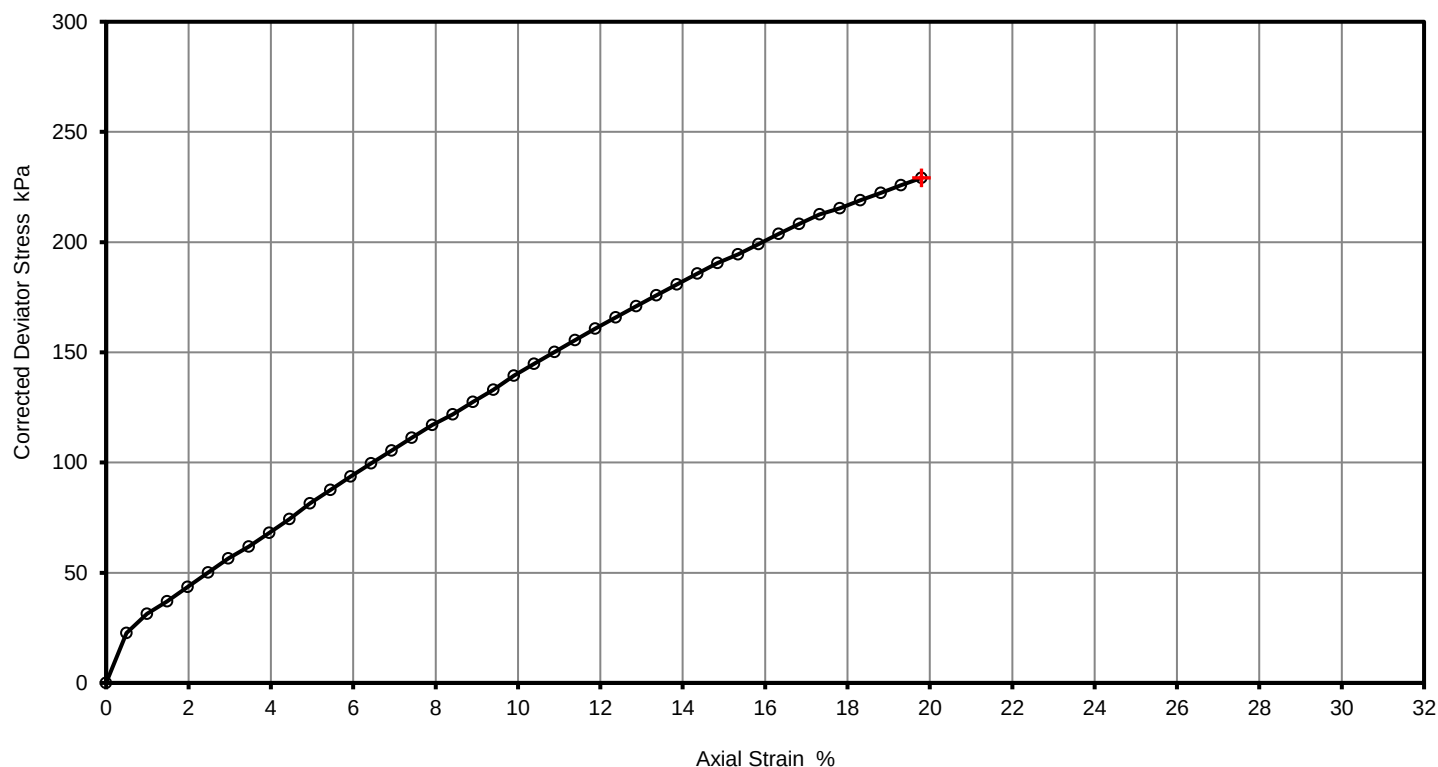
## Deviator Stress v Axial Strain

0.5mm membrane, correction factor = 1.87

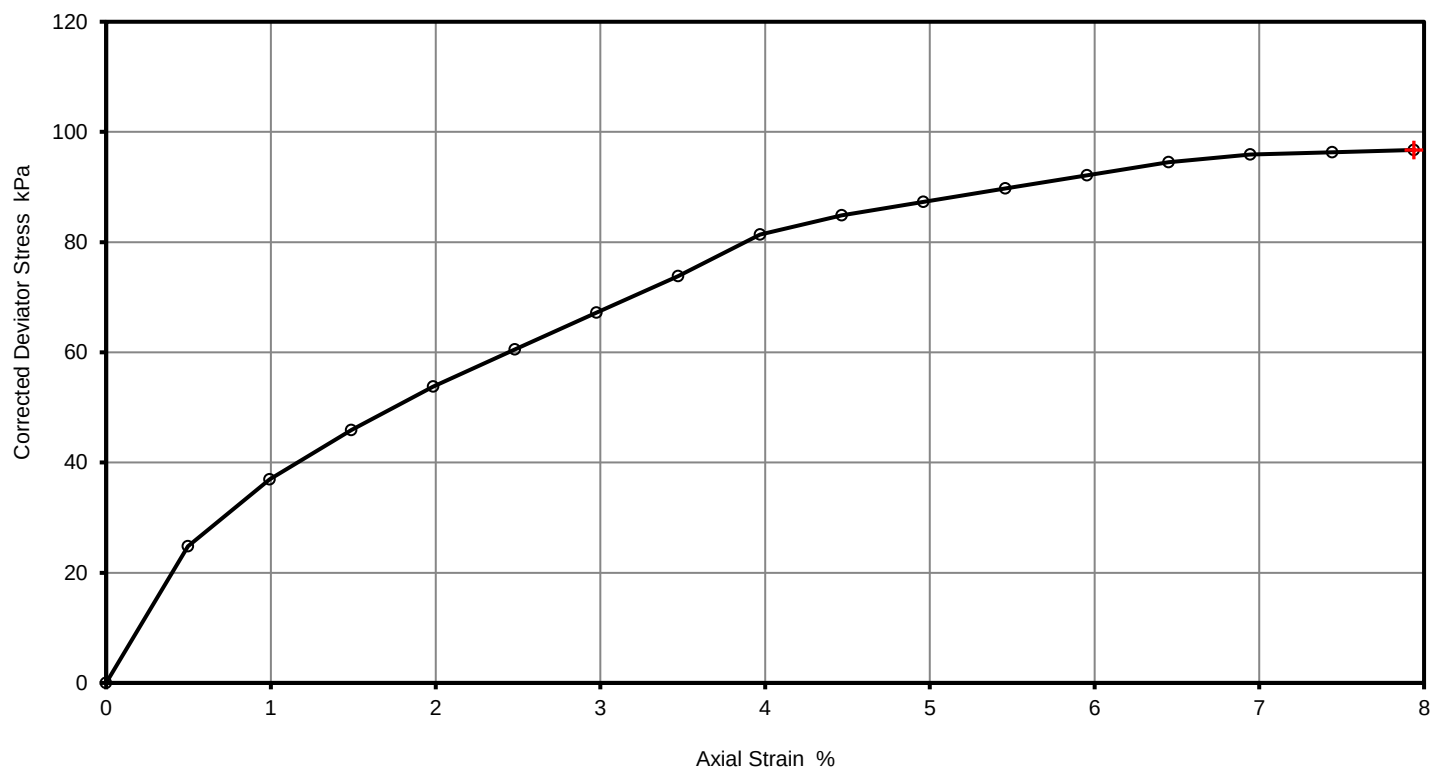
## Deviator Stress v Axial Strain

0.5mm membrane, correction factor = 0.95

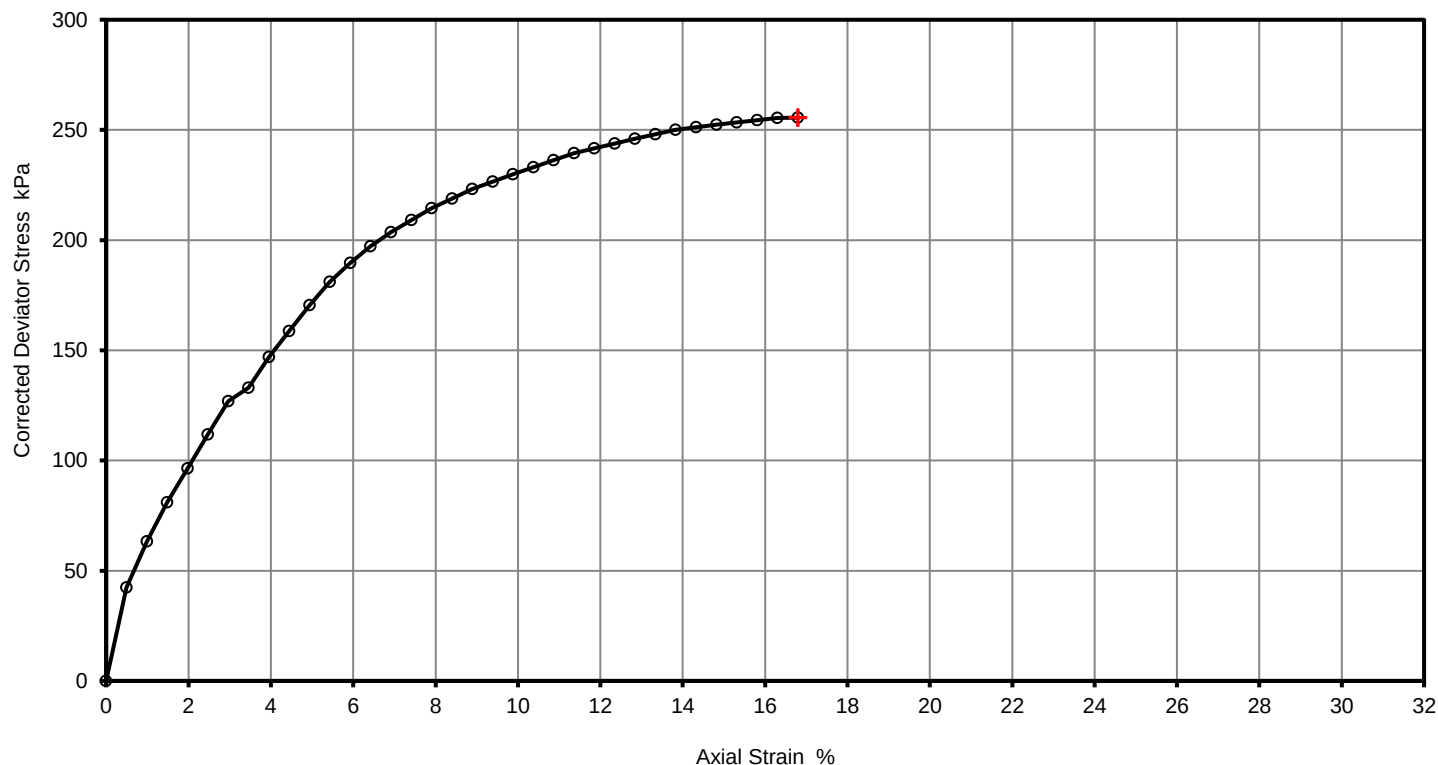
## Deviator Stress v Axial Strain

0.5mm membrane, correction factor = 1.65

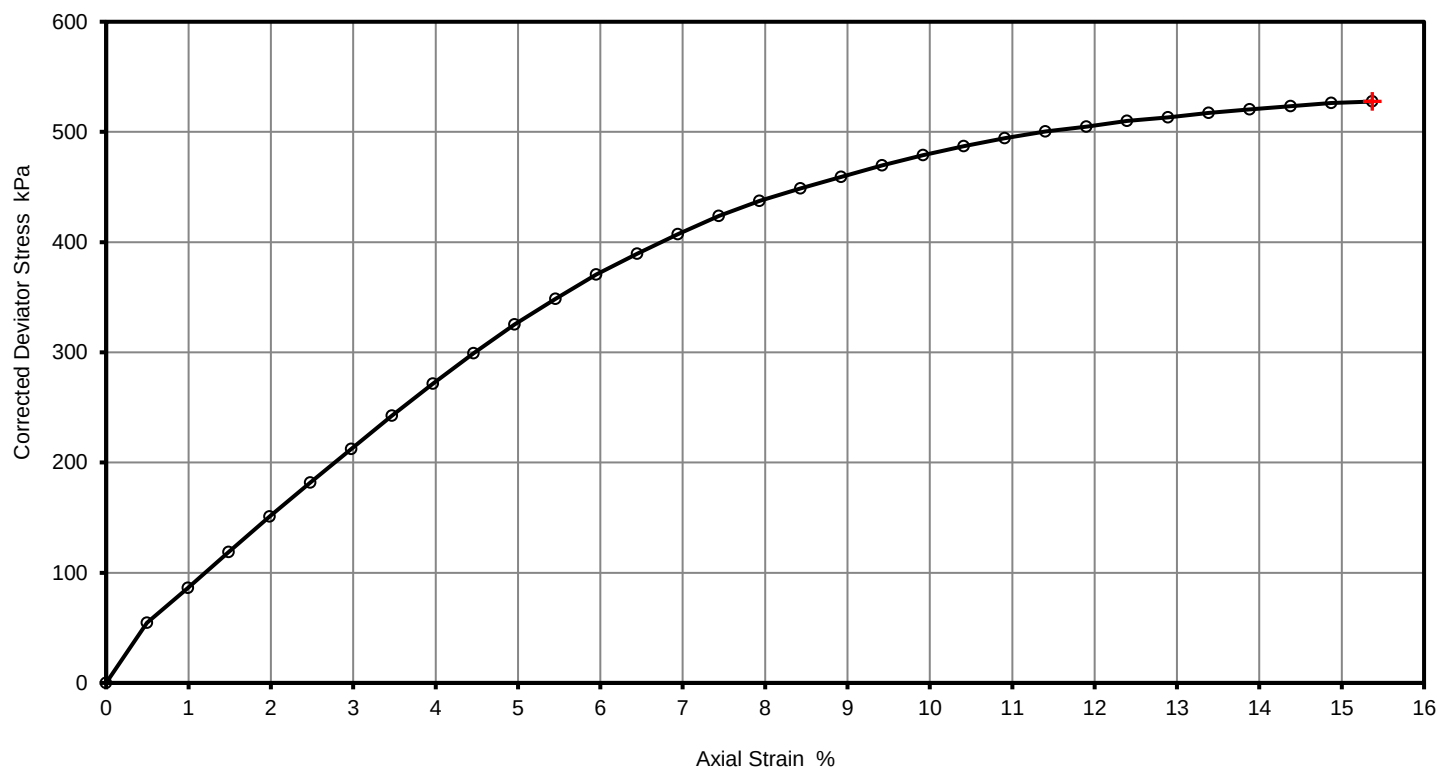
## Deviator Stress v Axial Strain

0.5mm membrane, correction factor = 1.53

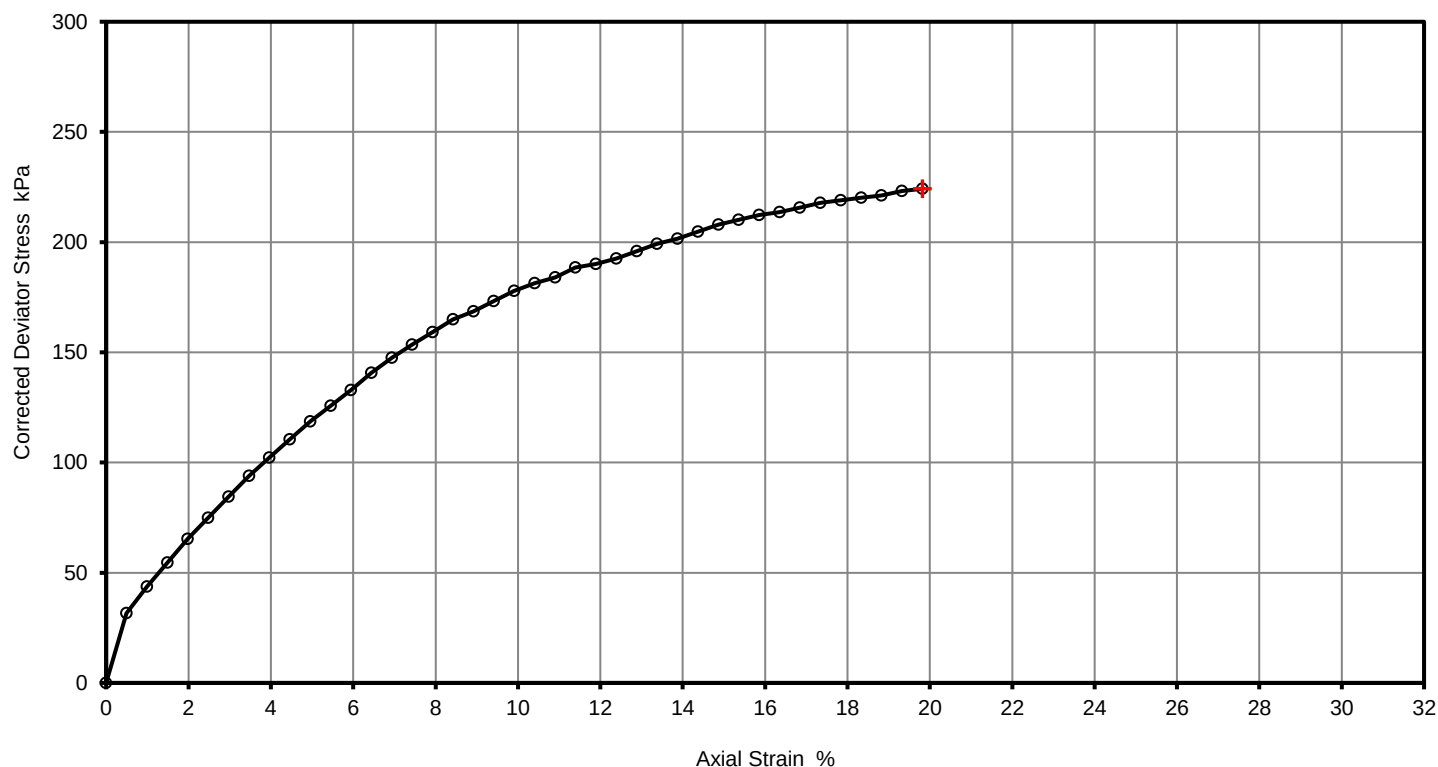
## Deviator Stress v Axial Strain

0.5mm membrane, correction factor = 1.90

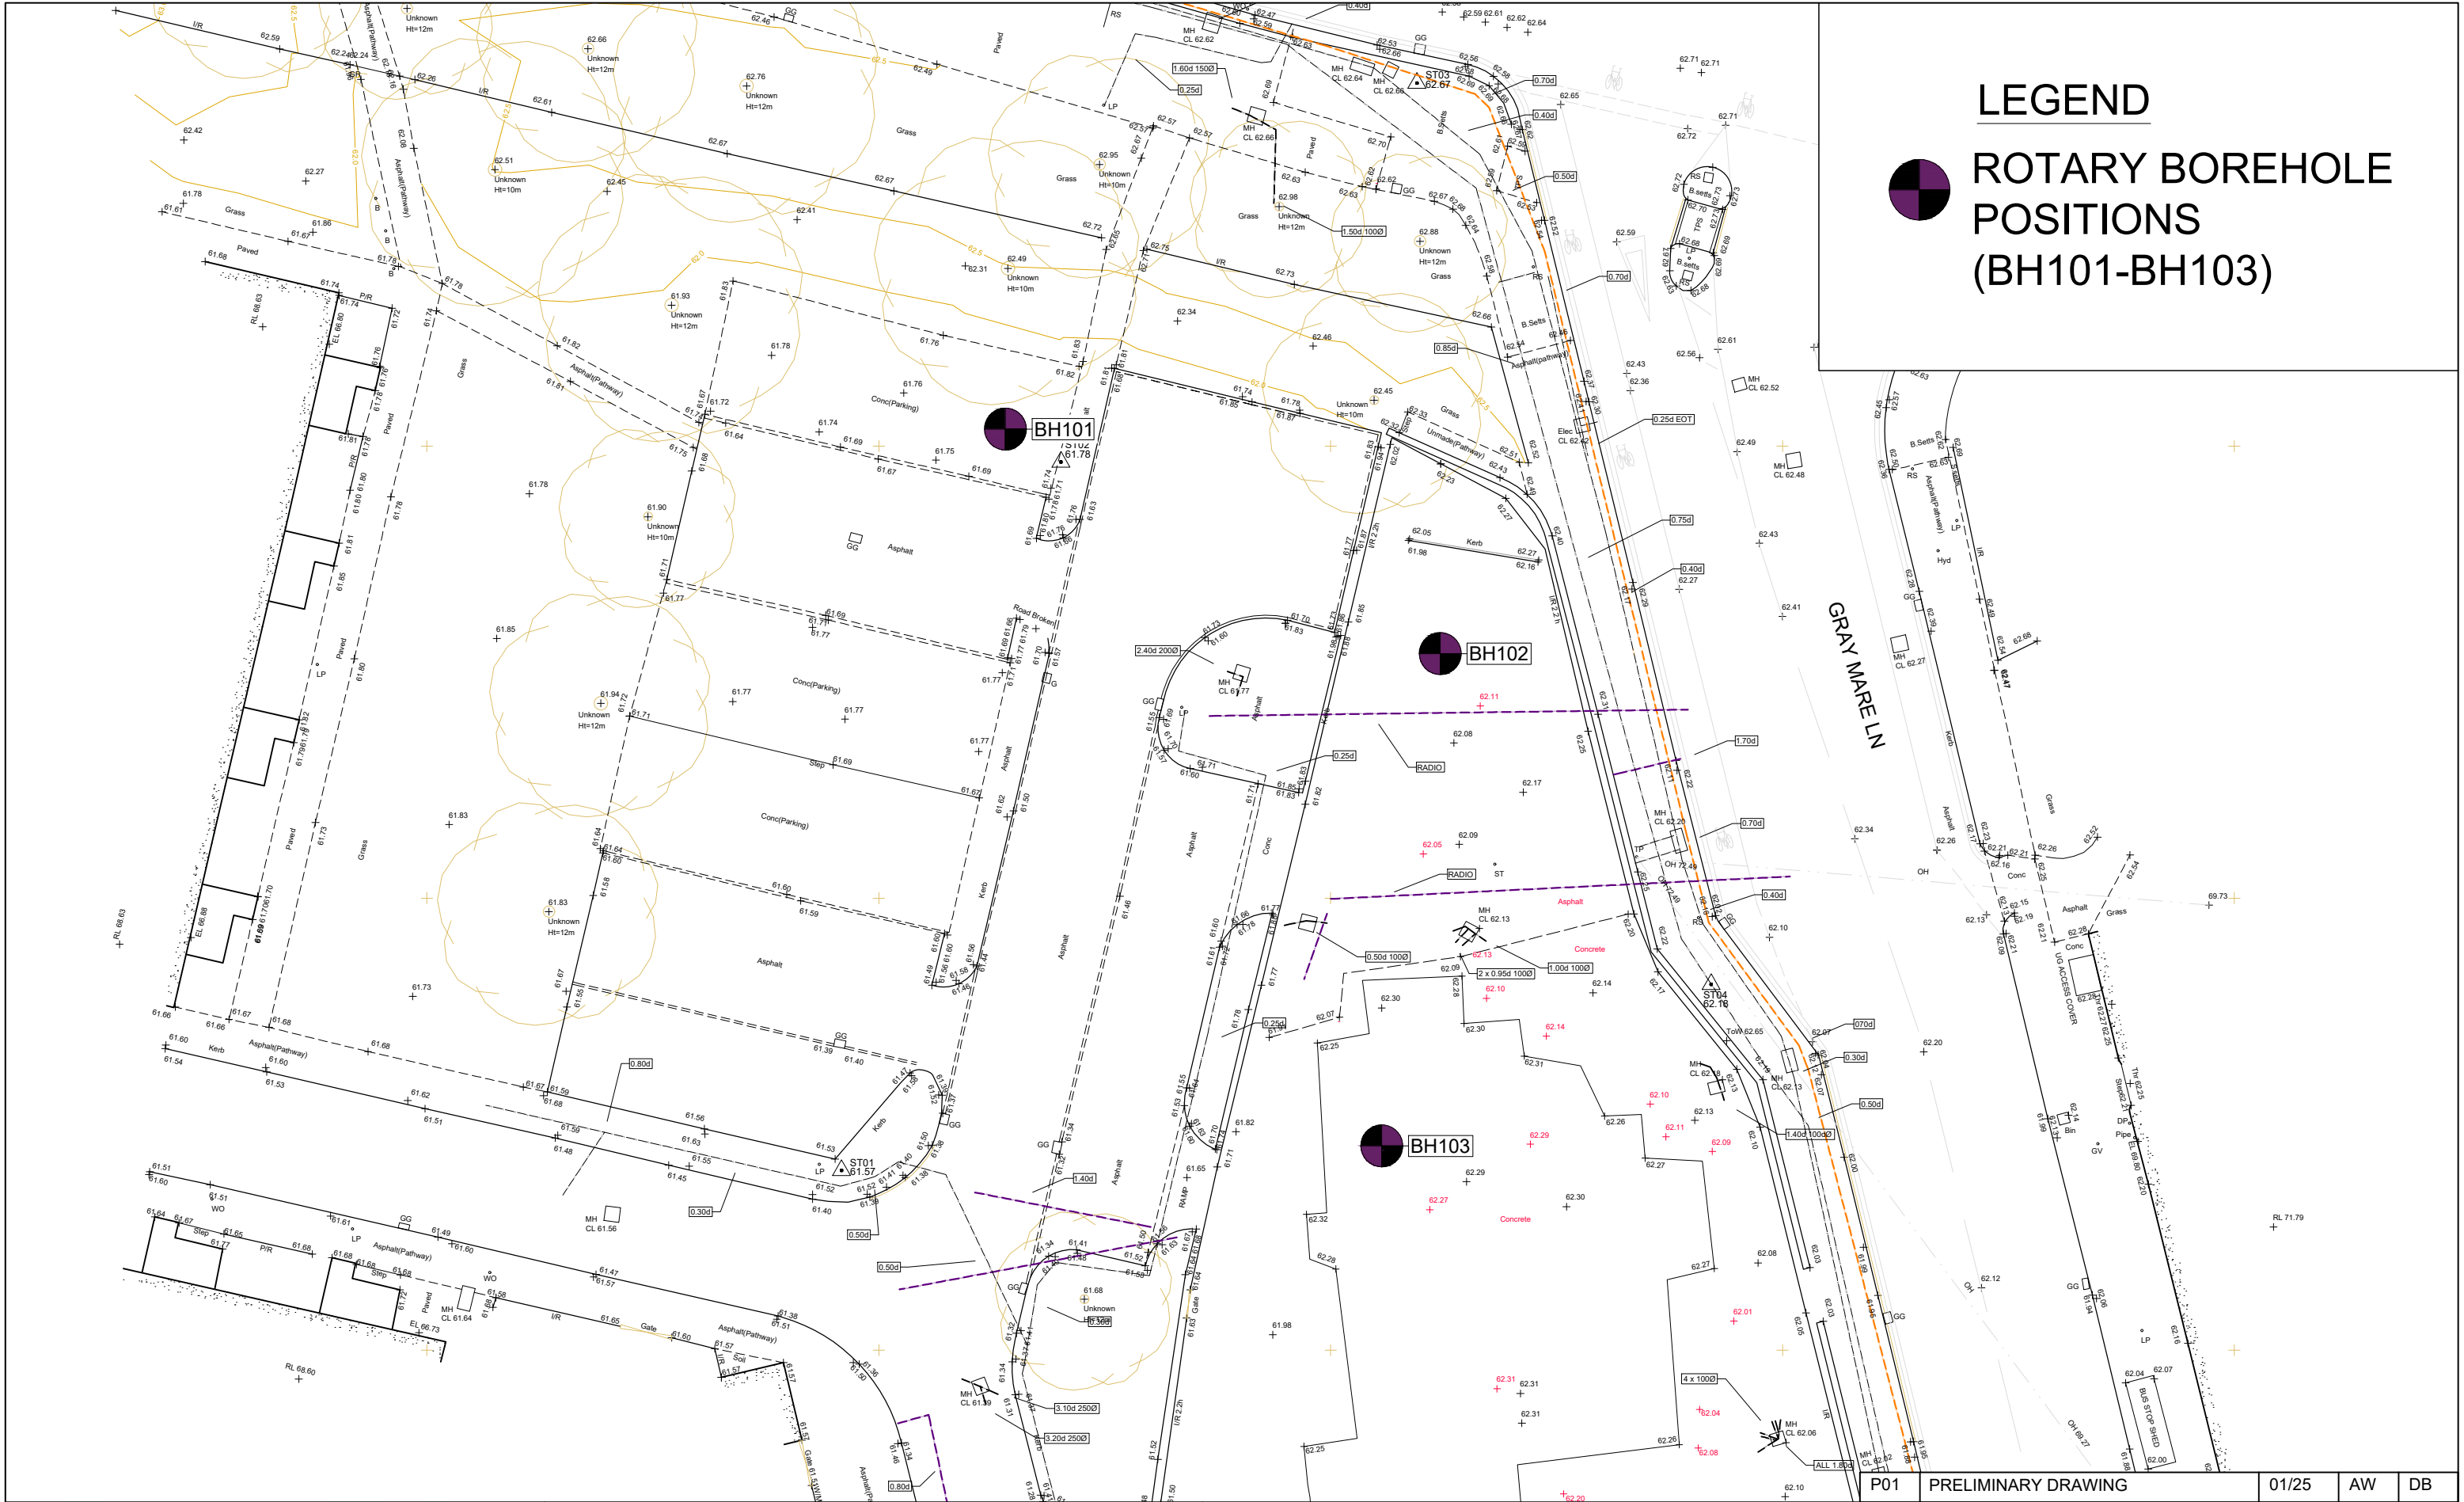
**Drawing Ref. – 34338-SUT-ZZ-XX-DR-G-7251 (Site Investigation on Proposed Layout)**

● ROTARY BOREHOLE POSITIONS (BH101-BH103)
