opening up works schedule

Subject: OUW  
Project: Rylands Building, Manchester  
Reference: OUW Schedule 05.02.21  
Author: EAJC  
Reviewer: NGRC

Ref: EAJC / OUW Schedule 05.02.21 / Rylands Building, Manchester / 05 February 2021

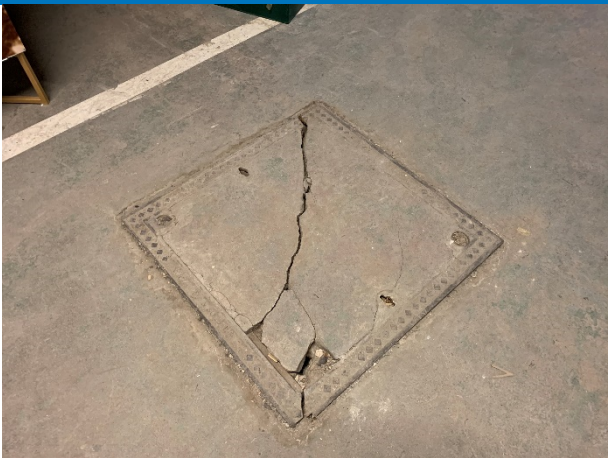
| Item | Level | Element | Grid Location | OUW | Value | Reinstatement | Photograph |
|---|---|---|---|---|---|---|---|
| 1 | -2 | Drainage | C10<br>C8<br>R1/17<br>T10-V12 | OUW5-1 (Low level)<br>OUW5-2 (Low level) | The site visits undertaken by Woolgar Hunter have identified a number of manholes, some of which are numbered up to MH14. A full drainage survey is required to determine the condition of the drainage network, as well as the exits from the structure. This will also enable the PDE with United Utilities to progress, for example. | N/A | |
| | | | | | | | Indicative location – specific photos required. |

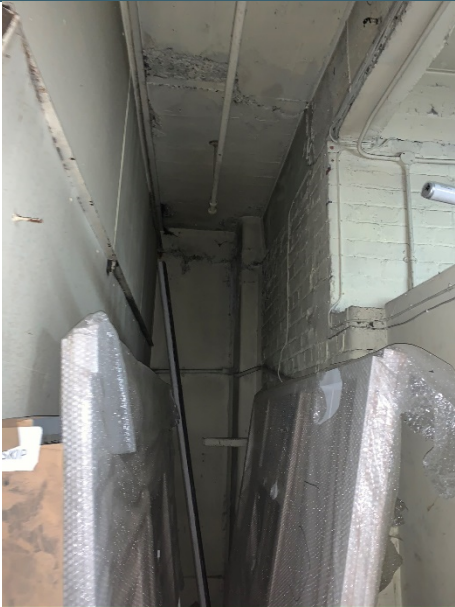
| Item | Level | Element | Grid Location | OUW | Value | Reinstatement | Photograph |
|---|---|---|---|---|---|---|---|
| 2 | -2 | Basement Wall/<br>Foundations | K12<br>L12<br>Q14<br>S1/17 | OUW1-6 (Low level)<br>OUW6-1 (Full height)<br>OUW6-2 (Mid level, only for S1/17) | Information on the existing foundations is required to develop the Stage 2 proposed foundation enhancement details, which will be required with the additional load from the proposed extension. This will be done using non-intrusive or minimal intrusive works wherever possible.<br><br>As the building has been poorly maintained for a period of time and there will be a change in load on the basement walls, non-intrusive techniques will be used to determine the wall's properties as described in the report, which will aid the development of any remedial details. Chemical and strength testing will allow for the structural properties of the basement wall to be verified, with the change in load that will be experienced. | Type 5<br>Type 8 | |
| | | | | | | | Indicative location – specific photos required. |

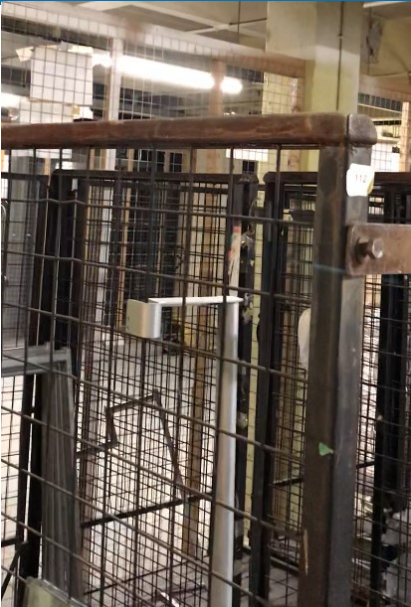
| Item | Level | Element | Grid Location | OUW | Value | Reinstatement | Photograph |
|---|---|---|---|---|---|---|---|
| 3 | -2 | Slab | H8-I9 | OUW3-4 (Low level) | Ferros scanning of the slab, which is non-intrusive work and will minimise disruption, will allow for a greater understanding of the composition of the reinforced concrete slab, which will be required to verify the capacity of the slab. | N/A | |
| | | | | | | | Updated photo required without stock present. |

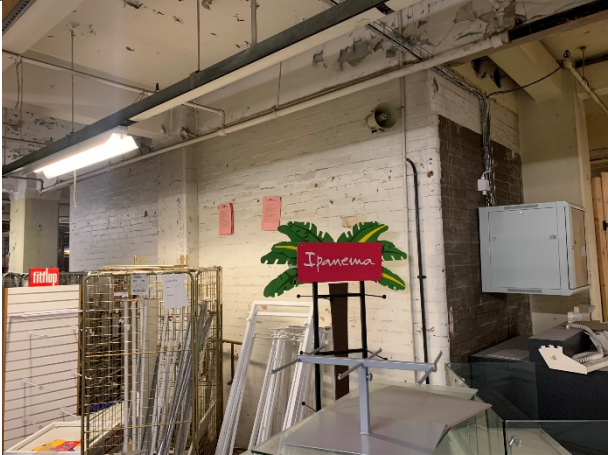
| Item | Level | Element | Grid Location | OUW | Value | Reinstatement | Photograph |
|---|---|---|---|---|---|---|---|
| 4 | -2 | Slab/<br>Foundations | R9/S12 | OUW3-4 (Low level)<br>OUW3-5 (Low level) | <p>Ferros scanning of the slab, which is non-intrusive work and will minimise disruption, will allow for a greater understanding of the composition of the reinforced concrete slab, which will be required to verify the capacity of the slab.</p> <p>With the increased height of the building, the enhanced core will require existing foundation to be enhanced. The arrangement of the existing core foundations must be understood to develop appropriate enhancement of the foundations.</p> | Type 5 | |
| | | | | | | | Indicative location – specific photo required. |

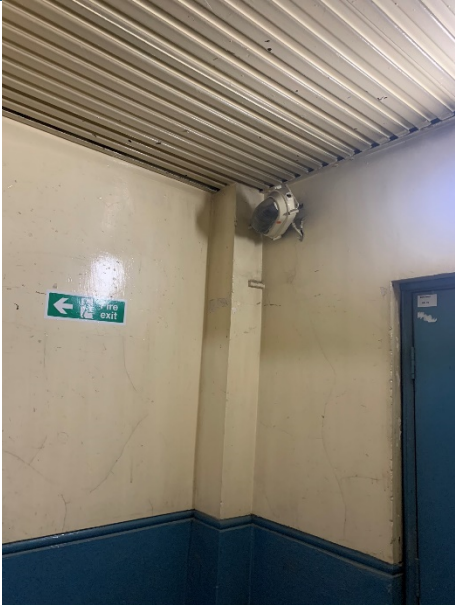
| Item | Level | Element | Grid Location | OUW | Value | Reinstatement | Photograph |
|---|---|---|---|---|---|---|---|
| 5 | -2 | Column/<br>Incoming<br>Beams/<br>Slab/<br>Foundations | F10 | OUW1-1 (High level)<br>OUW1-3 (Full height/ high level)<br>OUW1-4 (High level)<br>OUW1-5 (Full height)<br>OUW1-6 (Low level) | <p>The connection of the slab to the steel grillage must be known to develop diaphragm action, which is critical for wind loading.</p> <p>The column/ beam attributes, as described in the report, are required to verify existing capacities of structure and develop enhancement details where possible. This will be undertaken using non-intrusive works where possible.</p> <p>The structure must be investigated to assess its potential for disproportionate collapse and nominal tying. This will only be achieved through intrusive works but will be kept to a minimum.</p> <p>The non-intrusive void scanning of the columns will provide insight into the level of compaction and quality of construction. The presence of voids will affect the suitability of the proposed enhancement details for columns.</p> | Type 1<br>Type 2<br>Type 4<br>Type 5 | |

| Item | Level | Element | Grid Location | Ouw | Value | Reinstatement | Photograph |
|---|---|---|---|---|---|---|---|
| | | | | | With the increased height of the building, the proposed core will require construction adjacent to existing foundations. Integration of the new core will require an understanding of the existing foundations to develop proposed foundations. | | Correct location – additional photos required. |

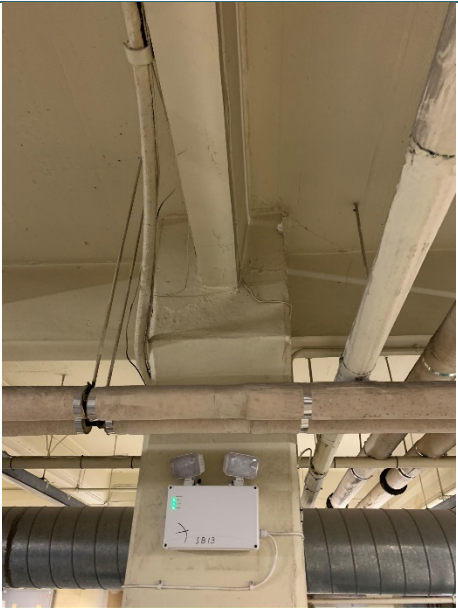
| Item | Level | Element | Grid Location | Ouw | Value | Reinstatement | Photograph |
|---|---|---|---|---|---|---|---|
| 6 | -2 | Column/<br>Incoming<br>Beams/<br>Slab/<br>Foundations | N9 | Ouw1-1 (High level)<br>Ouw1-2 (Low level)<br>Ouw1-3 (Full height/ high level)<br>Ouw1-4 (High level)<br>Ouw1-5 (Full height)<br>Ouw1-6 (Low level) | <p>The connection of the slab to the steel grillage must be known to develop diaphragm action, which is critical for wind loading.</p> <p>Ferros scanning of the slab, which is non-intrusive work and will minimise disruption, will allow for a greater understanding of the composition of the reinforced concrete slab, which will be required to verify the capacity of the slab.</p> <p>The column/ beam attributes, as described in the report, are required to verify existing capacities of structure and develop enhancement details where possible. This will be undertaking using non-intrusive works where possible.</p> <p>The structure must be investigated to assess its potential for disproportionate collapse and nominal tying. This will only be achieved through intrusive works but will be kept to a minimum.</p> <p>The non-intrusive void scanning of the columns will provide insight into the level of compaction and quality of construction. The presence of voids will affect the suitability of the proposed enhancement details for columns.</p> <p>As the foundations under the roof extension will experience a change in load, the capacity of the existing foundations must be understood to develop a suitable enhancement detail.</p> | Type 1<br>Type 2<br>Type 4<br>Type 5 | |

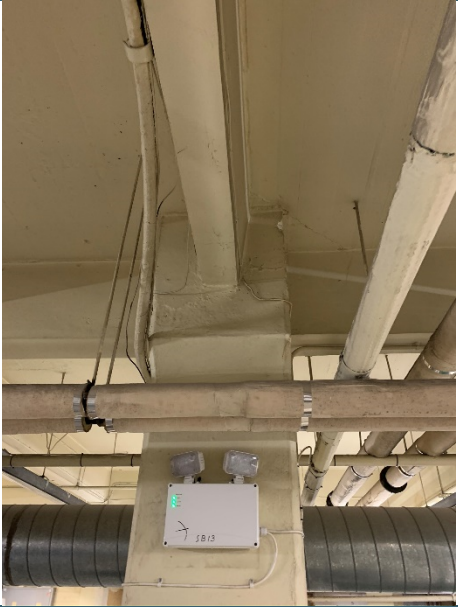
| Item | Level | Element | Grid Location | Ouw | Value | Reinstatement | Photograph |
|---|---|---|---|---|---|---|---|
| 7 | -2 | Column/<br>Incoming<br>Beams/<br>Slab/<br>Foundations | O10 | Ouw1-1 (High level)<br>Ouw1-2 (Low level)<br>Ouw1-3 (Full height/ high level)<br>Ouw1-4 (High level)<br>Ouw1-5 (Full height)<br>Ouw1-6 (Low level) | <p>The connection of the slab to the steel grillage must be known to develop diaphragm action, which is critical for wind loading.</p> <p>Ferros scanning of the slab, which is non-intrusive work and will minimise disruption, will allow for a greater understanding of the composition of the reinforced concrete slab, which will be required to verify the capacity of the slab.</p> <p>The column/ beam attributes, as described in the report, are required to verify existing capacities of structure and develop enhancement details where possible. This will be undertaking using non-intrusive works where possible.</p> <p>The structure must be investigated to assess its potential for disproportionate collapse and nominal tying. This will only be achieved</p> | Type 1<br>Type 2<br>Type 4<br>Type 5 | |

| Item | Level | Element | Grid Location | OUW | Value | Reinstatement | Photograph |
|---|---|---|---|---|---|---|---|
| | | | | | through intrusive works but will be kept to a minimum.<br>The non-intrusive void scanning of the columns will provide insight into the level of compaction and quality of construction. The presence of voids will affect the suitability of the proposed enhancement details for columns.<br>As the foundations under the roof extension will experience a change in load, the capacity of the existing foundations must be understood to develop a suitable enhancement detail. | | Indicative location – specific photo required. |

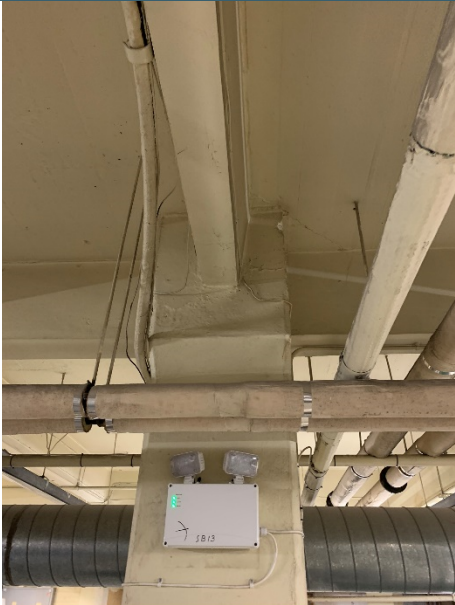
| Item | Level | Element | Grid Location | OUW | Value | Reinstatement | Photograph |
|---|---|---|---|---|---|---|---|
| 8 | -2 | Column/<br>Incoming<br>Beams/<br>Slab/<br>Foundations | O12 | OUW1-1 (High level)<br>OUW1-2 (Low level)<br>OUW1-3 (Full height/ high level)<br>OUW1-4 (High level)<br>OUW1-5 (Full height)<br>OUW1-6 (Low level) | The connection of the slab to the steel grillage must be known to develop diaphragm action, which is critical for wind loading.<br>Ferroscanning of the slab, which is non-intrusive work and will minimise disruption, will allow for a greater understanding of the composition of the reinforced concrete slab, which will be required to verify the capacity of the slab.<br>The column/ beam attributes, as described in the report, are required to verify existing capacities of structure and develop enhancement details where possible. This will be undertaken using non-intrusive works where possible.<br>The structure must be investigated to assess its potential for disproportionate collapse and nominal tying. This will only be achieved through intrusive works but will be kept to a minimum.<br>The non-intrusive void scanning of the columns will provide insight into the level of compaction and quality of construction. The presence of voids will affect the suitability of the proposed enhancement details for columns.<br>As the foundations under the roof extension will experience a change in load, the capacity of the existing foundations must be understood to develop a suitable enhancement detail. | Type 1<br>Type 2<br>Type 4<br>Type 5 | |

Indicative location – specific photo required.

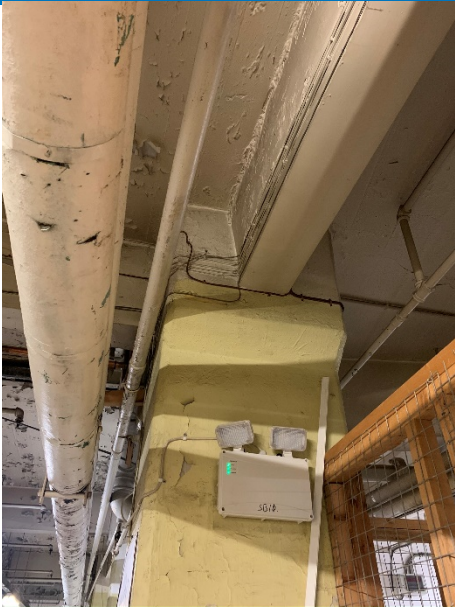
| Item | Level | Element | Grid Location | OUW | Value | Reinstatement | Photograph |
|---|---|---|---|---|---|---|---|
| 9 | -2 | Column/<br>Incoming<br>Beams/<br>Slab/<br>Foundations | H7 | OUW3-3 (Full height/ high level)<br>OUW3-4 (Low level)<br>OUW3-5 (Low level)<br>OUW3-6 (Full height) | <p>The column/ beam attributes, as described in the report, are required to verify existing capacities of structure and develop enhancement details where possible. This will be undertaking using non-intrusive works where possible.</p> <p>Ferros scanning of the slab, which is non-intrusive work and will minimise disruption, will allow for a greater understanding of the composition of the reinforced concrete slab, which will be required to verify the capacity of the slab.</p> <p>The non-intrusive void scanning of the columns will provide insight into the level of compaction and quality of construction. The presence of voids will affect the suitability of the proposed enhancement details for columns.</p> <p>With the increased height of the building, the proposed core will require construction adjacent to existing foundations. Integration of the new core will require an understanding of the existing foundations to develop proposed foundations.</p> | Type 1<br>Type 2<br>Type 4<br>Type 5 | |

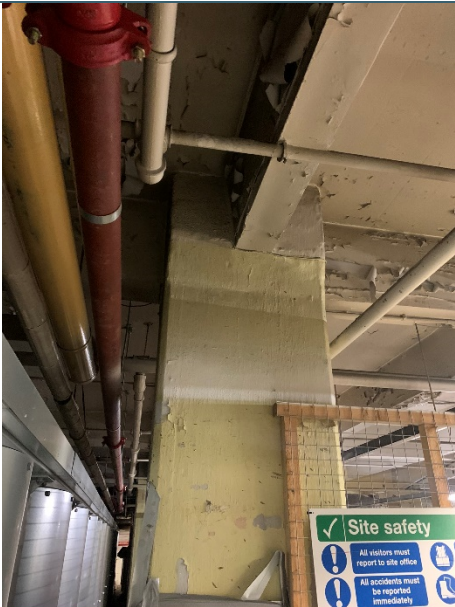
| Item | Level | Element | Grid Location | OUW | Value | Reinstatement | Photograph |
|---|---|---|---|---|---|---|---|
| 10 | -2 | Column/<br>Incoming<br>Beams/<br>Slab/<br>Foundations | H10 | OUW3-3 (Full height/ high level)<br>OUW3-4 (Low level)<br>OUW3-5 (Low level)<br>OUW3-6 (Full height) | <p>The column/ beam attributes, as described in the report, are required to verify existing capacities of structure and develop enhancement details where possible. This will be undertaking using non-intrusive works where possible.</p> <p>Ferros scanning of the slab, which is non-intrusive work and will minimise disruption, will allow for a greater understanding of the composition of the reinforced concrete slab, which will be required to verify the capacity of the slab.</p> <p>The non-intrusive void scanning of the columns will provide insight into the level of compaction and quality of construction. The presence of voids will affect the suitability of the proposed enhancement details for columns.</p> <p>With the increased height of the building, the proposed core will require construction adjacent to existing foundations. Integration of the new core will require an understanding of the existing foundations to develop proposed foundations.</p> | Type 1<br>Type 2<br>Type 4<br>Type 5 | <p>Indicative location – specific photo required.</p> |

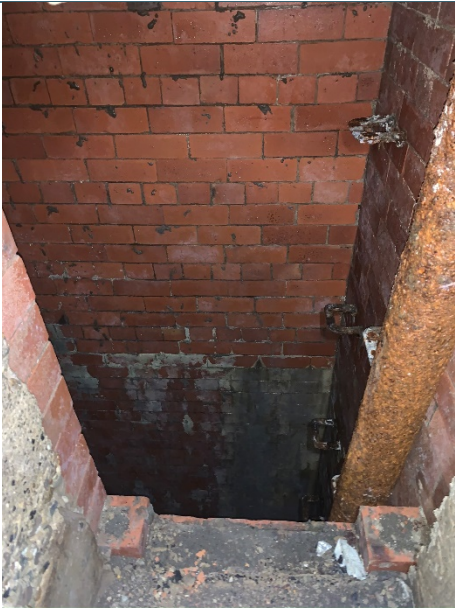
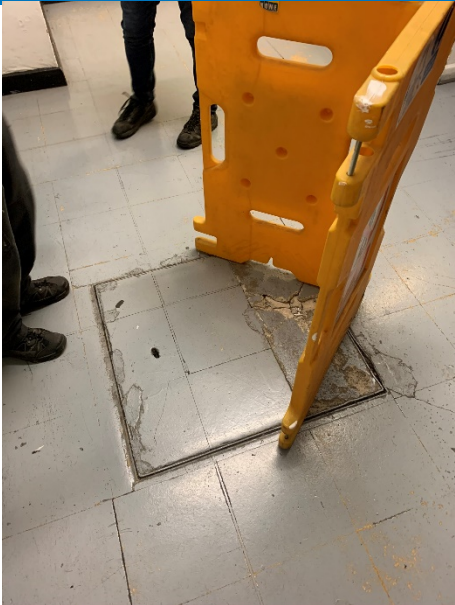
| Item | Level | Element | Grid Location | OUW | Value | Reinstatement | Photograph |
|---|---|---|---|---|---|---|---|
| 12 | -1 | Drainage | A8-A9<br>E12-F12<br>D1/1-E1/1<br>T14<br>Q2/15-R1/15<br>W10-X12<br>O1-O2 | OUW5-1 (Low level)<br>OUW5-2 (Low level) | <p>The site visits undertaken by Woolgar Hunter have identified a number of manholes, some of which are numbered up to MH14. A full drainage survey is required to determine the condition of the drainage network, as well as the exits from the structure. This will also enable the PDE with United Utilities to progress, for example.</p> | N/A | |

| Item | Level | Element | Grid Location | OUW | Value | Reinstatement | Photograph |
|---|---|---|---|---|---|---|---|
| | | | | | | | Indicative location – specific photos required. |

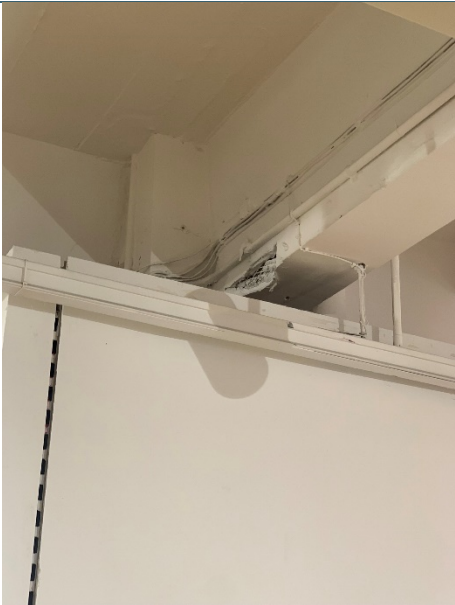
| Item | Level | Element | Grid Location | OUW | Value | Reinstatement | Photograph |
|---|---|---|---|---|---|---|---|
| 13 | -1 | Column/<br>Incoming<br>Beams/ Slab | H10 | OUW3-1 (Low level)<br>OUW3-3 (Full height/ high level)<br>OUW3-6 (Full height) | The connection of the slab to the steel grillage must be known to develop diaphragm action, which is critical for wind loading.<br>The column/ beam attributes, as described in the report, are required to verify existing capacities of structure and develop enhancement details where possible. This will be undertaken using non-intrusive works where possible.<br>The non-intrusive void scanning of the columns will provide insight into the level of compaction and quality of construction. The presence of voids will affect the suitability of the proposed enhancement details for columns. | Type 1<br>Type 2<br>Type 4 | |
| | | | | | | | Indicative location – specific photo required. |

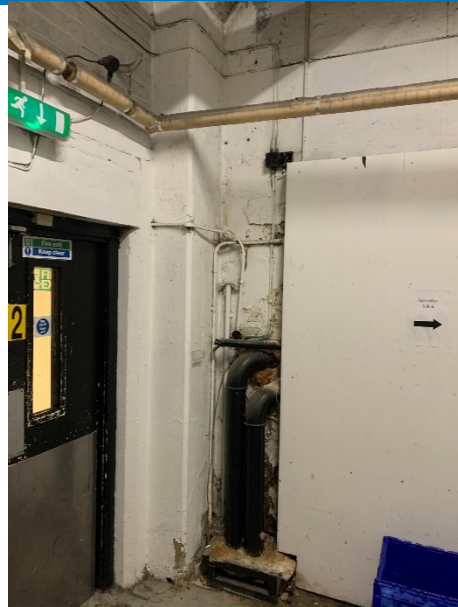
| Item | Level | Element | Grid Location | Ouw | Value | Reinstatement | Photograph |
|---|---|---|---|---|---|---|---|
| 14 | -1 | Column/<br>Incoming<br>Beams/ Slab | G10 | Ouw1-1 (Low level)<br>Ouw1-3 (Full height/ high level)<br>Ouw1-4 (High level)<br>Ouw1-5 (Full height) | <p>The connection of the slab to the steel grillage must be known to develop diaphragm action, which is critical for wind loading.</p> <p>The column/ beam attributes, as described in the report, are required to verify existing capacities of structure and develop enhancement details where possible. This will be undertaken using non-intrusive works where possible.</p> <p>The structure must be investigated to assess its potential for disproportionate collapse and nominal tying. This will only be achieved through intrusive works but will be kept to a minimum.</p> <p>The non-intrusive void scanning of the columns will provide insight into the level of compaction and quality of construction. The presence of voids will affect the suitability of the proposed enhancement details for columns.</p> | Type 1<br>Type 2<br>Type 4 | |
| Indicative location – specific photo required. | | | | | | | |

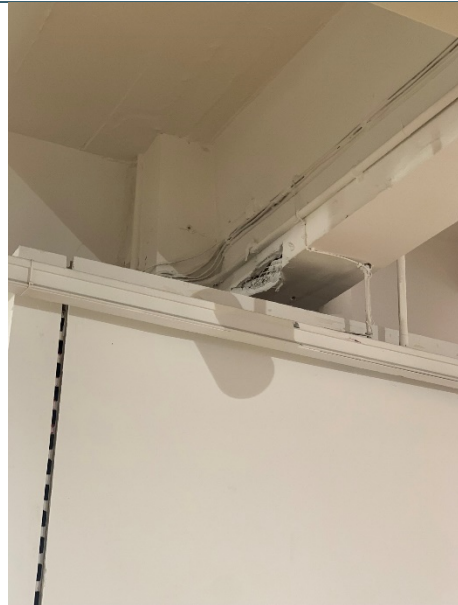
| Item | Level | Element | Grid Location | Ouw | Value | Reinstatement | Photograph |
|---|---|---|---|---|---|---|---|
| 15 | -1 | Column/<br>Incoming<br>Beams/ Slab | O12 | Ouw1-1 (Low level)<br>Ouw1-2 (Low level)<br>Ouw1-3 (Full height/ high level)<br>Ouw1-4 (High level)<br>Ouw1-5 Full height) | <p>The connection of the slab to the steel grillage must be known to develop diaphragm action, which is critical for wind loading.</p> <p>Ferros scanning of the slab, which is non-intrusive work and will minimise disruption, will allow for a greater understanding of the composition of the reinforced concrete slab, which will be required to verify the capacity of the slab.</p> <p>The column/ beam attributes, as described in the report, are required to verify existing capacities of structure and develop enhancement details where possible. This will be undertaken using non-intrusive works where possible.</p> <p>The structure must be investigated to assess its potential for disproportionate collapse and nominal tying. This will only be achieved through intrusive works but will be kept to a minimum.</p> <p>The non-intrusive void scanning of the columns will provide insight into the level of compaction and quality of construction. The presence of voids will affect the suitability of the proposed enhancement details for columns.</p> | Type 1<br>Type 2<br>Type 4 | |
| Indicative location – specific photo required. | | | | | | | |

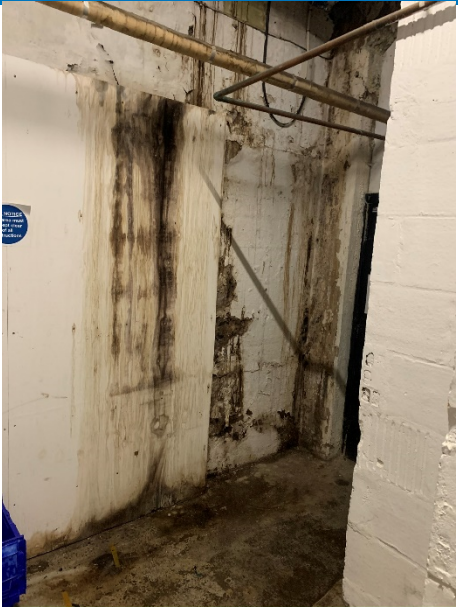
| Item | Level | Element | Grid Location | Ouw | Value | Reinstatement | Photograph |
|---|---|---|---|---|---|---|---|
| 16 | -1 | Column/<br>Basement<br>Wall | A8<br>D14<br>G1/1<br>Q14<br>S1/15 | Ouw4-1 (High level)<br>Ouw6-1 (Full height) | As the building has been poorly maintained for a period of time and there will be a change in load on the basement walls, non-intrusive techniques will be used to determine the wall's properties as described in the report, which will aid the development of any remedial details.<br>As the building has been poorly maintained for a period of time and there will be a change in load on the basement walls, non-intrusive techniques will be used to determine the wall's properties as described in the report, which will aid the development of any remedial details.<br>Additionally, the perimeter columns transfer out at high level in the basement. The associated steel and fixings will need to be inspected to determine condition and potential loss of section. | Type 8 | <br>Indicative location – specific photos required. |

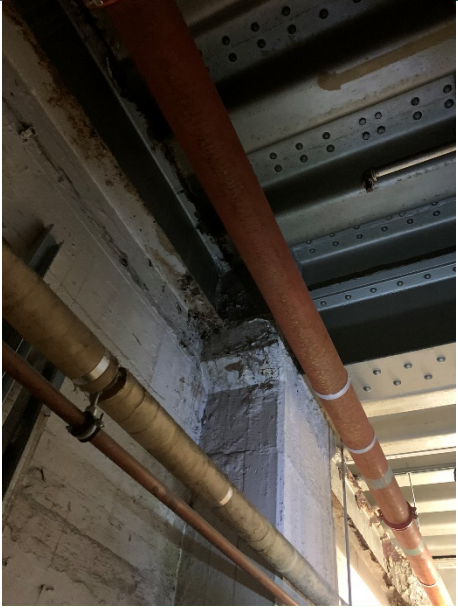
| Item | Level | Element | Grid Location | Ouw | Value | Reinstatement | Photograph |
|---|---|---|---|---|---|---|---|
| 17 | -1 | Column/<br>Basement<br>Wall/ Slab | S14 | Ouw1-2 (Low level)<br>Ouw1-6 (Low level)<br>Ouw6-1 (Full height) | Ferros scanning of the slab, which is non-intrusive work and will minimise disruption, will allow for a greater understanding of the composition of the reinforced concrete slab, which will be required to verify the capacity of the slab.<br>Information on the existing foundations is required to develop the Stage 2 proposed foundation enhancement details, which will be required with the additional load from the proposed extension. This will be done using non-intrusive or minimal intrusive works wherever possible.<br>As the building has been poorly maintained for a period of time and there will be a change in load on the basement walls, non-intrusive techniques will be used to determine the wall's properties as described in the report, which will aid the development of any remedial details.<br>Additionally, the perimeter columns transfer out at high level in the basement. The associated steel and fixings will need to be inspected to determine condition and potential loss of section. | Type 8 | <br>Indicative location – specific location required. |

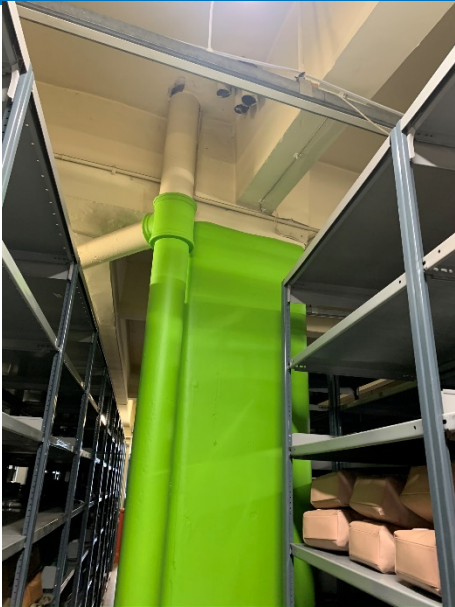
| Item | Level | Element | Grid Location | Ouw | Value | Reinstatement | Photograph |
|---|---|---|---|---|---|---|---|
| 18 | 4 | Column/<br>Incoming<br>Beams/ Slab | H7 | Ouw3-1 (Low level)<br>Ouw3-3 (Full height/ high level)<br>Ouw3-6 (Full height) | <p>The connection of the slab to the steel grillage must be known to develop diaphragm action, which is critical for wind loading.</p> <p>The column/ beam attributes, as described in the report, are required to verify existing capacities of structure and develop enhancement details where possible. This will be undertaken using non-intrusive works where possible.</p> <p>The non-intrusive void scanning of the columns will provide insight into the level of compaction and quality of construction. The presence of voids will affect the suitability of the proposed enhancement details for columns.</p> | Type 1<br>Type 2<br>Type 4 | |

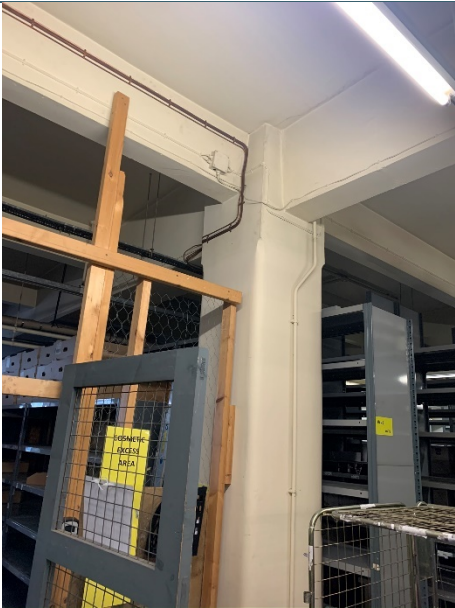
| Item | Level | Element | Grid Location | Ouw | Value | Reinstatement | Photograph |
|---|---|---|---|---|---|---|---|
| 19 | 4 | Column/<br>Incoming<br>Beams/ Slab | H10 | Ouw3-1 (Low level)<br>Ouw3-3 (Full height/ high level)<br>Ouw3-6 (Full height) | <p>The connection of the slab to the steel grillage must be known to develop diaphragm action, which is critical for wind loading.</p> <p>The column/ beam attributes, as described in the report, are required to verify existing capacities of structure and develop enhancement details where possible. This will be undertaken using non-intrusive works where possible.</p> <p>The non-intrusive void scanning of the columns will provide insight into the level of compaction and quality of construction. The presence of voids will affect the suitability of the proposed enhancement details for columns.</p> | Type 1<br>Type 2<br>Type 4 | |

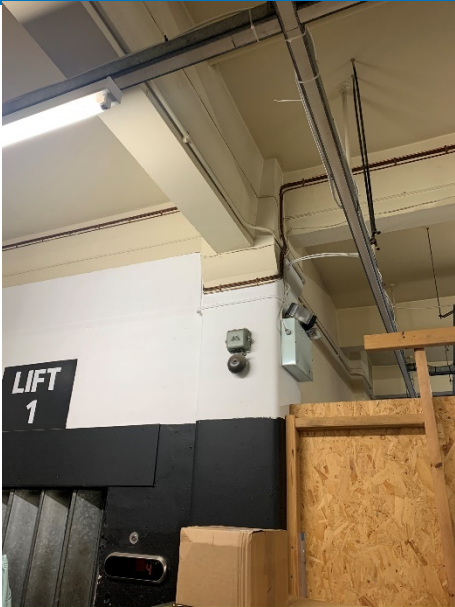
| Item | Level | Element | Grid Location | Ouw | Value | Reinstatement | Photograph |
|---|---|---|---|---|---|---|---|
| 20 | 4 | Column/<br>Incoming<br>Beams/ Slab | G10 | Ouw1-1 (Low level)<br>Ouw1-3 (Full height/ high level)<br>Ouw1-4 (High level)<br>Ouw1-5 (Full height) | <p>The connection of the slab to the steel grillage must be known to develop diaphragm action, which is critical for wind loading.</p> <p>The column/ beam attributes, as described in the report, are required to verify existing capacities of structure and develop enhancement details where possible. This will be undertaken using non-intrusive works where possible.</p> <p>The structure must be investigated to assess its potential for disproportionate collapse and nominal tying. This will only be achieved through intrusive works but will be kept to a minimum.</p> <p>The non-intrusive void scanning of the columns will provide insight into the level of compaction and quality of construction. The presence of voids will affect the suitability of the proposed enhancement details for columns.</p> | Type 1<br>Type 2<br>Type 4 | |

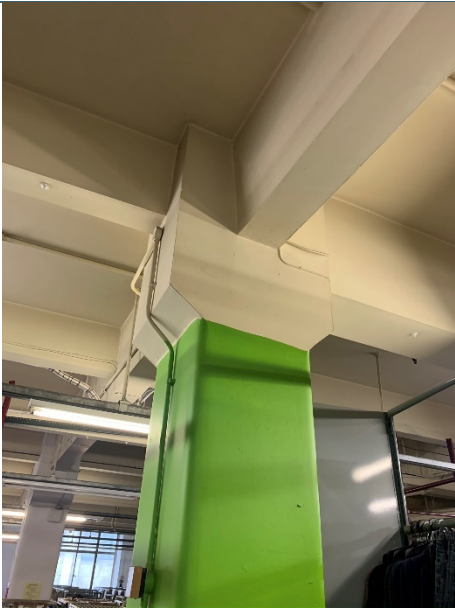
| Item | Level | Element | Grid Location | Ouw | Value | Reinstatement | Photograph |
|---|---|---|---|---|---|---|---|
| 21 | 4 | Column/<br>Incoming<br>Beams/ Slab | N9 | Ouw1-1/ Ouw2-1 (Low level)<br>Ouw1-3/ Ouw2-3 (Full height/ high level)<br>Ouw1-4 (High level)<br>Ouw1-5 Full height) | <p>The connection of the slab to the steel grillage must be known to develop diaphragm action, which is critical for wind loading.</p> <p>The column/ beam attributes, as described in the report, are required to verify existing capacities of structure and develop enhancement details where possible. This will be undertaken using non-intrusive works where possible.</p> <p>The structure must be investigated to assess its potential for disproportionate collapse and nominal tying. This will only be achieved through intrusive works but will be kept to a minimum.</p> <p>The non-intrusive void scanning of the columns will provide insight into the level of compaction and quality of construction. The presence of voids will affect the suitability of the proposed enhancement details for columns.</p> <p>It should be noted that undertaking Ouw1-1 and Ouw1-3, also completes Ouw2-1, and Ouw2-3. The Ouw on the same structure serves two purposes to minimise works on the structure.</p> | Type 1<br>Type 2<br>Type 4 | <p>Indicative location – specific photo required.</p> |

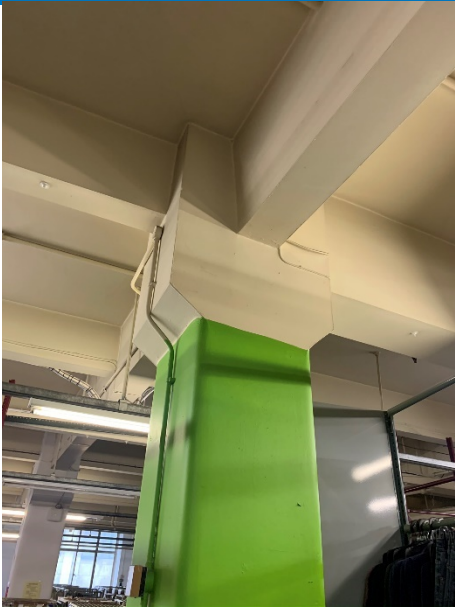
| Item | Level | Element | Grid Location | Ouw | Value | Reinstatement | Photograph |
|---|---|---|---|---|---|---|---|
| 22 | 4 | Column/<br>Incoming<br>Beams/ Slab | O10 | Ouw1-1 (Low level)<br>Ouw1-3 (Full height/ high level)<br>Ouw1-4 (High level)<br>Ouw1-5 Full height) | <p>The connection of the slab to the steel grillage must be known to develop diaphragm action, which is critical for wind loading.</p> <p>The column/ beam attributes, as described in the report, are required to verify existing capacities of structure and develop enhancement details where possible. This will be undertaken using non-intrusive works where possible.</p> <p>The structure must be investigated to assess its potential for disproportionate collapse and nominal tying. This will only be achieved through intrusive works but will be kept to a minimum.</p> <p>The non-intrusive void scanning of the columns will provide insight into the level of compaction and quality of construction. The presence of voids will affect the suitability of the proposed enhancement details for columns.</p> | Type 1<br>Type 2<br>Type 4 | |
| Indicative location – specific photo required. | | | | | | | |

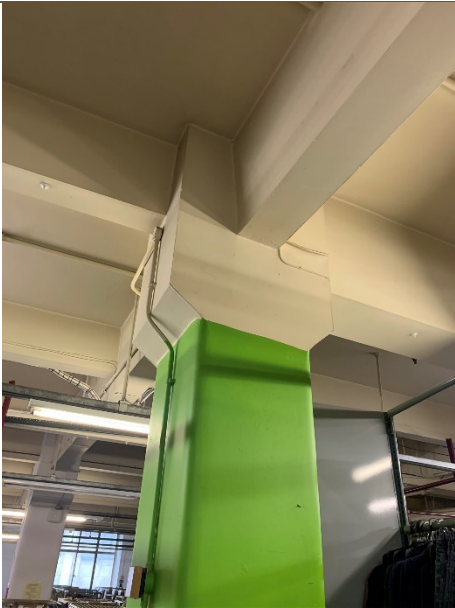
| Item | Level | Element | Grid Location | Ouw | Value | Reinstatement | Photograph |
|---|---|---|---|---|---|---|---|
| 23 | 4 | Column/<br>Incoming<br>Beams/ Slab | Q12 | Ouw1-1 (Low level)<br>Ouw1-3 (Full height/ high level)<br>Ouw1-4 (High level)<br>Ouw1-5 Full height) | <p>The connection of the slab to the steel grillage must be known to develop diaphragm action, which is critical for wind loading.</p> <p>The column/ beam attributes, as described in the report, are required to verify existing capacities of structure and develop enhancement details where possible. This will be undertaken using non-intrusive works where possible.</p> <p>The structure must be investigated to assess its potential for disproportionate collapse and nominal tying. This will only be achieved through intrusive works but will be kept to a minimum.</p> <p>The non-intrusive void scanning of the columns will provide insight into the level of compaction and quality of construction. The presence of voids will affect the suitability of the proposed enhancement details for columns.</p> | Type 1<br>Type 2<br>Type 4 | |
| Indicative location – specific photo required. | | | | | | | |

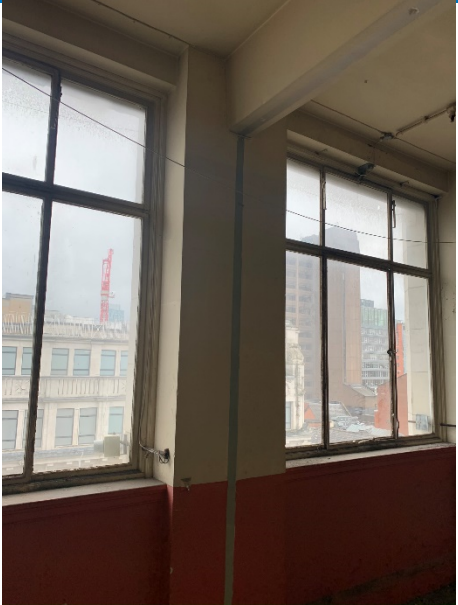
| Item | Level | Element | Grid Location | OUW | Value | Reinstatement | Photograph |
|---|---|---|---|---|---|---|---|
| 24 | 4 | Column | 15/S1 | OUW4-1 (Low/ high level) | Works to date have surveyed the external face of the façade but not the internal face. It is known from other locations that the façade steelwork has deteriorated. OUW area required to determine the condition of the steelwork and associated bracketry, as well as the potential loss of the section. The selected locations have identified perimeter columns of different types, based on the stone façade. One of each column has been selected to minimise the façade OUW. The results of façade OUW will be used to develop column enhancement details for supporting the extension and will be fed into the remediation strategy for the façade steelwork for anodic/ cathodic protection. | Type 3 | |
| | | | | | | | Indicative location – specific photo required. |

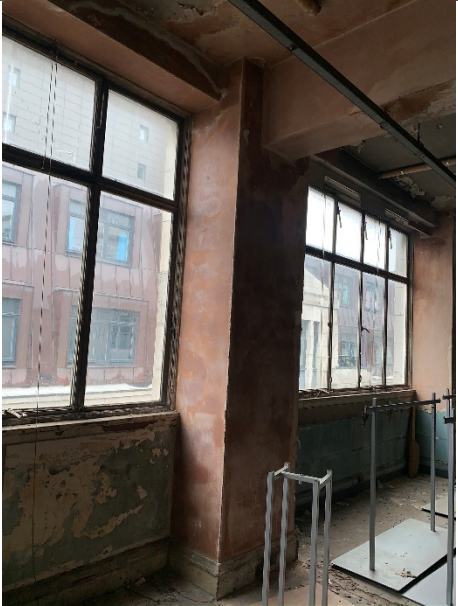
| Item | Level | Element | Grid Location | OUW | Value | Reinstatement | Photograph |
|---|---|---|---|---|---|---|---|
| 25 | 4 | Column | Q14 | OUW4-1 (Low/ high level) | Works to date have surveyed the external face of the façade but not the internal face. It is known from other locations that the façade steelwork has deteriorated. OUW area required to determine the condition of the steelwork and associated bracketry, as well as the potential loss of the section. The selected locations have identified perimeter columns of different types, based on the stone façade. One of each column has been selected to minimise the façade OUW. The results of façade OUW will be used to develop column enhancement details for supporting the extension and will be fed into the remediation strategy for the façade steelwork for anodic/ cathodic protection. | Type 3 | |
| | | | | | | | Indicative location – specific photo required. |

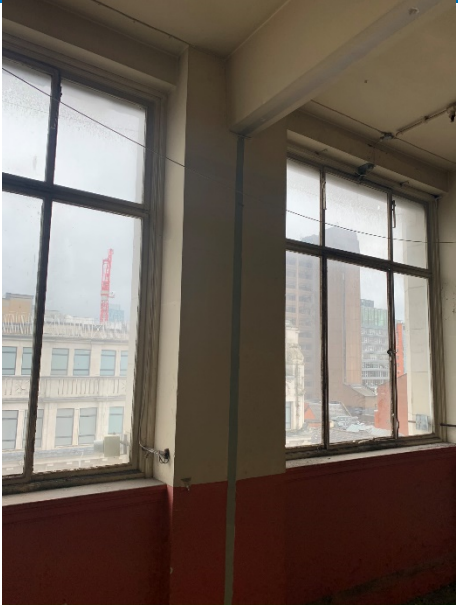
| Item | Level | Element | Grid Location | OUW | Value | Reinstatement | Photograph |
|---|---|---|---|---|---|---|---|
| 26 | 4 | Column | A8 | OUW4-1 (Low/ high level) | Works to date have surveyed the external face of the façade but not the internal face. It is known from other locations that the façade steelwork has deteriorated. OUW area required to determine the condition of the steelwork and associated bracketry, as well as the potential loss of the section. The selected locations have identified perimeter columns of different types, based on the stone façade. One of each column has been selected to minimise the façade OUW. The results of the OUW will be fed into the remediation strategy for the façade steelwork for anodic/ cathodic protection. | Type 3 | |
| | | | | | | | Indicative location – specific photo required. |

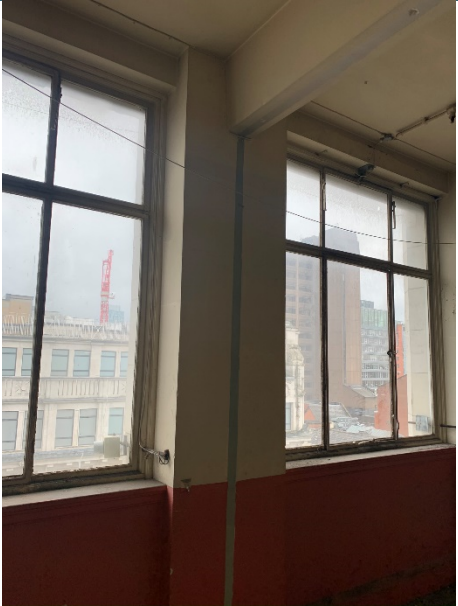
| Item | Level | Element | Grid Location | OUW | Value | Reinstatement | Photograph |
|---|---|---|---|---|---|---|---|
| 27 | 4 | Column | 1/E1-G1 | OUW4-1 (Low/ high level) | Works to date have surveyed the external face of the façade but not the internal face. It is known from other locations that the façade steelwork has deteriorated. OUW area required to determine the condition of the steelwork and associated bracketry, as well as the potential loss of the section. The selected locations have identified perimeter columns of different types, based on the stone façade. One of each column has been selected to minimise the façade OUW. The results of the OUW will be fed into the remediation strategy for the façade steelwork for anodic/ cathodic protection. | Type 3 | |
| | | | | | | | Indicative location – specific photo required. |

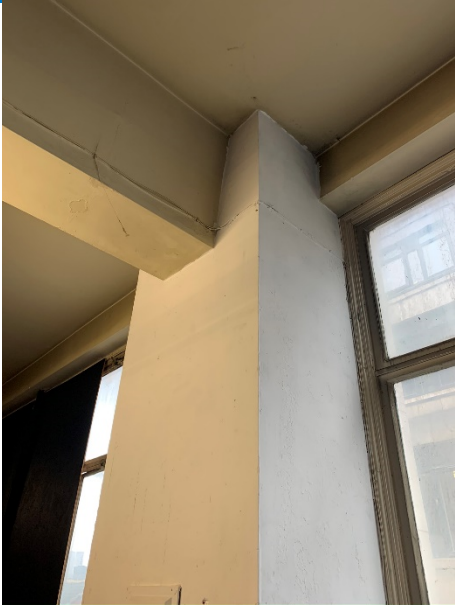
| Item | Level | Element | Grid Location | OUW | Value | Reinstatement | Photograph |
|---|---|---|---|---|---|---|---|
| 28 | 4 | Column | D14 | OUW4-1 (Low/ high level) | Works to date have surveyed the external face of the façade but not the internal face. It is known from other locations that the façade steelwork has deteriorated. OUW area required to determine the condition of the steelwork and associated bracketry, as well as the potential loss of the section. The selected locations have identified perimeter columns of different types, based on the stone façade. One of each column has been selected to minimise the façade OUW. The results of the OUW will be fed into the remediation strategy for the façade steelwork for anodic/ cathodic protection. | Type 3 | |

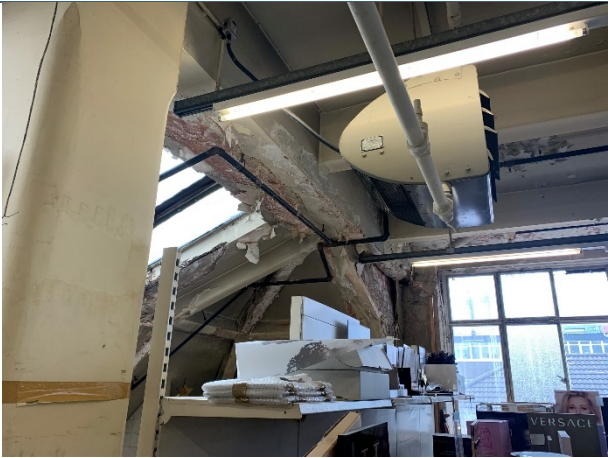
| Item | Level | Element | Grid Location | OUW | Value | Reinstatement | Photograph |
|---|---|---|---|---|---|---|---|
| 29 | 4 | Beams | B12-B14 | OUW1-3 (High level)<br>OUW1-4 (High level)<br>OUW1-5 (High level) | Previous surveys have noted movement on the external face of the façade at the corner of High Street and Bridgewater Place. The photo shown the internal dilapidation below the movement in the façade. OUW are proposed to investigate the condition of the steel columns and steel beams in disrepair, which might be part of the cause of the façade movement. | Type 1<br>Type 2<br>Type 3 | |

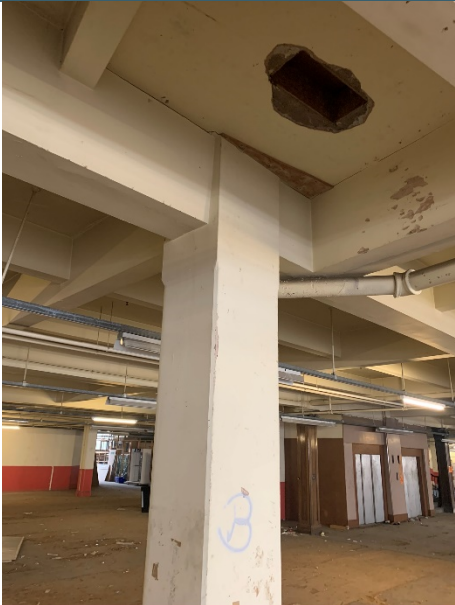
| Item | Level | Element | Grid Location | OUW | Value | Reinstatement | Photograph |
|---|---|---|---|---|---|---|---|
| 30 | 5 | Column/<br>Incoming<br>Beams/ Slab | H7 | OUW3-1 (Low level)<br>OUW3-3 (Full height/ high level)<br>OUW3-6 (Full height) | The connection of the slab to the steel grillage must be known to develop diaphragm action, which is critical for wind loading. The column/ beam attributes, as described in the report, are required to verify existing capacities of structure and develop enhancement details where possible. This will be undertaken using non-intrusive works where possible. The non-intrusive void scanning of the columns will provide insight into the level of compaction and quality of construction. The presence of voids will affect the suitability of the proposed enhancement details for columns. | Type 1<br>Type 2<br>Type 4 | |

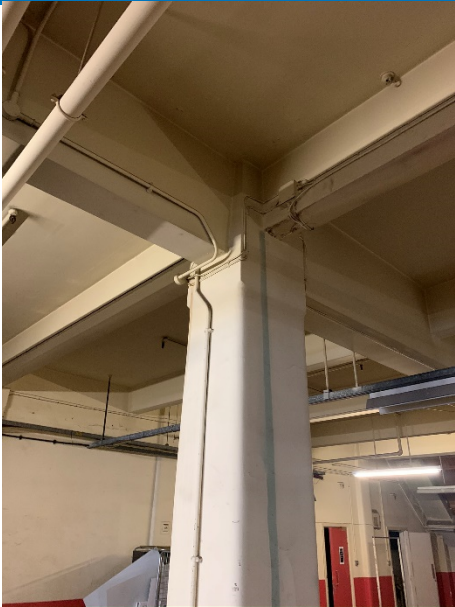
| Item | Level | Element | Grid Location | Ouw | Value | Reinstatement | Photograph |
|---|---|---|---|---|---|---|---|
| 31 | 5 | Column/<br>Incoming<br>Beams/ Slab | H10 | Ouw3-1 (Low level)<br>Ouw3-3 (Full height/ high level)<br>Ouw3-6 (Full height) | <p>The connection of the slab to the steel grillage must be known to develop diaphragm action, which is critical for wind loading.</p> <p>The column/ beam attributes, as described in the report, are required to verify existing capacities of structure and develop enhancement details where possible. This will be undertaken using non-intrusive works where possible.</p> <p>The non-intrusive void scanning of the columns will provide insight into the level of compaction and quality of construction. The presence of voids will affect the suitability of the proposed enhancement details for columns.</p> | Type 1<br>Type 2<br>Type 4 | |

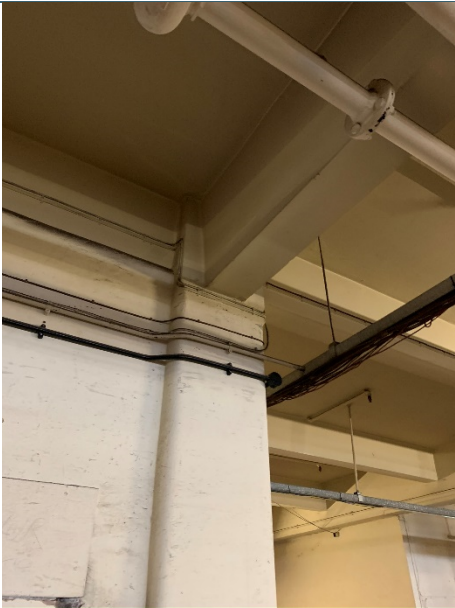
| Item | Level | Element | Grid Location | Ouw | Value | Reinstatement | Photograph |
|---|---|---|---|---|---|---|---|
| 32 | 5 | Column/<br>Incoming<br>Beams/ Slab | G10 | Ouw1-1 (Low level)<br>Ouw1-3 (Full height/ high level)<br>Ouw1-4 (High level)<br>Ouw1-5 (Full height) | <p>The connection of the slab to the steel grillage must be known to develop diaphragm action, which is critical for wind loading.</p> <p>The column/ beam attributes, as described in the report, are required to verify existing capacities of structure and develop enhancement details where possible. This will be undertaken using non-intrusive works where possible.</p> <p>The structure must be investigated to assess its potential for disproportionate collapse and nominal tying. This will only be achieved through intrusive works but will be kept to a minimum.</p> <p>The non-intrusive void scanning of the columns will provide insight into the level of compaction and quality of construction. The presence of voids will affect the suitability of the proposed enhancement details for columns.</p> | Type 1<br>Type 2<br>Type 4 | |

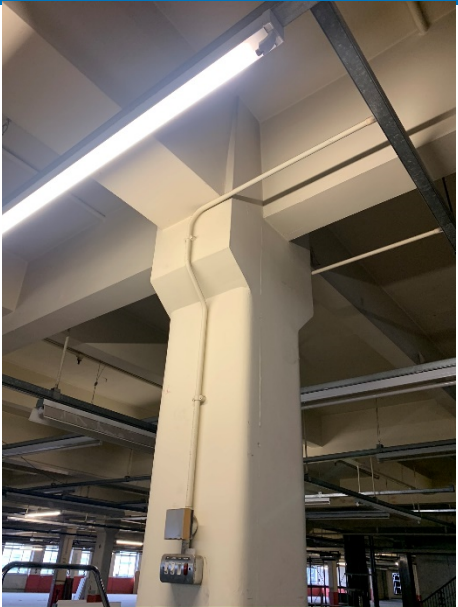
| Item | Level | Element | Grid Location | OUW | Value | Reinstatement | Photograph |
|---|---|---|---|---|---|---|---|
| 33 | 5 | Column/<br>Incoming<br>Beams/ Slab | N9 | OUW1-1/ OUW2-1 (Low level)<br>OUW1-3/ OUW2-3 (Full height/<br>high level)<br>OUW1-4 (High level)<br>OUW1-5 Full height) | <p>The connection of the slab to the steel grillage must be known to develop diaphragm action, which is critical for wind loading.</p> <p>The column/ beam attributes, as described in the report, are required to verify existing capacities of structure and develop enhancement details where possible. This will be undertaken using non-intrusive works where possible.</p> <p>The structure must be investigated to assess its potential for disproportionate collapse and nominal tying. This will only be achieved through intrusive works but will be kept to a minimum.</p> <p>The non-intrusive void scanning of the columns will provide insight into the level of compaction and quality of construction. The presence of voids will affect the suitability of the proposed enhancement details for columns.</p> <p>It should be noted that undertaking OUW1-1 and OUW1-3, also completes OUW2-1, and OUW2-3. The OUW on the same structure serves two purposes to minimise works on the structure.</p> | Type 1<br>Type 2<br>Type 4 | |
| Indicative location – specific photo required. | | | | | | | |

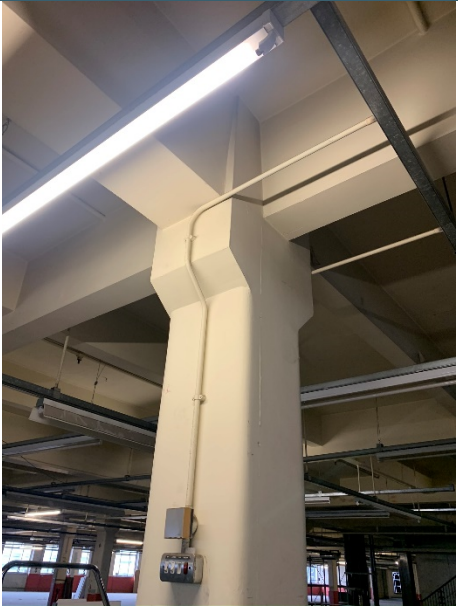
| Item | Level | Element | Grid Location | OUW | Value | Reinstatement | Photograph |
|---|---|---|---|---|---|---|---|
| 34 | 5 | Column/<br>Incoming<br>Beams/ Slab | O10 | OUW1-1 (Low level)<br>OUW1-3 (Full height/ high level)<br>OUW1-4 (High level)<br>OUW1-5 Full height) | <p>The connection of the slab to the steel grillage must be known to develop diaphragm action, which is critical for wind loading.</p> <p>The column/ beam attributes, as described in the report, are required to verify existing capacities of structure and develop enhancement details where possible. This will be undertaken using non-intrusive works where possible.</p> <p>The structure must be investigated to assess its potential for disproportionate collapse and nominal tying. This will only be achieved through intrusive works but will be kept to a minimum.</p> <p>The non-intrusive void scanning of the columns will provide insight into the level of compaction and quality of construction. The presence of voids will affect the suitability of the proposed enhancement details for columns.</p> | Type 1<br>Type 2<br>Type 4 | |
| Indicative location – specific photo required. | | | | | | | |

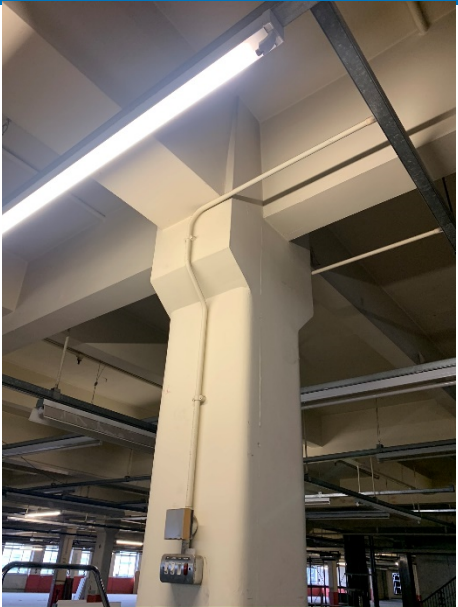
| Item | Level | Element | Grid Location | OUW | Value | Reinstatement | Photograph |
|---|---|---|---|---|---|---|---|
| 35 | 5 | Column/<br>Incoming<br>Beams/ Slab | Q12 | OUW1-1 (Low level)<br>OUW1-3 (Full height/ high level)<br>OUW1-4 (High level)<br>OUW1-5 Full height) | <p>The connection of the slab to the steel grillage must be known to develop diaphragm action, which is critical for wind loading.</p> <p>The column/ beam attributes, as described in the report, are required to verify existing capacities of structure and develop enhancement details where possible. This will be undertaken using non-intrusive works where possible.</p> <p>The structure must be investigated to assess its potential for disproportionate collapse and nominal tying. This will only be achieved through intrusive works but will be kept to a minimum.</p> <p>The non-intrusive void scanning of the columns will provide insight into the level of compaction and quality of construction. The presence of voids will affect the suitability of the proposed enhancement details for columns.</p> | Type 1<br>Type 2<br>Type 4 | |
| Indicative location – specific photo required. | | | | | | | |

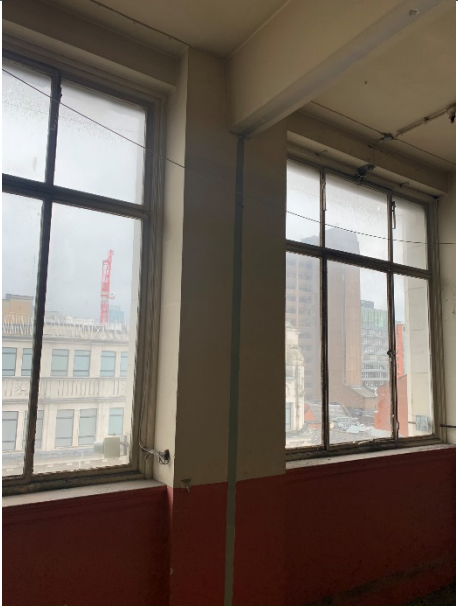
| Item | Level | Element | Grid Location | OUW | Value | Reinstatement | Photograph |
|---|---|---|---|---|---|---|---|
| 36 | 5 | Column | 15/S1 | OUW4-1 (Low/ high level) | <p>Works to date have surveyed the external face of the façade but not the internal face. It is known from other locations that the façade steelwork has deteriorated. OUW area required to determine the condition of the steelwork and associated bracketry, as well as the potential loss of the section. The selected locations have identified perimeter columns of different types, based on the stone façade. One of each column has been selected to minimise the façade OUW. The results of façade OUW will be used to develop column enhancement details for supporting the extension and will be fed into the remediation strategy for the façade steelwork for anodic/ cathodic protection.</p> | Type 3 | |
| Indicative location – specific photo required. | | | | | | | |

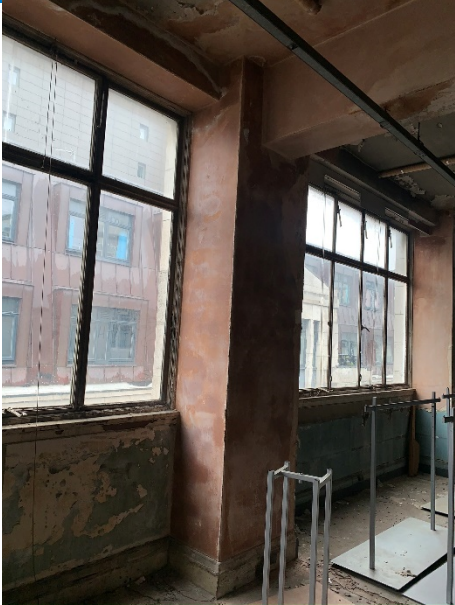
| Item | Level | Element | Grid Location | OUW | Value | Reinstatement | Photograph |
|---|---|---|---|---|---|---|---|
| 37 | 5 | Column | Q14 | OUW4-1 (Low/ high level) | Works to date have surveyed the external face of the façade but not the internal face. It is known from other locations that the façade steelwork has deteriorated. OUW area required to determine the condition of the steelwork and associated bracketry, as well as the potential loss of the section. The selected locations have identified perimeter columns of different types, based on the stone façade. One of each column has been selected to minimise the façade OUW. The results of façade OUW will be used to develop column enhancement details for supporting the extension and will be fed into the remediation strategy for the façade steelwork for anodic/ cathodic protection. | Type 3 | <p>Indicative location – specific photo required.</p> |

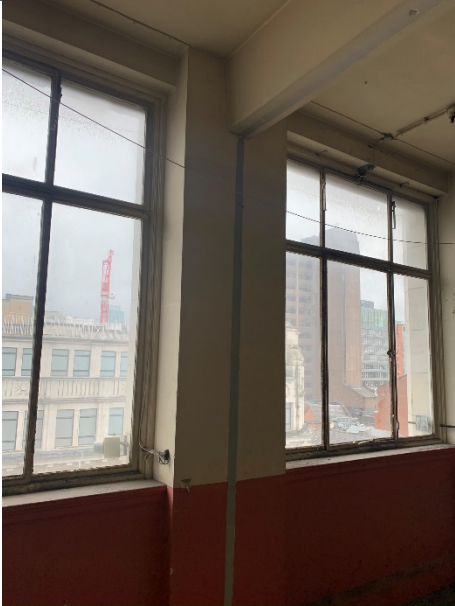
| Item | Level | Element | Grid Location | OUW | Value | Reinstatement | Photograph |
|---|---|---|---|---|---|---|---|
| 38 | 5 | Column | A8 | OUW4-1 (Low/ high level) | Works to date have surveyed the external face of the façade but not the internal face. It is known from other locations that the façade steelwork has deteriorated. OUW area required to determine the condition of the steelwork and associated bracketry, as well as the potential loss of the section. The selected locations have identified perimeter columns of different types, based on the stone façade. One of each column has been selected to minimise the façade OUW. The results of the OUW will be fed into the remediation strategy for the façade steelwork for anodic/ cathodic protection. | Type 3 | <p>Indicative location – specific photo required.</p> |
