opening up works schedule

Subject: OUW  
Project: Rylands Building, Manchester  
Reference: OUW Schedule 05.02.21  
Author: EAJC  
Reviewer: NGRC

Ref: EAJC / OUW Schedule 05.02.21 / Rylands Building, Manchester / 05 February 2021

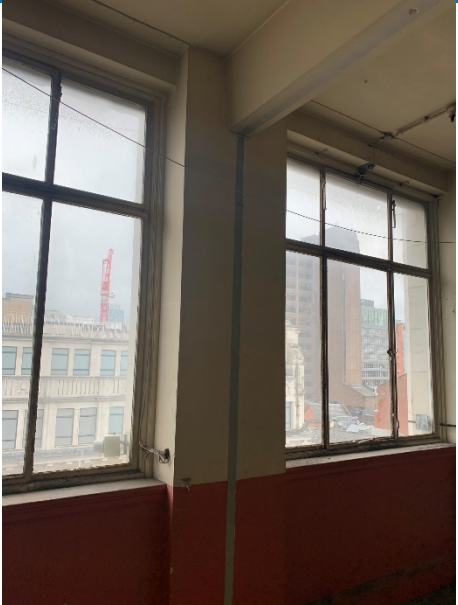
| Item | Level | Element | Grid Location | OUW | Value | Reinstatement | Photograph |
|---|---|---|---|---|---|---|---|
| 39 | 5 | Column | 1/E1-G1 | OUW4-1 (Low/ high level) | Works to date have surveyed the external face of the façade but not the internal face. It is known from other locations that the façade steelwork has deteriorated. OUW area required to determine the condition of the steelwork and associated bracketry, as well as the potential loss of the section. The selected locations have identified perimeter columns of different types, based on the stone façade. One of each column has been selected to minimise the façade OUW. The results of the OUW will be fed into the remediation strategy for the façade steelwork for anodic/ cathodic protection. | Type 3 | |
| | | | | | | | Indicative location – specific photo required. |

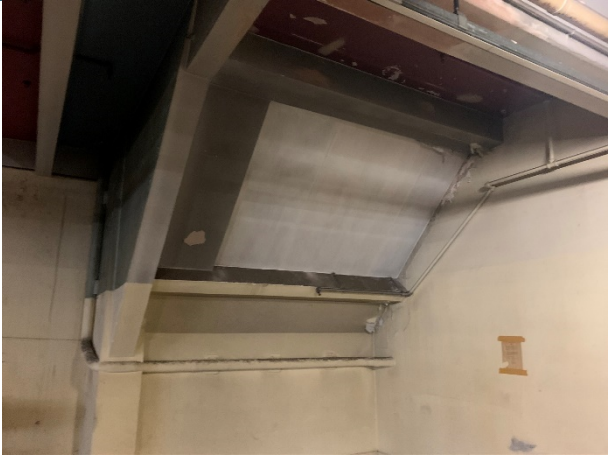
| Item | Level | Element | Grid Location | OUW | Value | Reinstatement | Photograph |
|---|---|---|---|---|---|---|---|
| 40 | 5 | Column/<br>Beams | D14 | OUW1-3 (Full height/ high level)<br>OUW1-4 (High level)<br>OUW1-5 (Full height) | The mansard roof is known to be in disrepair after external inspections from independent surveyors, as well as internal surveys from members of the design team. OUW to inspect the condition of the structure as well as the connectivity to the primary structural frame is proposed. The OUW will aid the understanding of the disrepair of the roof as well as the developing enhancement details to support the proposed extension. | Type 7 | |

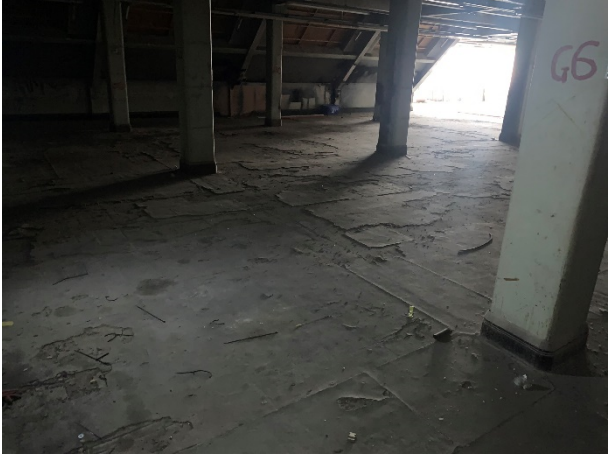
| Item | Level | Element | Grid Location | OUW | Value | Reinstatement | Photograph |
|---|---|---|---|---|---|---|---|
| 41 | 5 | Slab | P9-P10 | OUW1-2 (High level) | Ferrosctanning of the slab, which is non-intrusive work and will minimise disruption, will allow for a greater understanding of the composition of the reinforced concrete slab, which will be required to verify the capacity of the slab. The ferrosctanning should be undertaken at high level to capture bottom reinforcement of the floor above. | N/A | |
| | | | | | | | Indicative location – specific photo required. |

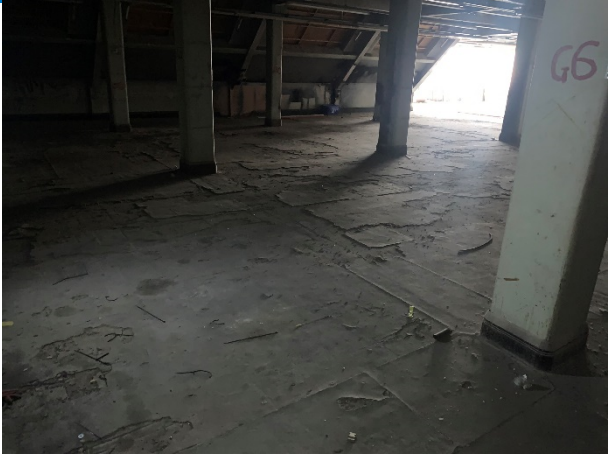
| Item | Level | Element | Grid Location | OUW | Value | Reinstatement | Photograph |
|---|---|---|---|---|---|---|---|
| 42 | 5 | Slab | L1/1-M1/2 | OUW1-2 (High level) | Ferros scanning of the slab, which is non-intrusive work and will minimise disruption, will allow for a greater understanding of the composition of the reinforced concrete slab, which will be required to verify the capacity of the slab. The ferros scanning should be undertaken at high level to capture bottom reinforcement of the floor above. | N/A | <br>Indicative location – specific photo required. |

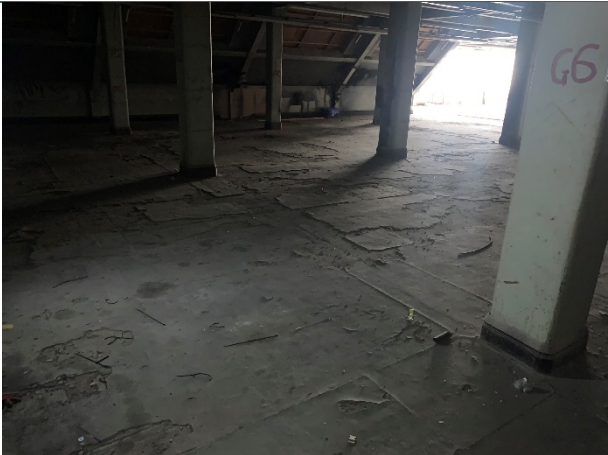
| Item | Level | Element | Grid Location | OUW | Value | Reinstatement | Photograph |
|---|---|---|---|---|---|---|---|
| 43 | 5 | Slab | G9-H10 | OUW3-2 (High level) | Ferros scanning of the slab, which is non-intrusive work and will minimise disruption, will allow for a greater understanding of the composition of the reinforced concrete slab, which will be required to verify the capacity of the slab. The ferros scanning should be undertaken at high level to capture bottom reinforcement of the floor above. | N/A | <br>Indicative location – specific photo required. |

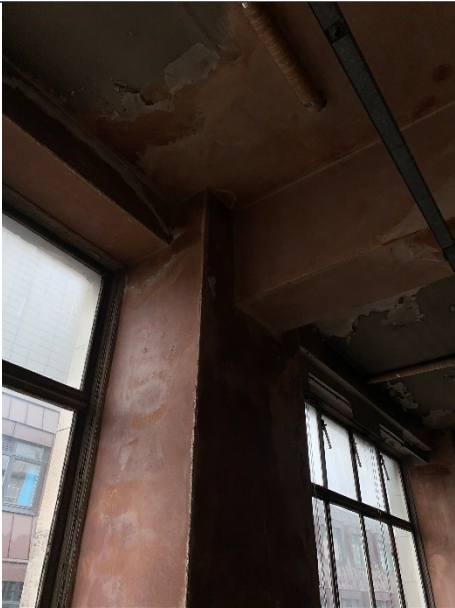
| Item | Level | Element | Grid Location | OUW | Value | Reinstatement | Photograph |
|---|---|---|---|---|---|---|---|
| 44 | 6 | Column/<br>Incoming<br>Beams/ Slab | O14 | OUW1-1 (High level)<br>OUW1-2 (Low level)<br>OUW1-3 (Full height/ high level)<br>OUW1-4 (High level)<br>OUW1-9 (High level) | <p>The connection of the slab to the steel grillage must be known to develop diaphragm action, which is critical for wind loading.</p> <p>Ferros scanning of the slab, which is non-intrusive work and will minimise disruption, will allow for a greater understanding of the composition of the reinforced concrete slab, which will be required to verify the capacity of the slab.</p> <p>The columns for the proposed roof extension will be positioned slightly off gridline 14. The enhancement detail has been theorised at Stage 2, based off information to date. Intrusive works will be required to develop the enhancement detail. The column/ beam attributes, as described in the report, are required to verify existing capacities of structure and develop enhancement details where possible. This will be undertaken using non-intrusive works where possible.</p> <p>With additional storeys being added directly above existing columns, the connection detail between the existing and new structure must be developed. This will be achieved through</p> | Type 1<br>Type 3<br>Type 6 | <br>Indicative location – specific photo required. |

| Item | Level | Element | Grid Location | Ouw | Value | Reinstatement | Photograph |
|---|---|---|---|---|---|---|---|
| | | | | | understanding the capping detail at the uppermost stack of the column. However, this may be required to be undertaken at low level at seventh. | | |

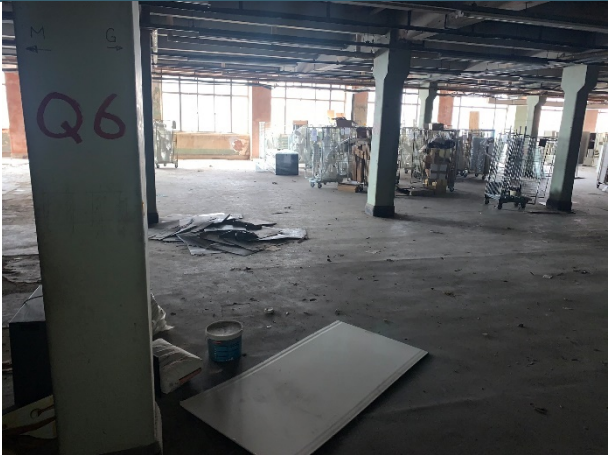
| Item | Level | Element | Grid Location | Ouw | Value | Reinstatement | Photograph |
|---|---|---|---|---|---|---|---|
| 45 | 6 | Slab | P9-P10 | Ouw1-2 (High/ low level)<br>Ouw1-8 (Low level) | Ferros scanning of the slab, which is non-intrusive work and will minimise disruption, will allow for a greater understanding of the composition of the reinforced concrete slab, which will be required to verify the capacity of the slab. The ferros scanning should be undertaken at low level and high level to capture top and bottom reinforcement of the respective floors.<br>Petrographic and compressive testing of the floor slab will enable a greater understanding of the mechanical properties and construction of the slab. This will enable verification of the slab capacities, which have been back-calculated at Stage 2. | Type 4 | |

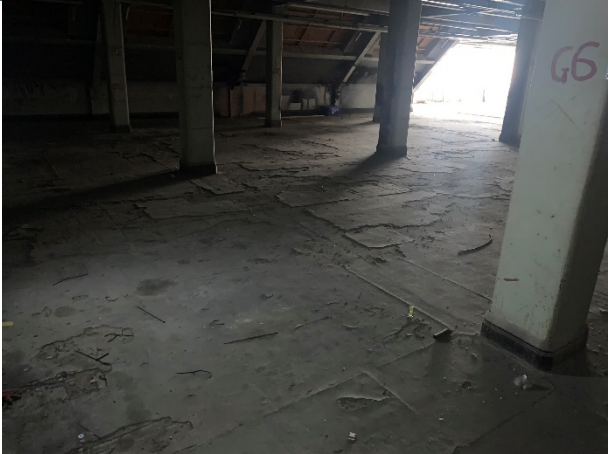
| Item | Level | Element | Grid Location | Ouw | Value | Reinstatement | Photograph |
|---|---|---|---|---|---|---|---|
| 46 | 6 | Slab | G9-H10 | Ouw3-2 (High/ low level) | Ferros scanning of the slab, which is non-intrusive work and will minimise disruption, will allow for a greater understanding of the composition of the reinforced concrete slab, which will be required to verify the capacity of the slab. The ferros scanning should be undertaken at low level and high level to capture top and bottom reinforcement of the respective floors. | N/A | |

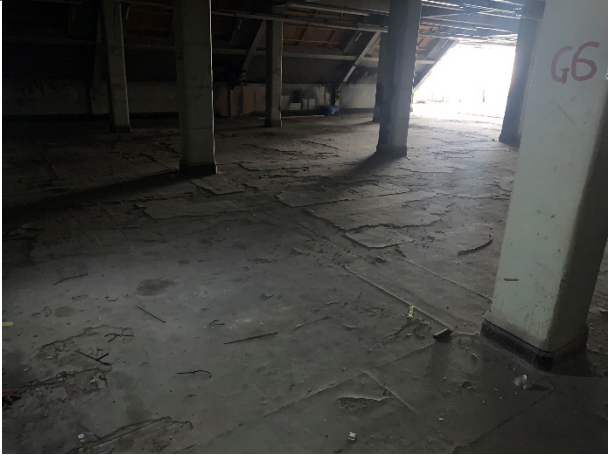
| Item | Level | Element | Grid Location | Ouw | Value | Reinstatement | Photograph |
|---|---|---|---|---|---|---|---|
| 47 | 6 | Slab | L1/1-M1/2 | Ouw1-2 (Low level) | Ferros scanning of the slab, which is non-intrusive work and will minimise disruption, will allow for a greater understanding of the composition of the reinforced concrete slab, which will be required to verify the capacity of the slab. | N/A | <br>Indicative location – specific photo required. |

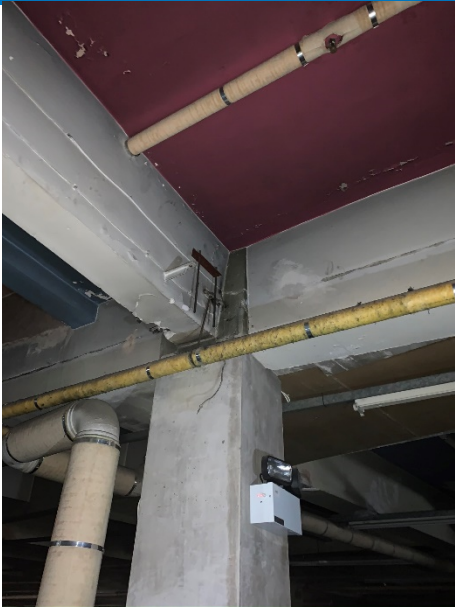
| Item | Level | Element | Grid Location | Ouw | Value | Reinstatement | Photograph |
|---|---|---|---|---|---|---|---|
| 48 | 6 | Column/<br>Incoming<br>Beams/ Slab | H7 | Ouw3-1 (Low level)<br>Ouw3-3 (Full height/ high level)<br>Ouw3-6 (Full height) | <p>The connection of the slab to the steel grillage must be known to develop diaphragm action, which is critical for wind loading.</p> <p>The column/ beam attributes, as described in the report, are required to verify existing capacities of structure and develop enhancement details where possible. This will be undertaking using non-intrusive works where possible.</p> <p>The non-intrusive void scanning of the columns will provide insight into the level of compaction and quality of construction. The presence of voids will affect the suitability of the proposed enhancement details for columns.</p> | Type 1<br>Type 2<br>Type 4<br>Type 6 | |

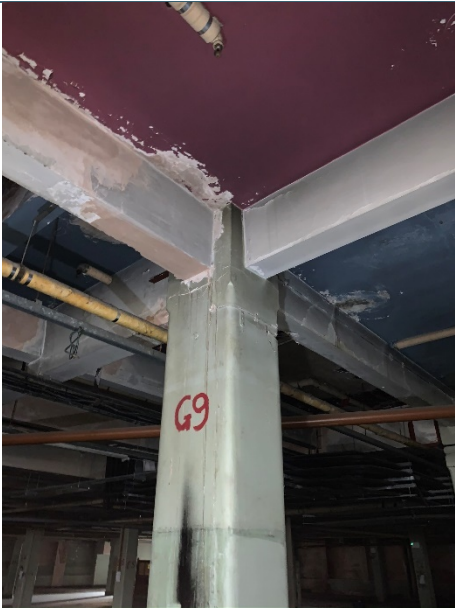
| Item | Level | Element | Grid Location | Ouw | Value | Reinstatement | Photograph |
|---|---|---|---|---|---|---|---|
| 49 | 6 | Column/<br>Incoming<br>Beams/ Slab | H10 | Ouw3-1 (Low level)<br>Ouw3-3 (Full height/ high level)<br>Ouw3-6 (Full height) | <p>The connection of the slab to the steel grillage must be known to develop diaphragm action, which is critical for wind loading.</p> <p>The column/ beam attributes, as described in the report, are required to verify existing capacities of structure and develop enhancement details where possible. This will be undertaking using non-intrusive works where possible.</p> <p>The non-intrusive void scanning of the columns will provide insight into the level of compaction and quality of construction. The presence of voids will affect the suitability of the proposed enhancement details for columns.</p> | Type 1<br>Type 2<br>Type 4<br>Type 6 | |

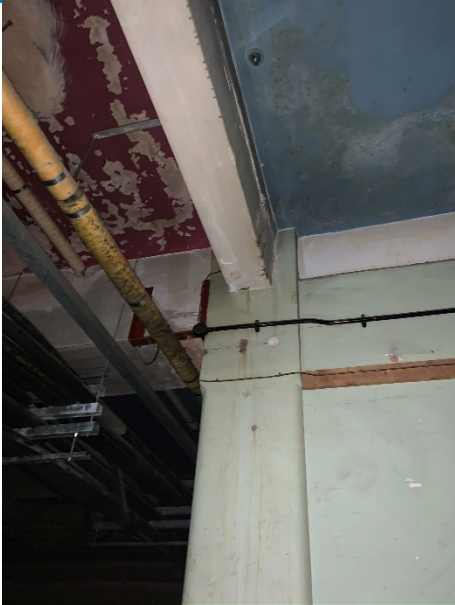
| Item | Level | Element | Grid Location | Ouw | Value | Reinstatement | Photograph |
|---|---|---|---|---|---|---|---|
| 50 | 6 | Column/<br>Incoming<br>Beams/ Slab | G10 | Ouw1-1 (Low level)<br>Ouw1-3 (Full height/ high level)<br>Ouw1-4 (High level)<br>Ouw1-5 (Full height) | <p>The connection of the slab to the steel grillage must be known to develop diaphragm action, which is critical for wind loading.</p> <p>The column/ beam attributes, as described in the report, are required to verify existing capacities of structure and develop enhancement details where possible. This will be undertaken using non-intrusive works where possible.</p> <p>The structure must be investigated to assess its potential for disproportionate collapse and nominal tying. This will only be achieved through intrusive works but will be kept to a minimum.</p> <p>The non-intrusive void scanning of the columns will provide insight into the level of compaction and quality of construction. The presence of voids will affect the suitability of the proposed enhancement details for columns.</p> | Type 1<br>Type 2<br>Type 4<br>Type 6 | |

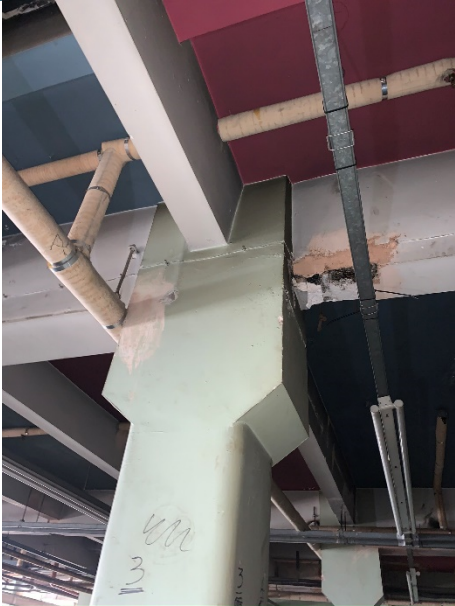
| Item | Level | Element | Grid Location | Ouw | Value | Reinstatement | Photograph |
|---|---|---|---|---|---|---|---|
| 51 | 6 | Column/<br>Incoming<br>Beams/ Slab | N9 | Ouw1-1/ Ouw2-1 (Low level)<br>Ouw1-2/ Ouw2-2 (Low level)<br>Ouw1-3/ Ouw2-3 (Full height/ high level)<br>Ouw1-4 (High level)<br>Ouw1-5 Full height)<br>Ouw1-9 (High level) | <p>The connection of the slab to the steel grillage must be known to develop diaphragm action, which is critical for wind loading.</p> <p>Ferros scanning of the slab, which is non-intrusive work and will minimise disruption, will allow for a greater understanding of the composition of the reinforced concrete slab, which will be required to verify the capacity of the slab. The OUW results will be cross-checked against the drawings from Manchester Central Library archive.</p> <p>The column/ beam attributes, as described in the report, are required to verify existing capacities of structure and develop enhancement details where possible. This will be undertaken using non-intrusive works where possible.</p> <p>The structure must be investigated to assess its potential for disproportionate collapse and nominal tying. This will only be achieved through intrusive works but will be kept to a minimum.</p> <p>The non-intrusive void scanning of the columns will provide insight into the level of compaction and quality of construction. The presence of voids will affect the suitability of the proposed enhancement details for columns.</p> <p>It should be noted that undertaking OUW1-1, OUW1-2, and OUW1-3, also completes OUW2-1, OUW2-2, and OUW2-3. The OUW on the same structure serves two purposes to minimise works on the structure.</p> <p>With additional storeys being added directly above existing columns, the connection detail between the existing and new structure must be developed. This will be achieved through</p> | Type 1<br>Type 2<br>Type 4<br>Type 6 | <p>Indicative location – specific photo required.</p> |

| Item | Level | Element | Grid Location | OUW | Value | Reinstatement | Photograph |
|---|---|---|---|---|---|---|---|
| | | | | | understanding the capping detail at the uppermost stack of the column. However, this may be required to be undertaken at low level at seventh. | | |

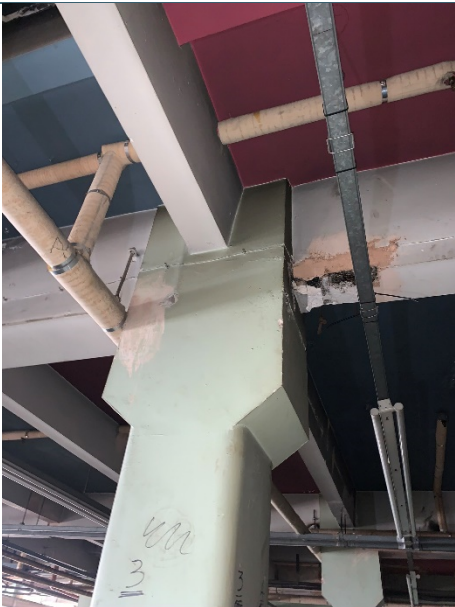
| Item | Level | Element | Grid Location | OUW | Value | Reinstatement | Photograph |
|---|---|---|---|---|---|---|---|
| 52 | 6 | Column/<br>Incoming<br>Beams/ Slab | O10 | OUW1-1 (Low level)<br>OUW1-2 (Low level)<br>OUW1-3 (Full height/ high level)<br>OUW1-4 (High level)<br>OUW1-5 Full height)<br>OUW1-9 (High level) | <p>The connection of the slab to the steel grillage must be known to develop diaphragm action, which is critical for wind loading.</p> <p>Ferrosscanning of the slab, which is non-intrusive work and will minimise disruption, will allow for a greater understanding of the composition of the reinforced concrete slab, which will be required to verify the capacity of the slab. The OUW results will be cross-checked against the drawings from Manchester Central Library archive.</p> <p>The column/ beam attributes, as described in the report, are required to verify existing capacities of structure and develop enhancement details where possible. This will be undertaking using non-intrusive works where possible.</p> <p>The structure must be investigated to assess its potential for disproportionate collapse and nominal tying. This will only be achieved through intrusive works but will be kept to a minimum.</p> <p>The non-intrusive void scanning of the columns will provide insight into the level of compaction and quality of construction. The presence of voids will affect the suitability of the proposed enhancement details for columns.</p> <p>With additional storeys being added directly above existing columns, the connection detail between the existing and new structure must be developed. This will be achieved through understanding the capping detail at the uppermost stack of the column. However, this may be required to be undertaken at low level at seventh.</p> | Type 1<br>Type 2<br>Type 4<br>Type 6 | |

Indicative location – specific photo required.

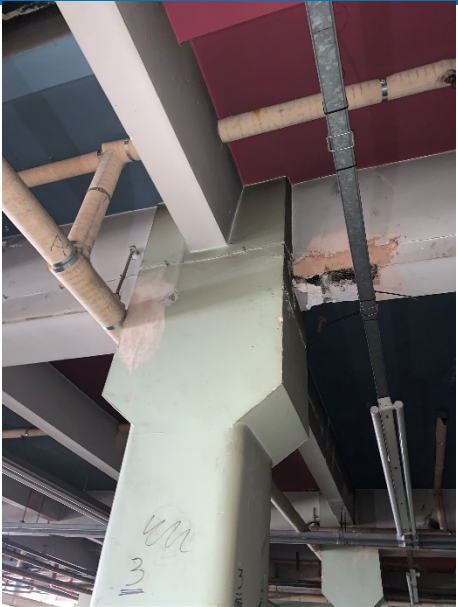
| Item | Level | Element | Grid Location | OUW | Value | Reinstatement | Photograph |
|---|---|---|---|---|---|---|---|
| 53 | 6 | Column/<br>Incoming<br>Beams/ Slab | Q12 | OUW1-1 (Low level) | <p>The connection of the slab to the steel grillage must be known to develop diaphragm action, which is critical for wind loading.</p> <p>Ferros scanning of the slab, which is non-intrusive work and will minimise disruption, will allow for a greater understanding of the composition of the reinforced concrete slab, which will be required to verify the capacity of the slab. The OUW results will be cross-checked against the drawings from Manchester Central Library archive.</p> <p>The column/ beam attributes, as described in the report, are required to verify existing capacities of structure and develop enhancement details where possible. This will be undertaken using non-intrusive works where possible.</p> <p>The structure must be investigated to assess its potential for disproportionate collapse and nominal tying. This will only be achieved through intrusive works but will be kept to a minimum.</p> <p>The non-intrusive void scanning of the columns will provide insight into the level of compaction and quality of construction. The presence of voids will affect the suitability of the proposed enhancement details for columns.</p> <p>With additional storeys being added directly above existing columns, the connection detail between the existing and new structure must be developed. This will be achieved through understanding the capping detail at the uppermost stack of the column. However, this may be required to be undertaken at low level at seventh.</p> | Type 1 | |

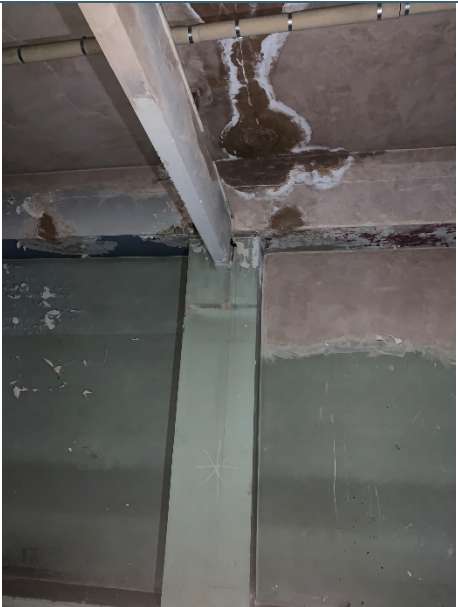
| Item | Level | Element | Grid Location | OUW | Value | Reinstatement | Photograph |
|---|---|---|---|---|---|---|---|
| 54 | 6 | Column | 15/S1 | OUW4-1 (Low/ mid level) | <p>Works to date have surveyed the external face of the façade but not the internal face. It is known from other locations that the façade steelwork has deteriorated. OUW area required to determine the condition of the steelwork and associated bracketry, as well as the potential loss of the section. The selected locations have identified perimeter columns of different types, based on the stone façade. One of each column has been selected to minimise the façade OUW. The results of façade OUW will be used to develop column enhancement details for supporting the extension and will be fed into the remediation strategy for the façade steelwork for anodic/ cathodic protection.</p> | Type 3 | |

Indicative location – specific photo required.

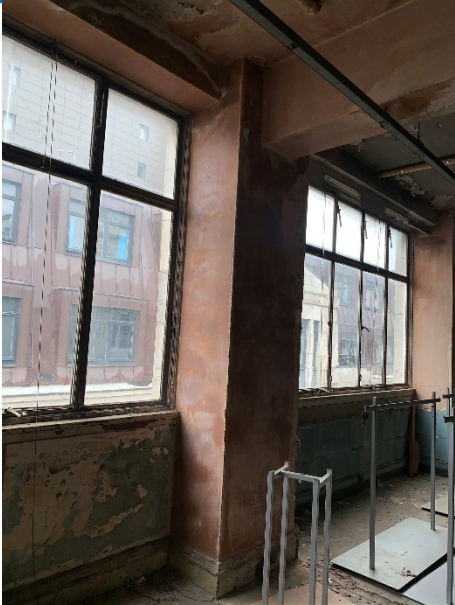
| Item | Level | Element | Grid Location | OUW | Value | Reinstatement | Photograph |
|---|---|---|---|---|---|---|---|
| 55 | 6 | Column | Q14 | OUW4-1 (Low/ mid level) | Works to date have surveyed the external face of the façade but not the internal face. It is known from other locations that the façade steelwork has deteriorated. OUW area required to determine the condition of the steelwork and associated bracketry, as well as the potential loss of the section. The selected locations have identified perimeter columns of different types, based on the stone façade. One of each column has been selected to minimise the façade OUW. The results of façade OUW will be used to develop column enhancement details for supporting the extension and will be fed into the remediation strategy for the façade steelwork for anodic/ cathodic protection. | Type 3 | <p>Indicative location – specific photo required.</p> |

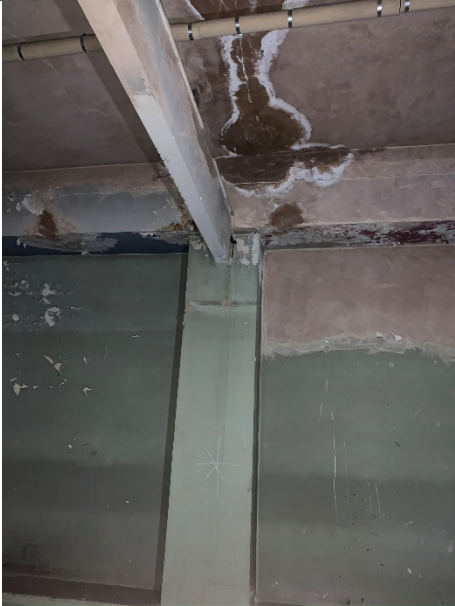
| Item | Level | Element | Grid Location | OUW | Value | Reinstatement | Photograph |
|---|---|---|---|---|---|---|---|
| 56 | 6 | Column | A8 | OUW4-1 (Low/ mid level) | Works to date have surveyed the external face of the façade but not the internal face. It is known from other locations that the façade steelwork has deteriorated. OUW area required to determine the condition of the steelwork and associated bracketry, as well as the potential loss of the section. The selected locations have identified perimeter columns of different types, based on the stone façade. One of each column has been selected to minimise the façade OUW. The results of the OUW will be fed into the remediation strategy for the façade steelwork for anodic/ cathodic protection. | Type 3 | <p>Indicative location – specific photo required.</p> |

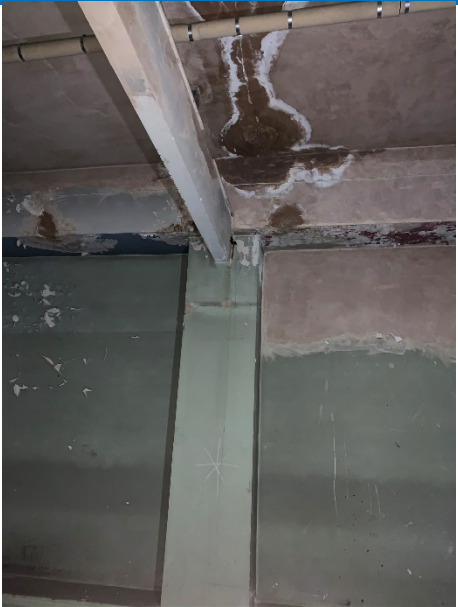
| Item | Level | Element | Grid Location | OUW | Value | Reinstatement | Photograph |
|---|---|---|---|---|---|---|---|
| 57 | 6 | Column | 1/E1-G1 | OUW4-1 (Low/ mid level) | Works to date have surveyed the external face of the façade but not the internal face. It is known from other locations that the façade steelwork has deteriorated. OUW area required to determine the condition of the steelwork and associated bracketry, as well as the potential loss of the section. The selected locations have identified perimeter columns of different types, based on the stone façade. One of each column has been selected to minimise the façade OUW. The results of the OUW will be fed into the remediation strategy for the façade steelwork for anodic/ cathodic protection. | Type 3 | |
| | | | | | | | Indicative location – specific photo required. |

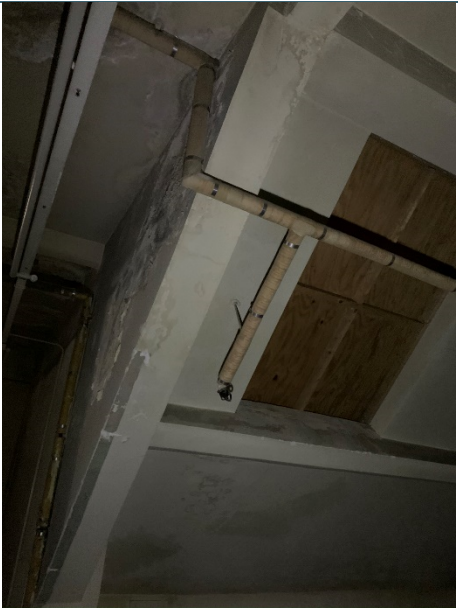
| Item | Level | Element | Grid Location | OUW | Value | Reinstatement | Photograph |
|---|---|---|---|---|---|---|---|
| 58 | 6 | Column/<br>Beams | D13 | OUW1-3 (Full height/ high level)<br>OUW1-4 (High level)<br>OUW1-5 (Full height) | The mansard roof is known to be in disrepair after external inspections from independent surveyors, as well as internal surveys from members of the design team. OUW to inspect the condition of the structure as well as the connectivity to the primary structural frame is proposed. The OUW will aid the understanding of the disrepair of the roof as well as the developing enhancement details to support the proposed extension. | Type 7 | |
| | | | | | | | Indicative location – specific photo required. |

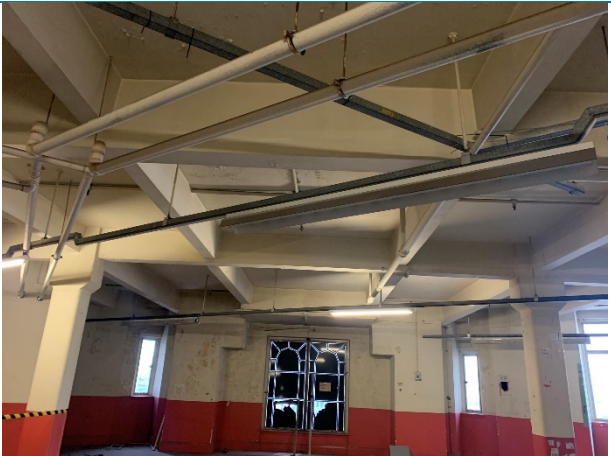
| Item | Level | Element | Grid Location | OUW | Value | Reinstatement | Photograph |
|---|---|---|---|---|---|---|---|
| 59 | 6 | Column/<br>Incoming<br>Beams/ Slab | T10 | OUW1-3 (Full height/ high level)<br>OUW1-4 (High level)<br>OUW1-9 (High level) | The column/ beam attributes, as described in the report, are required to verify existing capacities of structure and develop enhancement details where possible. This will be undertaken using non-intrusive works where possible.<br><br>The structure must be investigated to assess its potential for disproportionate collapse and nominal tying. This will only be achieved through intrusive works but will be kept to a minimum.<br><br>With additional storeys being added directly above existing columns, the connection detail between the existing and new structure must | Type 1<br>Type 2<br>Type 6 | |

| Item | Level | Element | Grid Location | OUW | Value | Reinstatement | Photograph |
|---|---|---|---|---|---|---|---|
| | | | | | be developed. This will be achieved through understanding the capping detail at the uppermost stack of the column. However, this may be required to be undertaken at low level at seventh. | | Indicative location – specific photo required. |

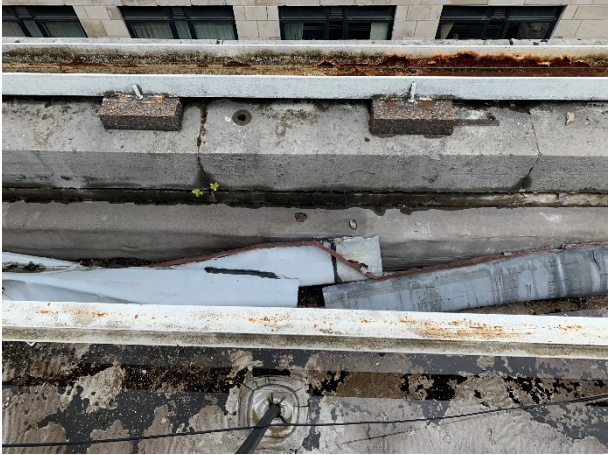
| Item | Level | Element | Grid Location | OUW | Value | Reinstatement | Photograph |
|---|---|---|---|---|---|---|---|
| 60 | 7 | Slab/<br>Column/<br>Incoming<br>Beams | O14 | OUW1-1 (Low level)<br>OUW1-9 (Low level) | OUW are required to understand the connection between the perimeter steelwork and roof steelwork to develop an enhancement detail, due to the increased load from the proposed extension.<br>With additional storeys being added directly above existing columns, the connection detail between the existing and new structure must be developed. This will be achieved through understanding the capping detail at the uppermost stack of the column.<br>OUW at high level at sixth have been specified at a high level as well. If the OUW at sixth determine the required information at O14, this OUW at O14 at seventh are not required. | Type 1<br>Type 3<br>Type 6 | <br>Indicative location – specific photo required. |

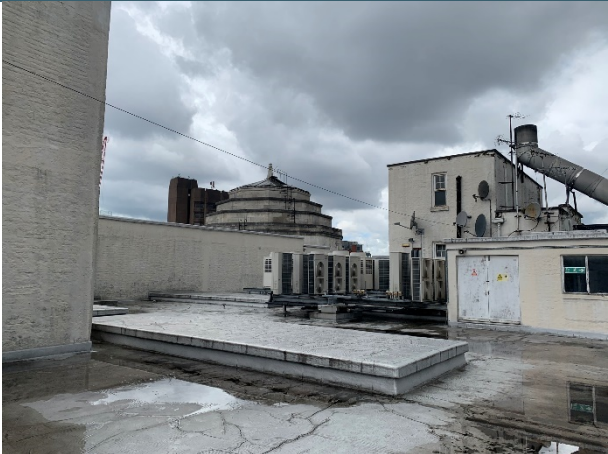
| Item | Level | Element | Grid Location | OUW | Value | Reinstatement | Photograph |
|---|---|---|---|---|---|---|---|
| 61 | 7 | Slab/<br>Column/<br>Incoming<br>Beams | N9 | OUW1-9 (Low level) | With additional storeys being added directly above existing columns, the connection detail between the existing and new structure must be developed. This will be achieved through understanding the capping detail at the uppermost stack of the column.<br>OUW at high level at sixth have been specified at a high level as well. If the OUW at sixth determine the required information at N9, this OUW at N9 at seventh are not required. | Type 6 | <br>Indicative location – specific photo required. |

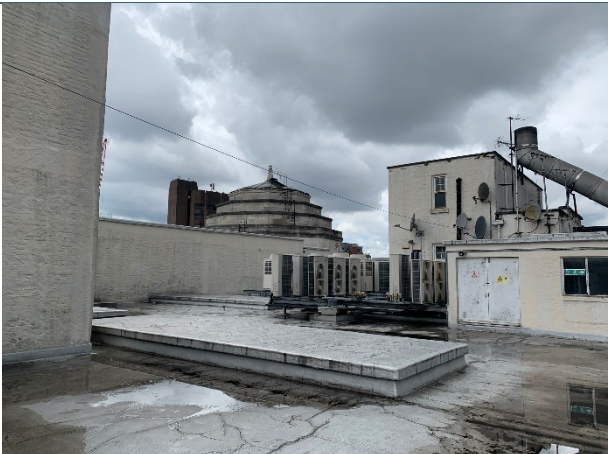
| Item | Level | Element | Grid Location | OUW | Value | Reinstatement | Photograph |
|---|---|---|---|---|---|---|---|
| 62 | 7 | Slab/<br>Column/<br>Incoming<br>Beams | O10 | OUW1-9 (Low level) | With additional storeys being added directly above existing columns, the connection detail between the existing and new structure must be developed. This will be achieved through understanding the capping detail at the uppermost stack of the column.<br>OUW at high level at sixth have been specified at a high level as well. If the OUW at sixth determine the required information at O10, this OUW at O10 at seventh are not required. | Type 6 | <br>Indicative location – specific photo required. |

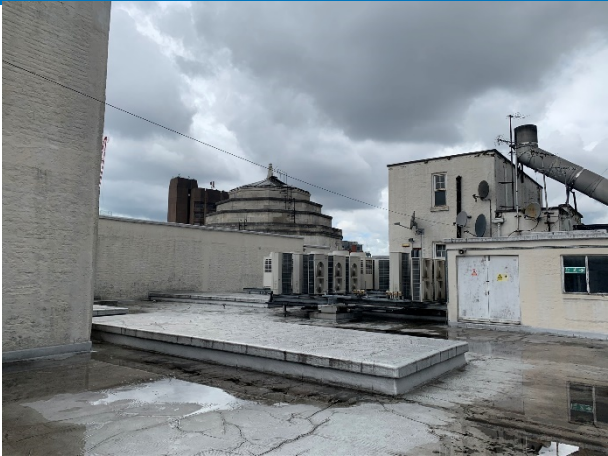
| Item | Level | Element | Grid Location | OUW | Value | Reinstatement | Photograph |
|---|---|---|---|---|---|---|---|
| 63 | 7 | Slab/<br>Column/<br>Incoming<br>Beams | Q12 | OUW1-9 (Low level) | With additional storeys being added directly above existing columns, the connection detail between the existing and new structure must be developed. This will be achieved through understanding the capping detail at the uppermost stack of the column.<br>OUW at high level at sixth have been specified at a high level as well. If the OUW at sixth determine the required information at Q12, this OUW at Q12 at seventh are not required. | Type 6 | <br>Indicative location – specific photo required. |

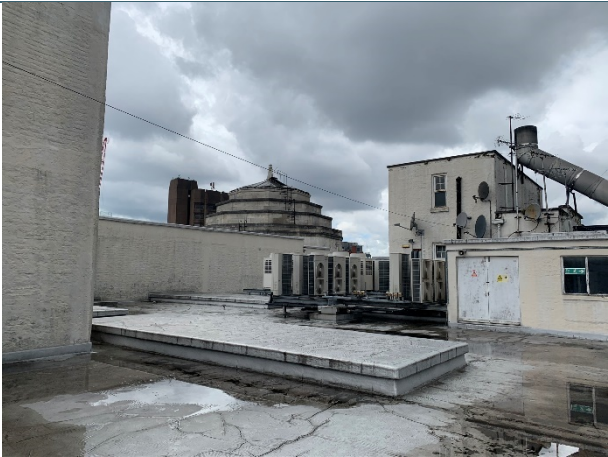
| Item | Level | Element | Grid Location | OUW | Value | Reinstatement | Photograph |
|---|---|---|---|---|---|---|---|
| 64 | 7 | Slab/<br>Column/<br>Incoming<br>Beams | T10 | OUW1-9 (Low level) | With additional storeys being added directly above existing columns, the connection detail between the existing and new structure must be developed. This will be achieved through understanding the capping detail at the uppermost stack of the column.<br>OUW at high level at sixth have been specified at a high level as well. If the OUW at sixth determine the required information at T10, this OUW at T10 at seventh are not required. | Type 6 | <br>Indicative location – specific photo required. |

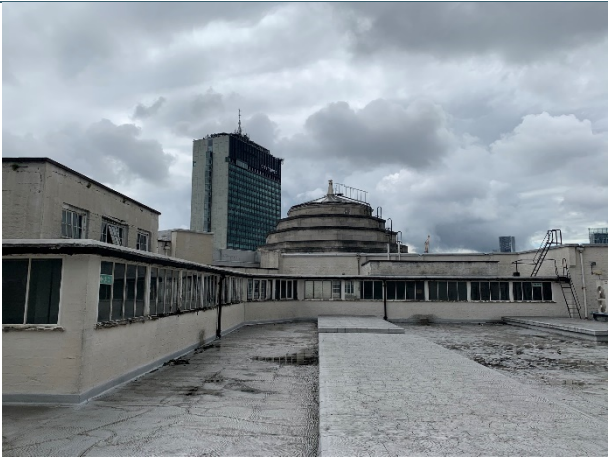
| Item | Level | Element | Grid Location | OUW | Value | Reinstatement | Photograph |
|---|---|---|---|---|---|---|---|
| 65 | 7 | Slab | P9-P10 | OUW1-1 (Low level)<br>OUW1-2 (Low level) | The connection of the slab to the steel grillage must be known to develop diaphragm action, which is critical for wind loading.<br>Ferroscanning of the roof slab, which is non-intrusive work and will minimise disruption, will allow for a greater understanding of the composition of the reinforced concrete slab, which will be required to verify the capacity of the slab. The OUW results will be cross-checked against the drawings from Manchester Central Library archive. | Type 6 | |

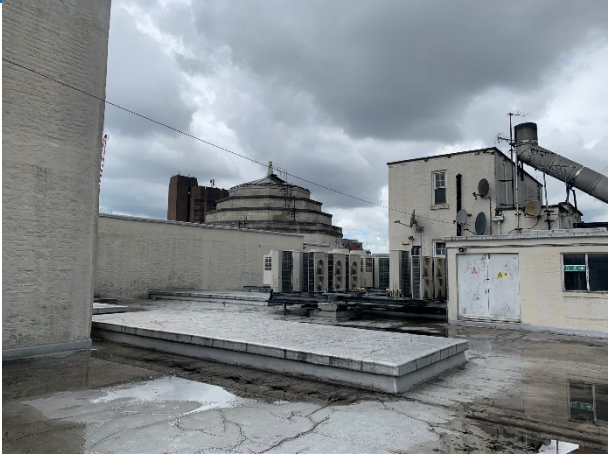
| Item | Level | Element | Grid Location | OUW | Value | Reinstatement | Photograph |
|---|---|---|---|---|---|---|---|
| 66 | 7 | Slab | G9-H10 | OUW3-1 (Low level)<br>OUW3-2 (Low level) | The connection of the slab to the steel grillage must be known to develop diaphragm action, which is critical for wind loading. Ferros scanning of the roof slab, which is non-intrusive work and will minimise disruption, will allow for a greater understanding of the composition of the reinforced concrete slab, which will be required to verify the capacity of the slab. The OUW results will be cross-checked against the drawings from Manchester Central Library archive. | Type 6 | <p>Indicative location – specific photo required.</p> |

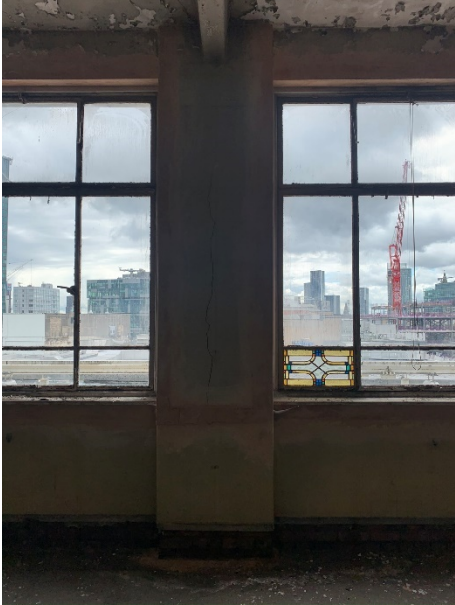
| Item | Level | Element | Grid Location | OUW | Value | Reinstatement | Photograph |
|---|---|---|---|---|---|---|---|
| 67 | 7 | Column | 2/E1-G1 | OUW4-2 (Low level) | Works to date have surveyed the external face of the façade but not the internal face. It is known from other locations that the façade steelwork has deteriorated. OUW area required to determine the condition of the steelwork and associated bracketry, as well as the potential loss of the section. The selected locations have identified perimeter columns of different types, based on the stone façade. One of each column has been selected to minimise the façade OUW. The results of the OUW will be fed into the remediation strategy for the façade steelwork for anodic/ cathodic protection. | Type 3 | <p>Indicative location – specific photo required.</p> |
