**Former Ducie Arms  
424 Stockport Road  
Longsight  
Manchester**

**Quantitative Ground Contamination  
Risk Assessment Report**

**Project Reference: P15726**

**Report Reference: R15737**

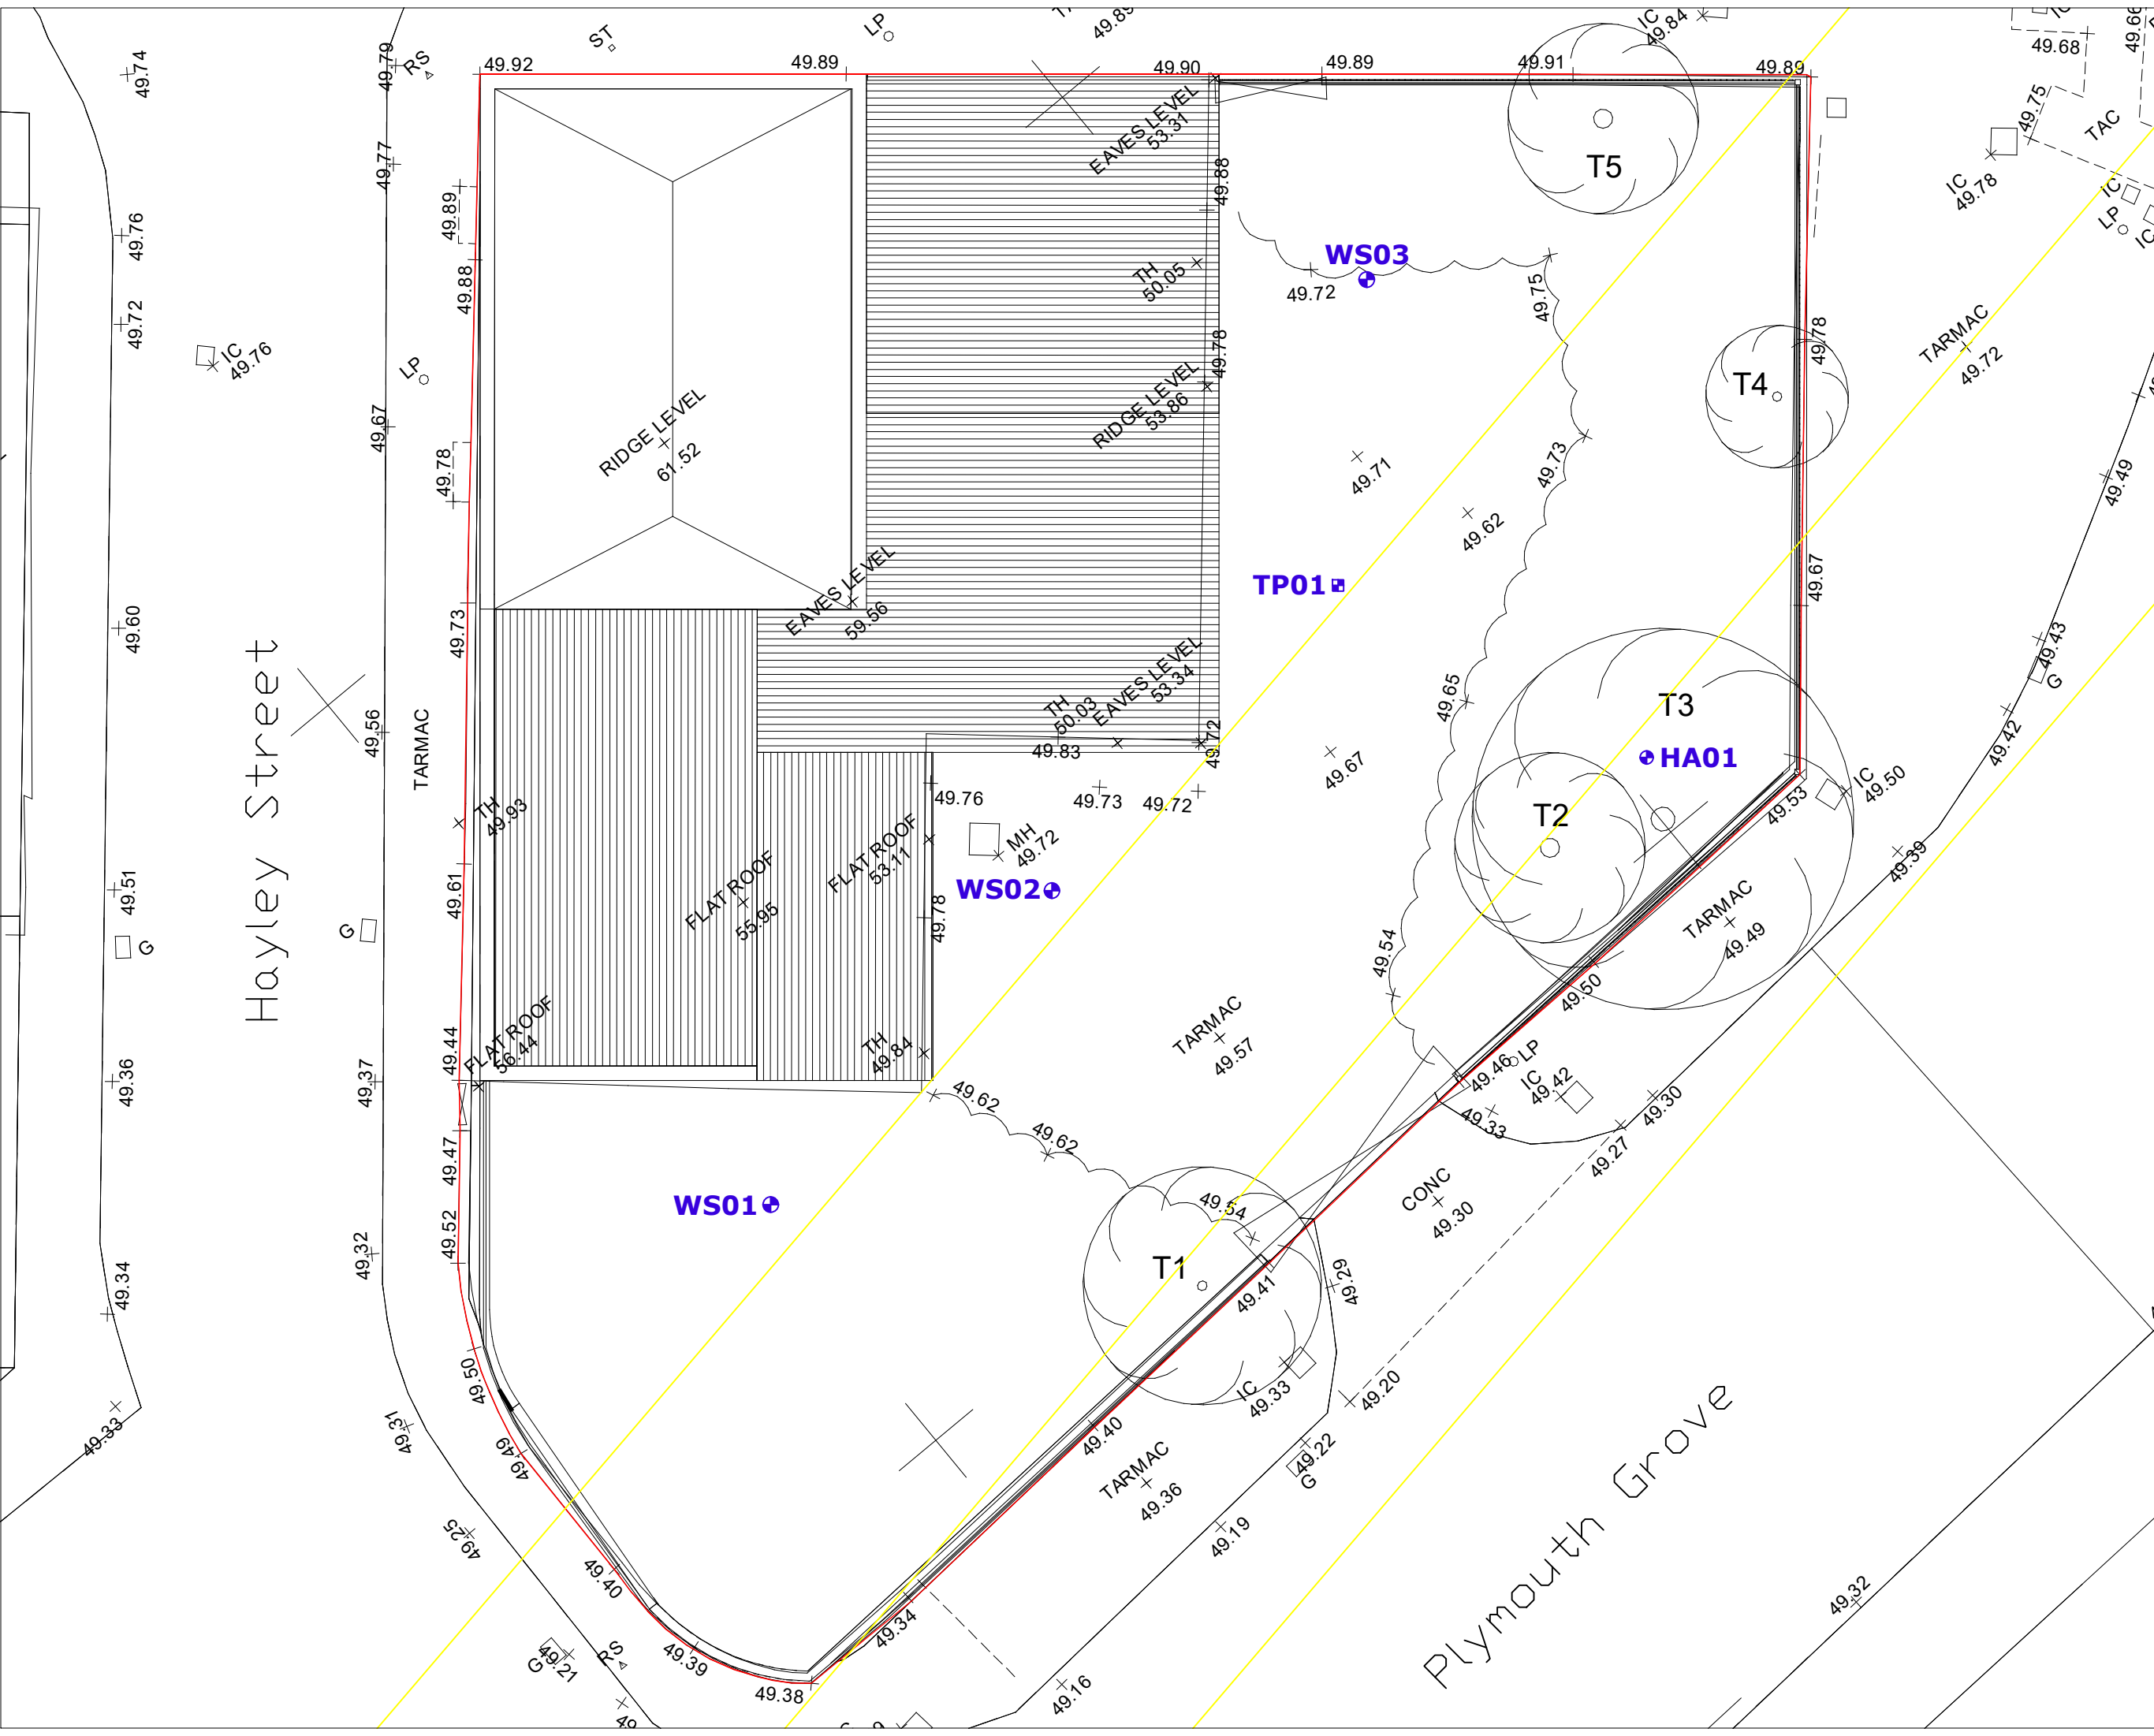
Figure 2 Site Plan

A large sewer runs beneath the site with an easement of 6.5m either side. Due to this no drilling could be undertaken within the easement, the extent of which is shown on Figure 2.

The site comprises a roughly triangular plot of land located to the south west of Stockport Road and between Plymouth Grove and Hayley Street in Longsight, Manchester. It is centred on the approximate Ordnance Survey national grid reference 386472 395932. A site location plan and site plan are presented as Figure 1 and Figure 2, respectively.
