## Alberton House

# Demolition Ground Investigation and Geo-Environmental Watching Brief Strategy

**Curtins Ref: 077764-CUR-XX-XX-T-GE-00003**

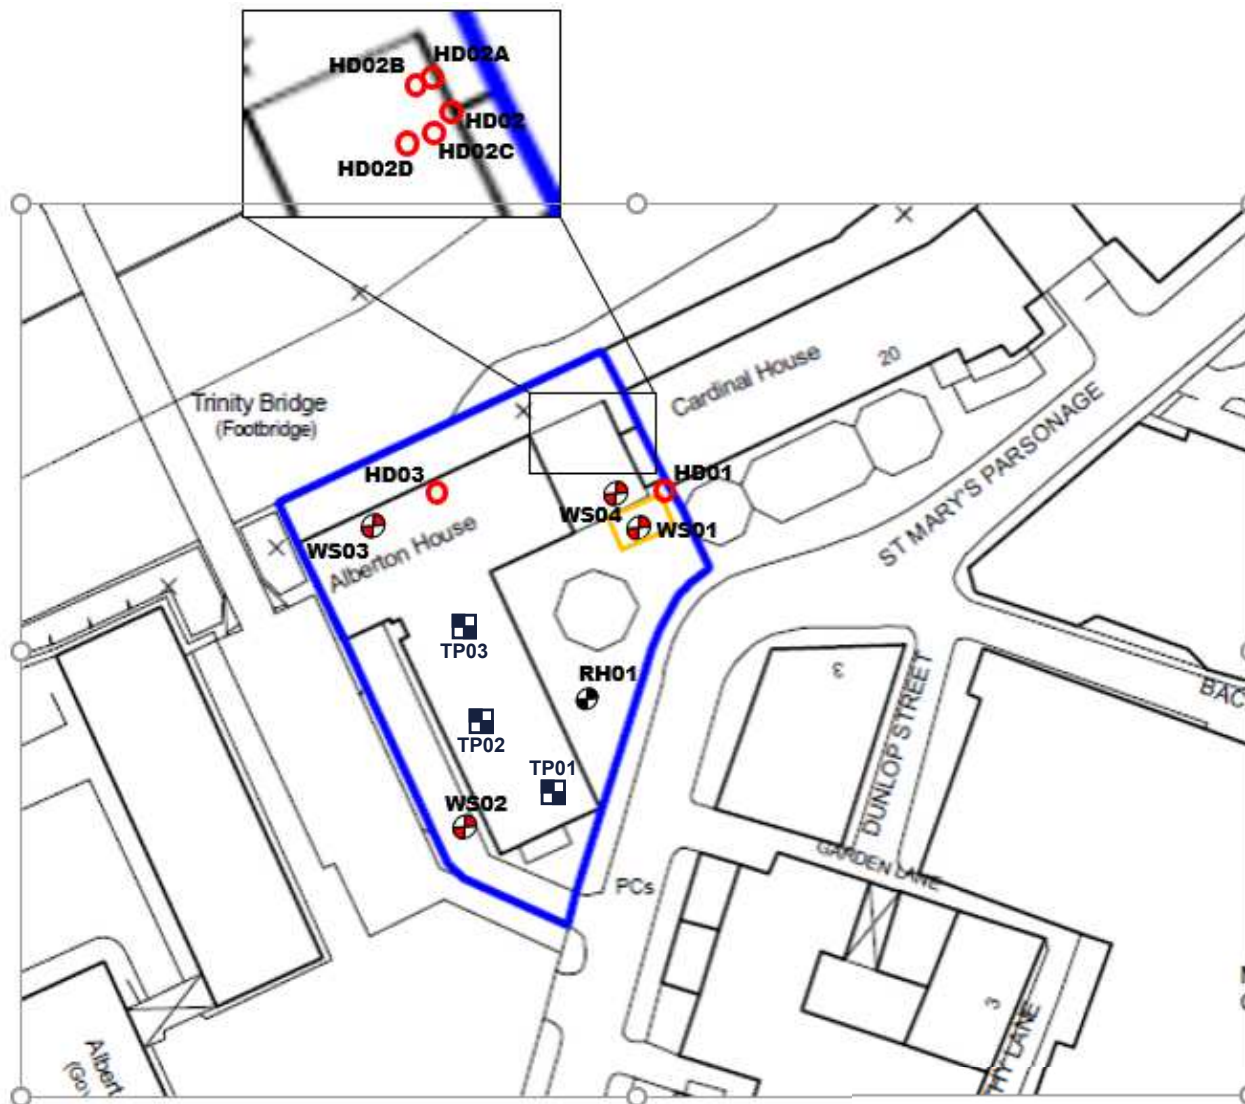
**Key:**

**2022 Ground Investigation**

Trial Pits Required to Expose the Existing Building Foundations and Record Foundation Type & Geometry (2022)

The footprint of the 4-storey building measures approximately 33.5m x 14.6m, with an approximate area of 500m<sup>2</sup>. It is proposed to undertake a minimum of 3 No. machine excavated trial pits within the footprint (approximately 13m grid spacing), obtaining up to 2 No. Made Ground soil samples per trial hole. Trial holes are to be located in a non-targeted, systematic array, beneath the existing building footprint, to provide adequate and representative coverage of the area. These works are anticipated to be completed within 1 working day. A proposed exploratory hole location plan is included in *Appendix A*.
