This Arboricultural Impact Assessment was commissioned by LaboSport to accompany a planning application for commercial development at Manley Park, Clarendon Road, Whalley Range, Manchester. A survey of the trees on site and within influencing distance of the boundaries was undertaken on the 30<sup>th</sup> and 31<sup>st</sup> October 2024 as part of a Preliminary Arboricultural Assessment to aid design and avoid unnecessary tree removal.

The proposed development of the site includes the construction of and new MUGA sports pitch with associated soft and hard landscaping.

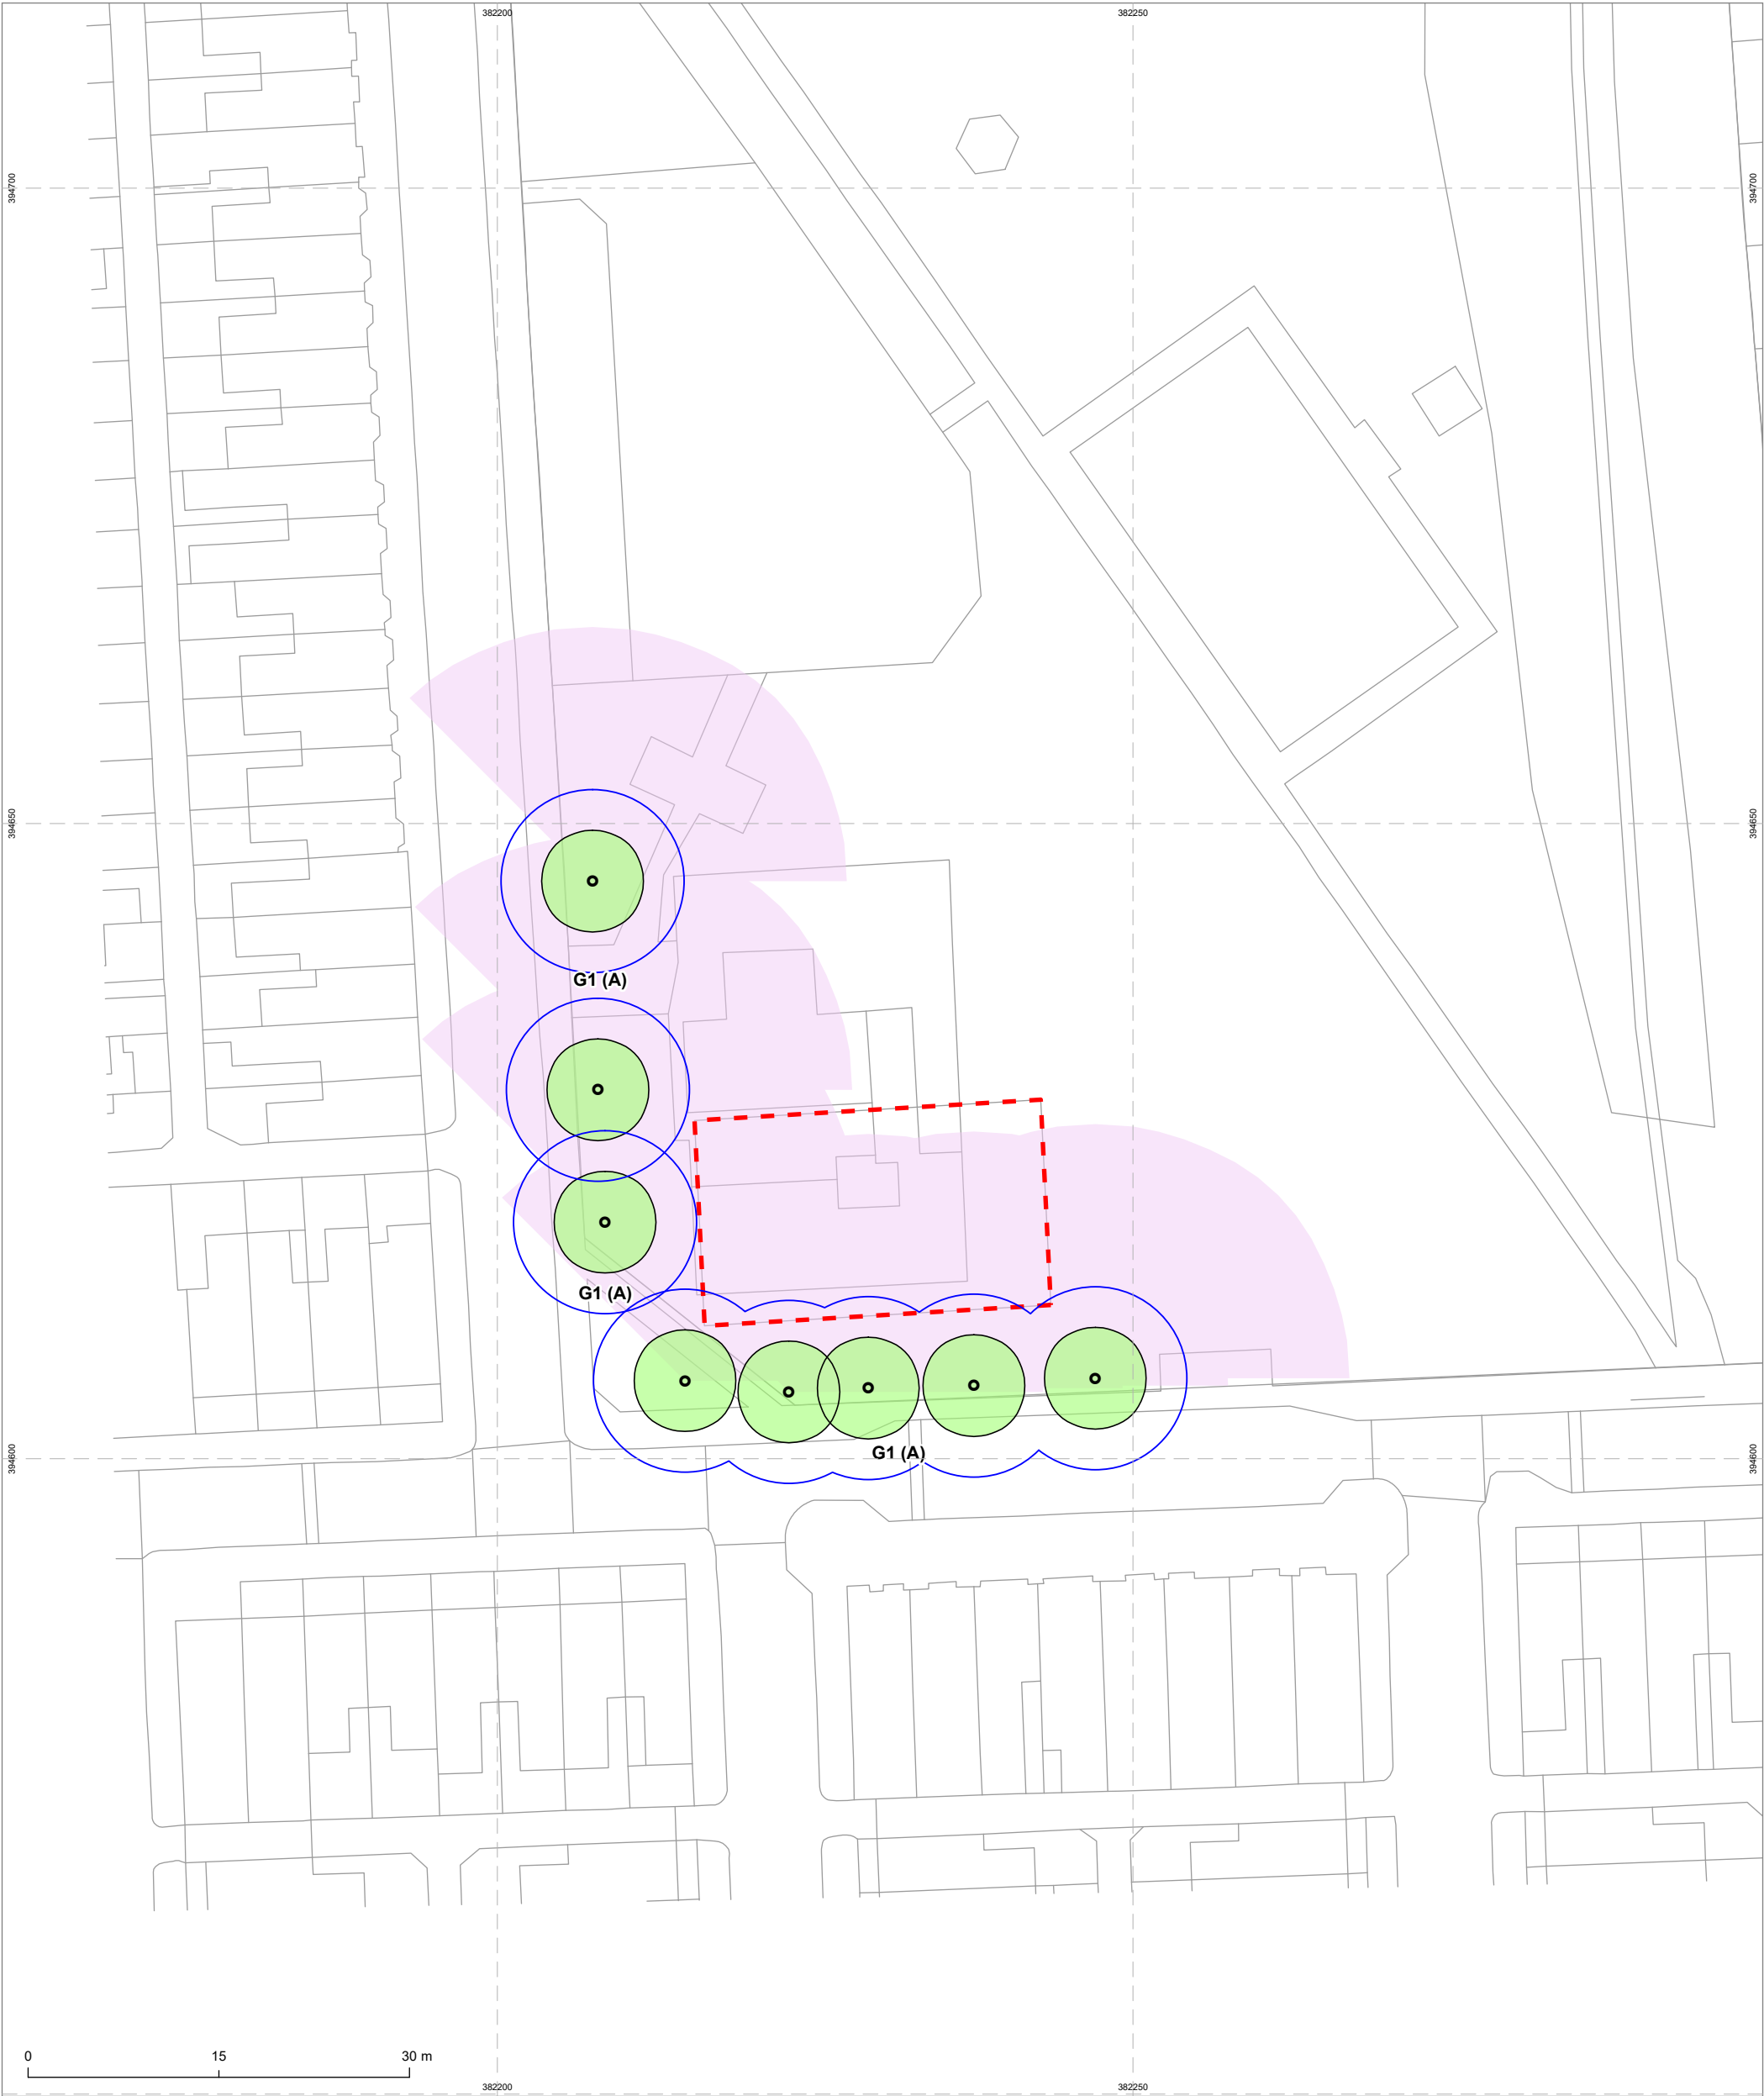
C181389-01-01

The Tree Survey Plan identifies the existing trees including above and below ground constraints which should be considered during the design process.

No trees are required to be removed to facilitate the development. The proposed development will ensure the retention and incorporation of all the trees recorded during the PAA survey and as marked on the attached Tree Survey Plan drawing C181389-01-01-Rev A.

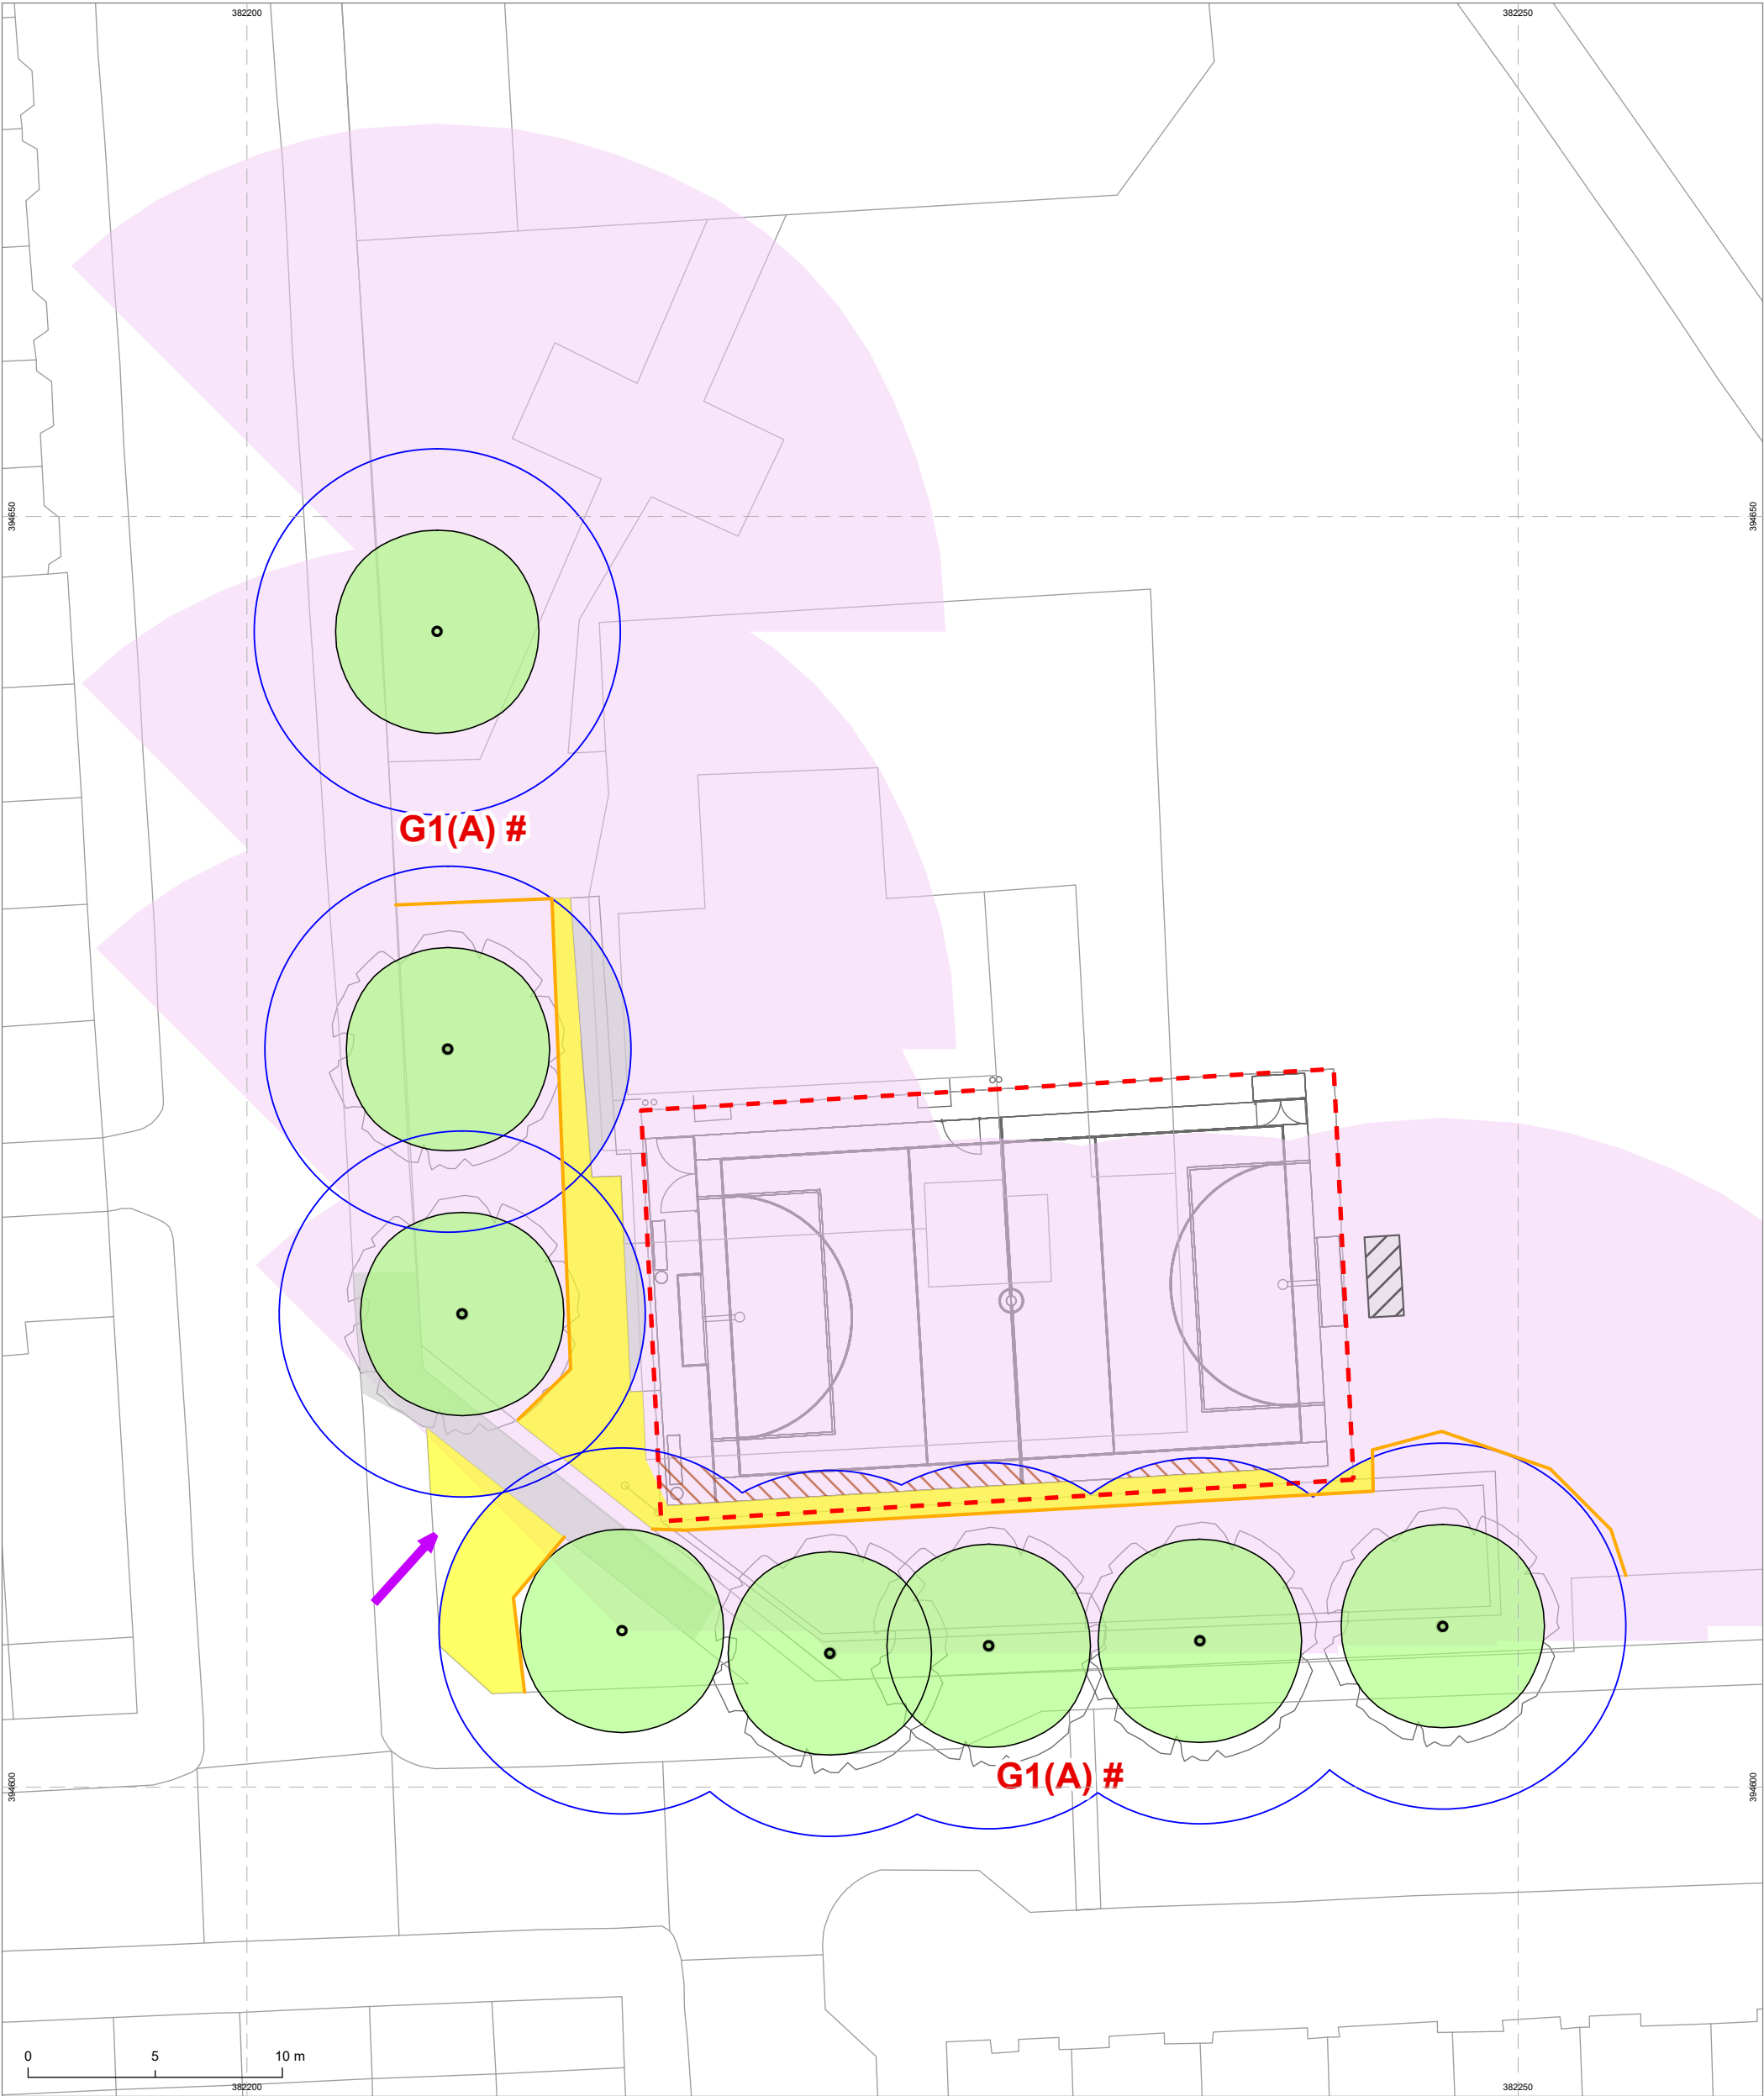
The Tree Retention Plan identifies which trees and hedgerows are to be retained and incorporated as part of the site development and which are to be removed.

The reduction in levels will be located at the periphery of the RPAs of the retained trees in group G1 and the proposed works are, therefore, unlikely to cause significant harm. The contractor access to site will require minimal access facilitation pruning and/or branch tie back works to the canopies of retained trees. All works within the RPAs or beneath the canopies of retained trees should be detailed as part of an Arboricultural Method Statement to ensure the method of construction is suitably considered.
