| project | ardwick barracks |
| drawing number | 2411-SKM-RF-XX-D-A-279501 P02 |

drill hall roof eaves + gable details

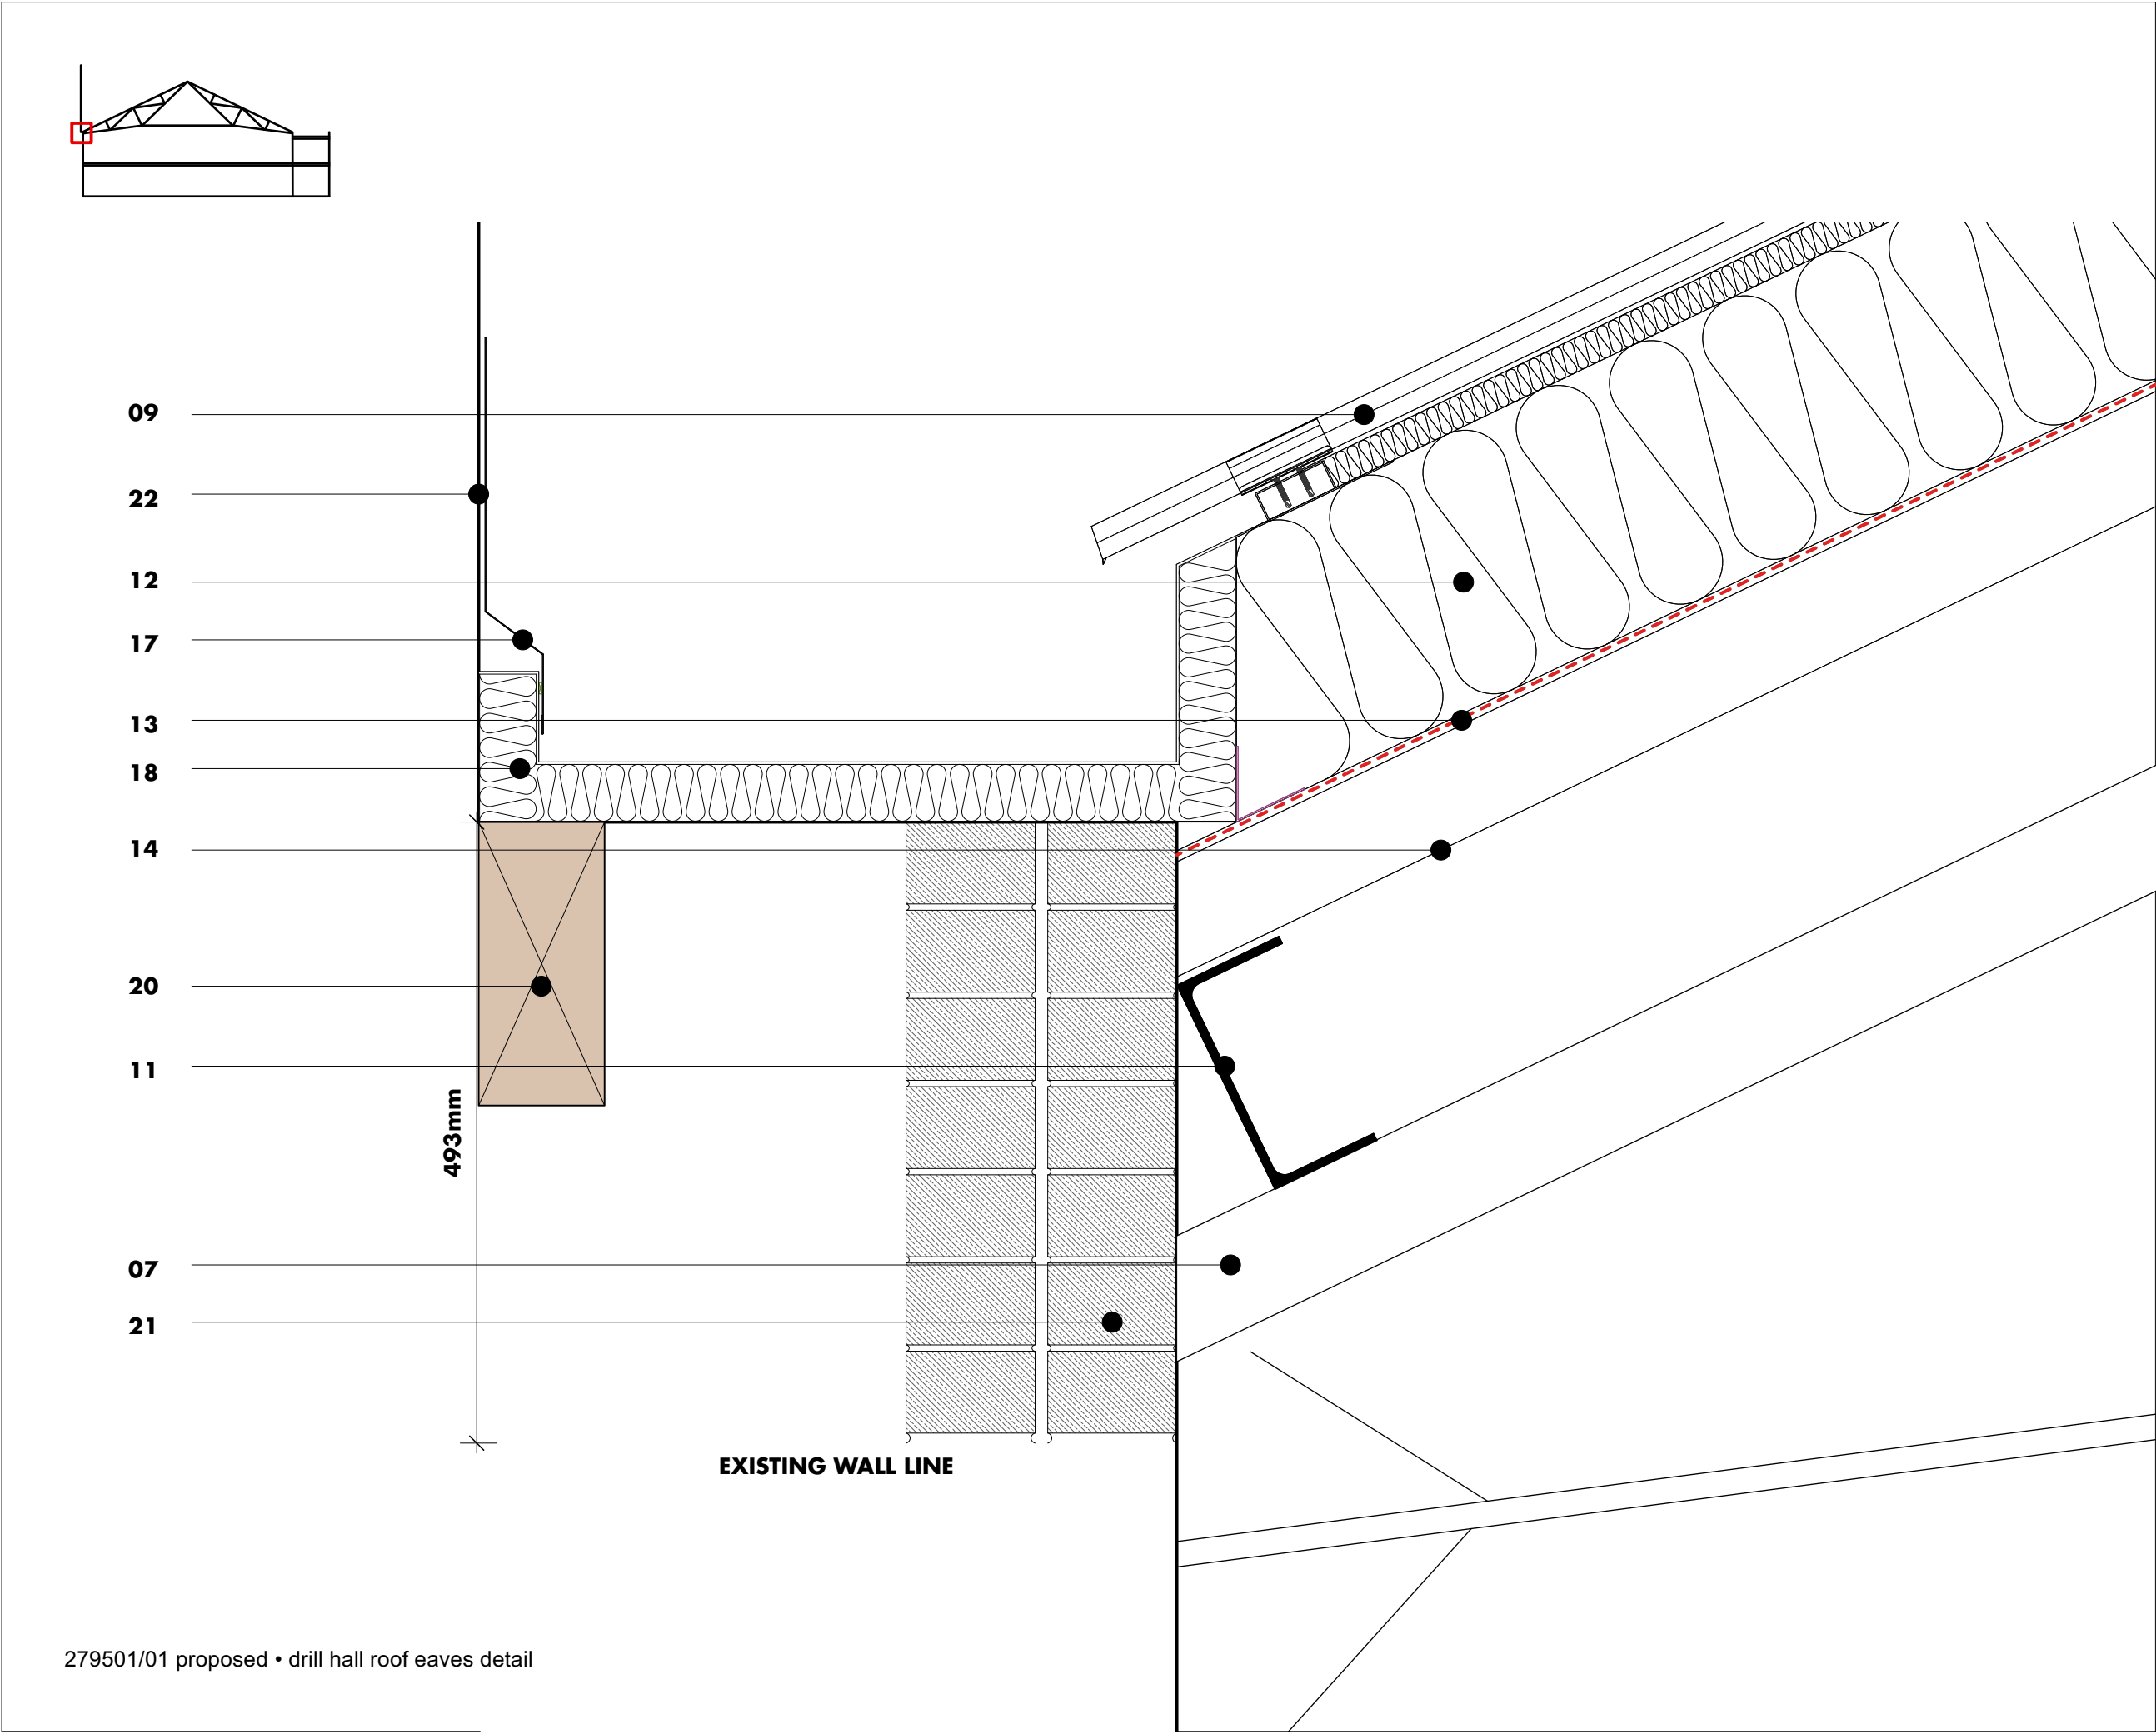
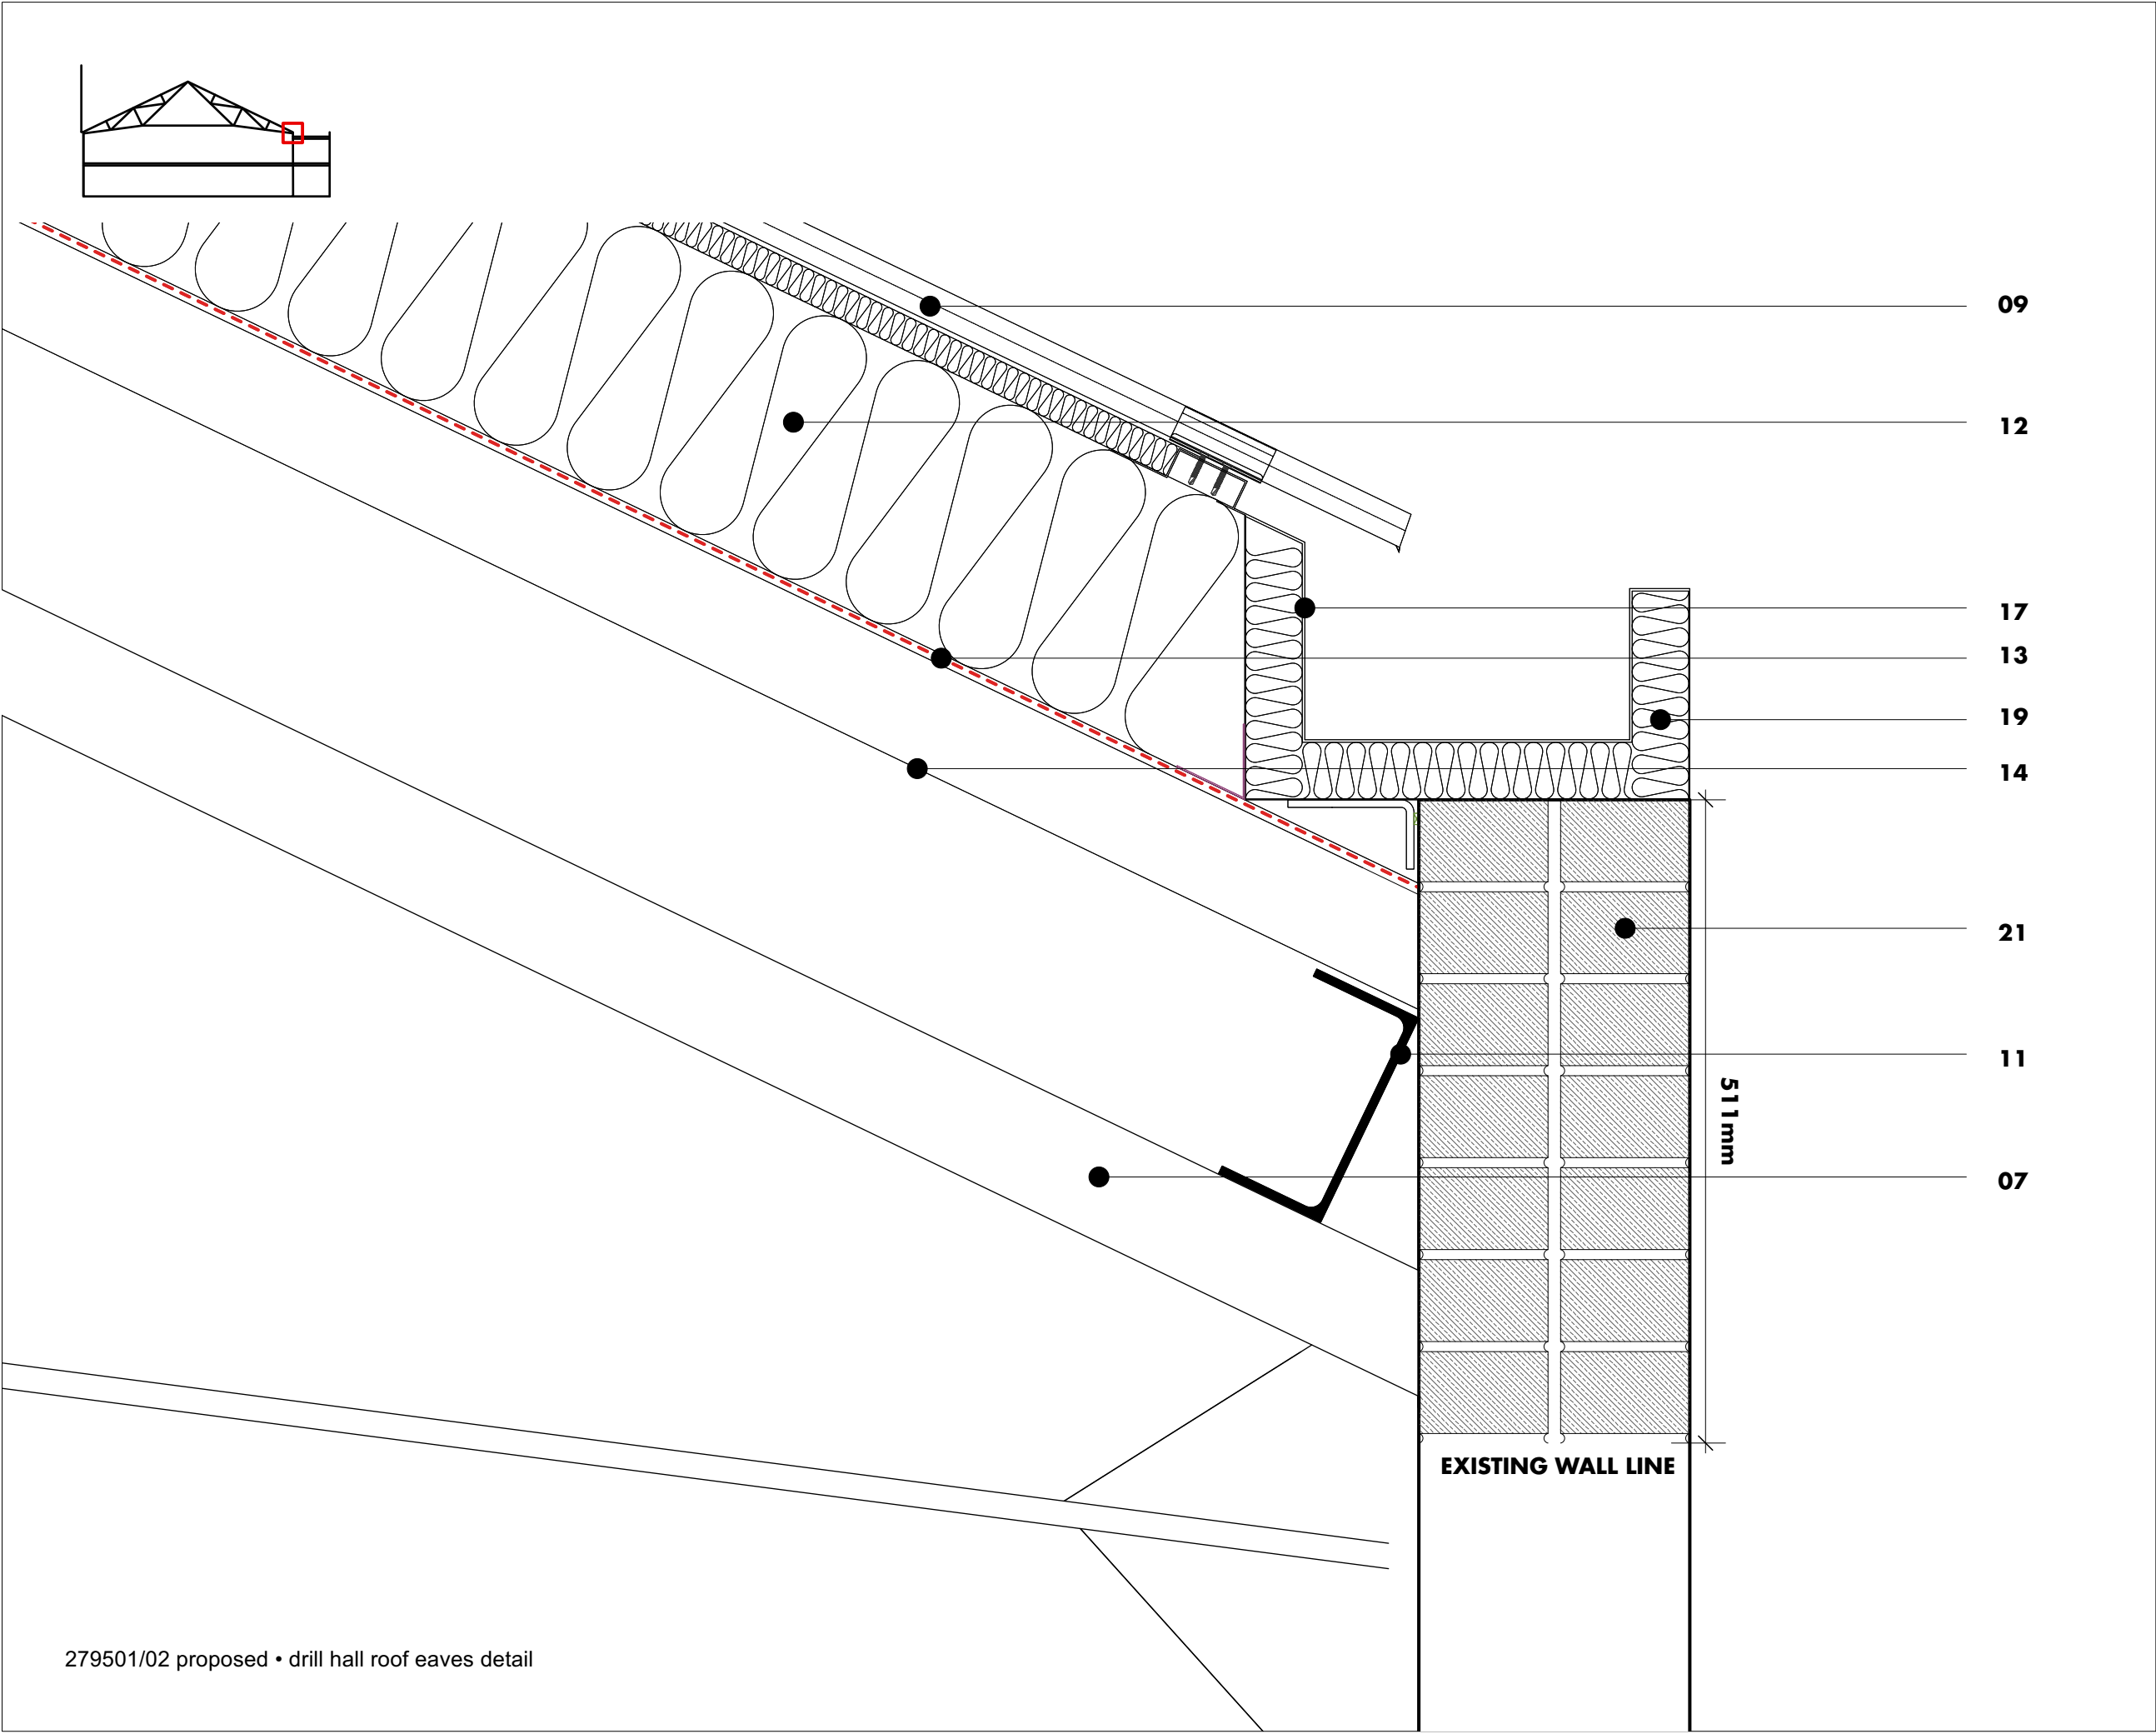
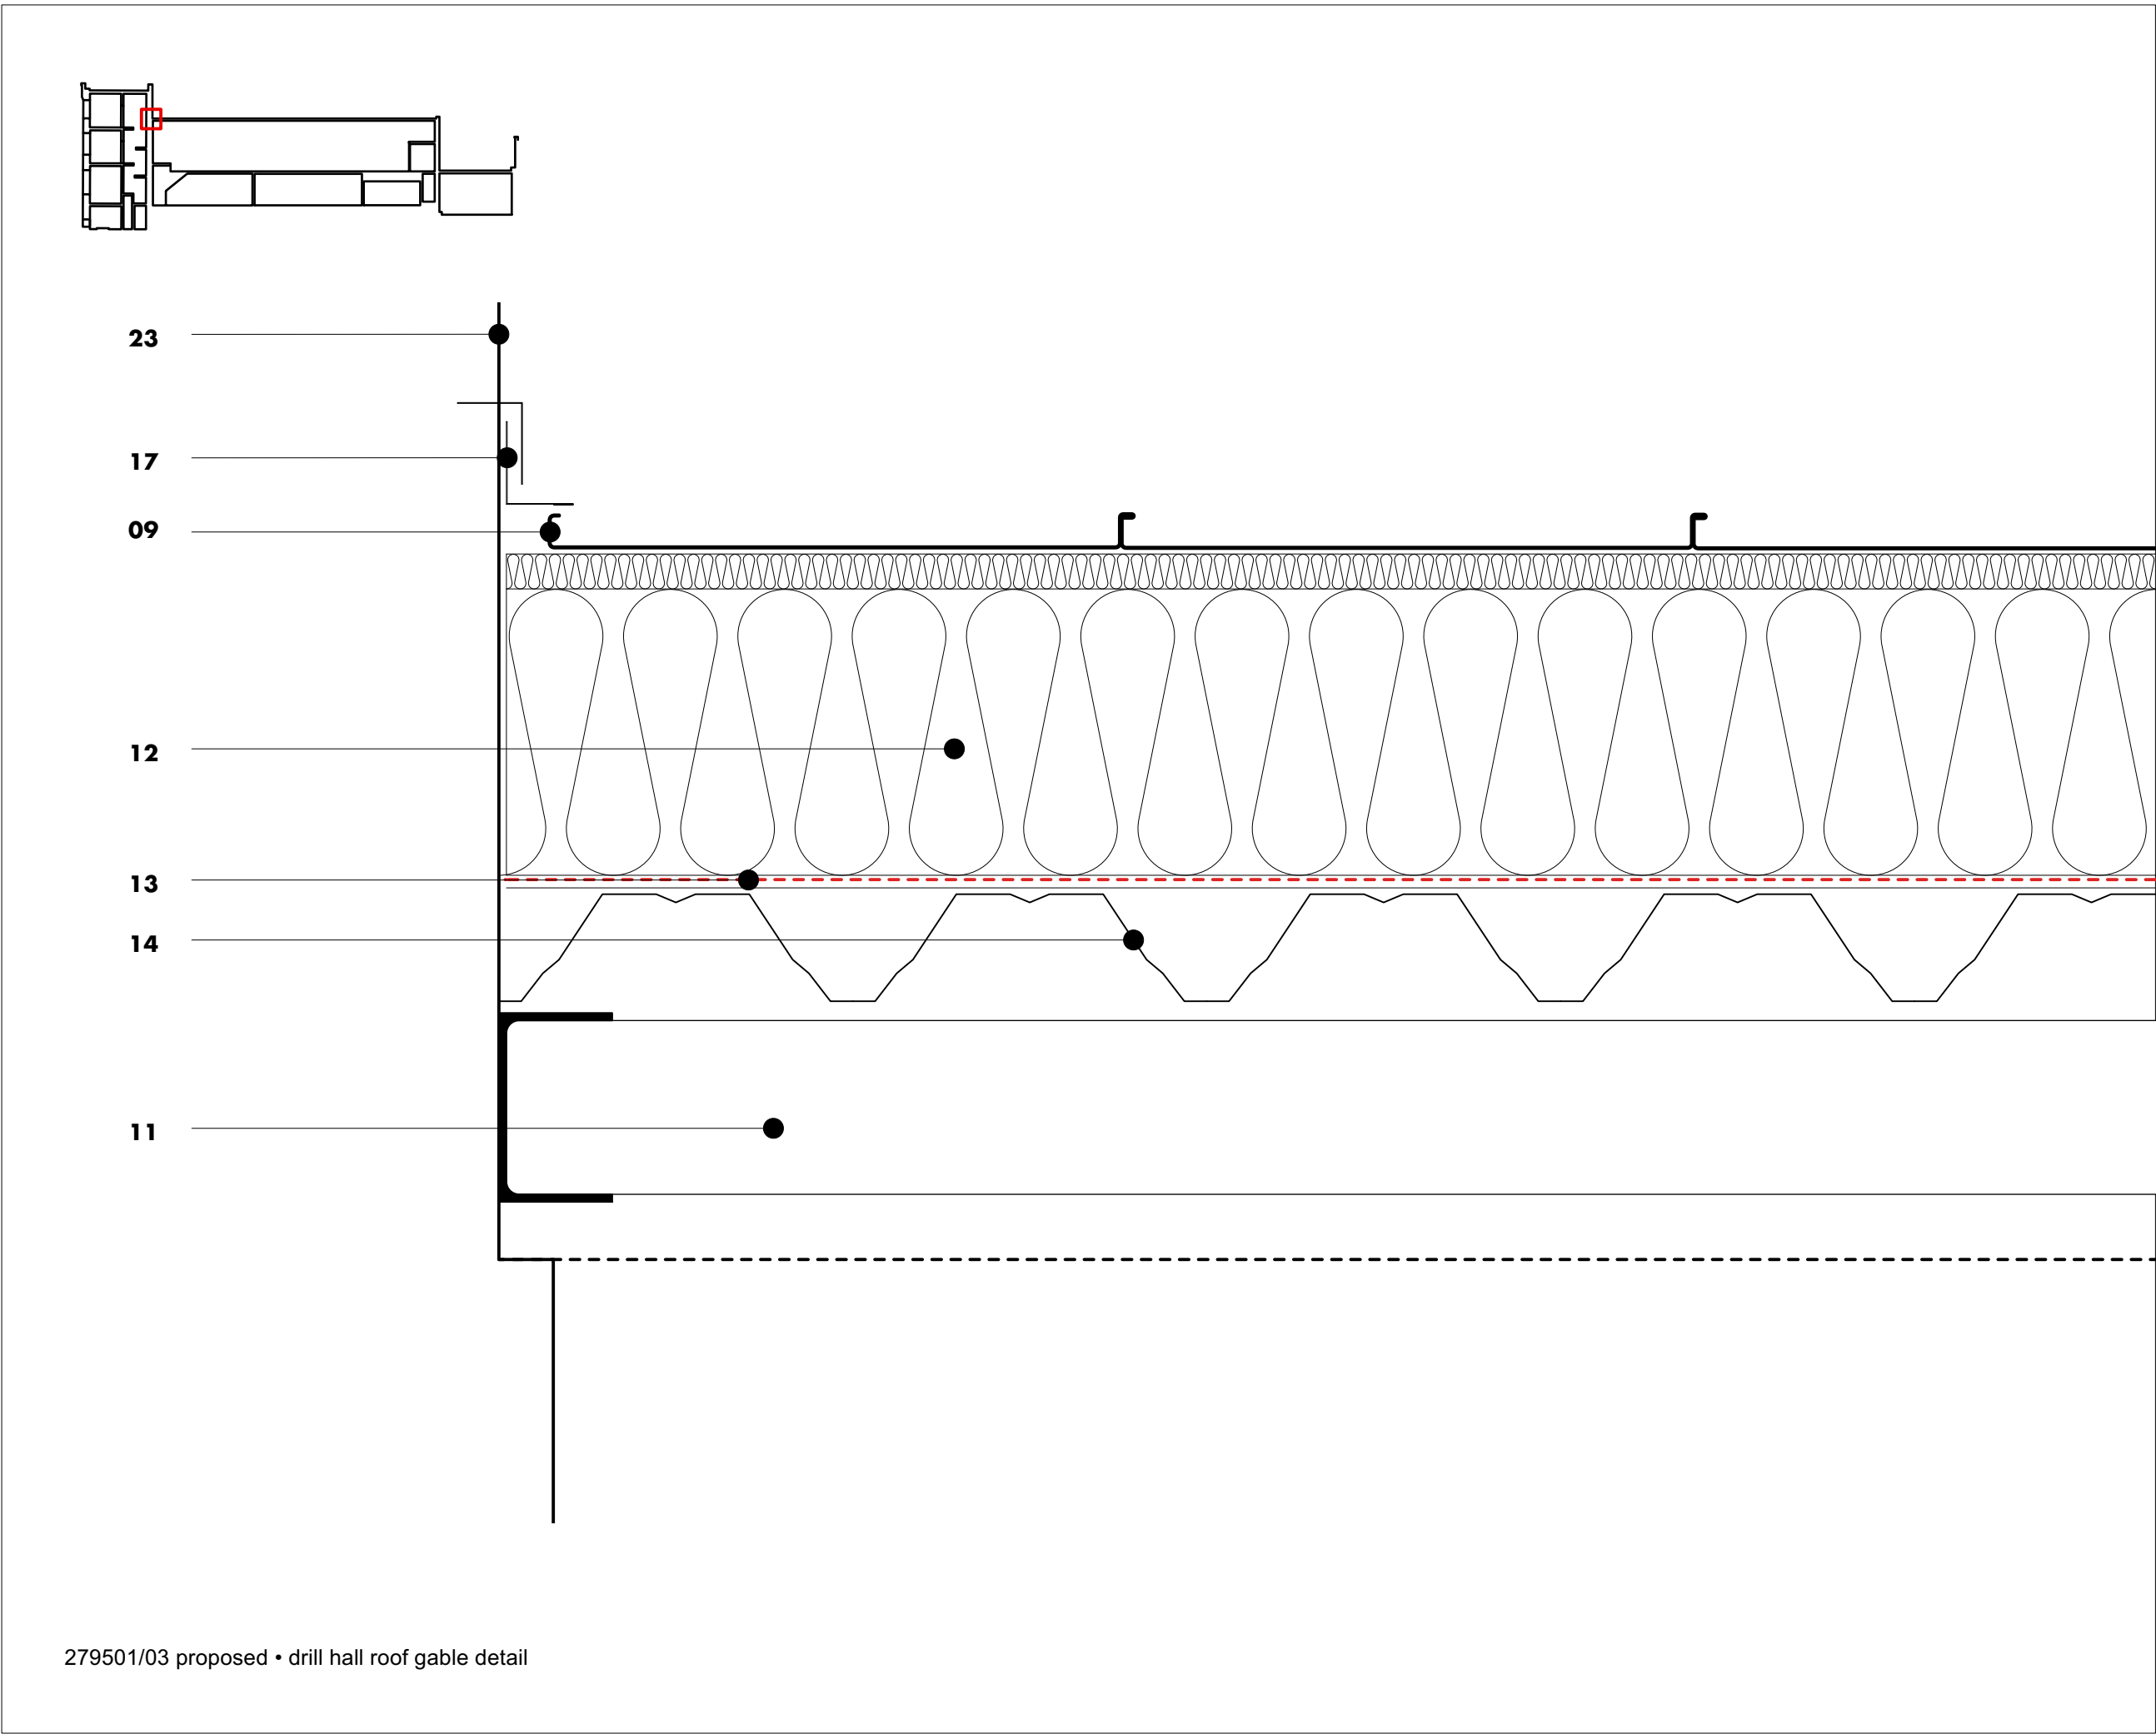
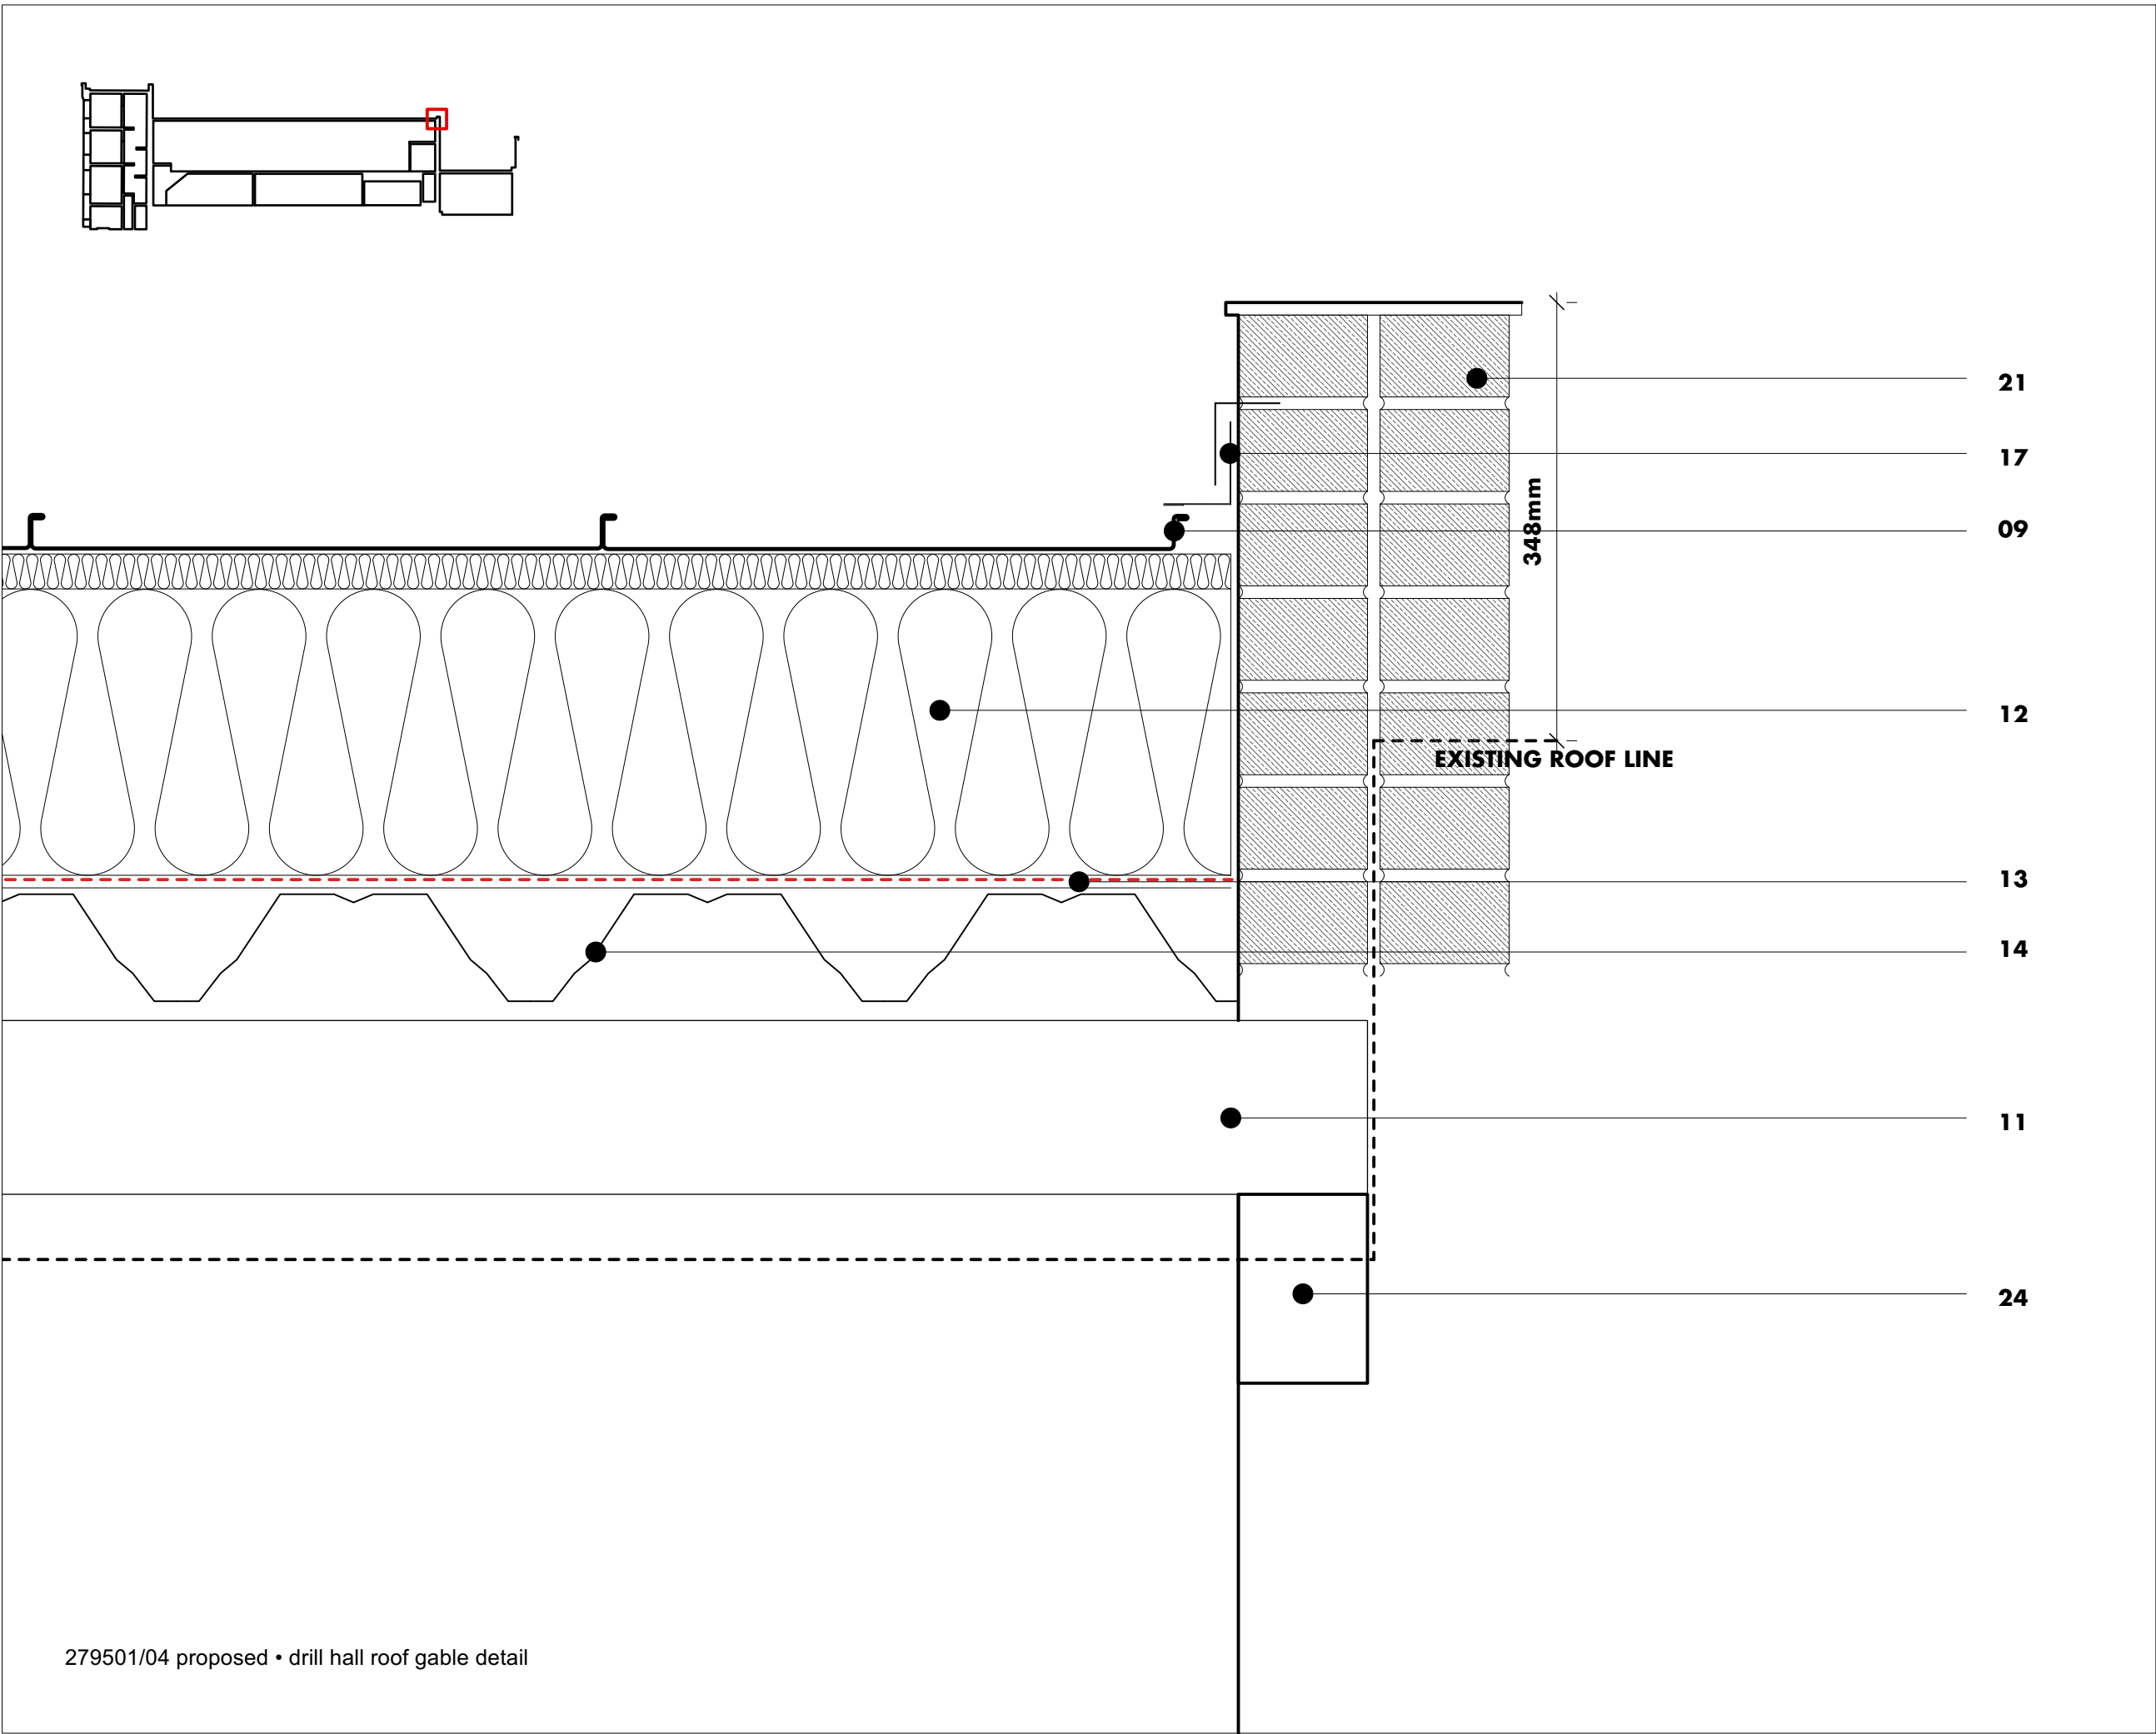
- 01 roof light flashing / drip
- 02 thermally broken aluminium-framed double glazed roof light system with flush opening vents
- 03 aluminium mullion
- 04 ridge beam - to S.Eng details

- 05 existing wrought iron support shoe - retained + cleaned
- 06 ppc aluminium roof light mullion
- 07 existing wrought iron truss - retained + cleaned
- 08 soft wood timber lining to roof light reveal - painted

- 09 standing seam aluminium roof sheet - RAL 7016 anthracite
- 10 timber roof light kerb/lip/stand
- 11 180x30mm PFC purlin - to S.Eng details
- 12 rigid rockwool insulation batts between standing seam support brackets

- 13 vapour barrier
- 14 perforated acoustic metal roof deck - to S.Eng details
- 15 omitted
- 16 omitted
- 17 aluminium flashing
- 18 insulated aluminium gutter (walkable for cleaning + maintenance access)

- 19 insulated aluminium walkable gutter to be fixed to proposed masonry (and timber wall plate on party wall side)
- 20 timber wall plate (25mm deep x 100mm wide) to be fixed to existing party wall - to S.Eng details

- 21 existing brickwork wall extended to suit deeper roof build up
- 22 neighbouring property
- 23 rear wall of barracks building
- 24 new padstone to support new PFC purlin
