Project  
Rutherford Building

Drawing Title  
Roof Detail 02 - Abutment to Vertical

Drawing Number  
2421-RBUM-ARC-XX-RL-DR-A-2421

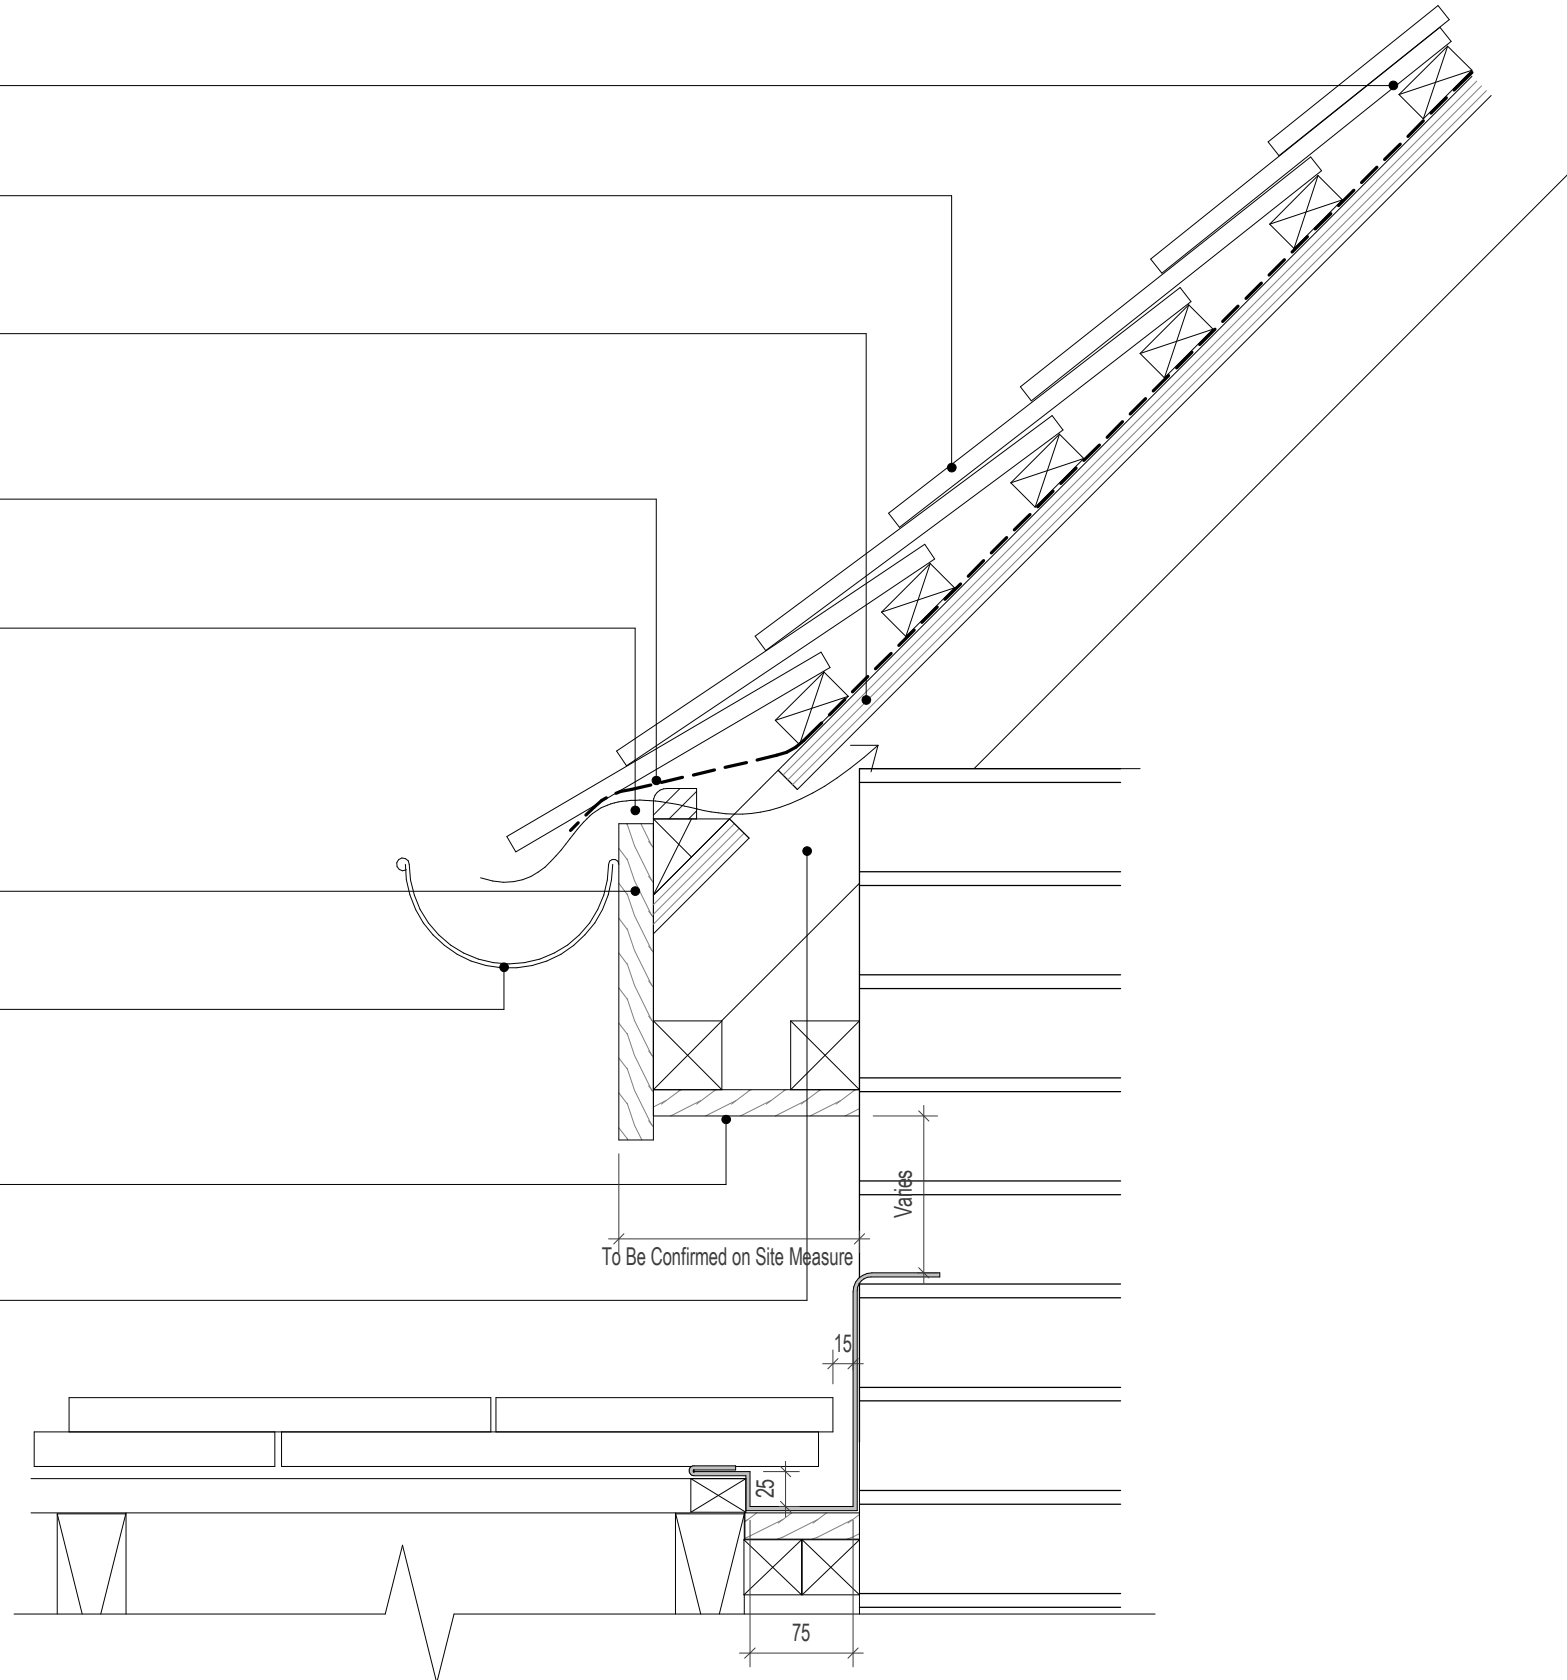
# 1 Roof Detail 2 - Abutment to Vertical 1 : 5

Tudor UNDER-TILE venting system  
at upper end of roof- quantity /  
calculations to follow .

Existing Clay Tile Temporarily  
Removed to Allow Installation of Vent  
and New Gutter Below

Existing 18mm Sarking Board under  
sarking felt. Provide 20mm gap to allow  
for airflow behind ventilator.

Existing Sarking Felt Taken  
Over Vent

New Propriety Eaves  
Ventilator

New Treated Timber Fascia Board  
Fixed to Ends of Existing Rafters

New Metal Heritage Rainwater  
Goods with Downpipe to Feed  
Adjacent Parapet

Fascia Closure Piece Run Between

Existing Rafter has been Left  
Exposed - Survey to Establish  
Condition. Patch Repairs as Required
