# KELLEN HOMES & GREATER MANCHESTER YOUTH FEDERATION

Mount Road, Gorton

Remedial Strategy

NA/C5150/11739 Rev E

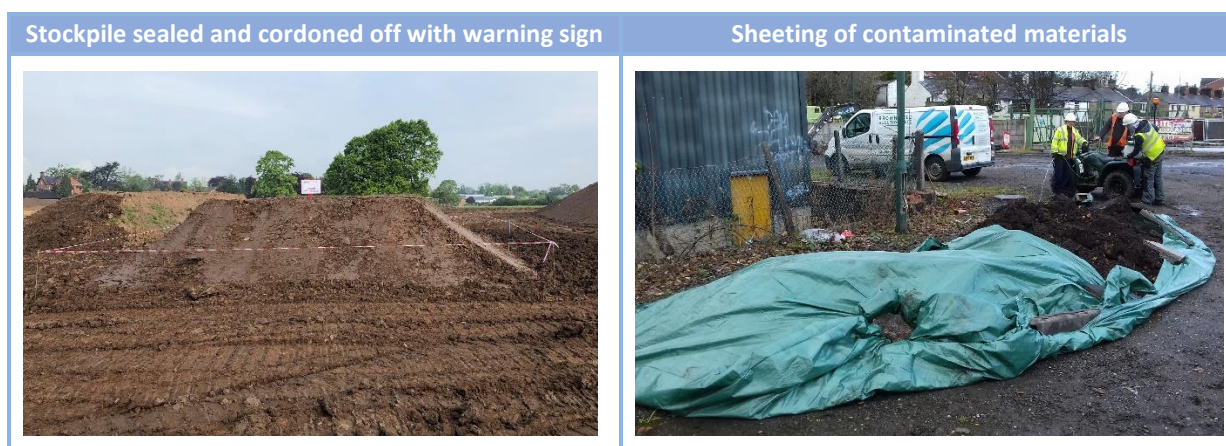
Examples of good site practice for stockpile management are presented below:

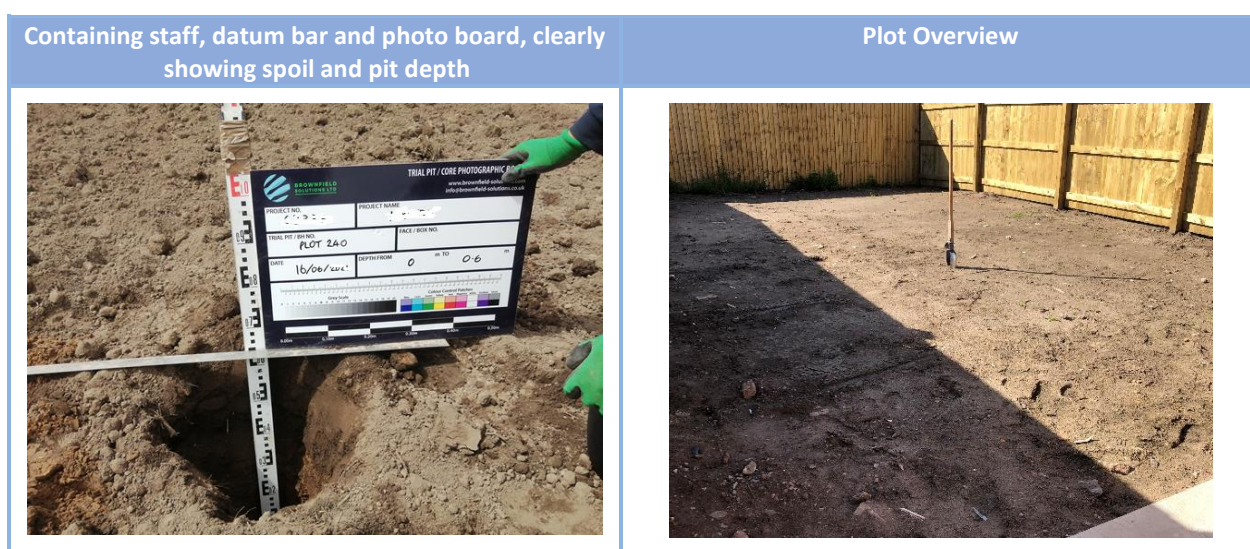
Once installed by the groundworks contractor, there is a requirement to provide evidence of the chemical suitability and depths of the clean cover system, with inspections to be carried out by a suitably qualified Geo-environmental Engineer in a randomly selected area of plots. Confirmatory photographs will be taken for inclusion in the validation report. An example of good practice for depth validation is provided below:

The frequency of garden validations shall be specified as every plot for the first ten plots constructed, then falling to one depth validation inspection pit per every four plots ready at the time of inspection (1 in 4). Photos of all other plots with soils in place during the time of the inspection should also be provided.

In areas of soft landscaping/public open space (POS), validation pits should be excavated at a frequency of circa one pit per 25m x 25m area of POS. In the area of the sports pitches, we propose 10 No. locations should be validated to avoid damage to the pitches; survey data (before and after placement of soils) may also be utilised to demonstrate the clean cover thickness.

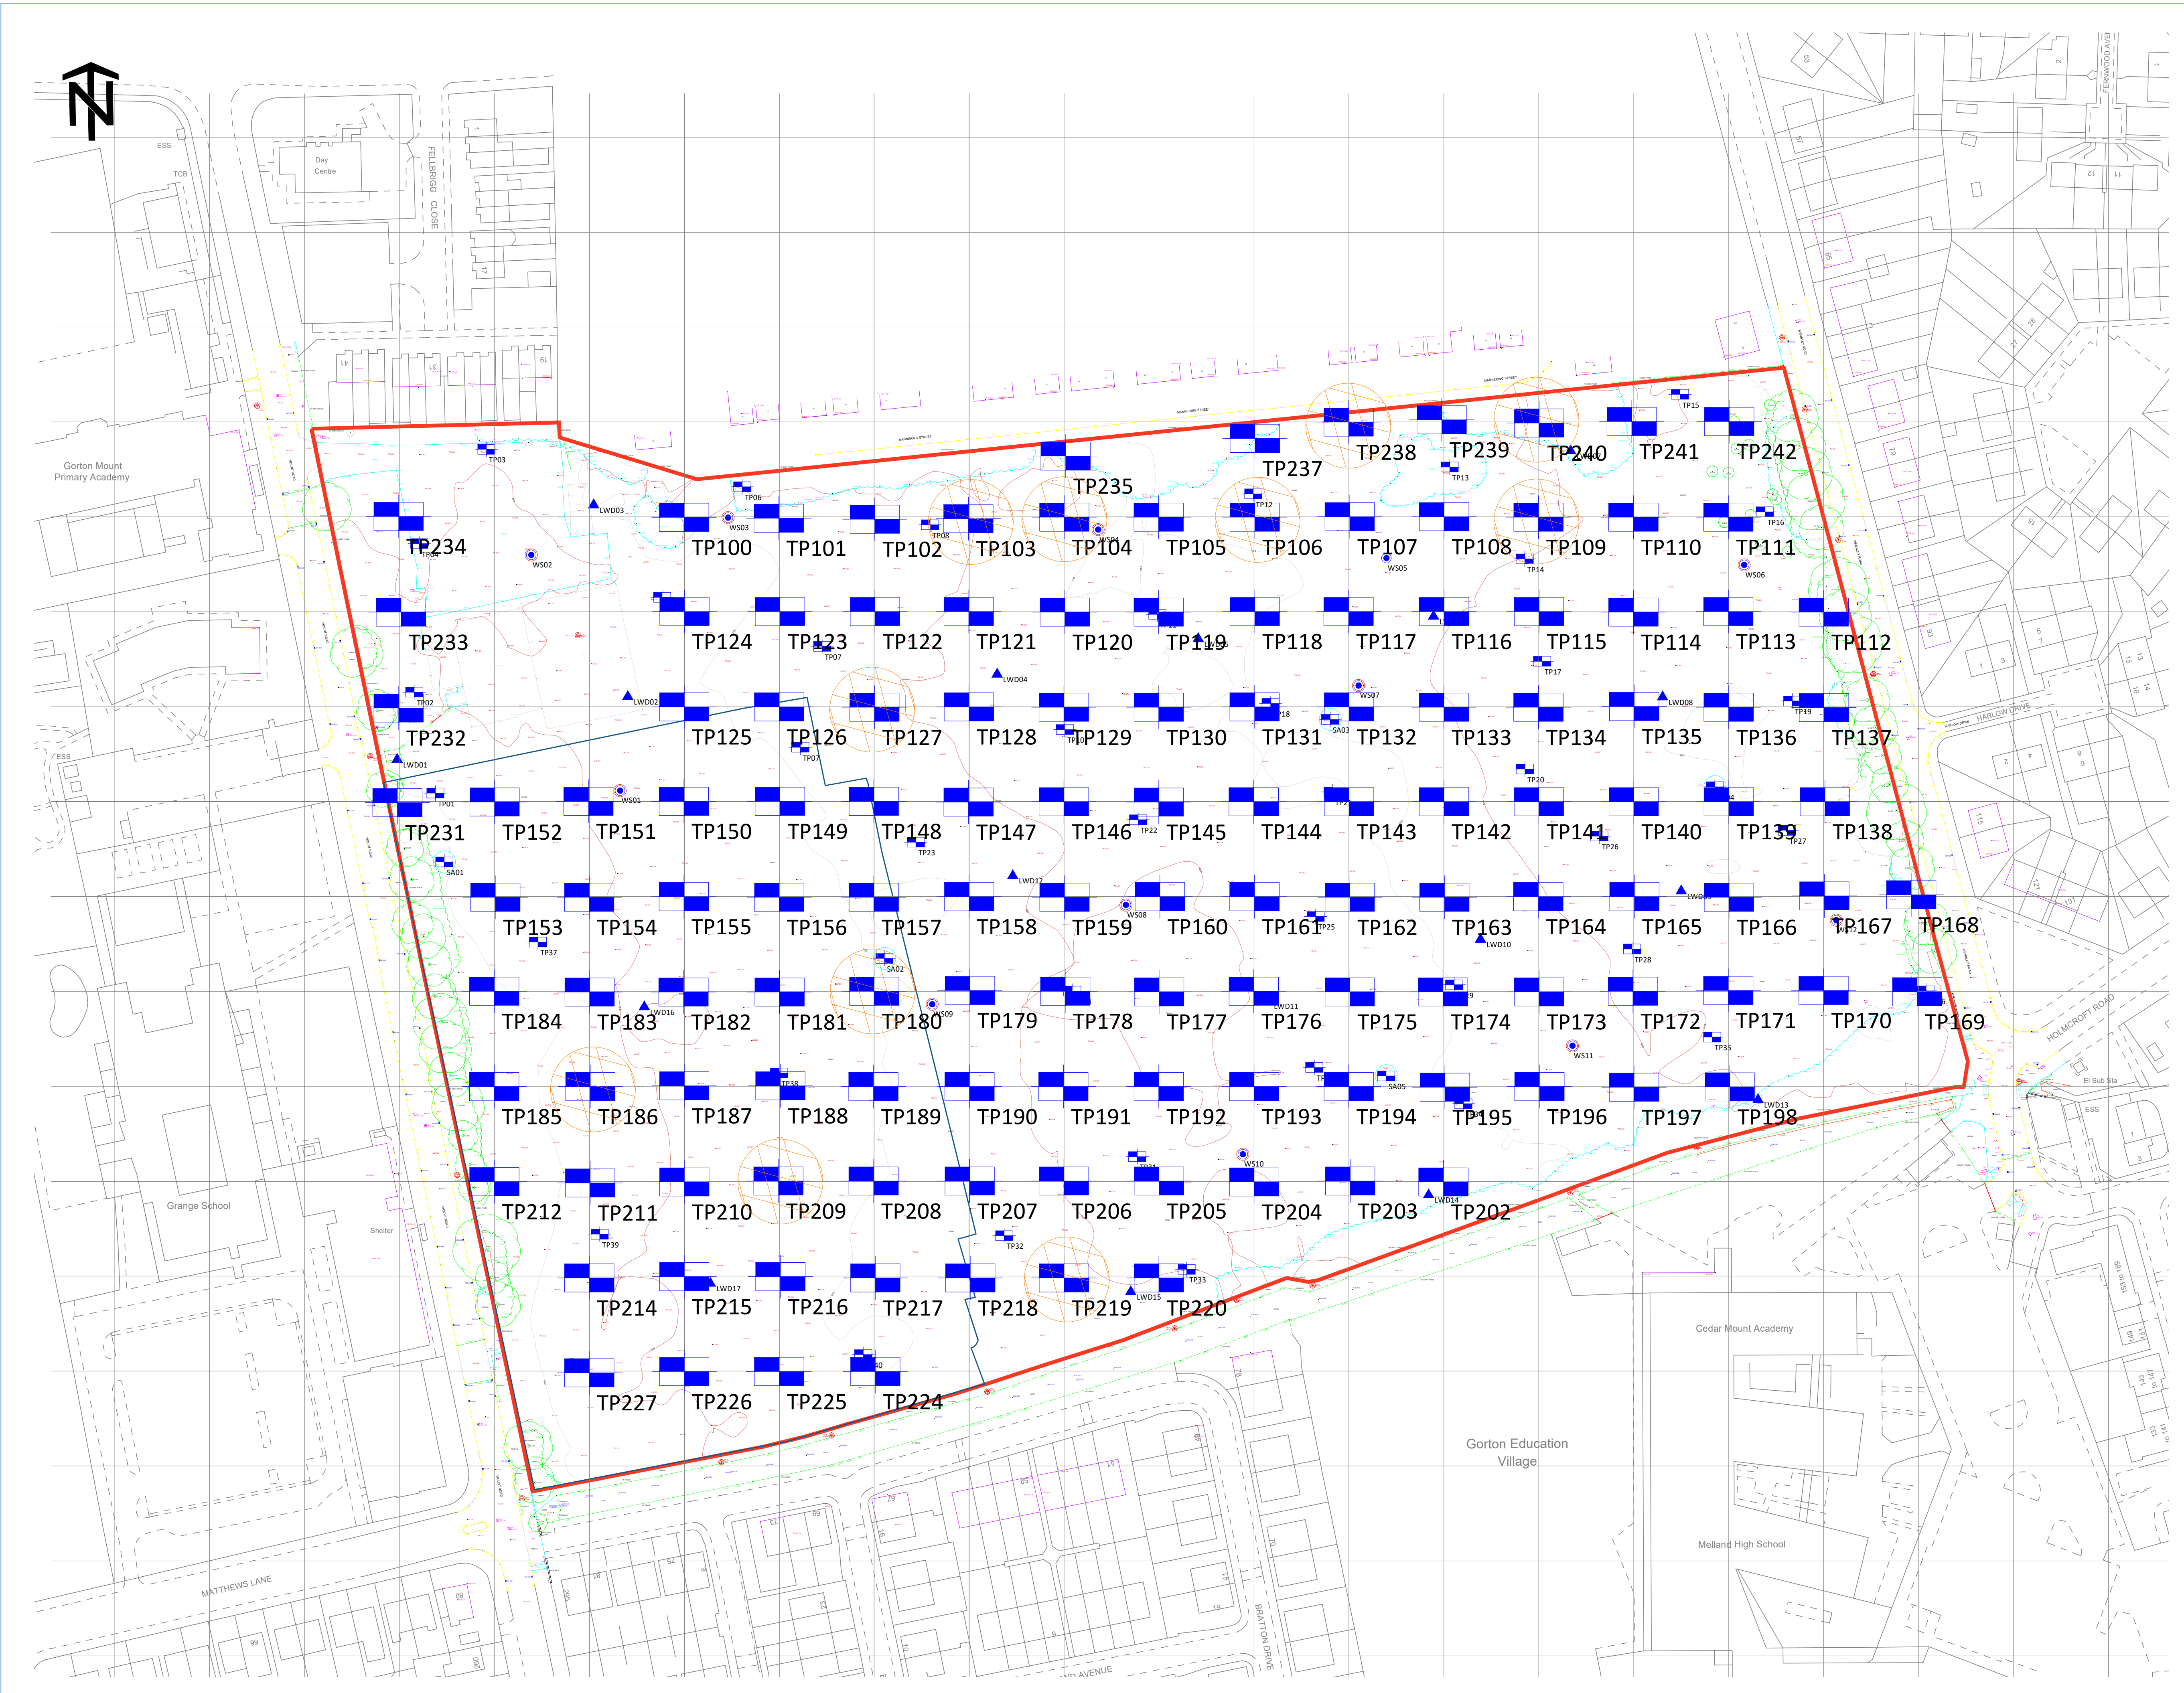
| KEY | |
|---|---|
| | MADE GROUND TOPSOIL SAMPLE IDENTIFIED AS HAZARDOUS FOR OFF SITE DISPOSAL PURPOSES |

NB: SYMBOL FOR LOCATIONS HIGHLIGHTED AS HAZARDOUS DOES NOT INDICATE LATERAL EXTENT OF HAZARDOUS MATERIAL - THERE MAY BE NO VISUAL DIFFERENCE IN SUCH MATERIALS.

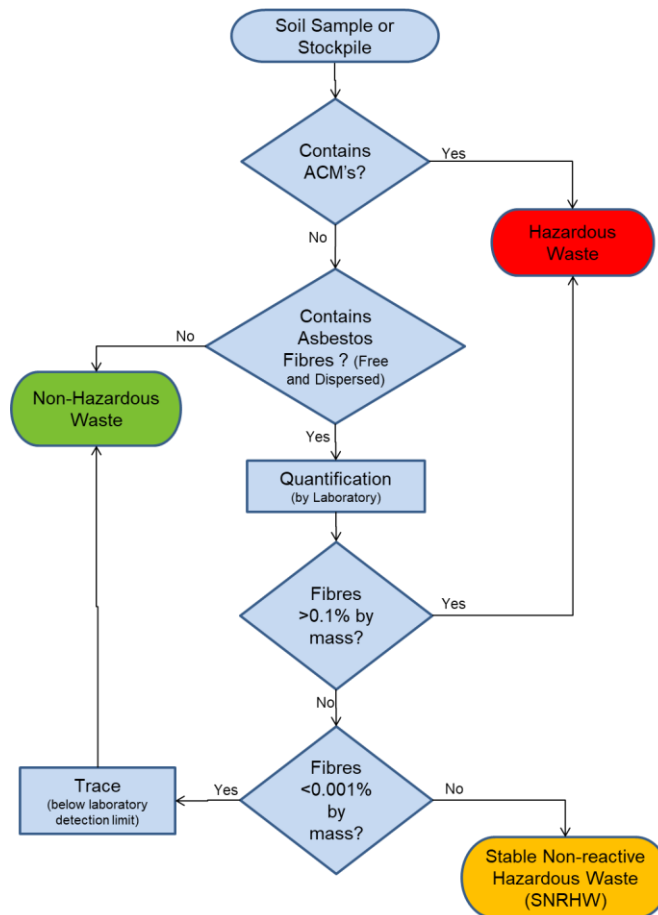
The assessment of asbestos containing waste is dependent on whether the asbestos is present as:

- Fibres that are free and dispersed, or
- Identifiable pieces of asbestos containing materials (ACM's)

Identifiable pieces of asbestos are any particle of a size that can be identified as potentially being asbestos by a competent person if examined by the naked eye. The result is that commonly soils with visible ACM's are sorted and the ACM's removed by hand picking and separate disposal.
