### 3.1.2 Protection

### 3.2.3 Mortar (including cement)

### 3.2.4 Stone masonry

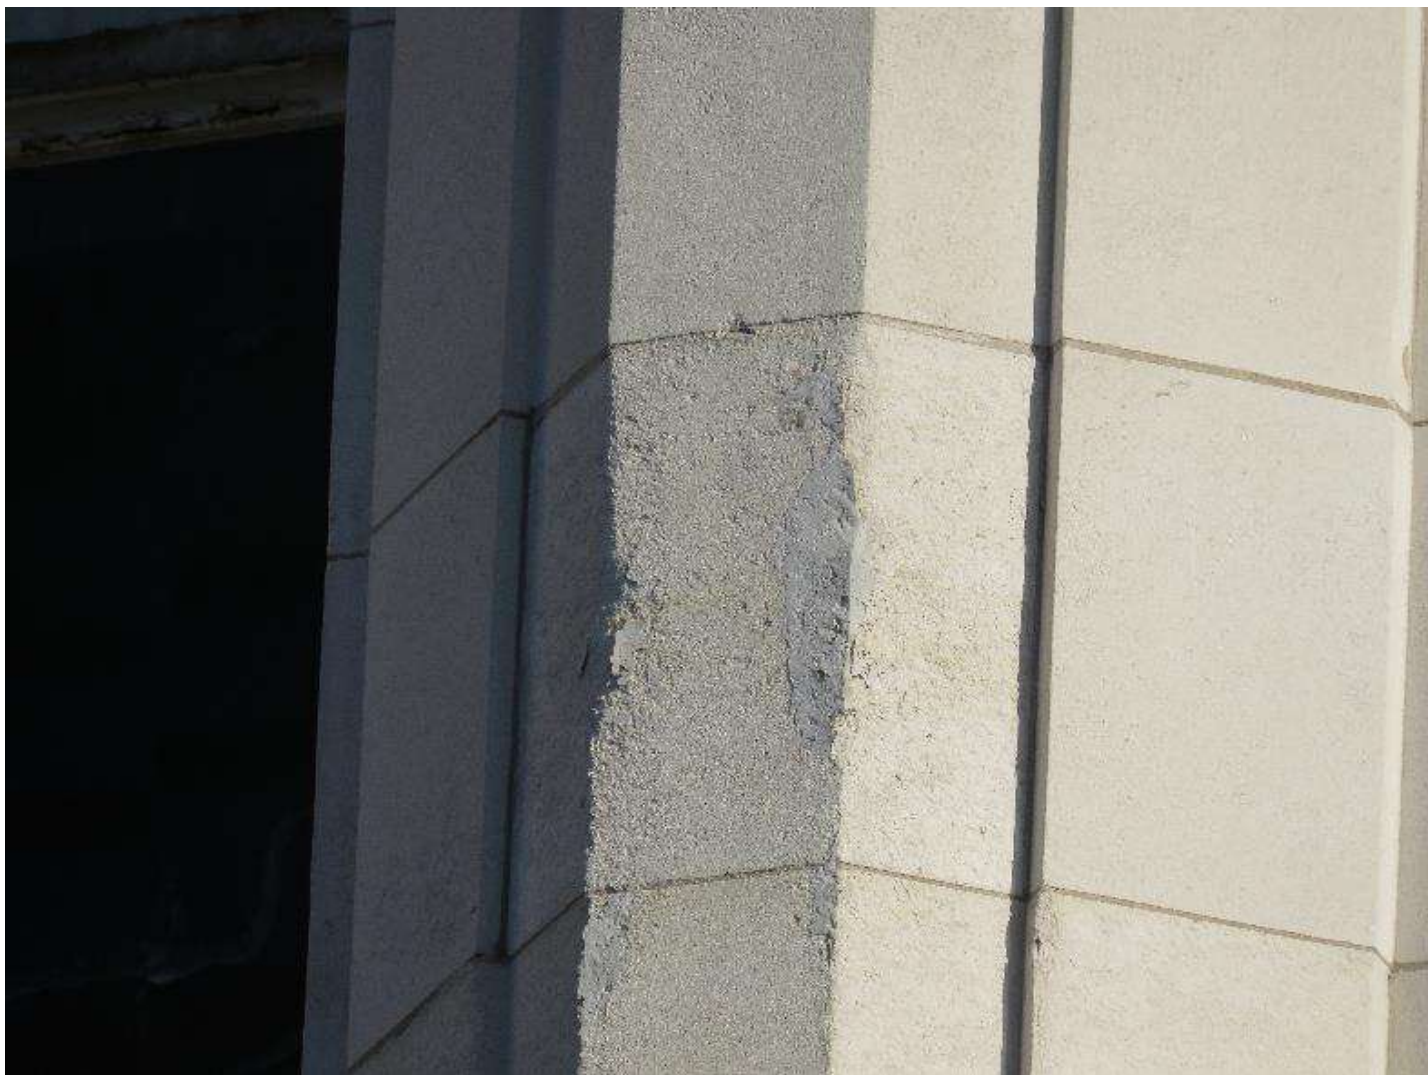
**Fig. 5:** The fine joints of the Portland stone cladding has a cream coloured mortar with very little aggregate, most likely a lime putty mortar with a fine aggregate.

- v) Mortar to the masonry will need to utilize a fine aggregate due to the thin joints and also be a close as possible colour match to the limestone as is the existing mortar unlike the patch cement pointing that has been used to isolated areas.

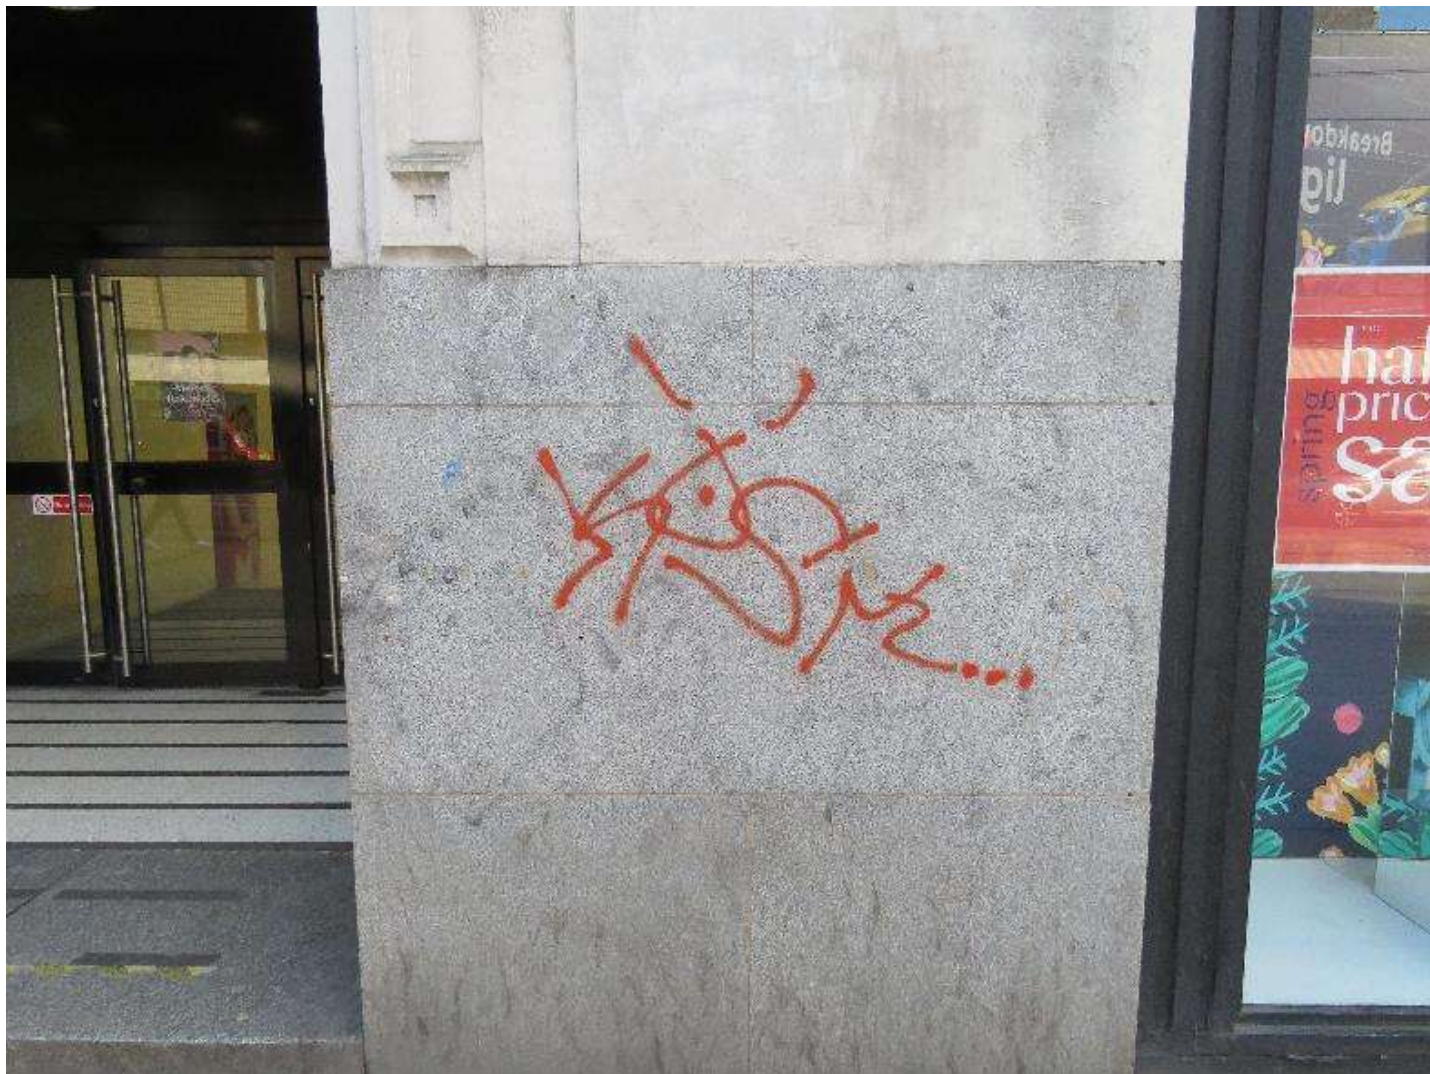
- i) **The granite cladding** to ground floor has only minor damage and the finish is generally acceptable.
- ii) The cladding has a polished finish and cleaning with fresh water and a non-abrasive cloth will be sufficient to remove dirt. Where heavy soiling and graffiti are present refer to section 3.35 and 3.36.

**Fig. 6:** View of the granite cladding to the entrance on High Street, with graffiti and soiling.

- iii) No other methods are to be utilised before prior consent by the project architect and / or conservation consultant.
- iv) Where cracking has occurred, this should be filled with a lime-based mortar to match the cladding joints. The contractor is to provide details of the mortar to be used to the project architect and / or the conservation consultant.

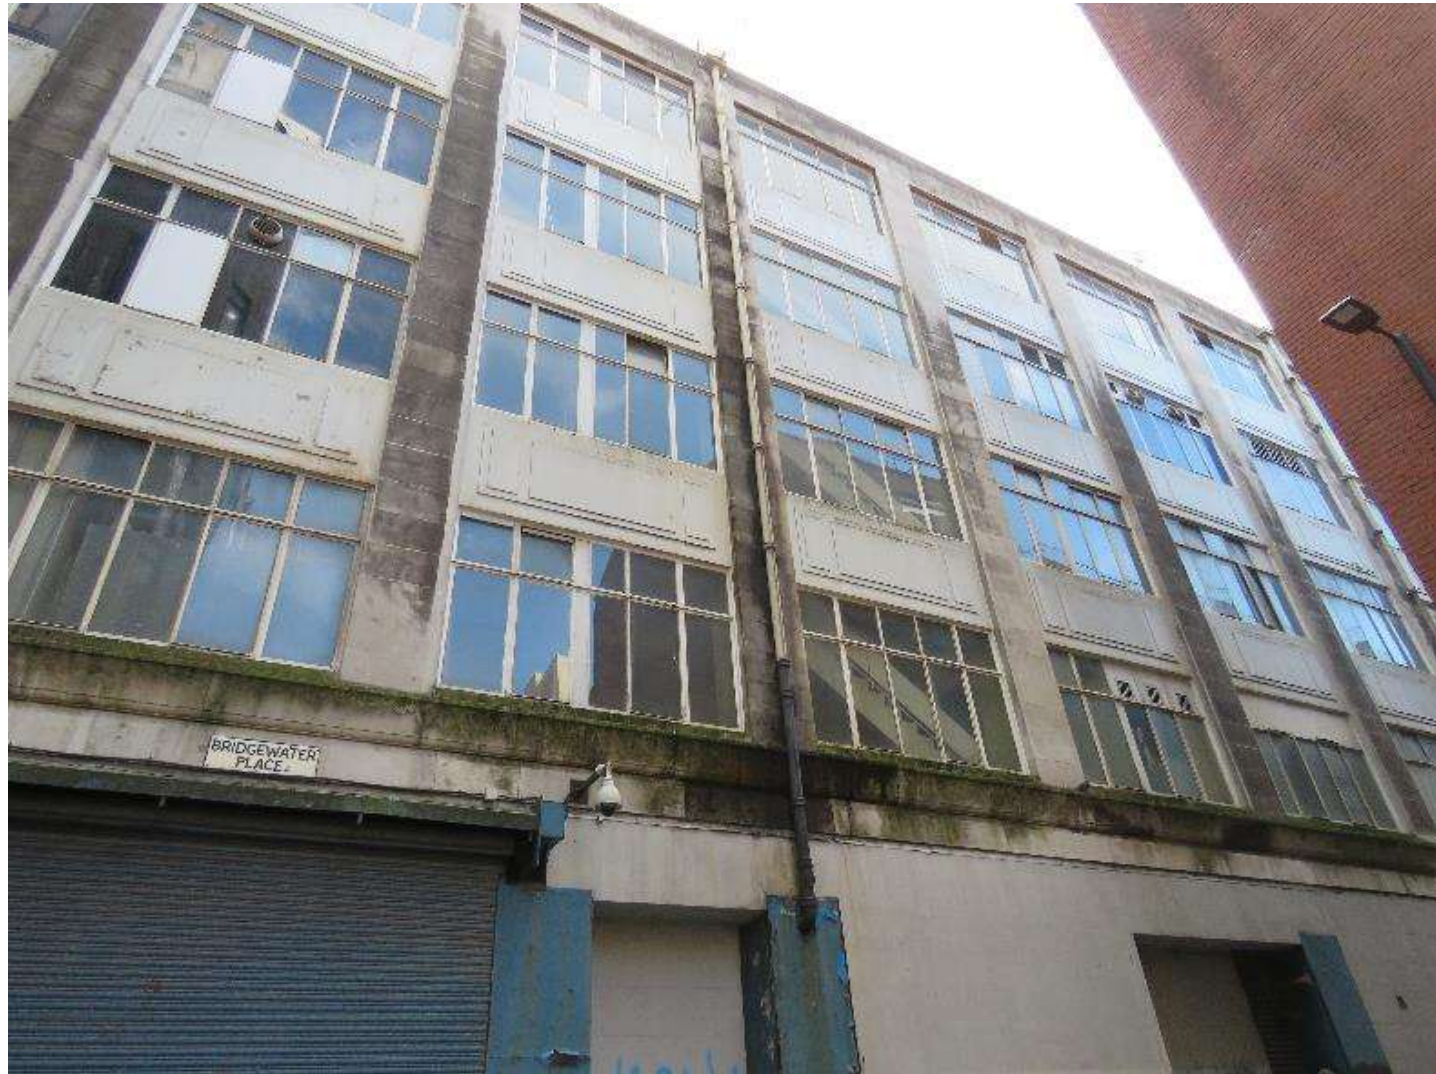
**Fig. 7:** View of the Portland limestone cladding to Bridgewater Place which has heavy soiling.

- viii) **The limestone masonry and cladding** to the building show areas of soiling / staining, graffiti, redundant fixings, inappropriate mortar repairs, minor damage, minor cracking and erosion.

- ix) Where soiling has occurred, the use of fresh water and a non-abrasive cloth should be firstly utilised, being careful not to saturate the stone. Where soiling has built up, it may be appropriate to use a steam cleaning system such as DOFF or JOSS. Prior to starting, trials should be carried out first as per section 3.7 and 3.28. Any cleaning should not be carried out when night-time temperatures are below 5°C within the following week.

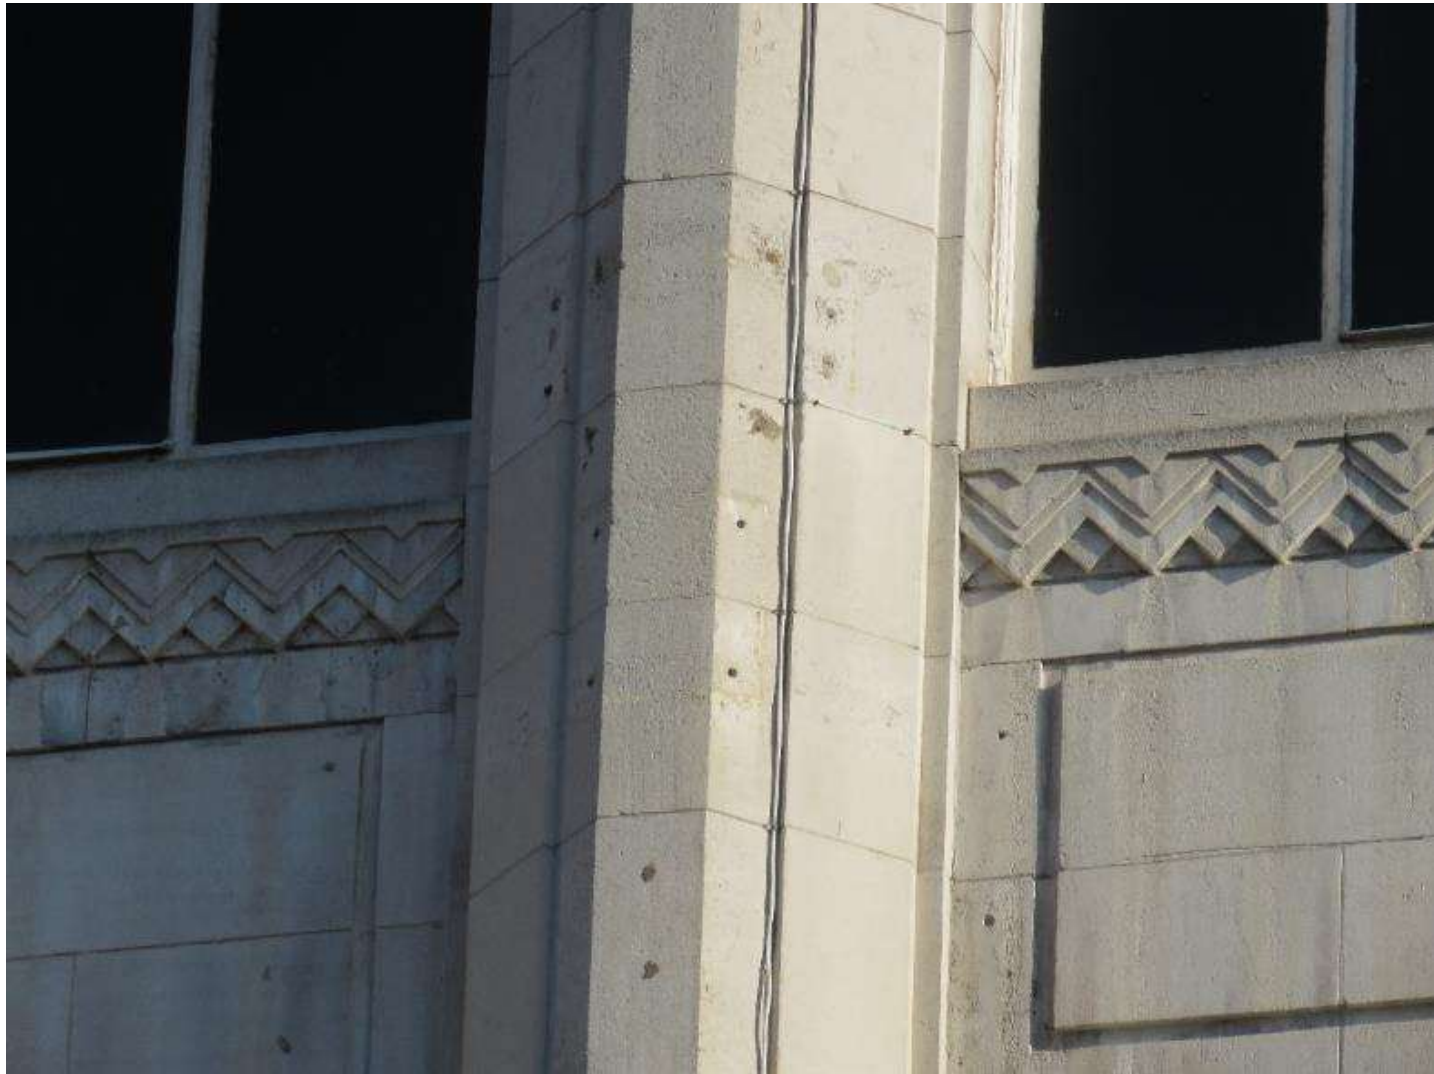
**Fig. 8:** Redundant fixings will need to be removed and the holes filled with a lime-based mortar repair, unlike the previous cement based repairs that have been undertaken.

- x) Trials of graffiti removal should be undertaken in line with section 3.7.
- xi) Chemical or abrasive cleaning methods are not suitable.
- xii) Where possible, redundant fixings should be removed, and a lime mortar repair undertaken as per section 3.7.

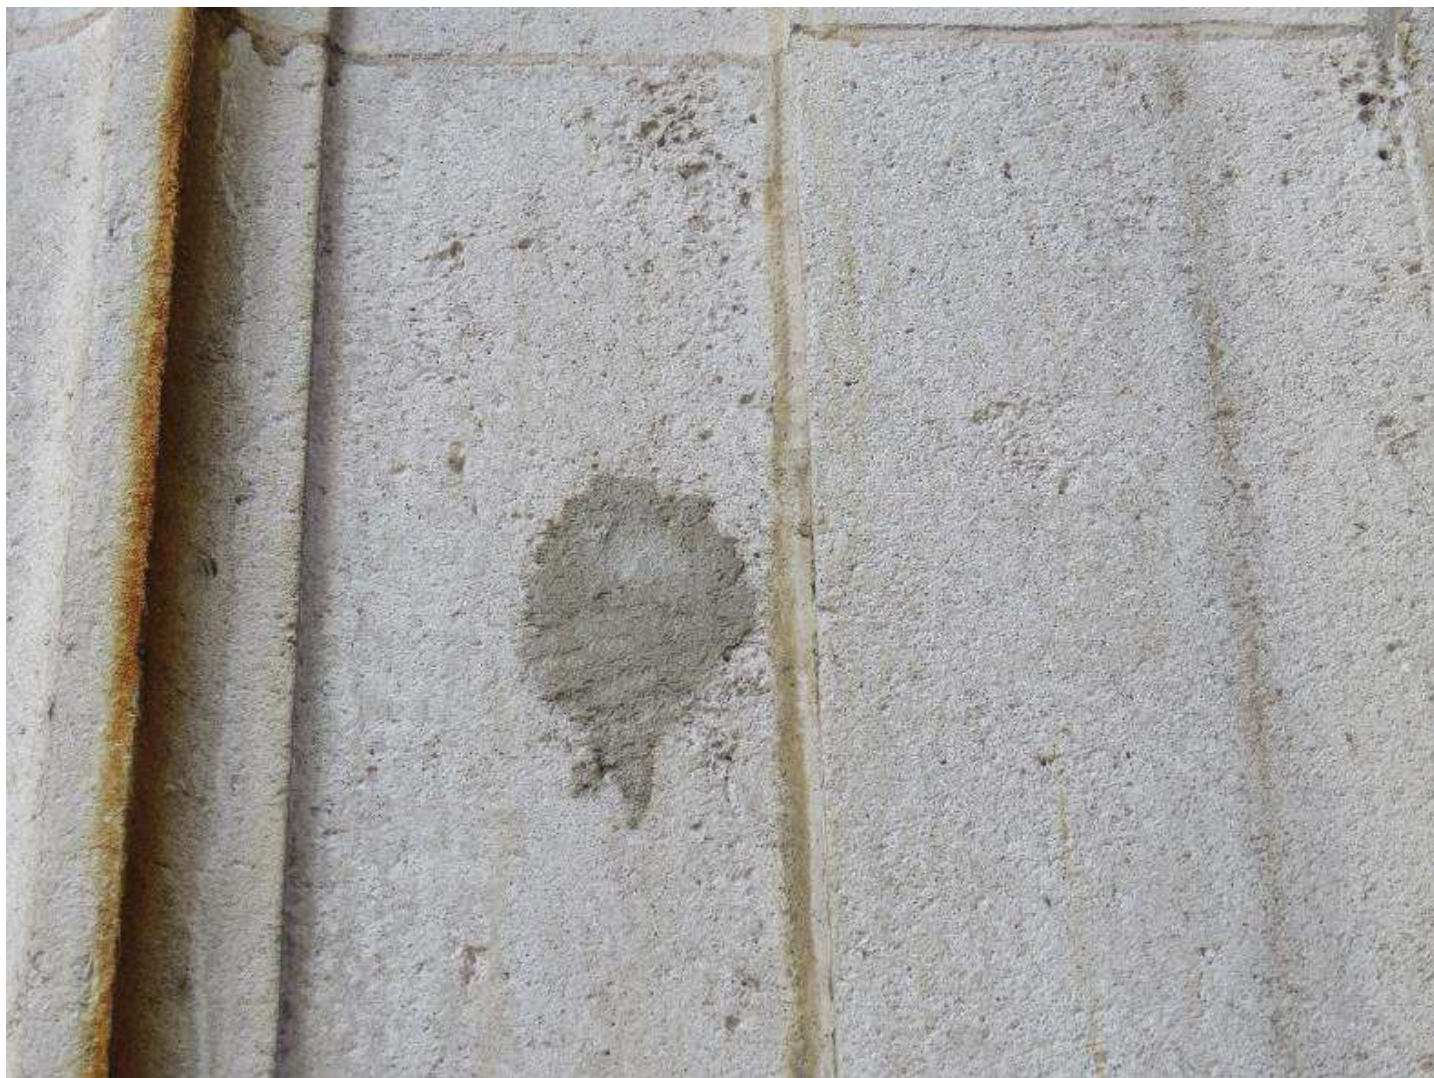
**Fig. 9:** The use of cement mortar repairs is inappropriate and where possible will need to be removed and replaced with a lime based mortar repair.

- xiii) Cement repairs have been carried out to the limestone where damage has occurred, or fixings have already been removed. Where cement repairs can be removed without causing damage to the surrounding stone they should be removed, and a lime mortar repair undertaken as per section 3.7.
