## CEMP REPORT

86 Cross Street, Manchester

Individual Restaurants

### Window frames:

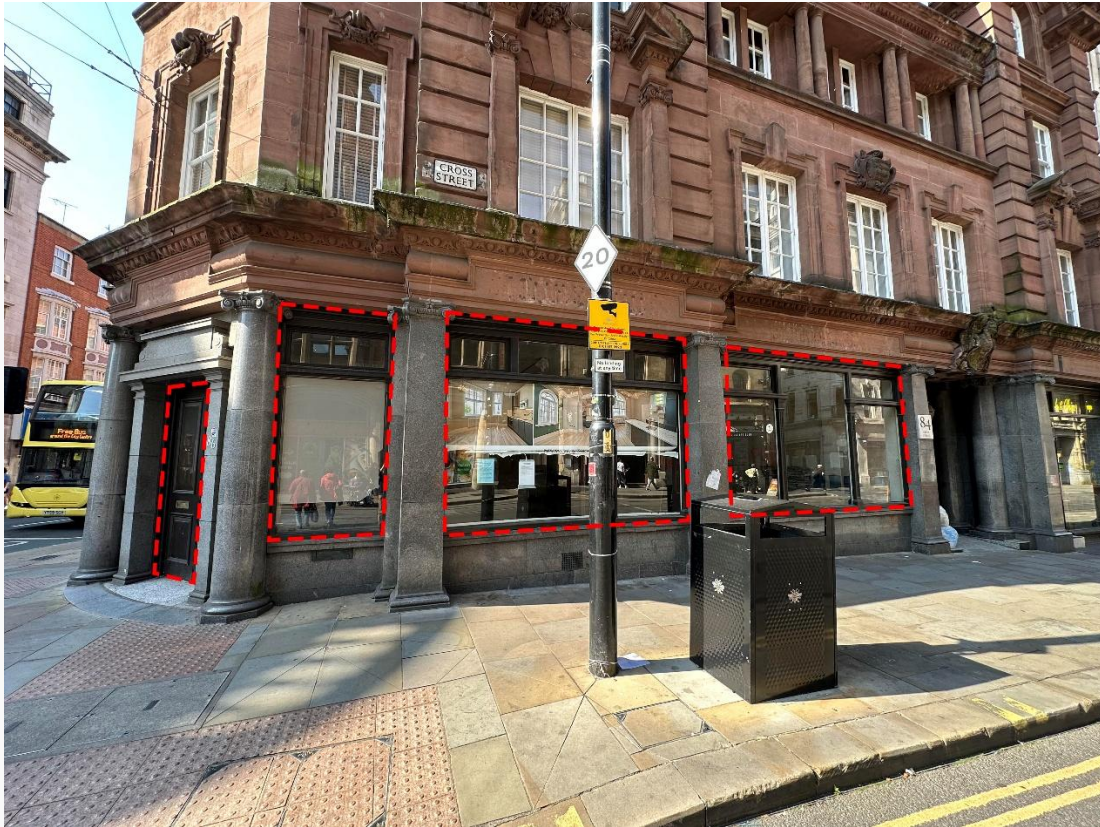
The existing windows are single glazed with hardwood, dark stained frames. The existing frames are in decent condition, but over the years the original windows have been replaced and some of the original frame detailing has been lost, this is especially evident on the Cross Street elevation to the left hand side window.

Photo showing Cross Street Elevation

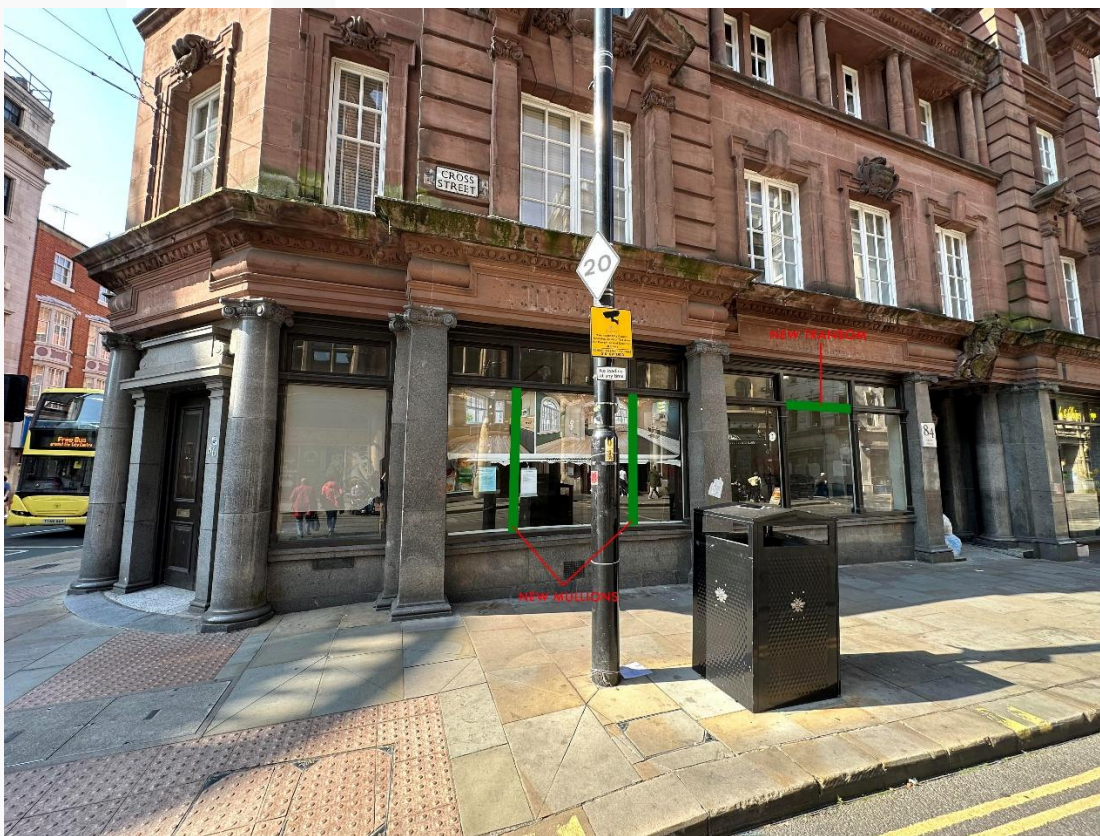
The proposal is to retain as much of the original as possible, *and* adding back the transom and mullions to be more in line with the original aesthetic. These new elements will be stained to match the existing shopfront. The windows will be replaced with double glazing for energy efficiency.

Photo showing the addition of mullions and transom to Cross Street Elevation windows

Any new elements will be manufactured in Ash wood material, which has been selected as it is considered a hardwood for durability, and a sustainable material, due to Ash being a fast growing and self-seeding, so is in plentiful supply.

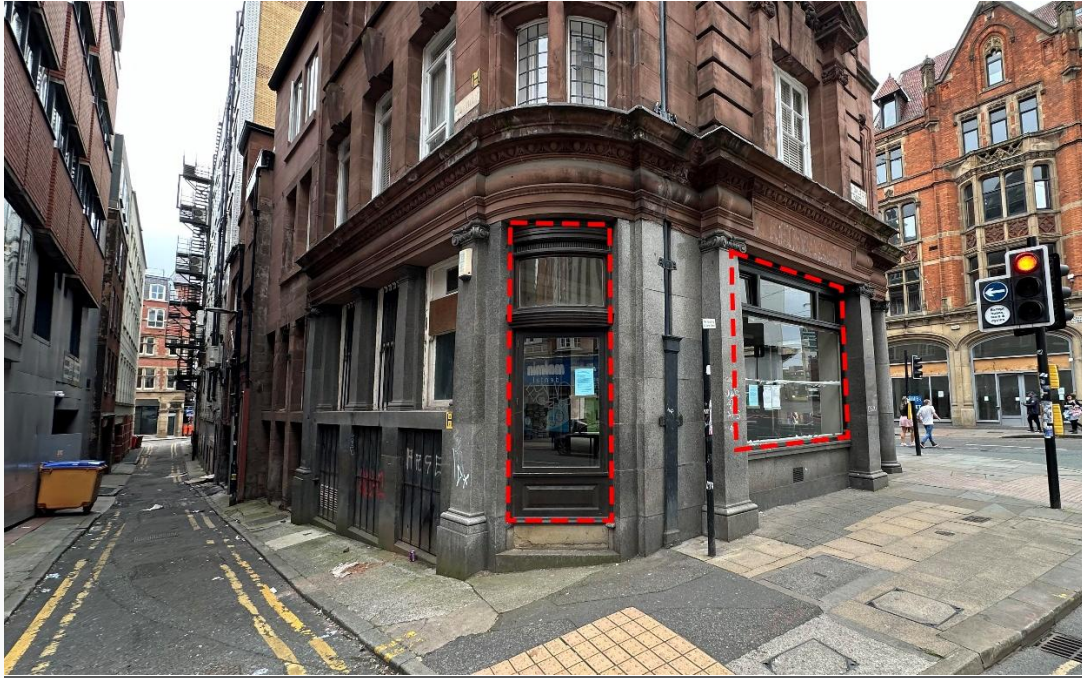
Photo showing John Dalton Street Elevation

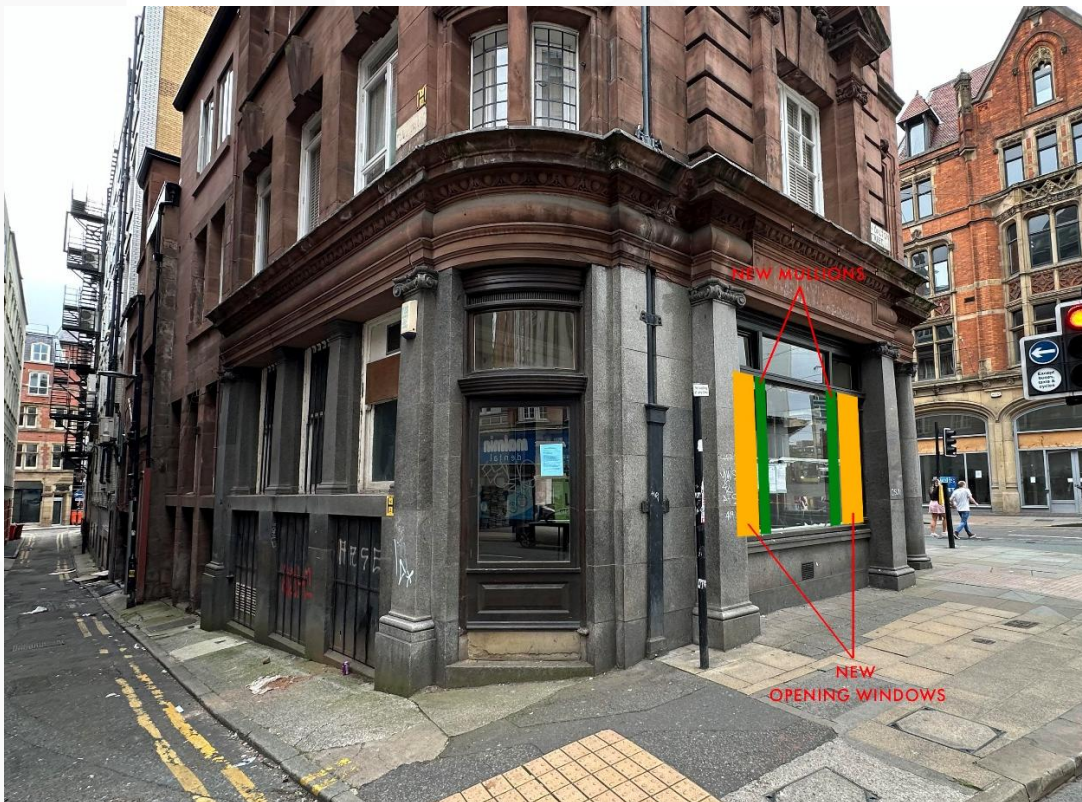
The proposal is to retain as much of the original as possible, *and* adding back the mullions to be more in line with the original aesthetic. New opening section of windows are to be added for a connection to the outside. These new elements will be stained to match the existing shopfront. The windows will be replaced with double glazing for energy efficiency.

Photo showing the addition of mullions and opening windows to John Dalton Street Elevation windows

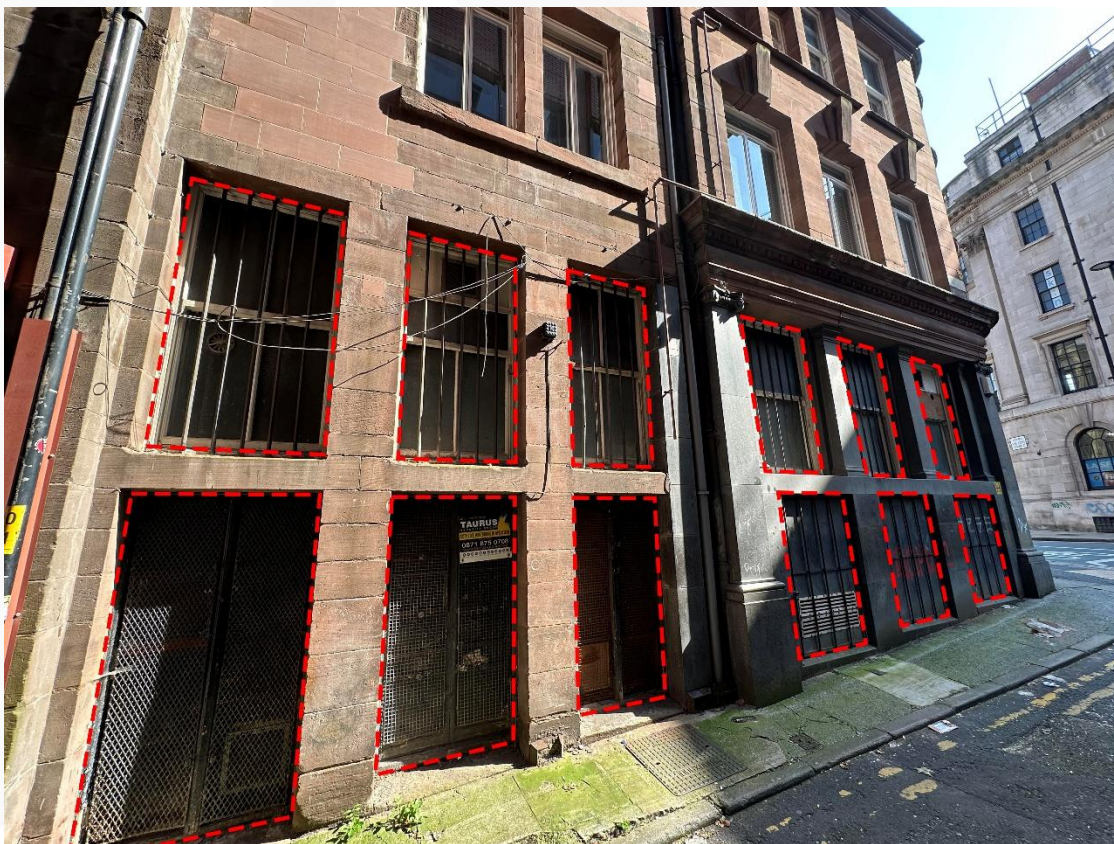
The window frames are in poor state of repair on Four Ways, as they have not been maintained to a good standard. The sash windows have been boarded up internally or partially boarded up from the outside so they appear externally obscured.

Photo showing Four Yards Elevation showing existing security bars and coverings

This is a quiet alley way and security has been an issue on this elevation for previous tenants. Over the years, security measures have been added to try to combat the issue. The three windows to the left hand side of this elevation at street level have been covered with an industrial style mesh. Eight have basic, non decorative metal security bars, varying in style and one window (upper right of this elevation) is partially boarded over.

The proposal includes removing all obscuring metal or timber, repairing any damage to the existing windows and frames and refinished to match the existing shopfront.

The proposed method for doing this, is to remove the existing beading and single glazing, replacing as much as possible with double glazing and a suitable new beading added back to support the glass.

The three windows to the upper right hand side will offer views through into the restaurant. The windows to the left hand side will be boarded up internally and louvred for mechanical solutions – see Window Details 2405-209 for details.

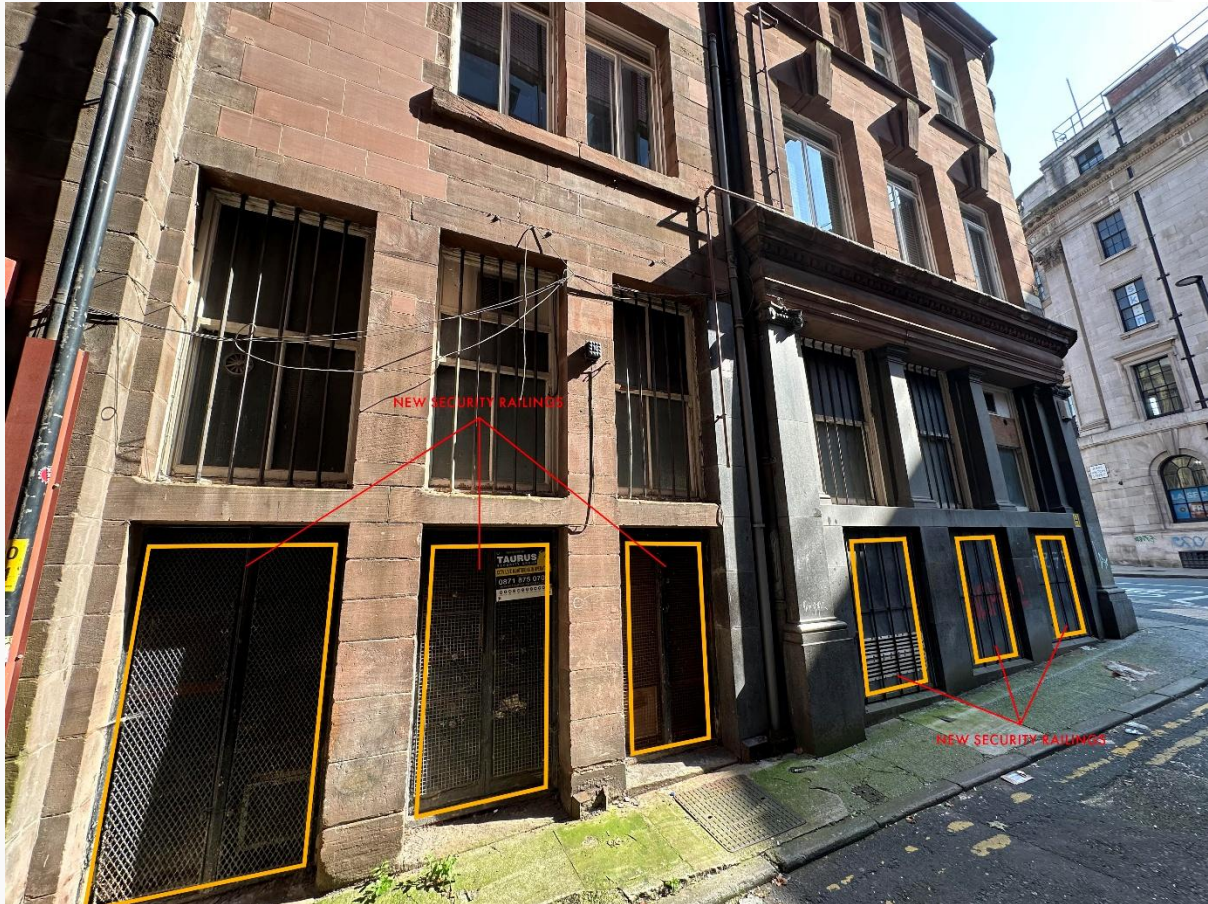
The proposal is to remove all of the existing security bars and replace the six lower windows at street level *only*, with a decorative fixed security bar solution. These will be constructed with 16mm steel vertical bars with a 30 x 30mm steel flat bar frame and arrow head finials

to the top rail and 100mm diameter circles to the base and beneath finials. The metal will be powder coated in black, matt finish.

The intent is that the new security bars will be fixed to the window frames to avoid causing any damage to the building stonework, this will be reviewed by specialist prior to install to ensure this offers a viable solution.

Photo showing Four Yards windows with security railing additions.

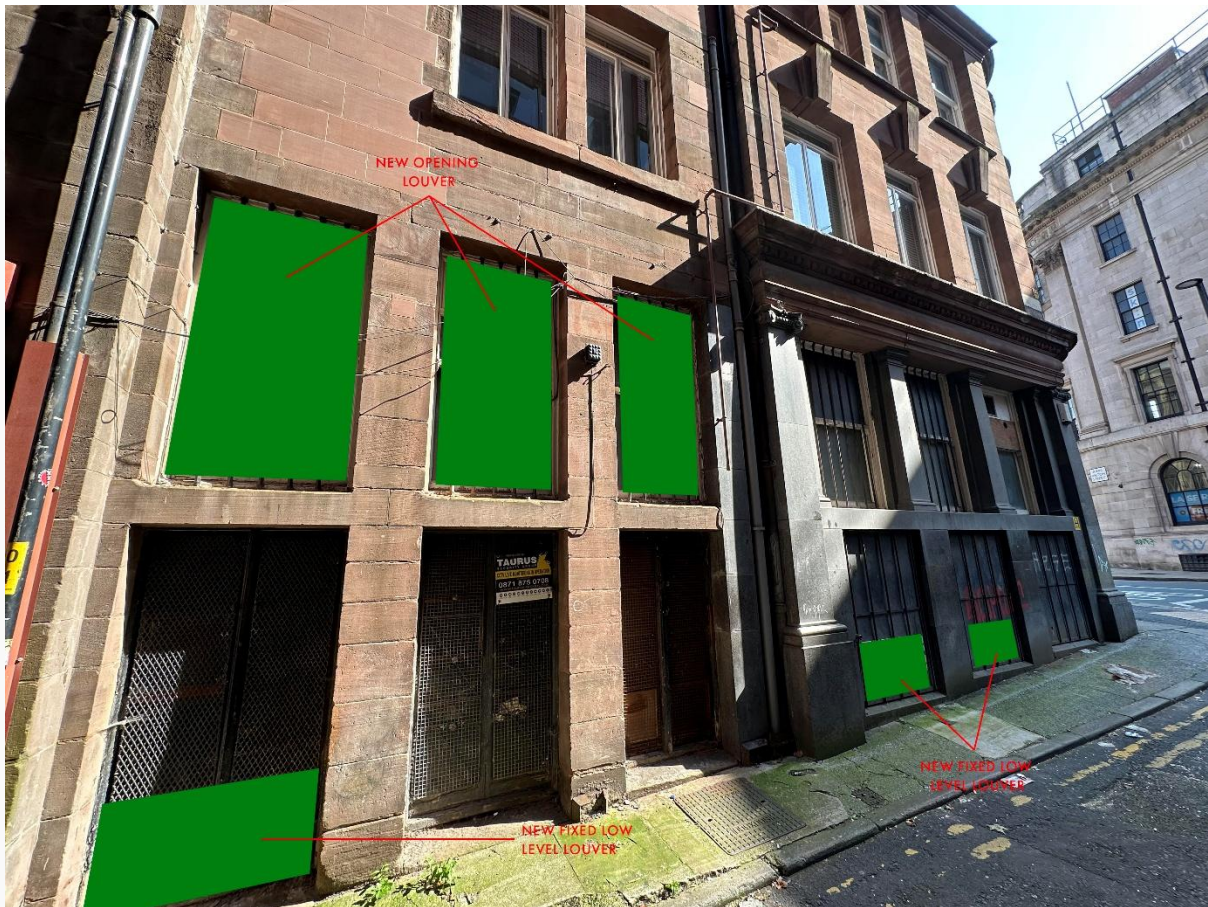
New timber louvres have been designed to the three windows on the upper side on the left hand elevation. These will be fixed in place, required to be 65% open and mesh lined for pest control purposes.

The louvres are for use in line with mechanical requirements requested by the planning department. They will be stained to match the existing shopfront.

Photo showing the addition of louvers to Four Yards Elevation windows
