**Project Title** SIM CONFERENCE CENTRE  
**Client** SCIENCE MUSEUM GROUP  
**Location** MANCHESTER

**Drawing ref** Second Floor Demolition & Removals Sections - Sheet 2

2 Existing Section BB  
1 : 50

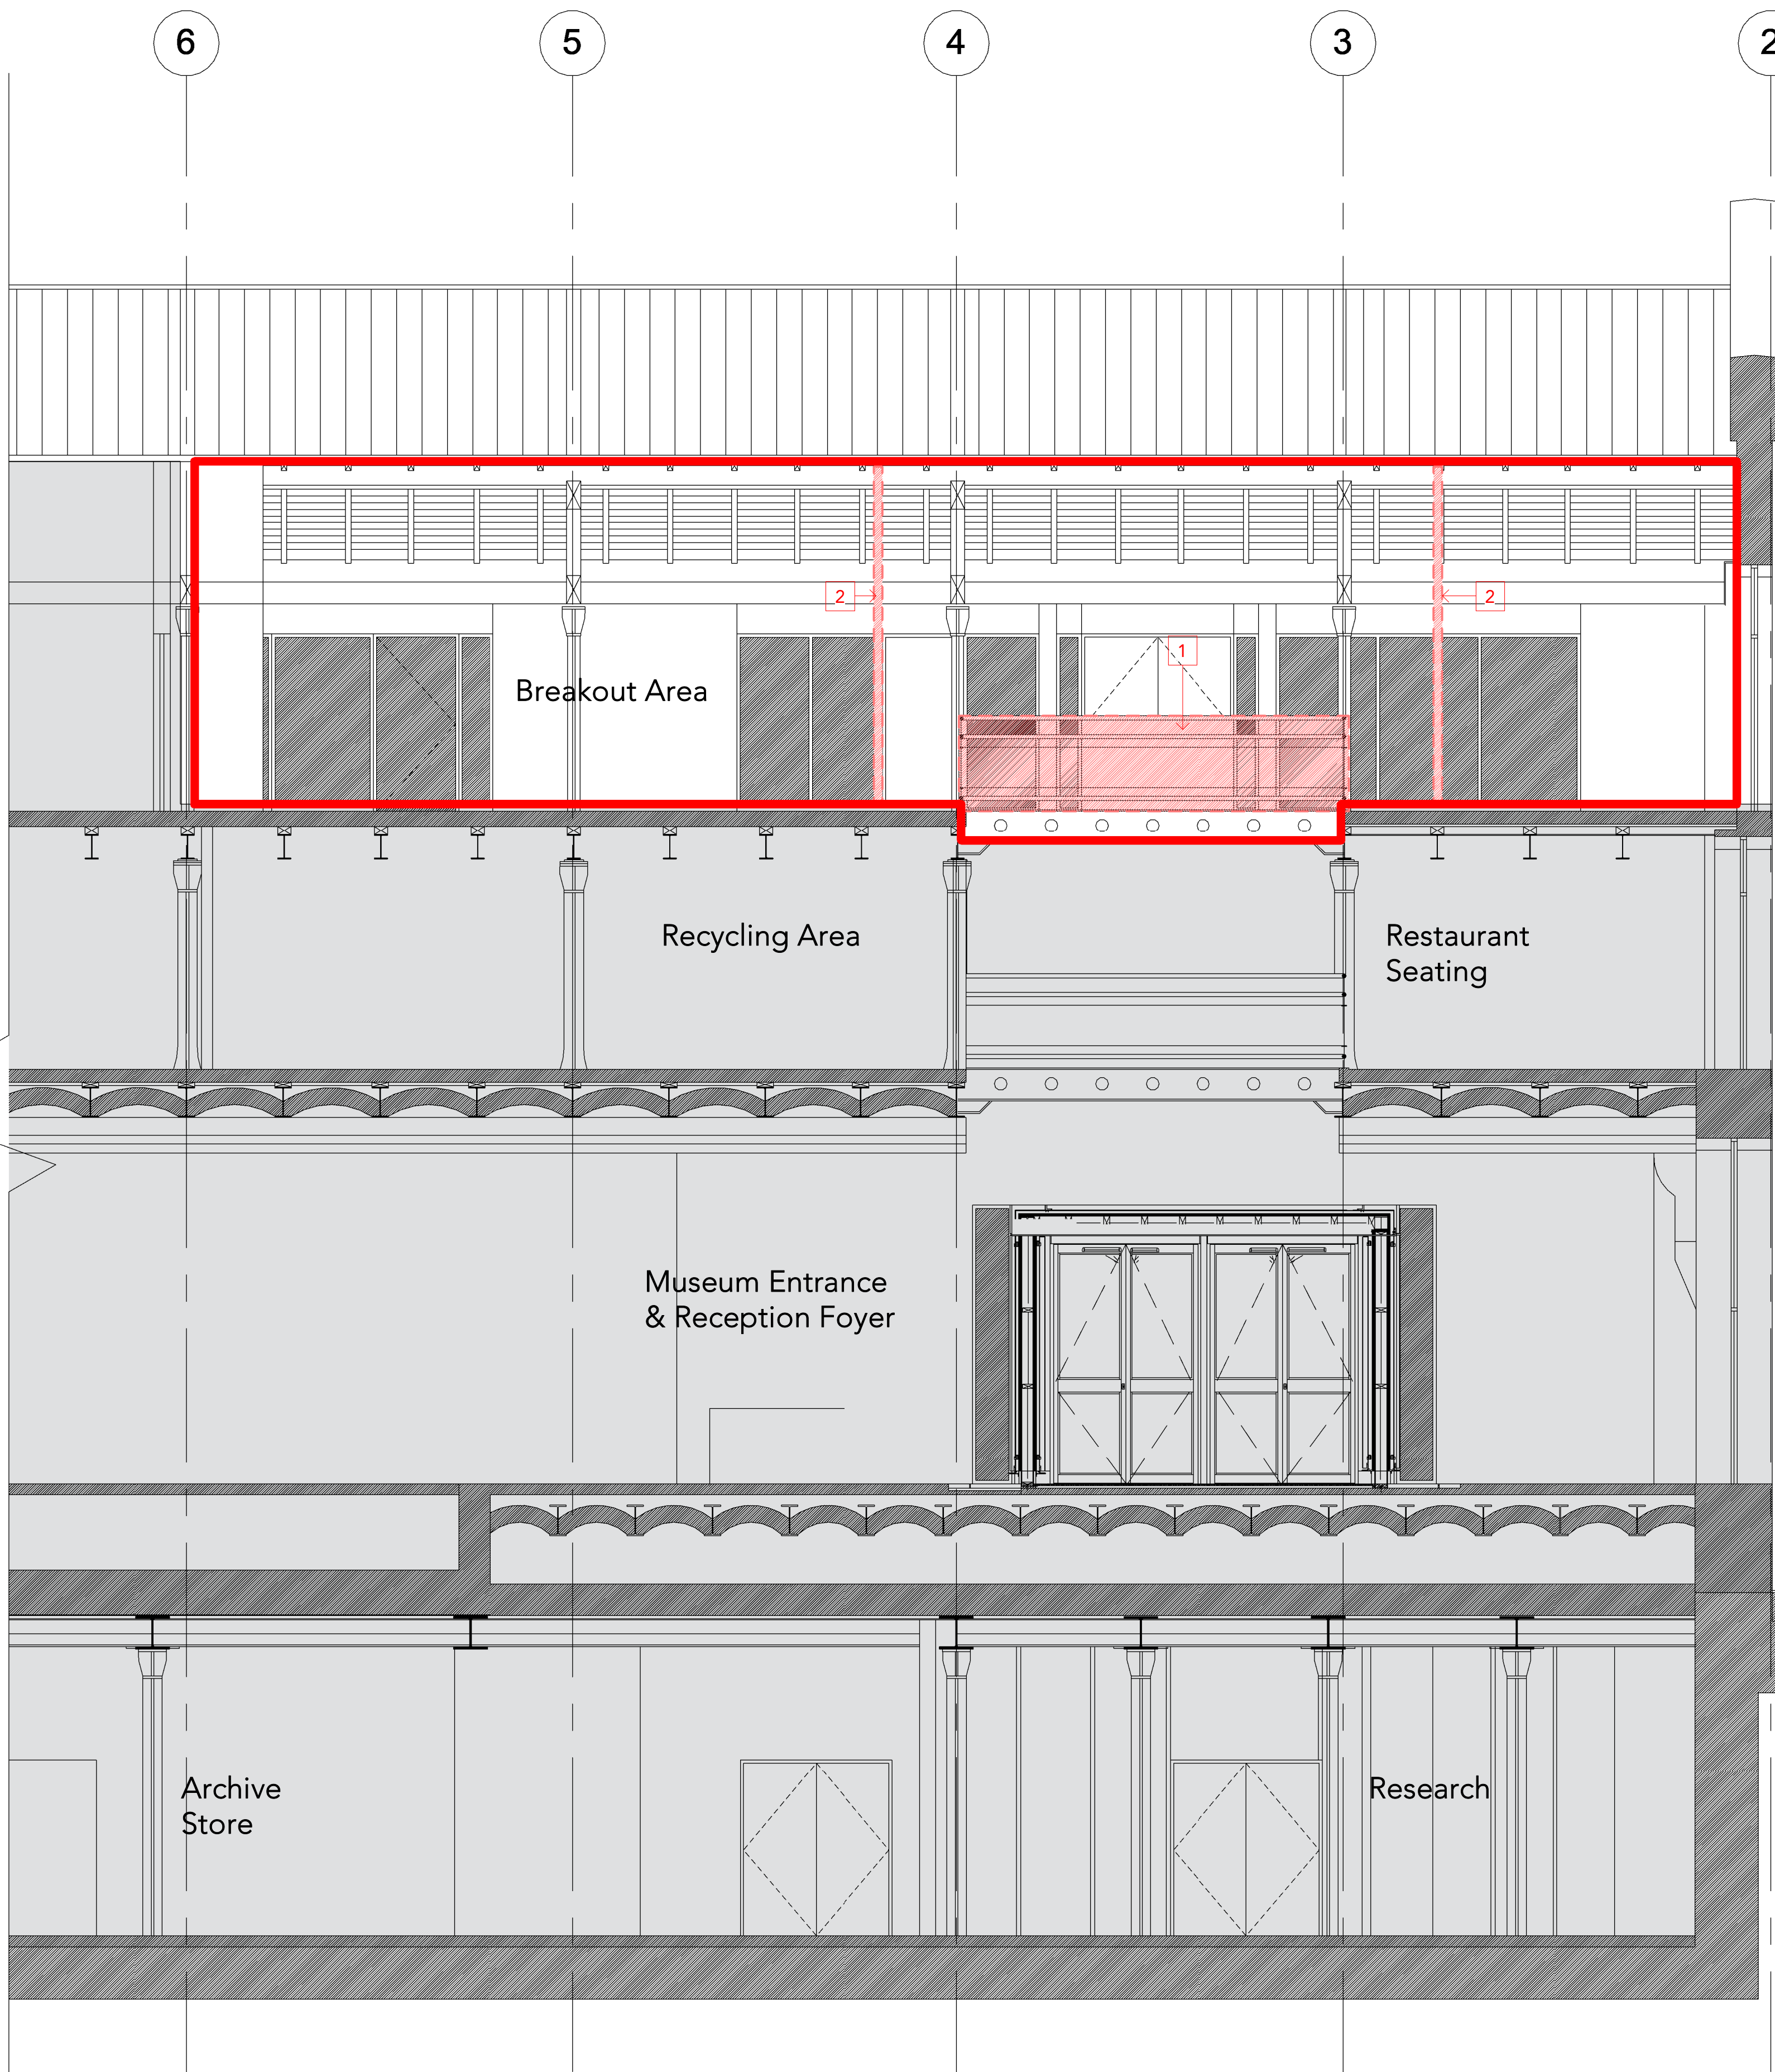
- 1 Carefully remove all existing balustrading around void including all associated elements and components. Allow for making good, consolidation and remediation.
- 2 Carefully remove all temporary wall around void including all associated elements and components. Allow for making good, consolidation and remediation.
- 3 Carefully remove existing floor finishes/coverings to include all separation layers/underlays. Allow for making good consolidation and remediation.
