Arboricultural  
Impact Assessment  
with  
Arboricultural Method Statement

**Grange School  
Matthews Lane  
Levenshulme  
M12 4GR**

Project No. AIA.13880.02

17<sup>th</sup> November 2024

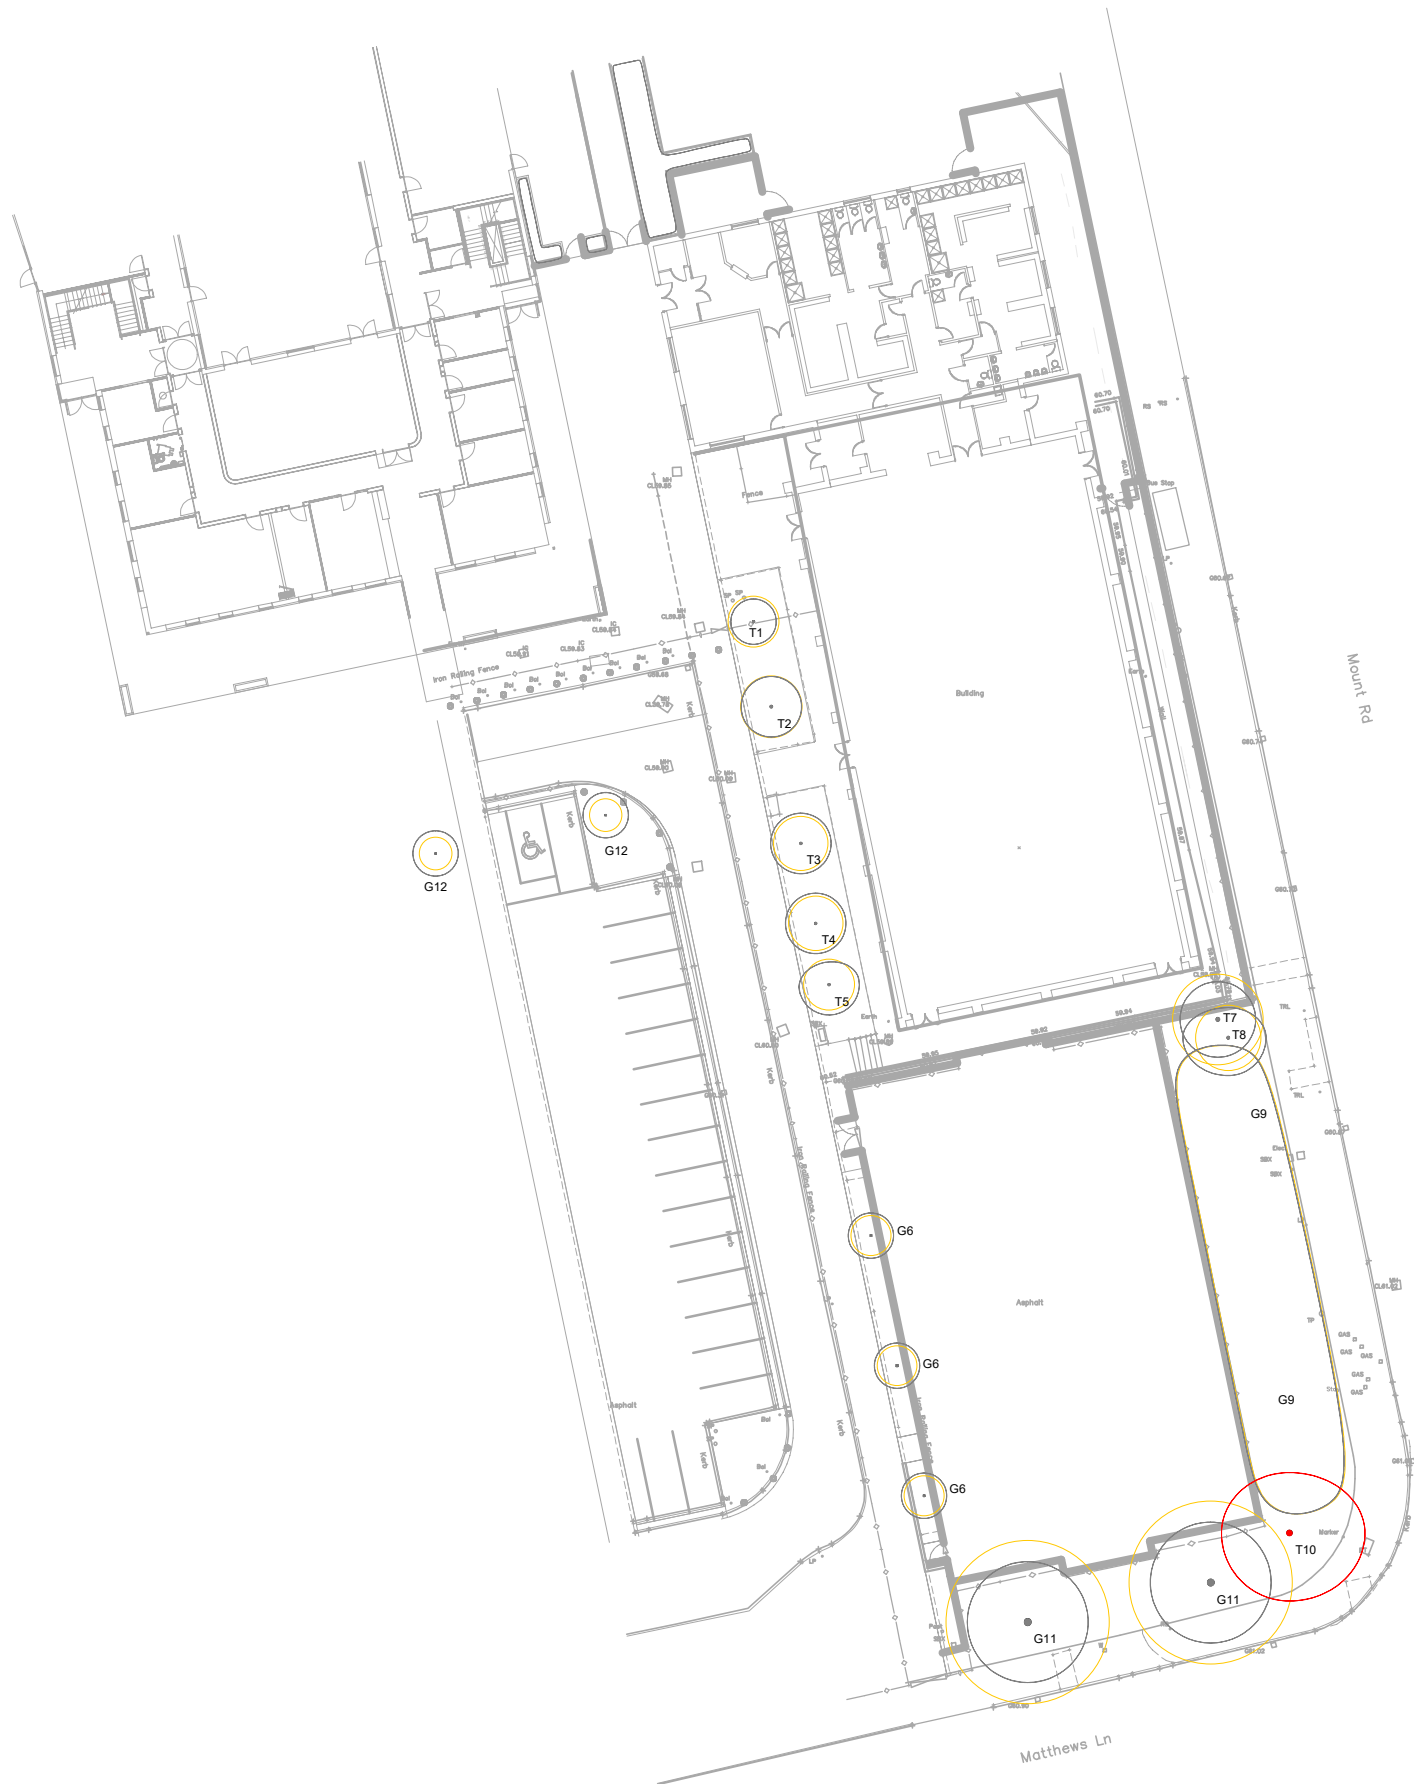
## Drawing 1. Tree Constraints Plan

2.2.1. Please see *Appendix 1* for the detailed list of existing species, age class, dimensions and condition of trees within the site, and *Appendix 2* for an explanation of retention category criteria. Tree locations can be seen on the *Tree Constraints Plan* at the rear of this report (*Drawing 1*).

- 2.3.1. The tree Root Protection Area (RPA) is a layout design tool indicating the area around a tree that, along with the tree stem and branches, must be considered during development. The protection of the roots and soil structure within the RPA should be treated as a priority. The RPA of each tree or group is marked on the *Tree Constraints Plan* at the rear of this report.

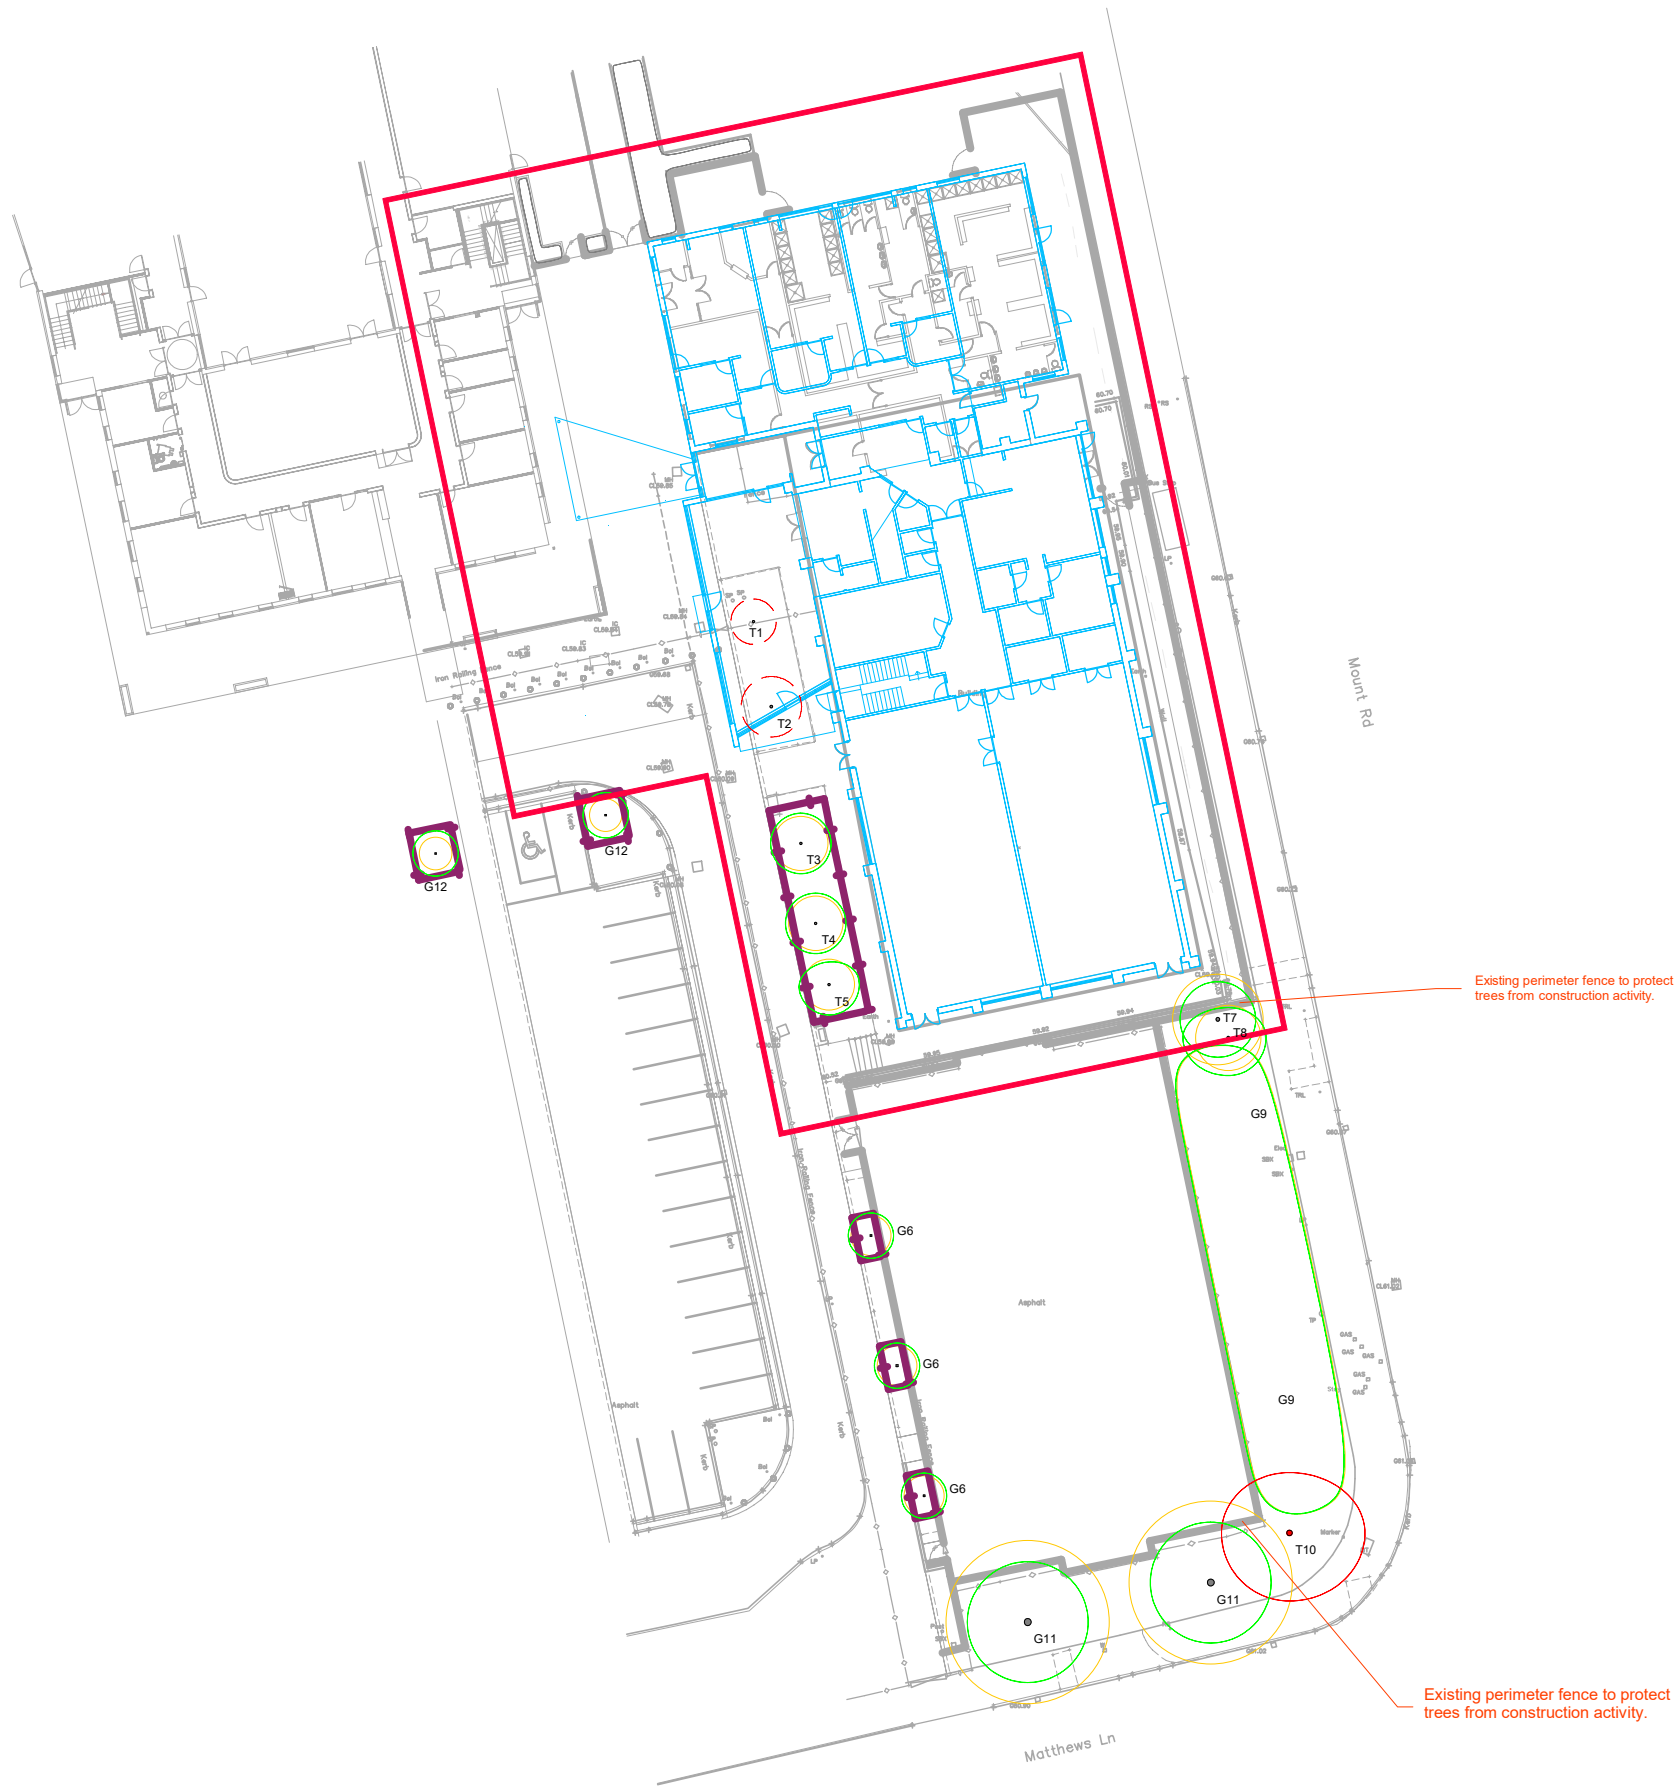
## Drawing 2. Tree Protection Plan

- 3.1.1. An extension to the existing building is proposed. The proposed layout drawing can be seen within the *Tree Protection Plan* to the rear of this report. This drawing has been used to assess the potential direct and indirect arboricultural impacts.

- 3.2.1. The proposed development directly impacts two trees. These trees shall require removal due to their close proximity to construction activity. All the trees proposed for removal are considered to be low-quality ('C' category) specimens. Please see the table below for the proposed tree removal details.

- 4.2.3. Please see *Appendix 4* for suggested barrier construction detail. It is recommended that in this instance the protective barrier shown in *Figure 2* would be appropriate. The suggested location for protective fencing is shown on the *Tree Protection Plan (Drawing 2)*.

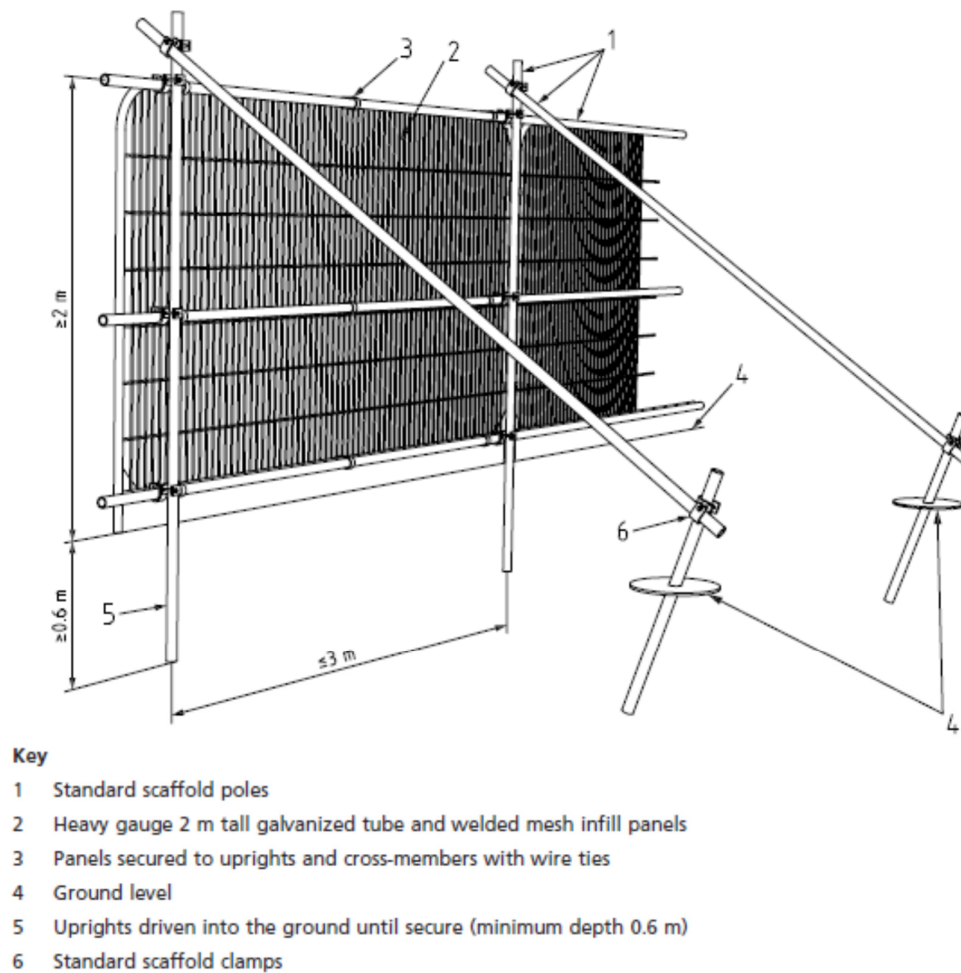
Figure 1. Default protective fencing barrier as detailed in BS 5837: 2012.

- A4.1 The default specification for protective barriers should consist of a vertical and horizontal scaffold framework, well-braced to resist impacts, as illustrated below. The vertical tubes should be spaced at a *maximum* interval of 3 m and driven securely into the ground. Onto this framework, welded mesh panels should be securely fixed. Care should be exercised when locating the vertical poles to avoid underground services and, in the case of the bracing poles, also to avoid contact with structural roots.
