Rutherford Building

Proposed GA Elevations - North + West

| 2130-RBUM-ARC-XX-ZZ-DR-A-2130 | P10 | | |

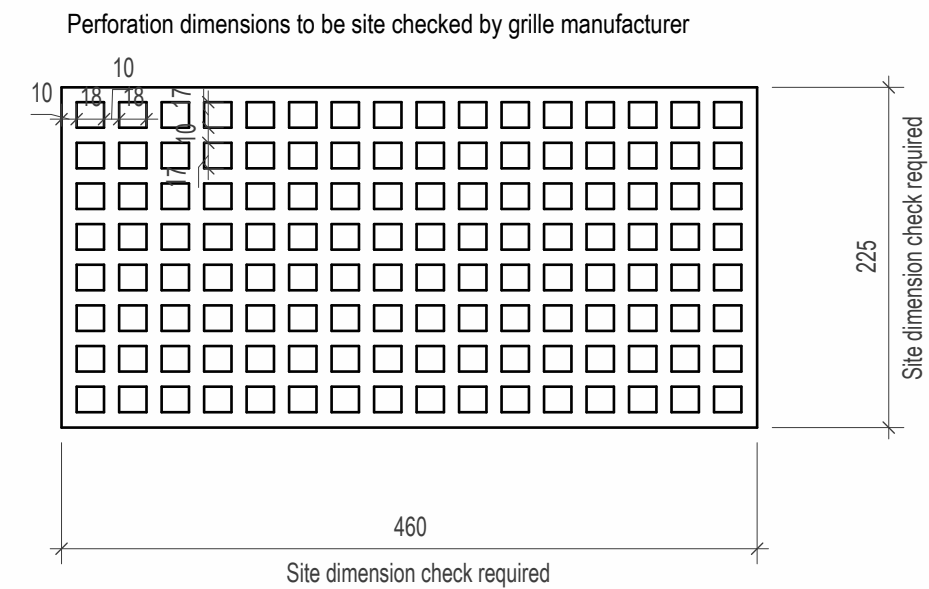
3 External Metal Grille  
1 : 5

| External Grills | | | | |
|---|---|---|---|---|
| EXG 01 | 225 | 460 | New Extract/Intake ductwork with iron grill cover | New Construction |

| Renovations Works_External | | |
|---|---|---|
| GNOTE EX 04 | NEW NOM. 225mm X 325mm STAINLESSs STEEL BOX TO ACT AS LINTEL FOR VENTILATION SERVICES- PLEASE REFER TO SE INFORMATION | 13 |

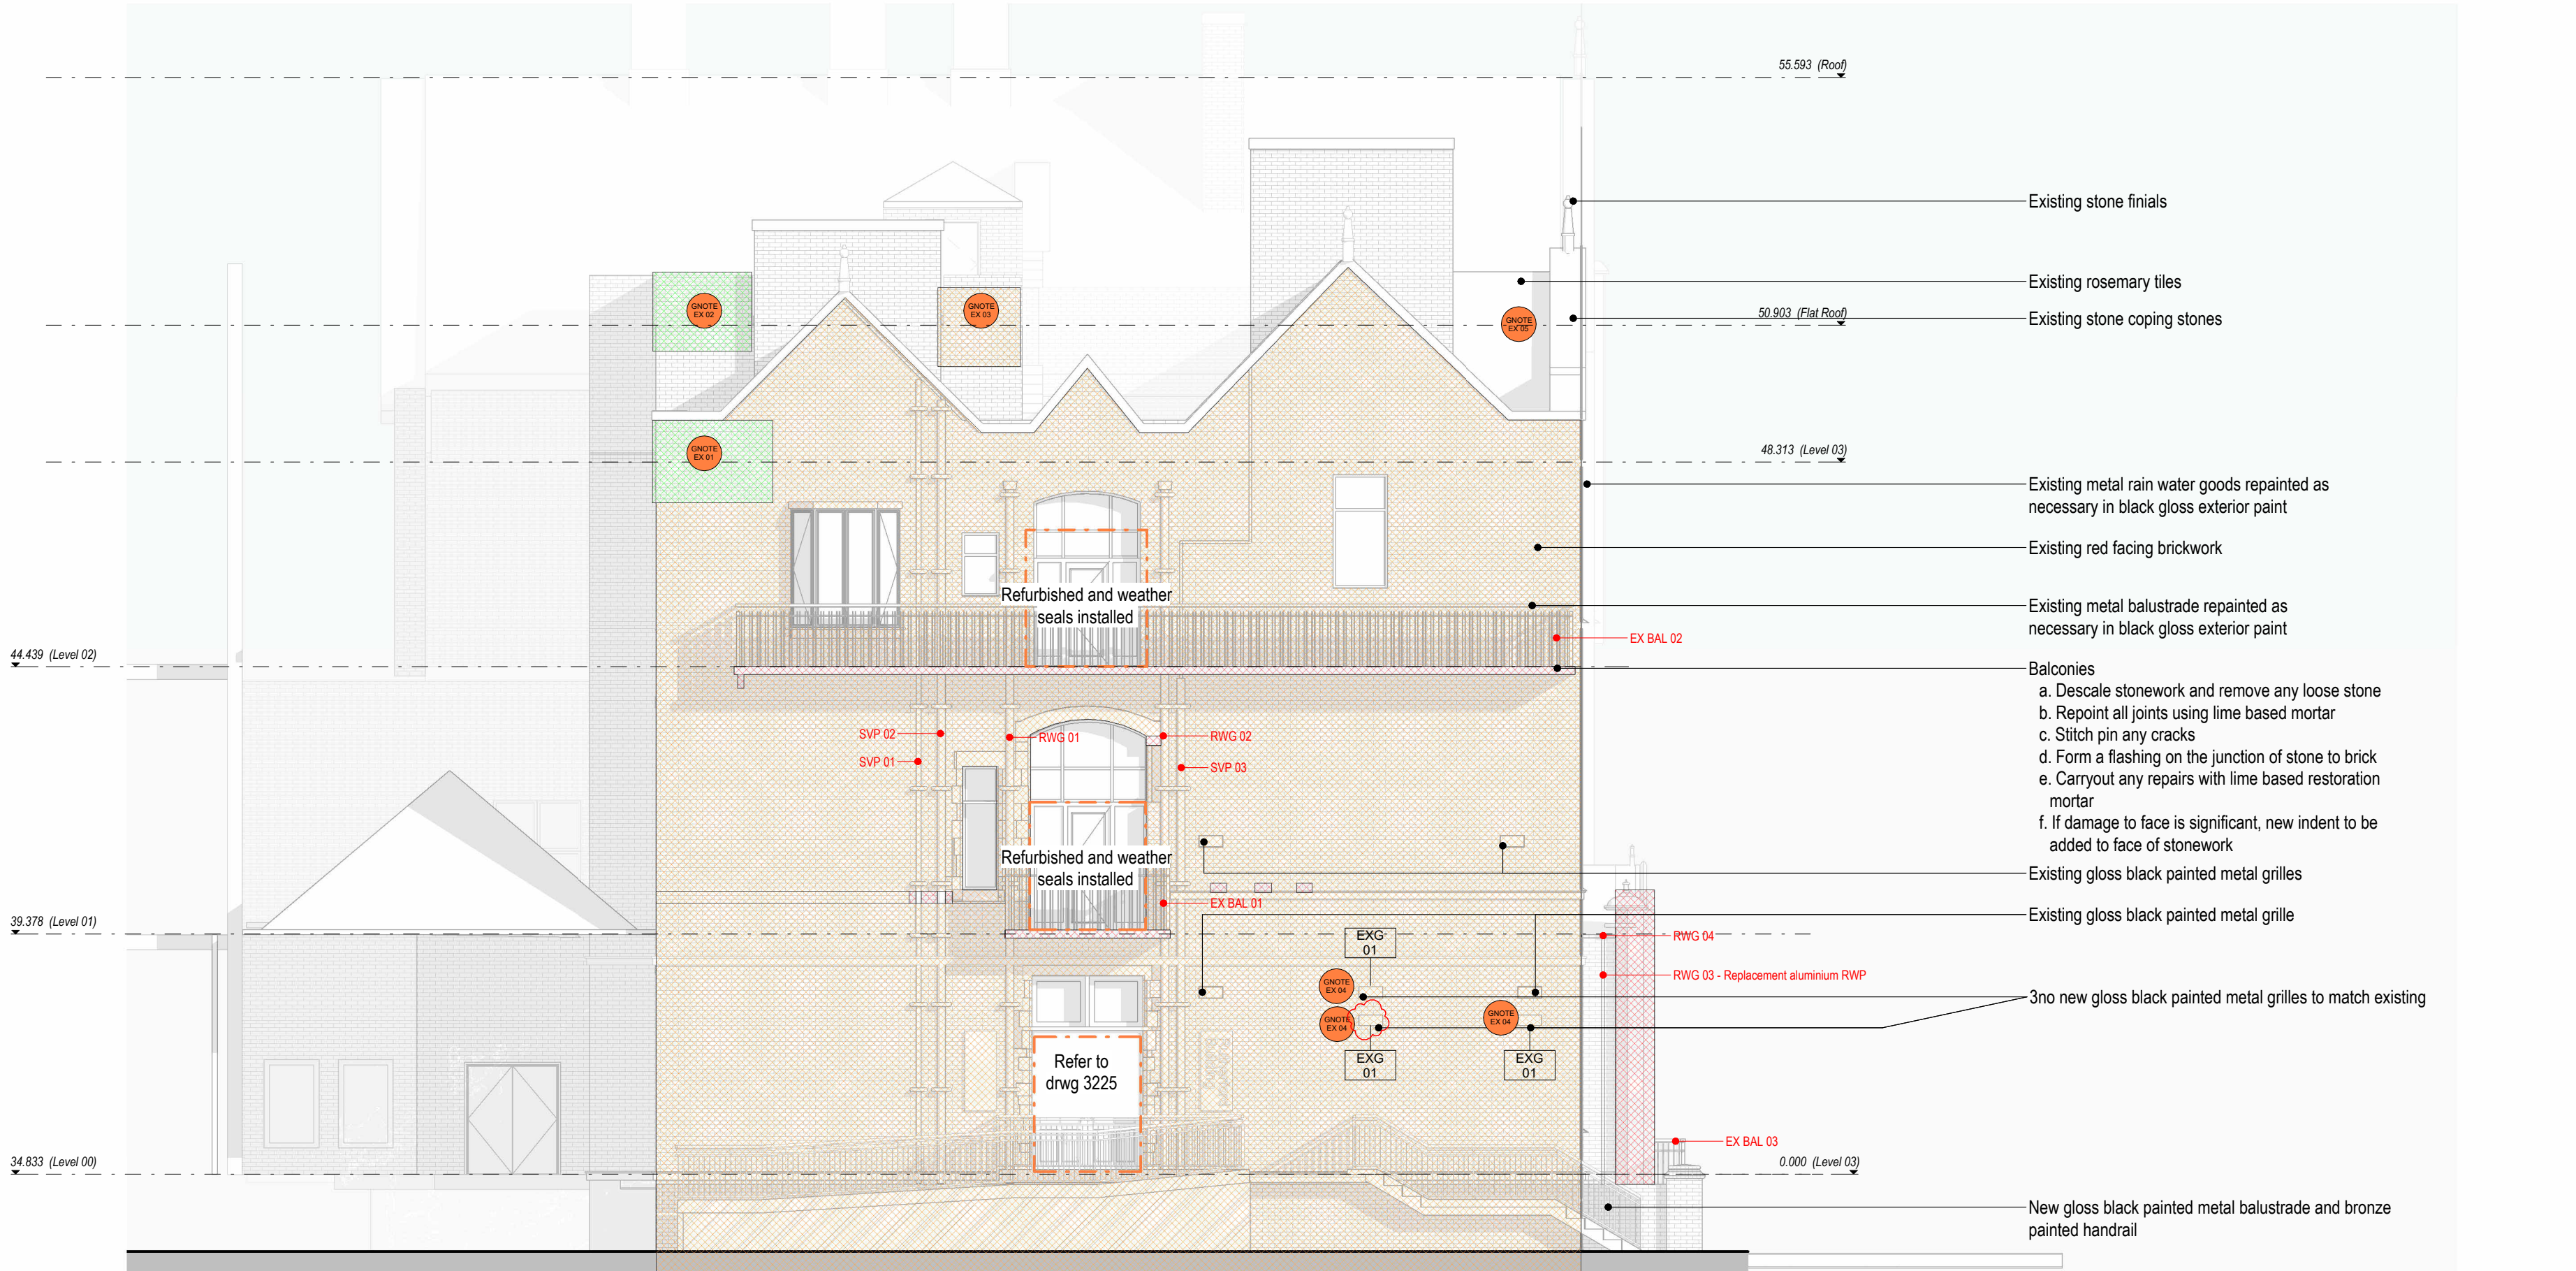
1 Proposed GA Elevation\_West  
1 : 100

| Renovations Works_External | | |
|---|---|---|
| GNOTE EX 01 | DISPLACED MASONRY TO CORNER OF PARAPET TO BE LOCALLY TAKEN DOWN AND REBUILT TO REINSTATE MASONRY BOND, CIRCA 1M² INCORPORATE ANCON AMR/S/D3.0/W60 BED JOINT REINFORCEMENT.RESET DISPLACED BRICK ADJACENT TO RAINWATER OUTLET | 4 |
| GNOTE EX 02 | DISPLACED MASONRY TO CORNER OF PARAPET AND AROUND RAINWATER OUTLET TO BE LOCALLY TAKEN DOWN AND REBUILT TO REINSTATE MASONRY BOND, CIRCA 2m² INCORPORATE ANCON AMR/S/D3.0/W60 BED JOINT REINFORCEMENT. | 4 |
| GNOTE EX 03 | REPOINTING REQUIRED TO JOINTS AROUND ACCESS LADDER AND ON SOUTH ELEVATION, CIRCA 2m² | 3 |

INDICATES STONEWORK REPAIRS AND REPOINTING REQUIRED. REFER TO STONE SPECIALIST'S METHOD STATEMENT

INDICATES AREA TO BE REPOINTED USING LIME MORTAR. NHL2 Lime mortar to stonework NHL3.5 Lime mortar to brickwork Mortar Specification: 3 parts local washed sand 1 part NHL 3.5 or 5 90ml black dye supplied from Womersleys Sand - 1450ml Lime - 450ml Black Dye - 90ml

INDICATES AREA OF LOCAL REBUILDING OF BRICKWORK
