Cardinal Global Logistics  
Harling Road, Sharston  
Repairs

Survey Elevations 1  
showing repairs

PROJECT REF. 2057  
DRWG NO. E(200)  
REVISION A  
SCALE 1:100 @ A3  
DATE 1st March 24  
DRAWN PL

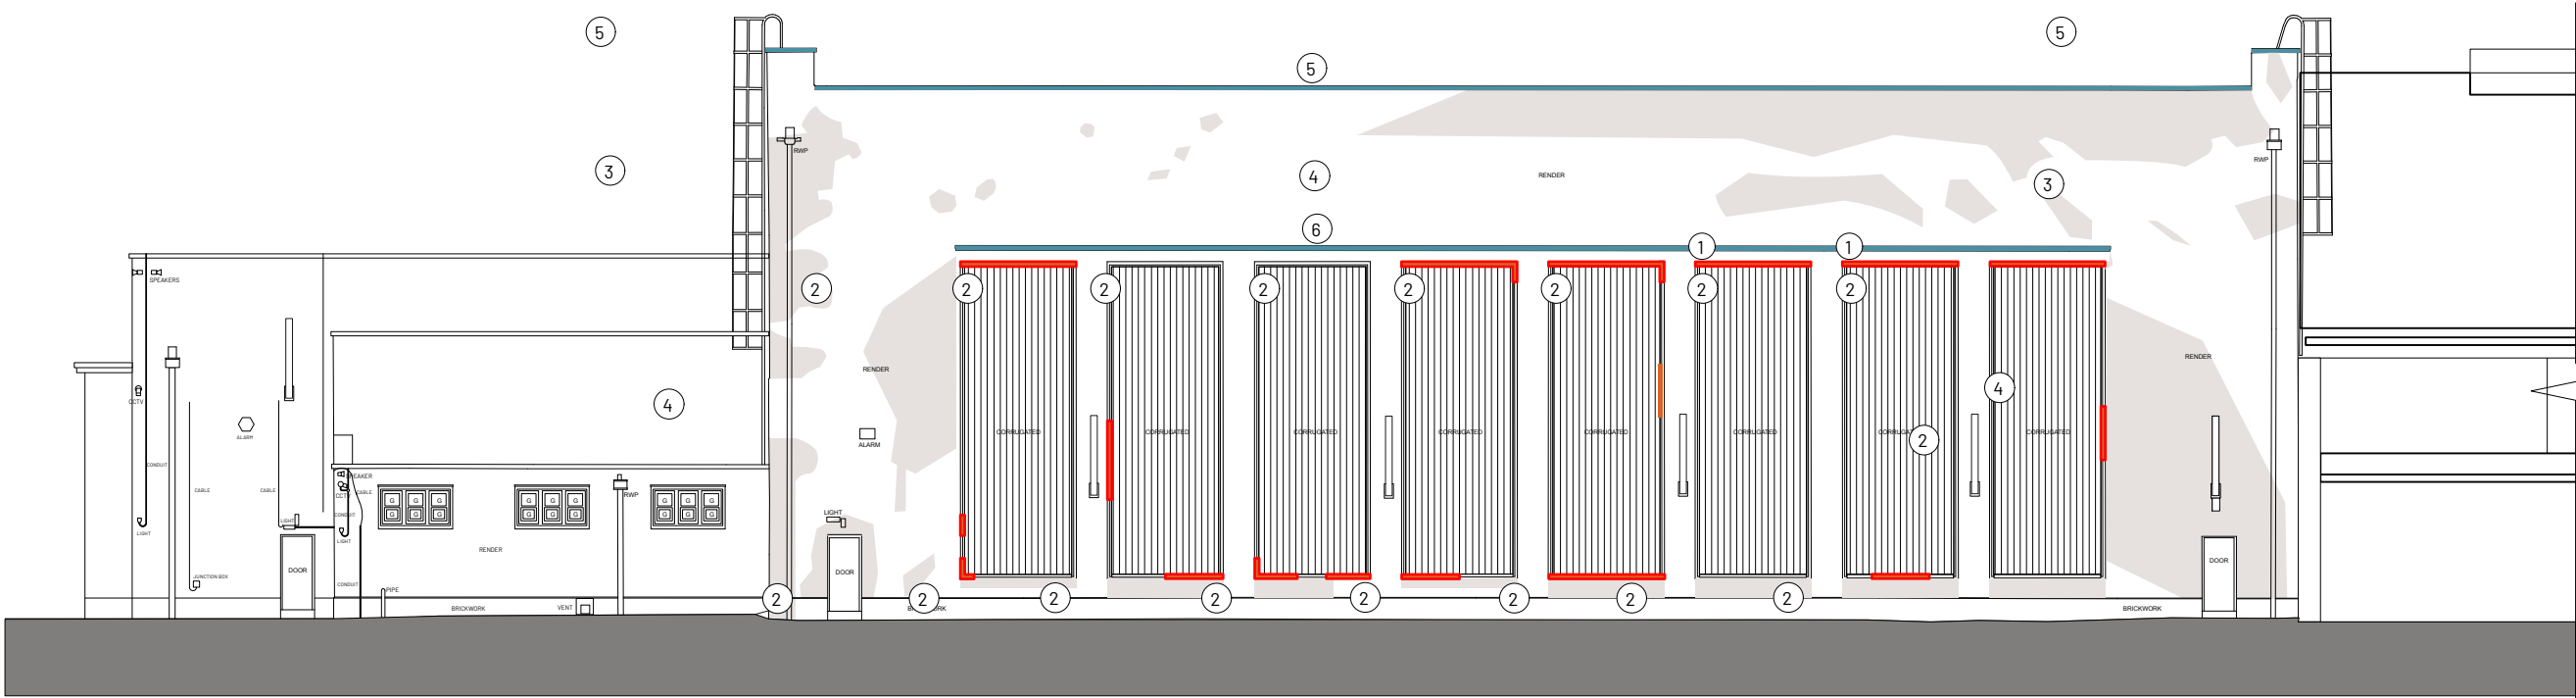
1 Harling Road Elevation  
Scale: 1:200

Missing or damaged  
render

Missing grouting

Damaged cast stone

- Repairs
1. Concrete repair to lintel  
internal lintel to structural  
engineer's specification
  2. Isolated replacement of cast  
stone facing to window  
surround
  3. Take down rainwater goods  
and re-fix after rendering
  4. Take off existing render and  
temporarily remove services  
items. Apply new render,  
finished to match original  
and refix services
  5. Lift copings and install DPC.  
Reinstate copings and grout.
  6. Replace grout between  
concrete cornice sections
