**BRUNSWICK MILL Bradford Rd Manchester M40 7EZ**

**METHOD STATEMENT FOR discharge of condition 7**

**Repair works to the interior and exterior masonry and stonework**

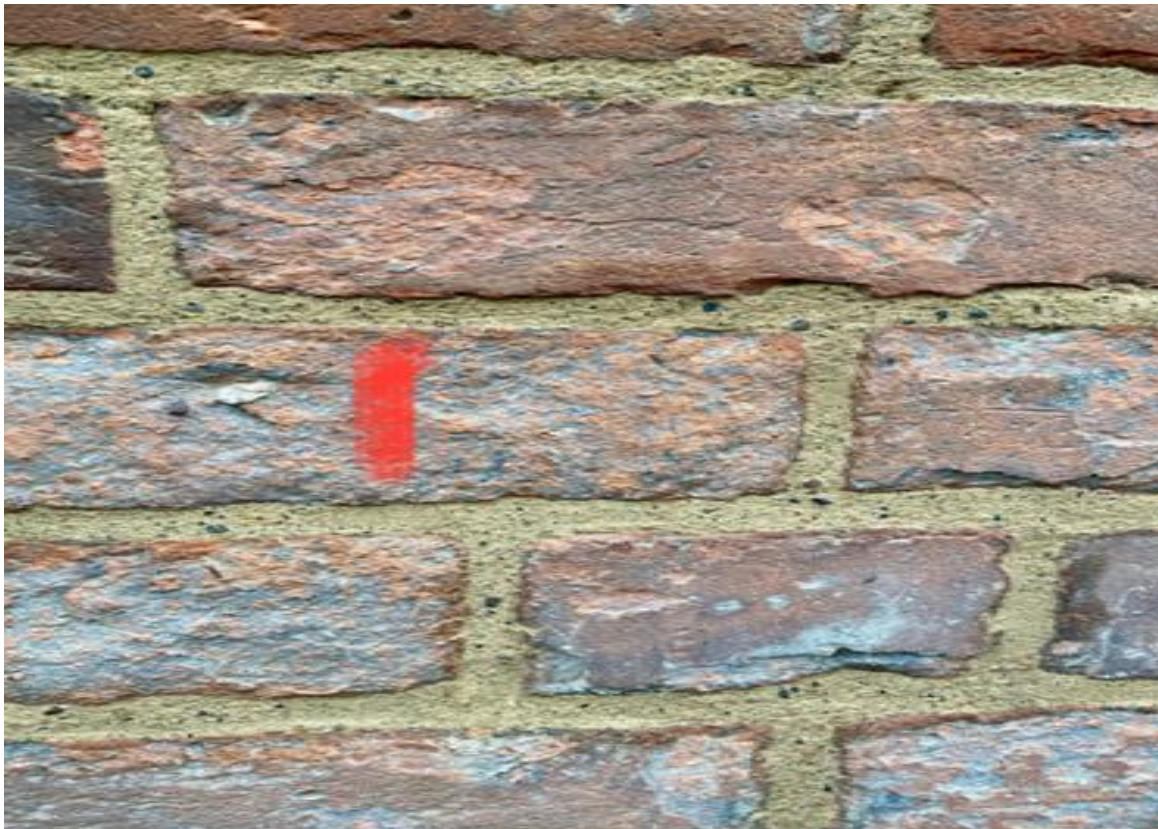
**Photo 1. 3 parts Nosterfield 1 part Sherbourne and 1 part NHL 3.5**

Areas of sample pointing have been carried out on Bradford Rd with 3 different types of mortar pointing carried out for one to be chosen to point the whole project. There have been many different types and colours of mortars used in areas of the building and some areas have been over pointed using a cementitious mortar. The colour of the mortar has also changed due to carbon build up over the years and in some areas the use of clinker has been used to colour the lime mortar. On our initial investigations we found that if we raked the mortar back as far as possible that the original mortar was found to be a light lime mortar which we would trust would have been a 3 parts Nosterfield 1 part Sherbourne and 1 part NHL 3.5 to be the best match. We have carried out a number of pointing samples to gain as near as possible match to the original mortar and texture for approval.

One sample of raking out has been carried out – sample 3 in photos below and three samples of pointing with different mortars (see photos below)

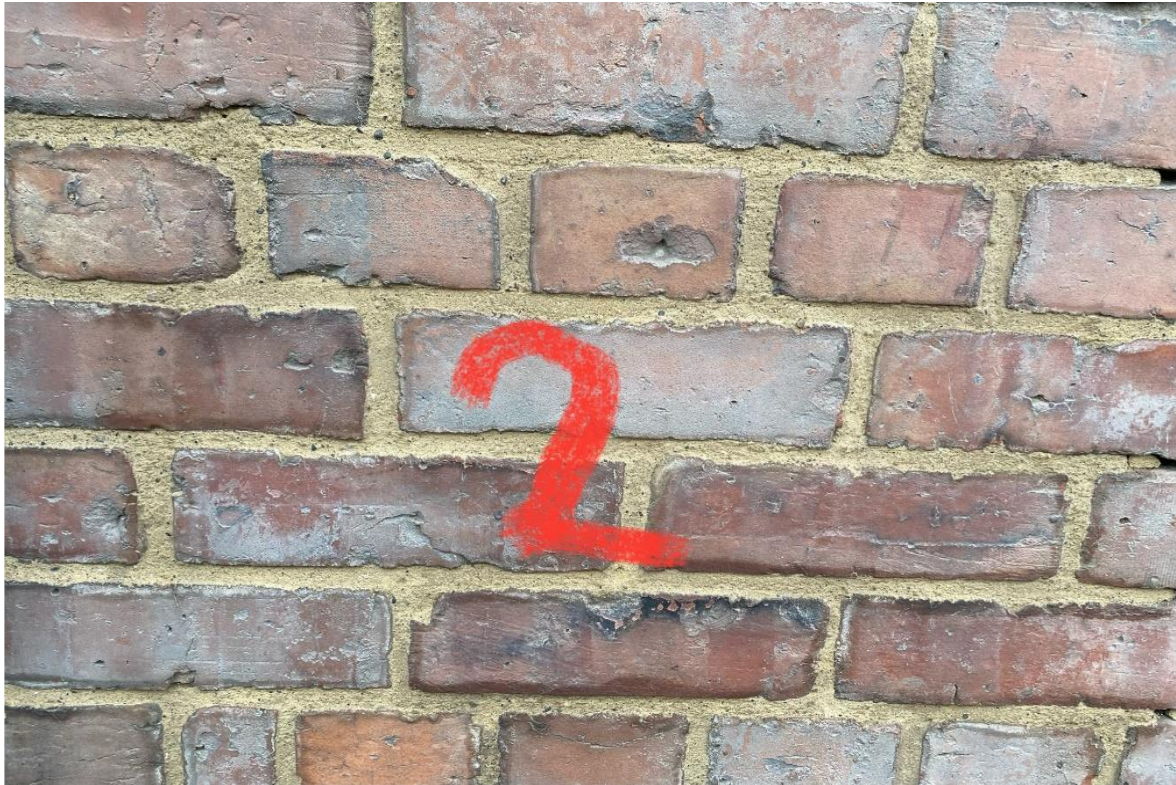
**Photo 2. 3 parts Sherbourne 1 part Nosterfield 1 part NHL 3.5.(Suggested option)**

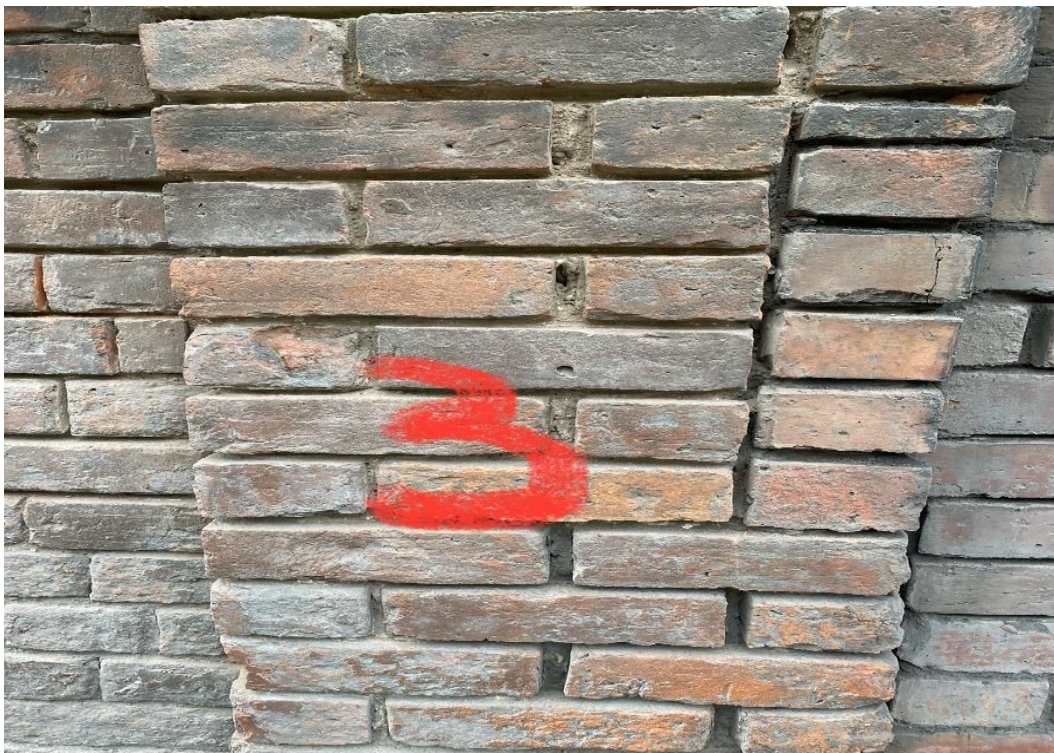
**Photo 3 - Raked out cutting through the centre of the mortar with a thin blade and then taken out the mortar using handheld tools to the required depth and brushed out leaving the area clean.**

The raking out will be carried out to a depth of not more than twice the width of the joint and any loose matter or materials will be brushed out of the joint leaving the area clean and washed out using a water spray to make sure that area is clean,

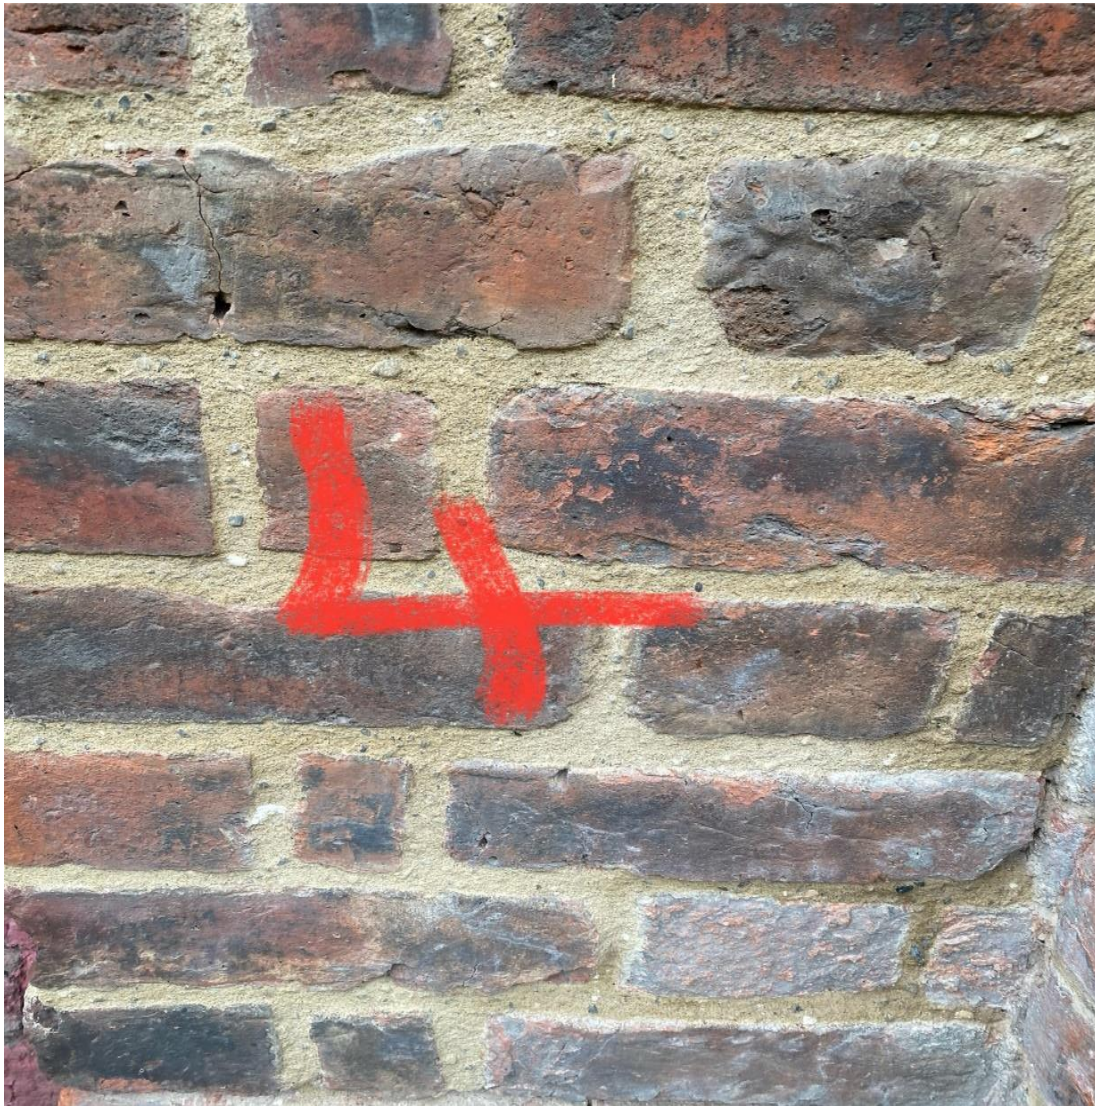
**Photo 4. parts 2 Sherbourne 2 parts Leighton Buzzard 1 part NHL 3.5.**
