| <b>Project Name:</b> | Plot H3 Accor Tribe Hotel |
| <b>Title:</b> | Attenuation Tank Position – Planning Condition 13 |
| <b>Document Ref:</b> | 213501-FSD-XX-XX-TN-S-7101 |

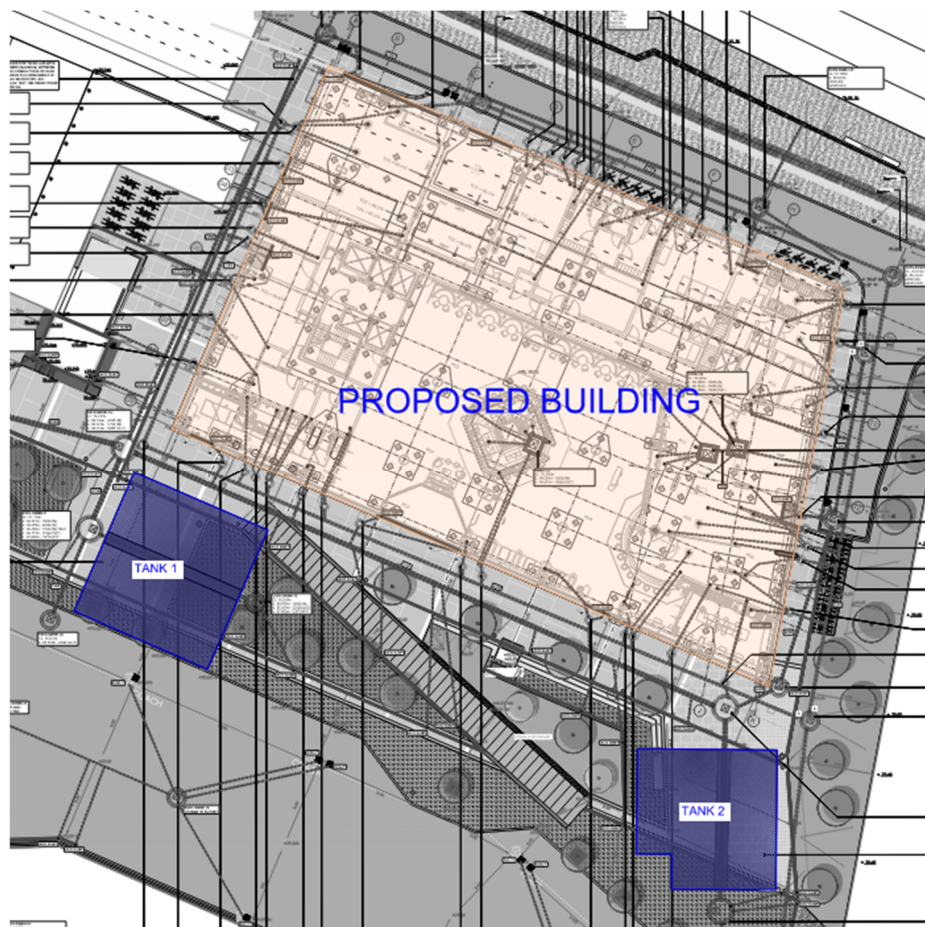
Figure 1: Site key plan showing attenuation tank locations

Two attenuation tanks are provided which form part of the sustainable drainage strategy for the site. Attenuation tank 1 is located to the west of the site and is positioned approximately 4.7m away from the proposed building.

Attenuation tank 2 is located approx. 5.5m away from the eastern corner of the proposed building and approx. 6.3m away from the closest site boundary; therefore tank 2 will not be affected or affect the proposed development. Attenuation tank 2 is not discussed further within this technical note.

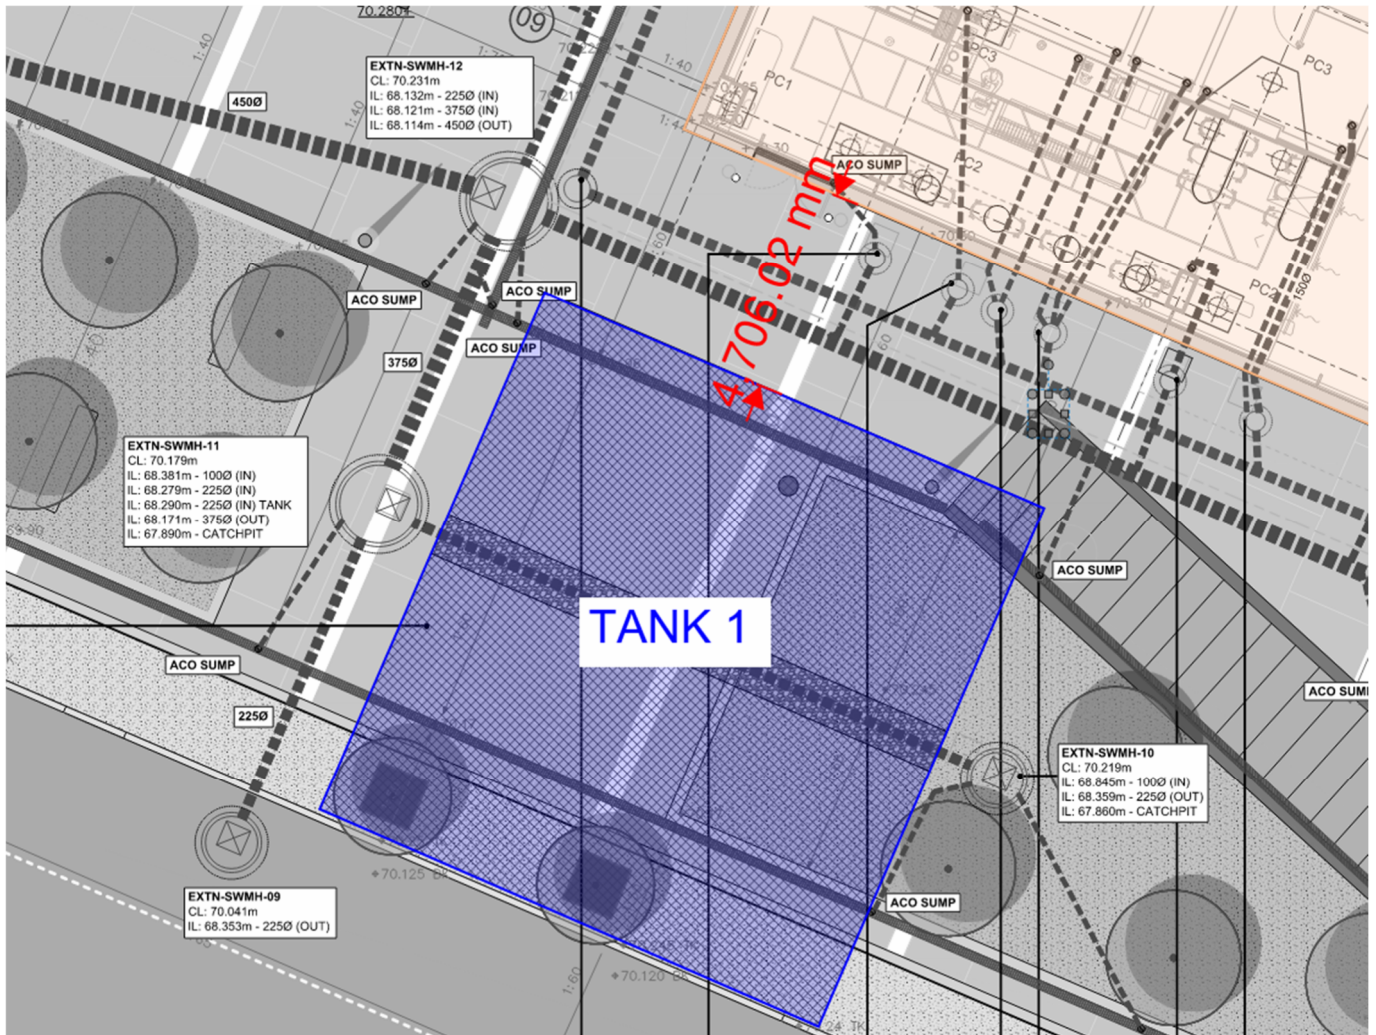
Figure 2: Attenuation tank 1 proximity to the proposed building

It can be seen from Figure 2 above the tank is positioned approx. 4.7m away from the external cladding of the proposed development.

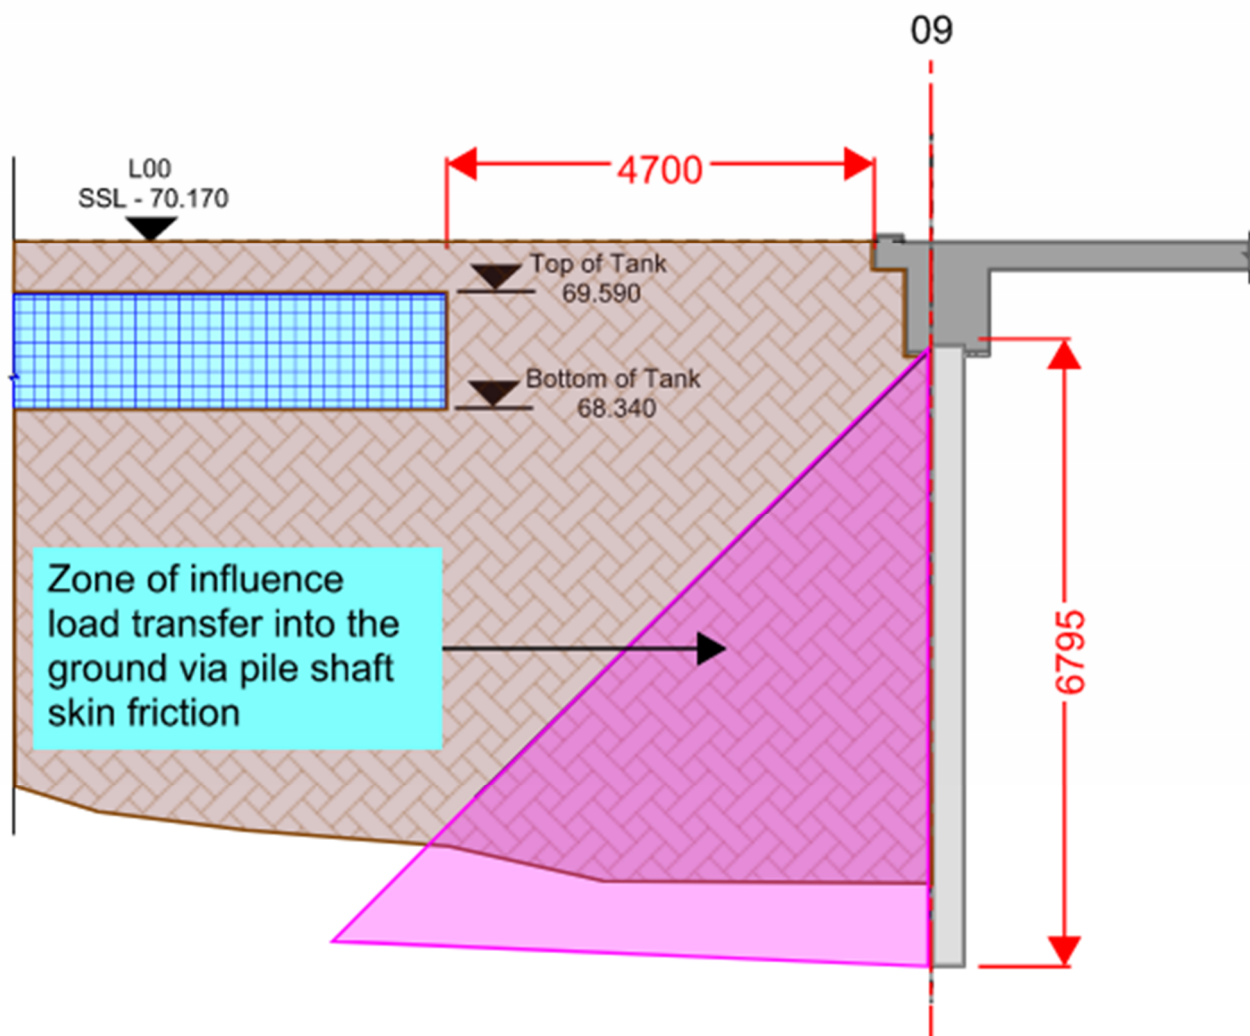
Figure 3 shows a section through this area, indicating the proximity of the attenuation tank 1 to the proposed building. It can be seen that location of the attenuation tank does not impact the structural stability of the piled foundations, and the piles will not transfer load via the ground of the attenuation tank as the attenuation tank is positioned outside of the zone of influence of the piles.

Figure 3: Section through attenuation tank and adjacent foundations

The proposed building is founded on traditional 450mm dia bearing piles which distribute the building loads to the ground at a depth outside of the zone of influence of attenuation tank 1.
