7.2 Appendix ii – 2024 morphological plans (following partial soft strip) by SLHA

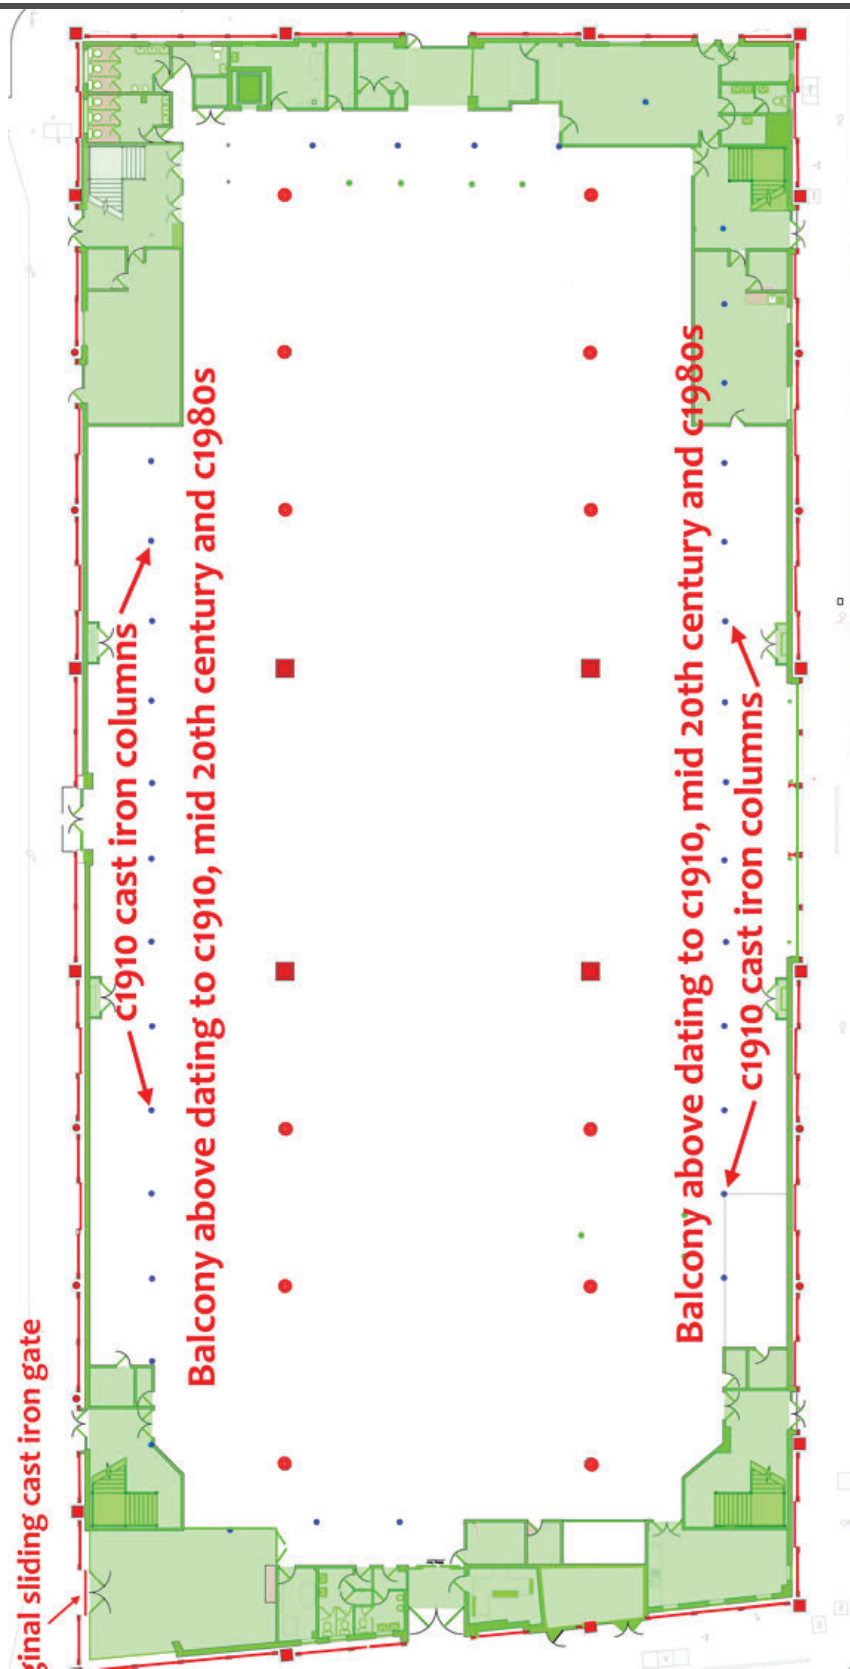
**Figure 161:** Ground floor morphological plan, illustrating areas and fabric dating to the c1980s highlighted **green**, fabric dating to the original construction (and faithful reproduction of missing cast iron elements) highlighted **red**, and surviving c1910 cast iron balcony columns highlighted **blue**.

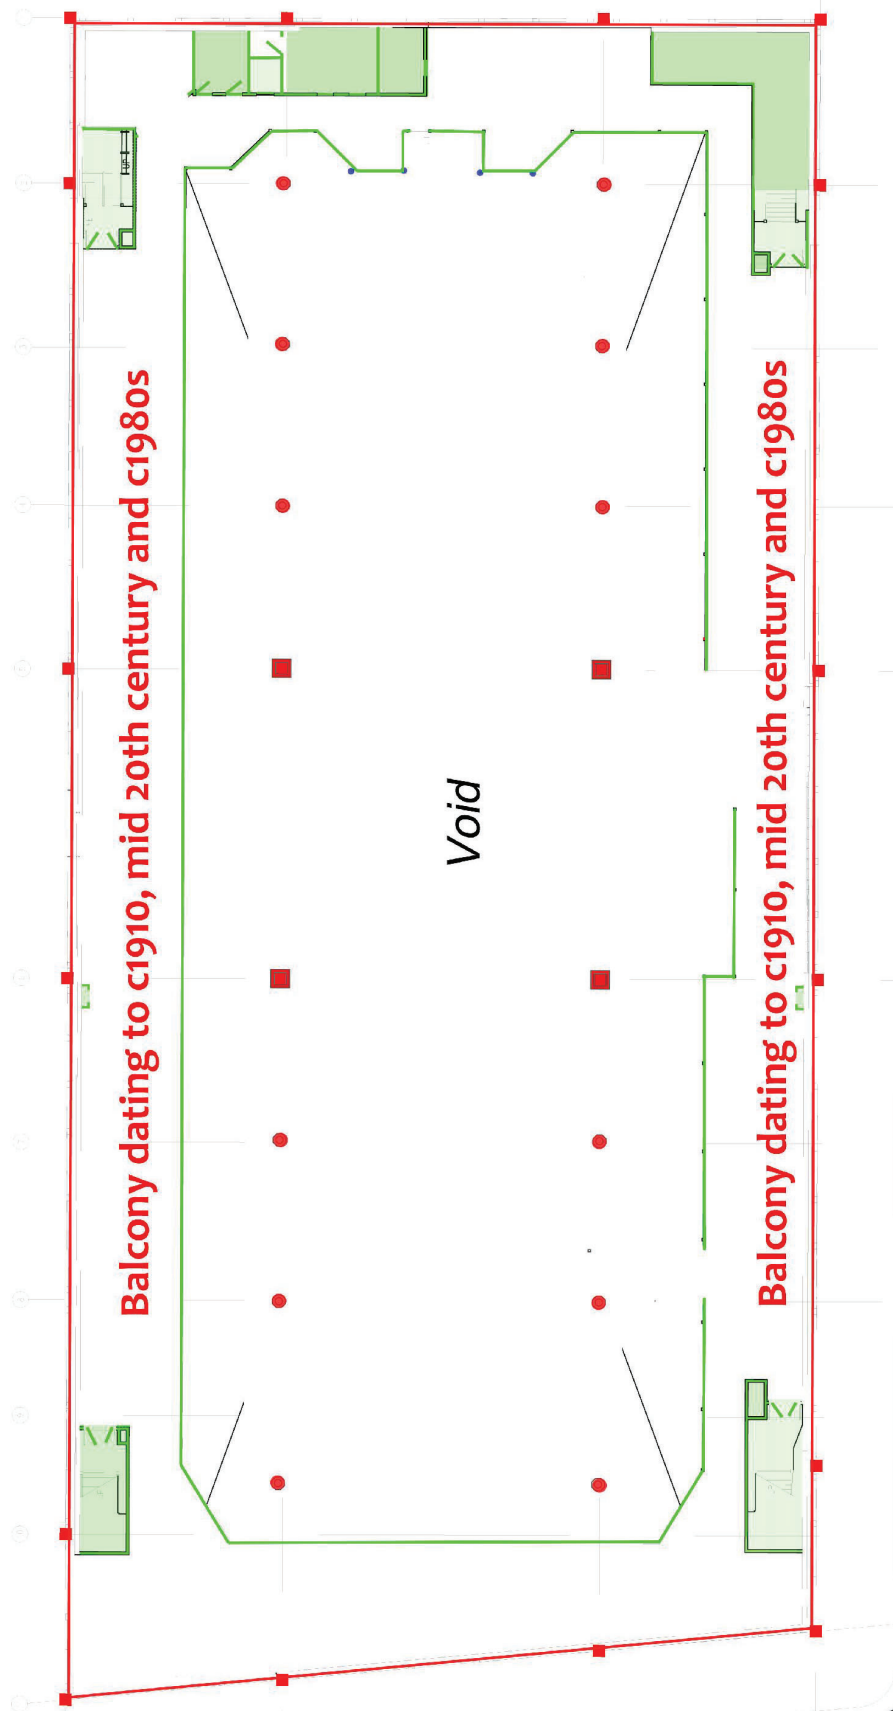
**Figure 162:** Mezzanine floor morphological plan, illustrating areas and fabric dating to the c1980s highlighted green, fabric dating to the original construction (and faithful reproduction of missing cast iron elements) highlighted red, and surviving c1910 cast iron balcony columns highlighted blue.
