REMEDIATION METHOD STATEMENT  
WITHINGTON CDC  
MANCHESTER  
BAM CONSTRUCTION LTD  
22182-IDOM-WCH006-XX-RP-Y-09002  
JUNE 2024

REMEDICATION METHOD STATEMENT  
WITHINGTON CDC  
MANCHESTER  
BAM CONSTRUCTION LTD  
22182-IDOM-WCH006-XX-RP-Y-09002  
JUNE 2024

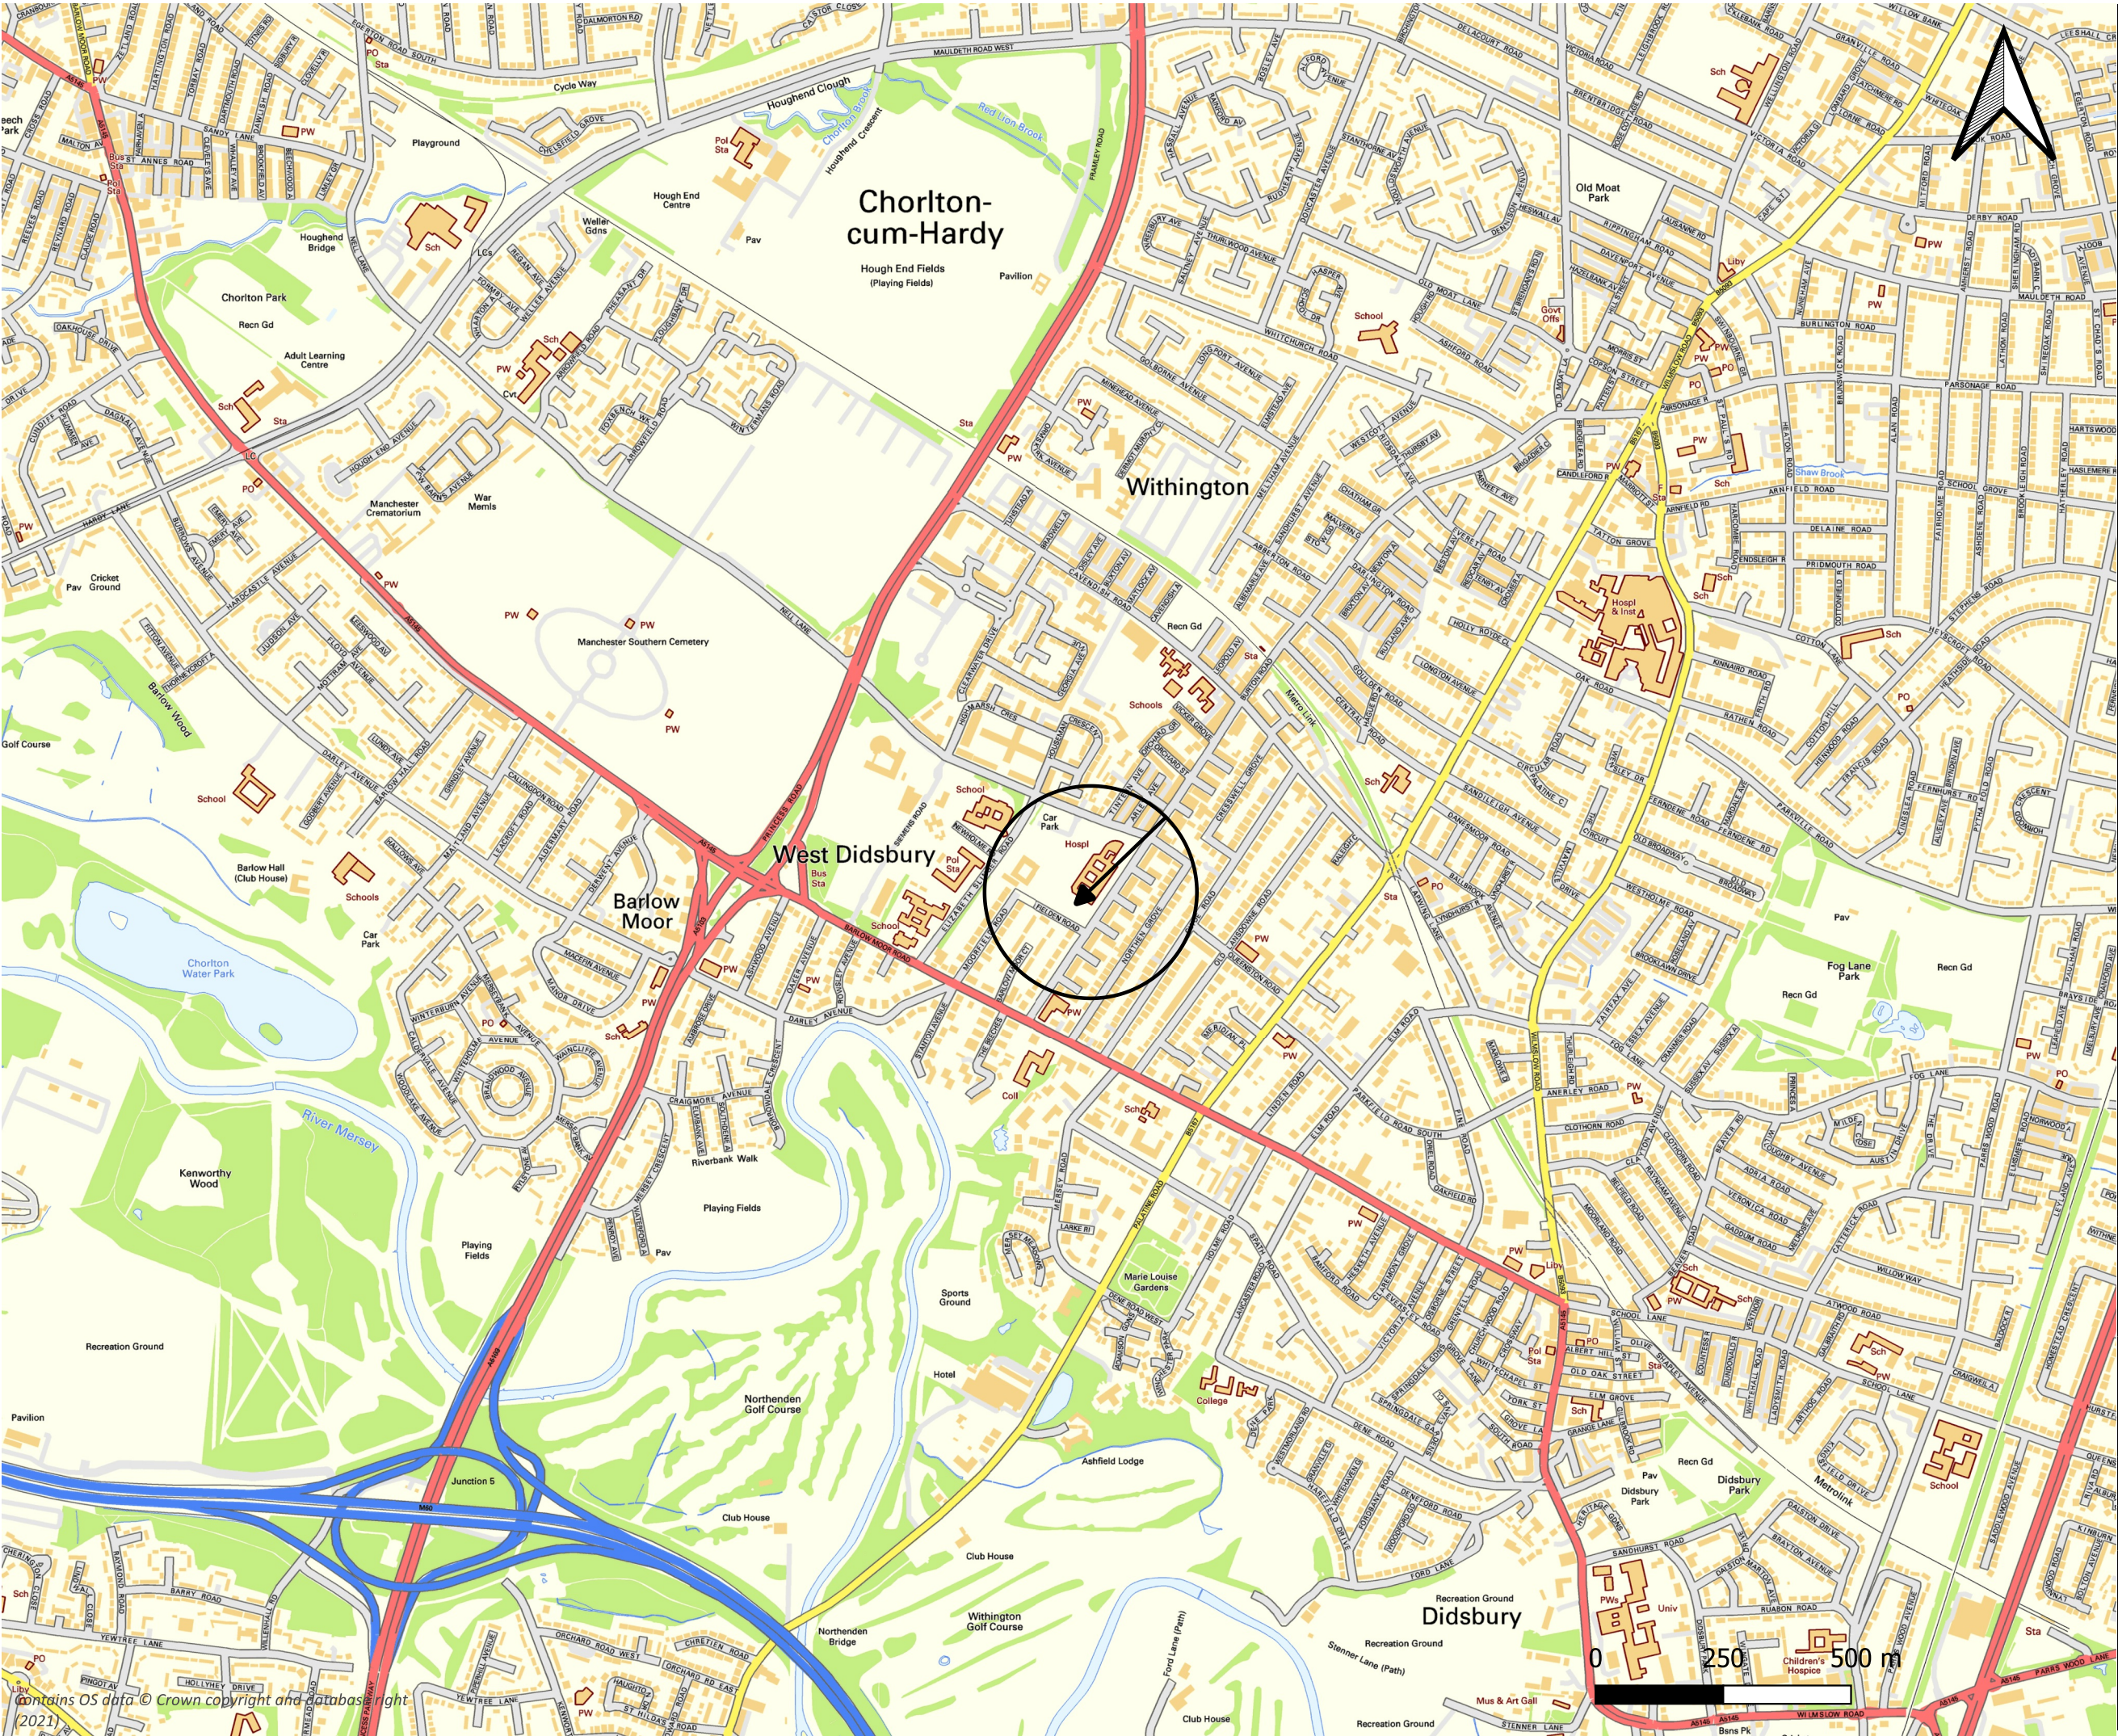
Site Location

- 3.1.1 The site is irregular in shape and covers an area of approximately 0.56 hectares centred at approximate National Grid Reference 383734, 392010 as indicated on drawing 22705-001-001, presented in Appendix 1 of this report.

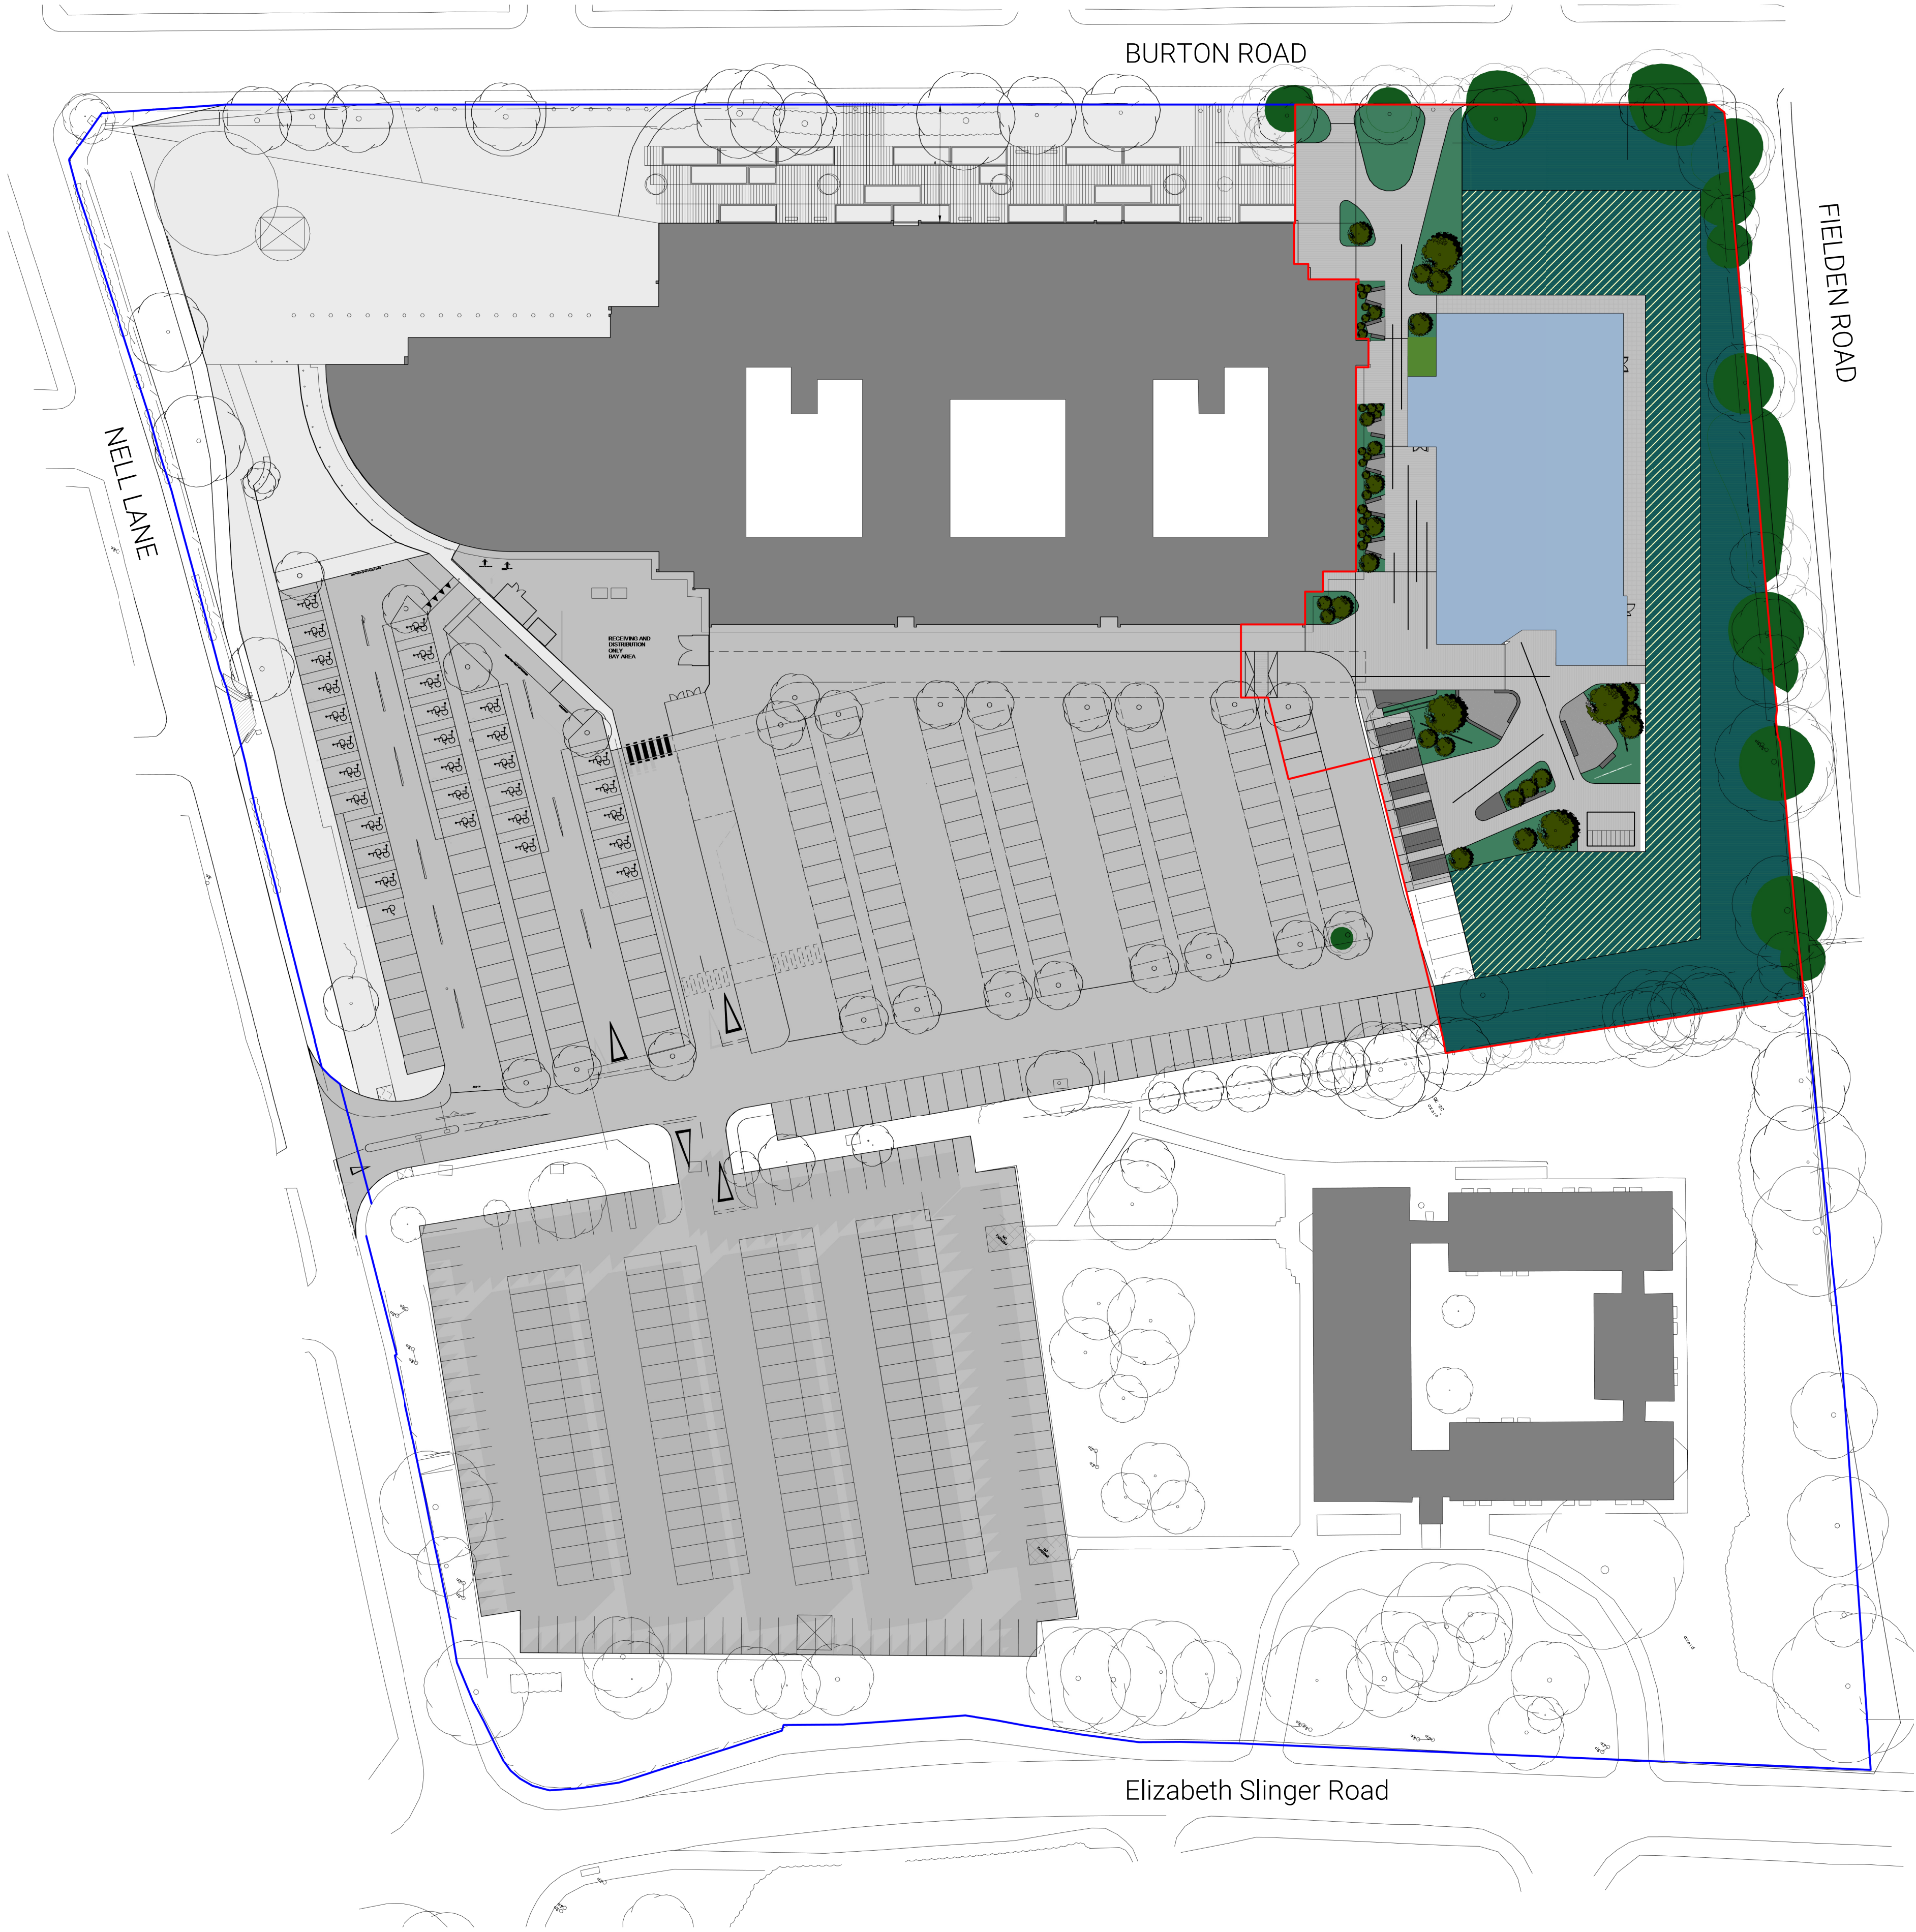
Ground Floor GA Plan  
1:500

- 1.1 BAM Construction Ltd (BAM) is acting as Principal Contractor for the redevelopment of land adjacent to Withington Community Hospital, Nell Lane, West Didsbury, Manchester, M20 2LR. The proposed development comprises an endoscopy and cardiorespiratory unit to be linked up to the existing hospital building adjacent to the site. The proposed layout plan is included in Appendix 1.

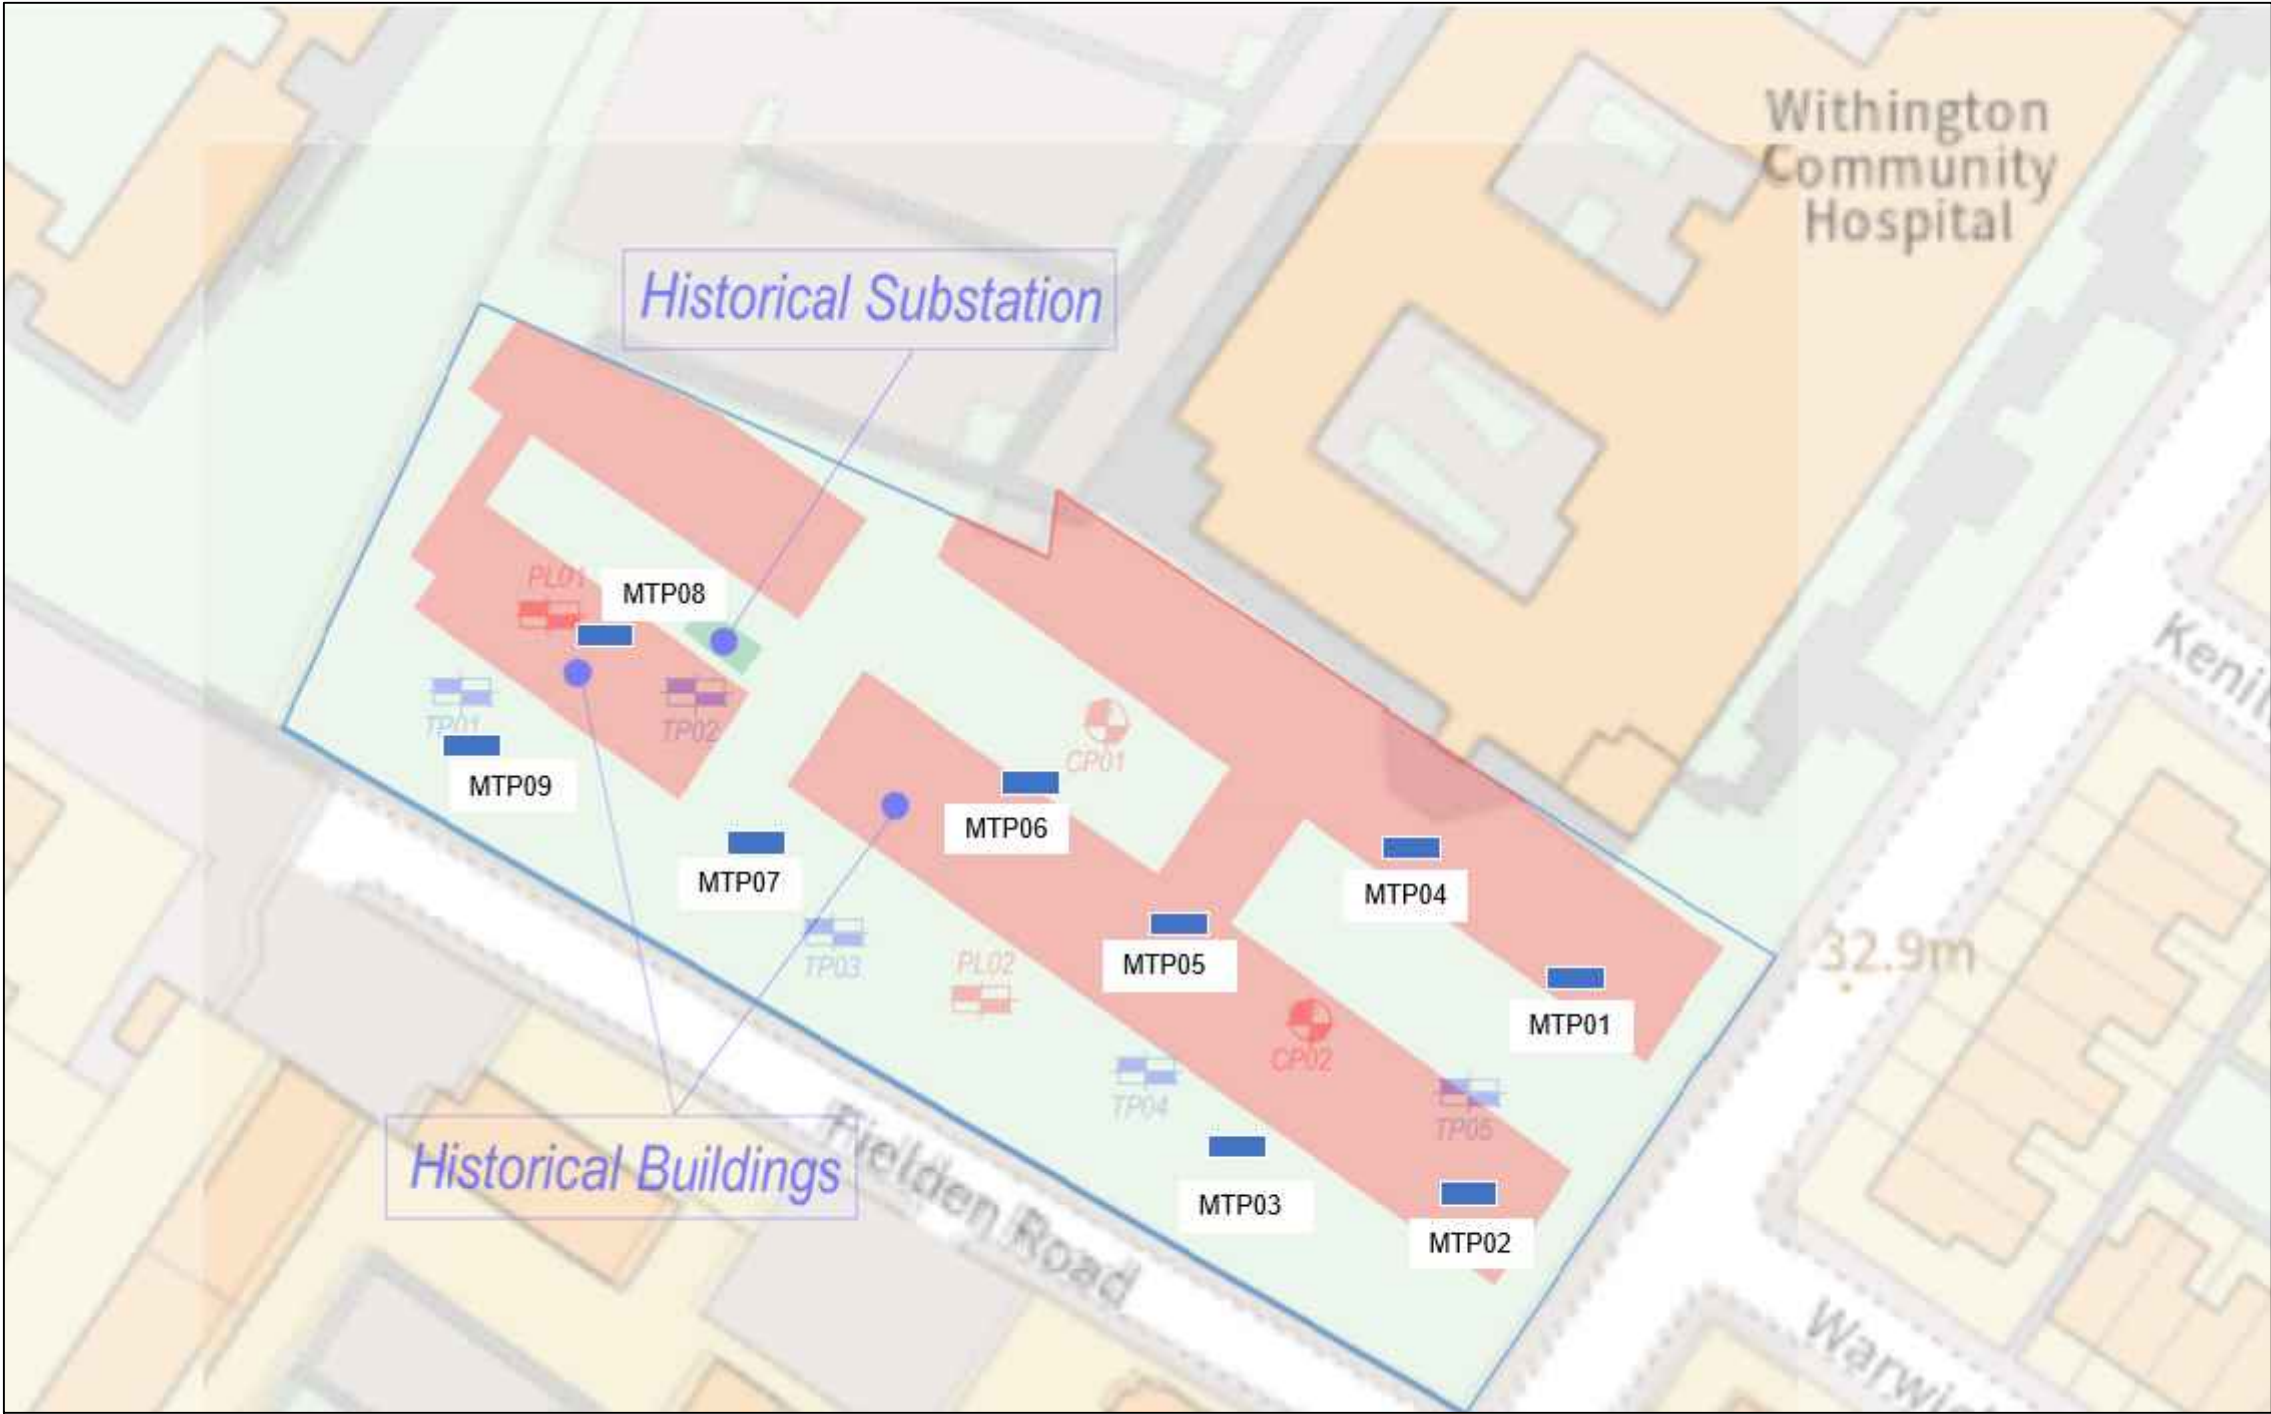
- 3.6.2 The Groundtech investigation included two boreholes (CP01 and CP02) and five trial pits (TP01-TP05). The IDOM investigation comprised a further nine trial pits (MTP01-MTP09). The exploratory hole locations are indicated on drawing 22705-304-001 enclosed in Appendix 1.

| LEGEND | | | | | |
|---|---|---|--|--|--|
| | CPref | GROUNDTECH MAY 23 BOREHOLE | | | |
