**ARBORICULTURAL IMPACT ASSESSMENT  
to BS 5837:2012  
at  
Land at Bailey Street/Enterprise Way  
Manchester  
Greater Manchester  
M90 4AB**

**Client:**  
KPP Architects Ltd

**JCA Ref:**  
21843-A/AJB

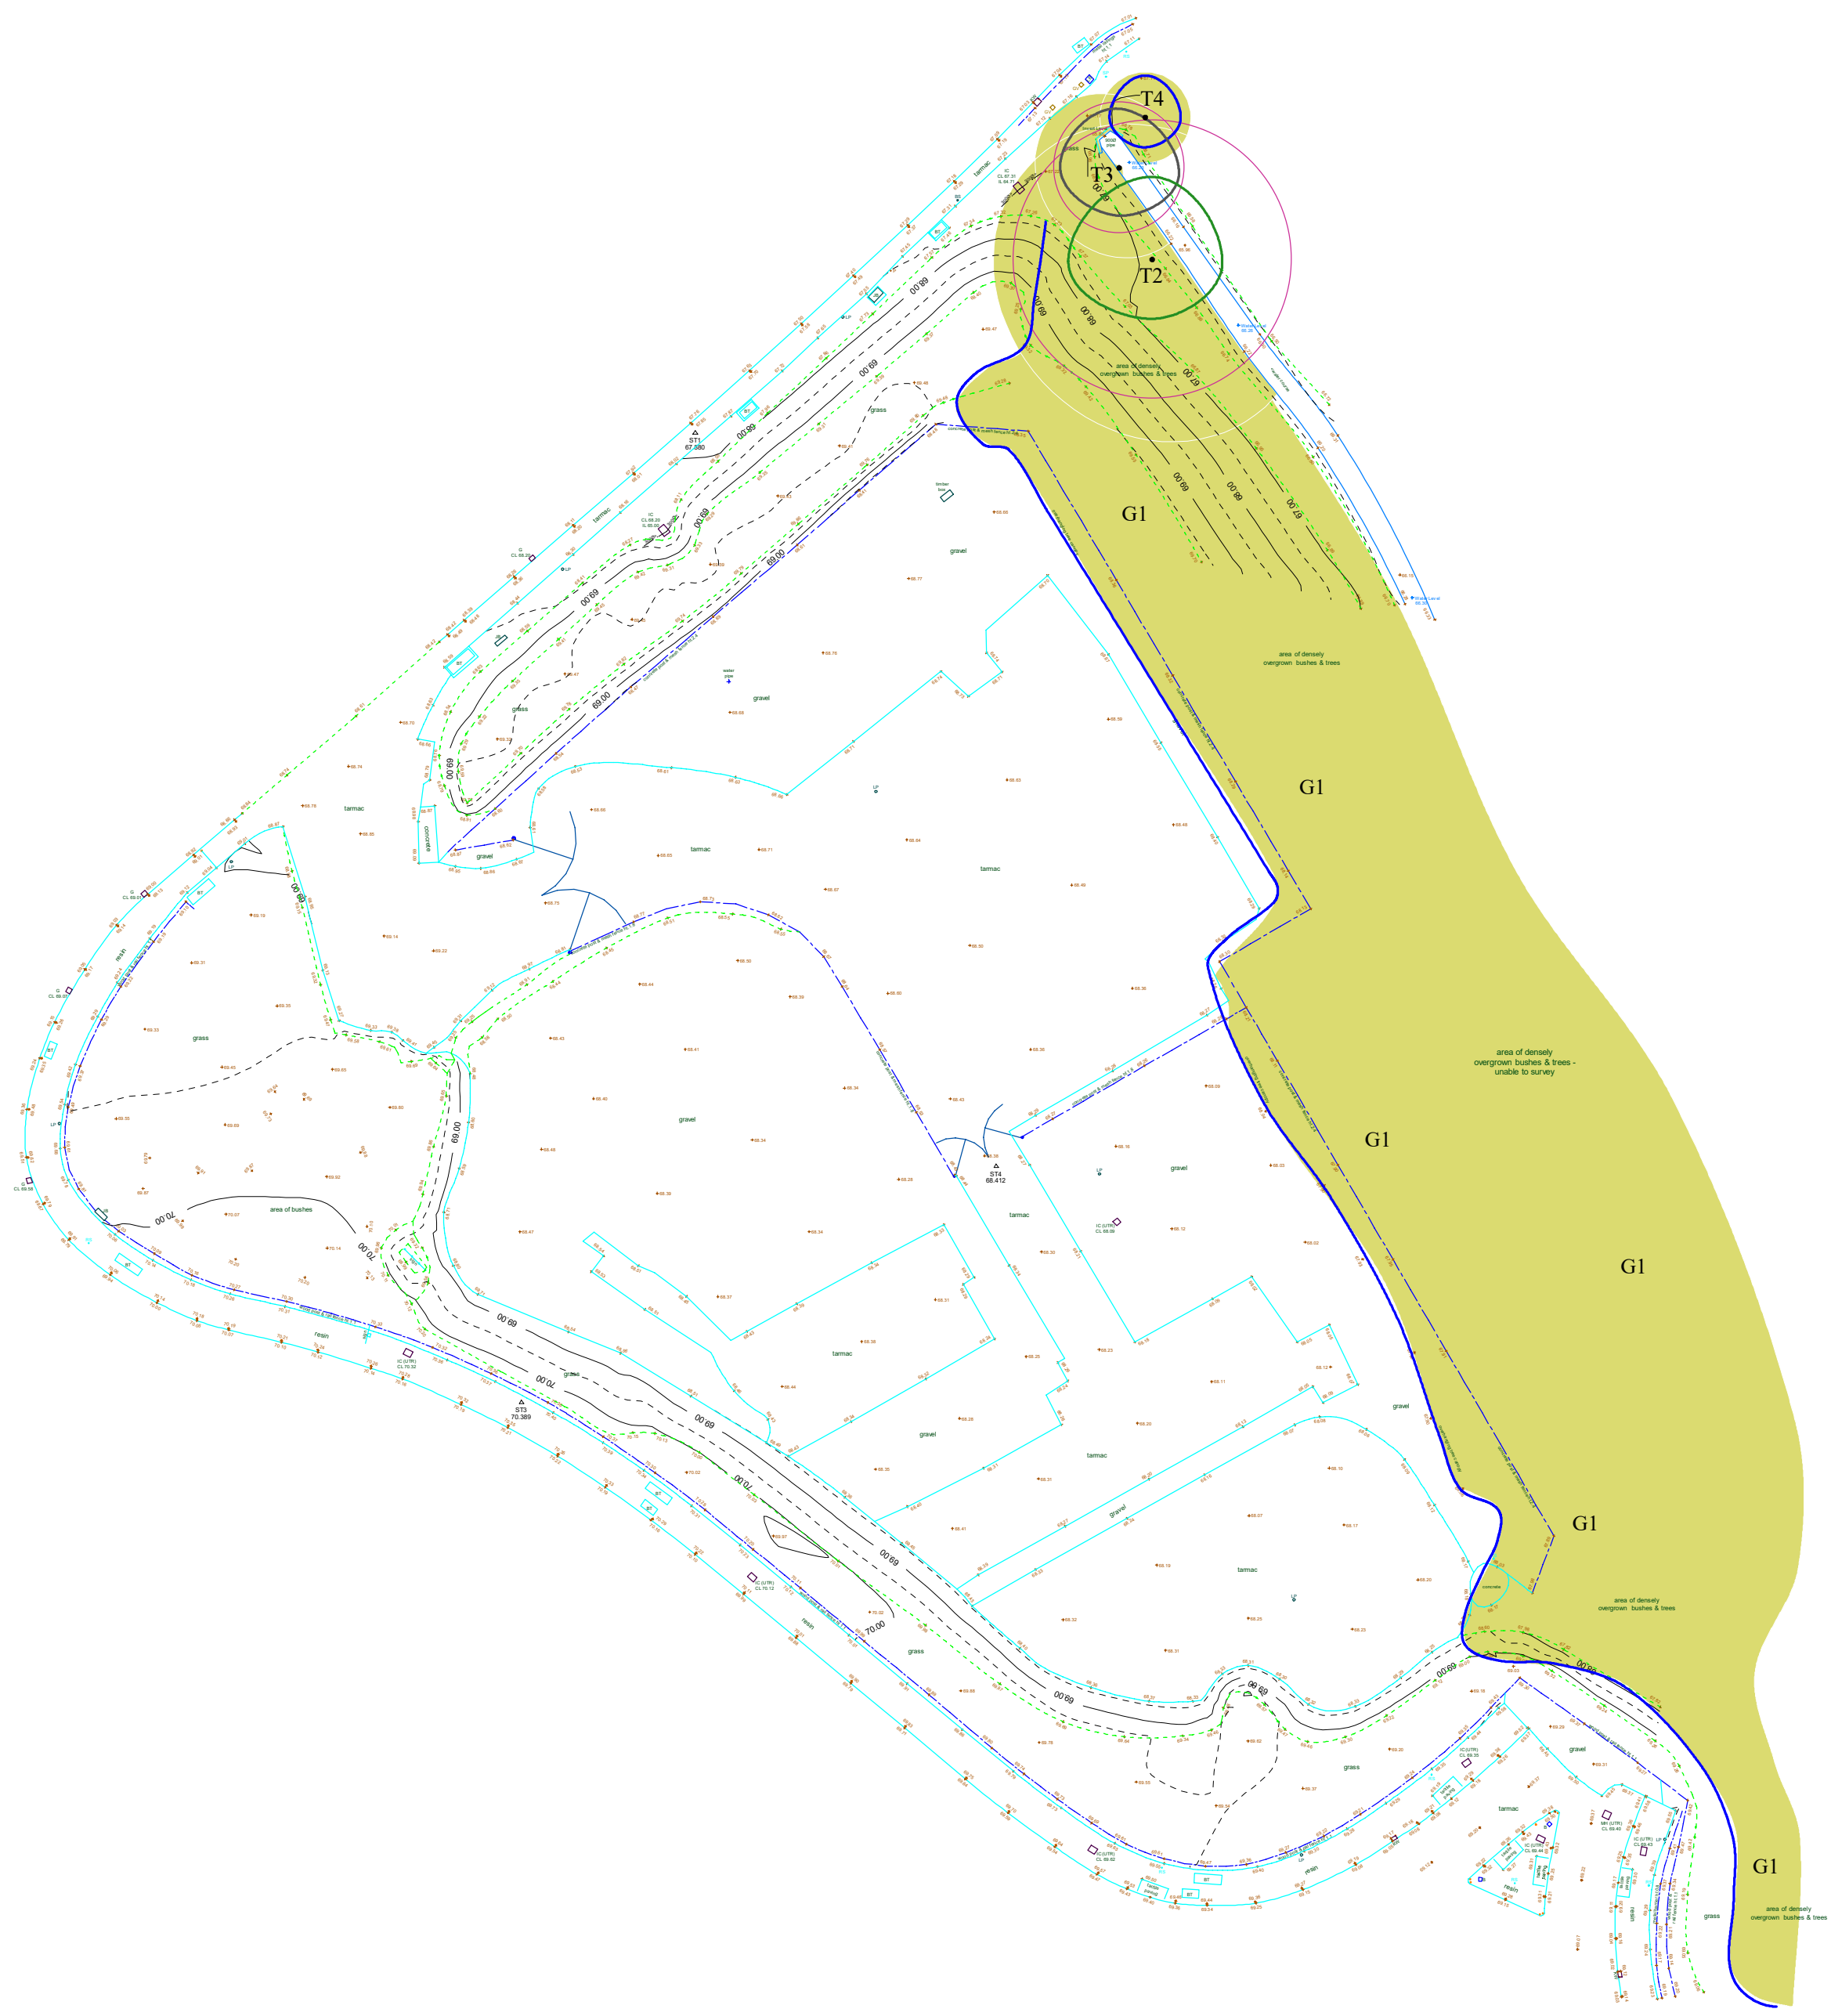
**Appendix 5:**  
**Tree Constraints Plan**

**Root Protection Area: RPA**

THE ROOT PROTECTION AREA SHOULD IDEALLY REMAIN UNDISTURBED IF THE TREE IS TO BE RETAINED.

THE DEVELOPMENT PROPOSALS SHOULD THEREFORE BE DESIGNED TO AVOID THE RPA OF ANY TREE WHICH IS TO BE RETAINED.

IF IT IS NECESSARY FOR THE DEVELOPMENT TO ENCROACH INTO THE RPA OF A TREE WHICH IS TO BE RETAINED THEN SPECIALIST CONSTRUCTION TECHNIQUES AND MATERIALS MUST BE CONSIDERED.

- 2.1 The tree information recorded during the original survey is detailed in the tables at **Appendix 1**. A full explanation of the tables can be found at **Appendix 2**. Please refer also to the Tree Constraints Plan at **Appendix 5** for tree locations.

- 4.6 The protection of retained trees can be achieved by the creation of a Construction Exclusion Zone based on the Root Protection Area of a tree. The Root Protection Area of each tree or group is marked on the Tree Constraints Plan at **Appendix 5**.
