Project Project No. 2211  
**room2 Homotel Manchester Piccadilly**  
Northside (Manchester Ltd)

Drawing Title  
**Planning  
Demolition Basement Plan**

| HMP-BA-12-B01-DP-A-0 | P01 S2 |

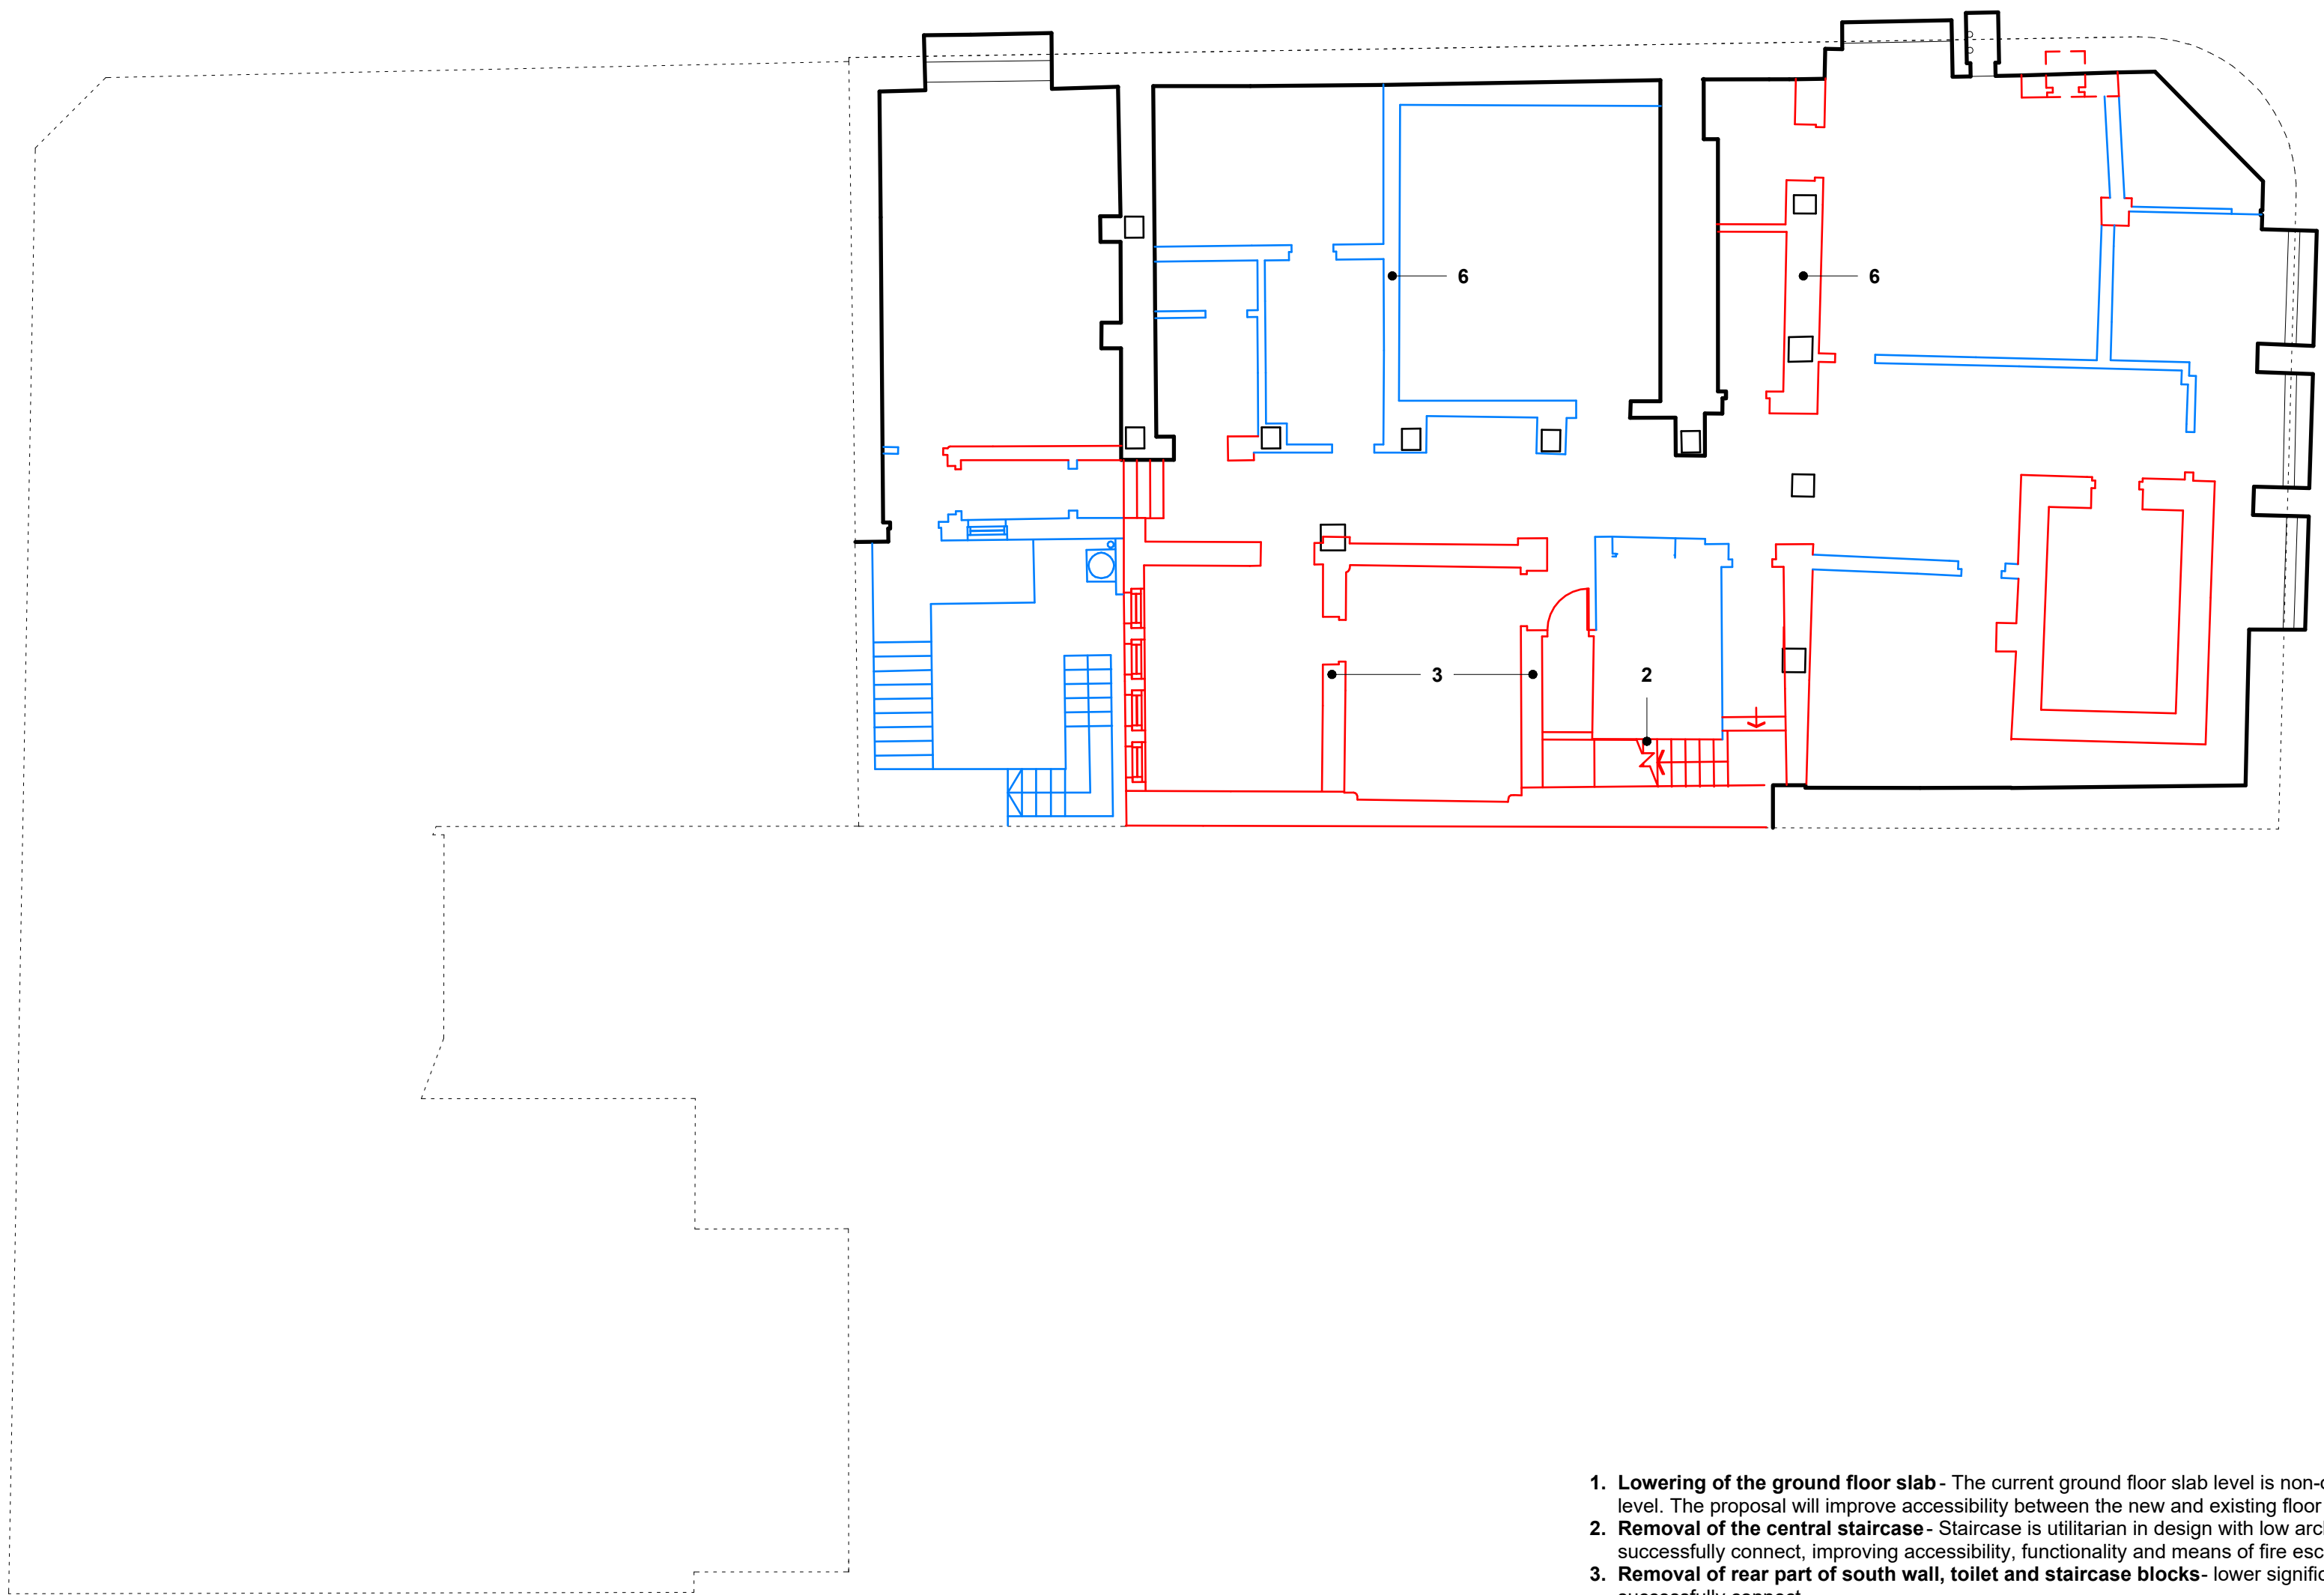
- Lowering of the ground floor slab** - The current ground floor slab level is non-original, it was later raised higher than the original banking hall that aligned with street level. The proposal will improve accessibility between the new and existing floor levels.

- Infilling of rear lightwell** - Infilling of the rear lightwell allows for insertion of the new core and generates space in centre of plan for accommodation and fire escape from 12 Piccadilly

- Strategic removal basement walls** – to facilitate space for heavy plant equipment and distribution. This intervention reduces the need for plant on other floor levels, prioritised available space for amenity and front of house functions
