PROPOSED NORTH ELEVATION

PROPOSED WEST ELEVATION

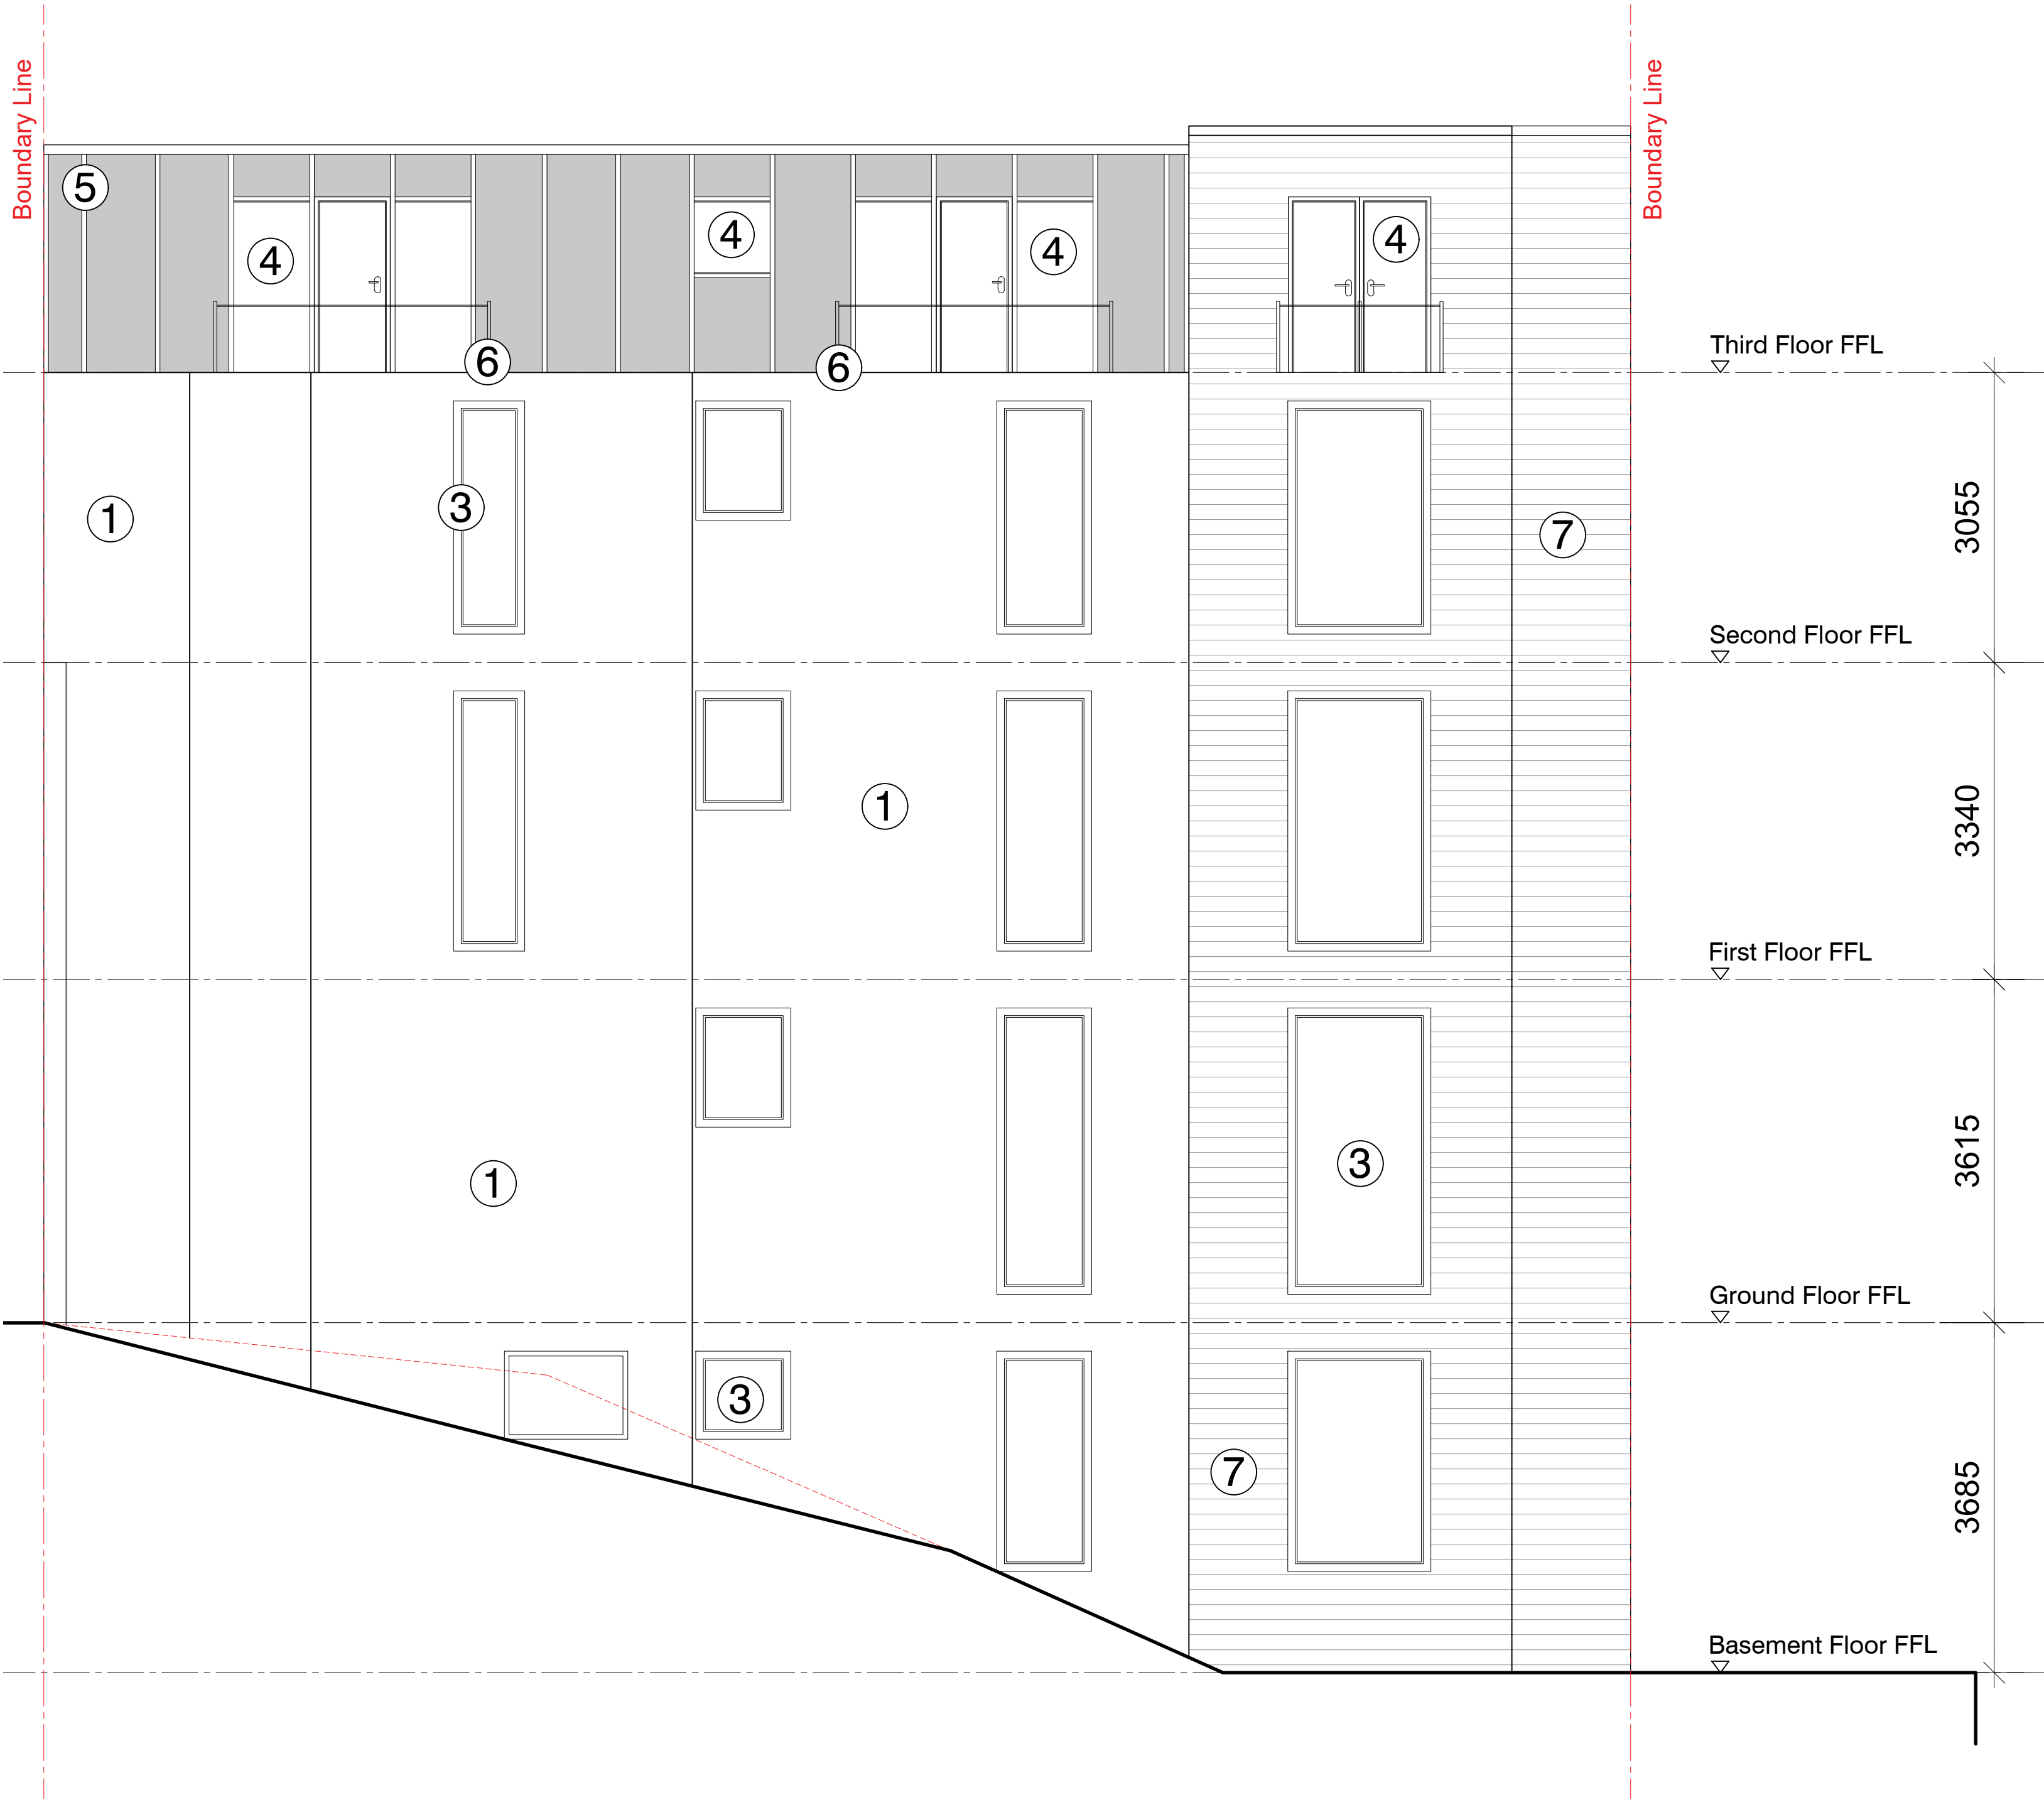
Existing brickwork to be made good where required
- 2

Existing broken window to be removed and replace with new double glazed window/door assemblies
- 3

Proposed black double glazed window/door assemblies
- 4

Proposed black double glazed window/door assemblies
- 5

Proposed black vertical standing seam zinc cladding
- 6

Proposed glass balustrade
- 7

Proposed brickwork to match existing
