***CONTAMINATED LAND RISK ASSESSMENT***

***PHASE 1 DESK TOP STUDY– PRELIMINARY RISK ASSESSMENT***

**Land at Herbert Street  
Manchester**

**Soil Environment Services Ltd  
July 2020**

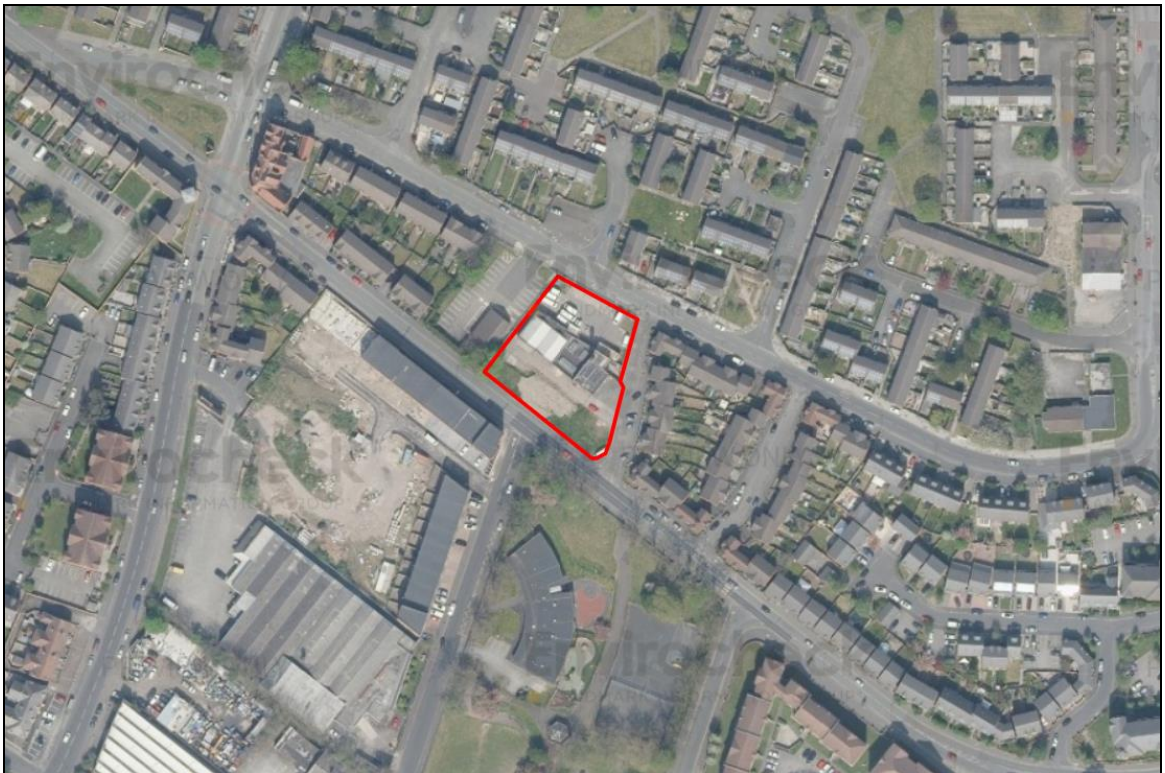
**PHOTO 1 Aerial view**

The site assessed for this investigation currently comprises 0.26 ha of land located on Herbert Street, Manchester. Roads bound the site to the north, east and south, with a government office building to the west (Photo 1). The site comprises a building most recently used for service garages activities, with grassed areas to the north and south (Photos 1-4). The site and surrounding land are relatively level.

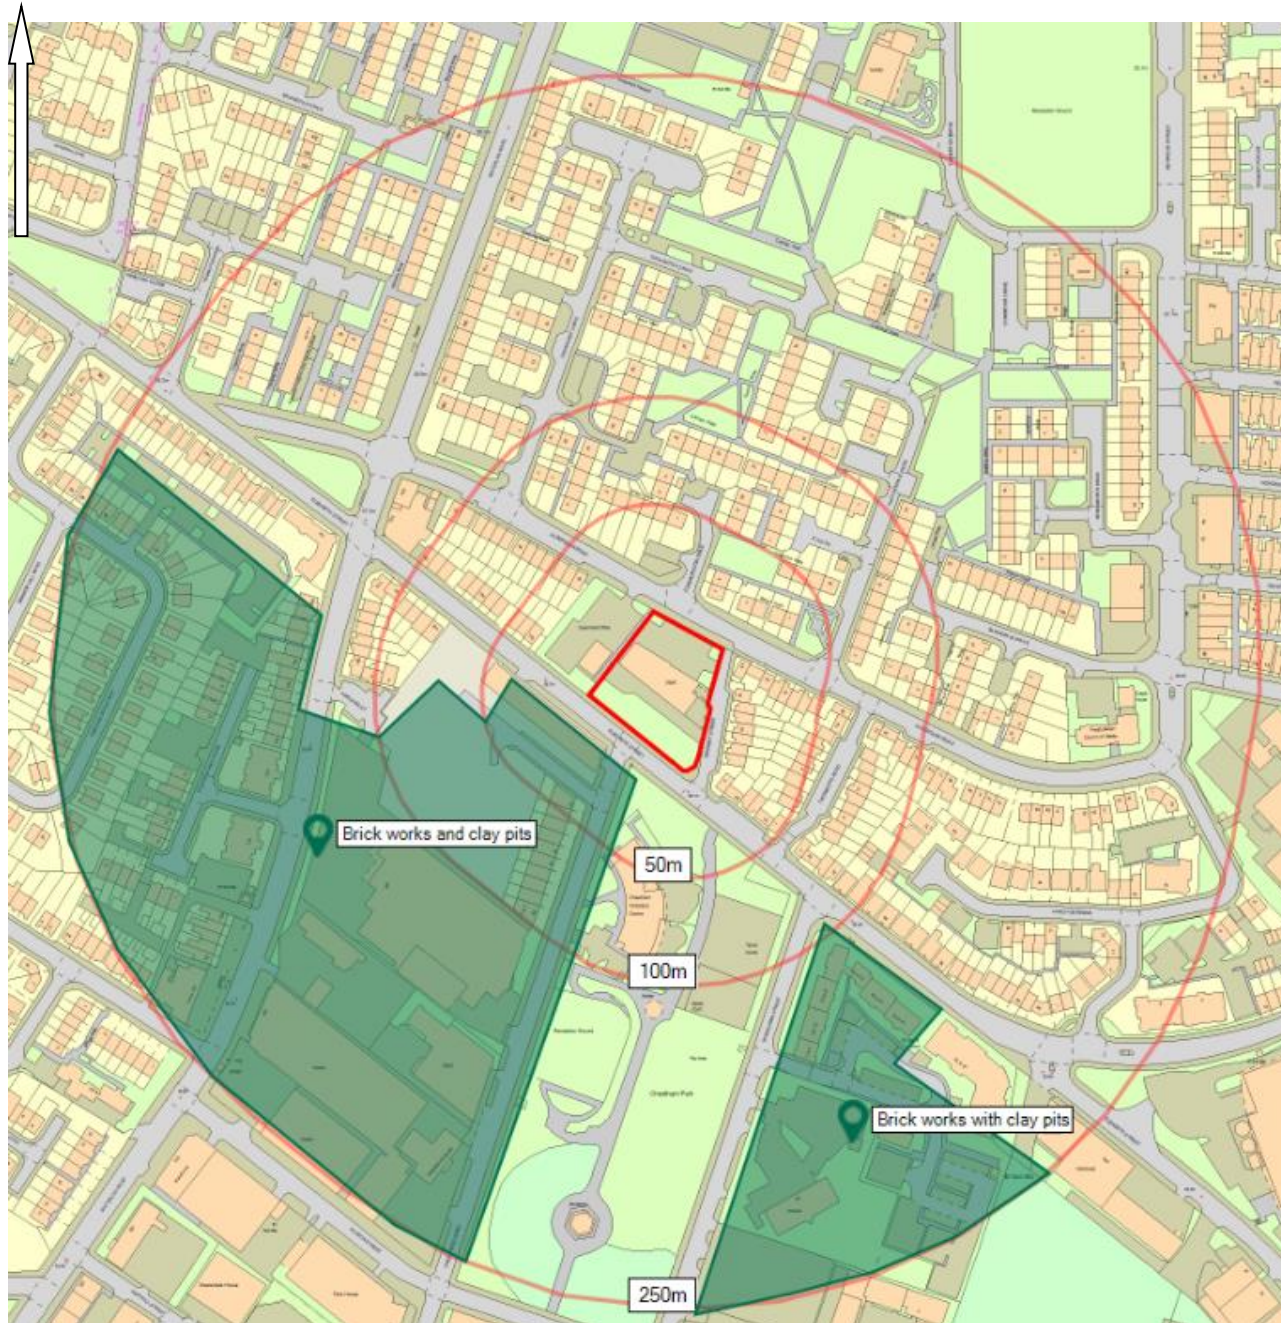
# **DRAWING 1**

**Current site setting**

Site boundary

### 2.1 Current setting and condition (Drawing 1)

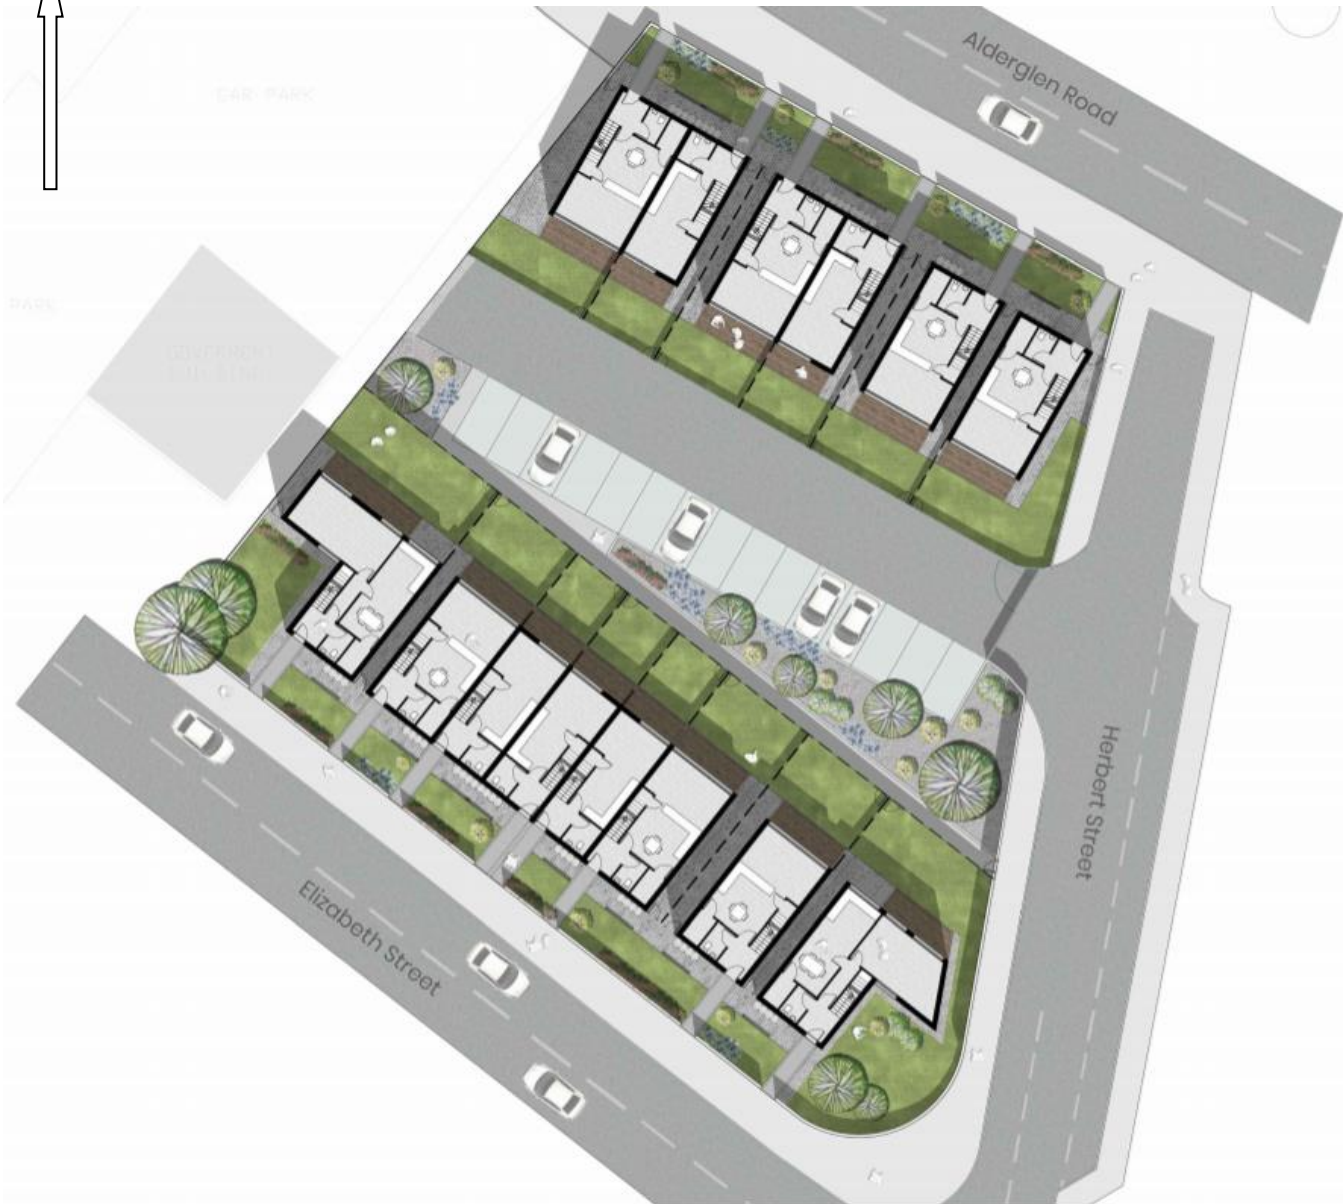
| Drawing number | 2 |

Site boundary

| Drawing title | Proposed site plan |

| Proposal | The proposal is for residential development (see Drawing 2 for proposal). No planning application was available for viewing at the time of report completion. |
