| Project | CHATSWORTH HOUSE, MANCHESTER |
| Title | TYPICAL INTERNAL REPAIR |
| Drawing No. | BR 001 |

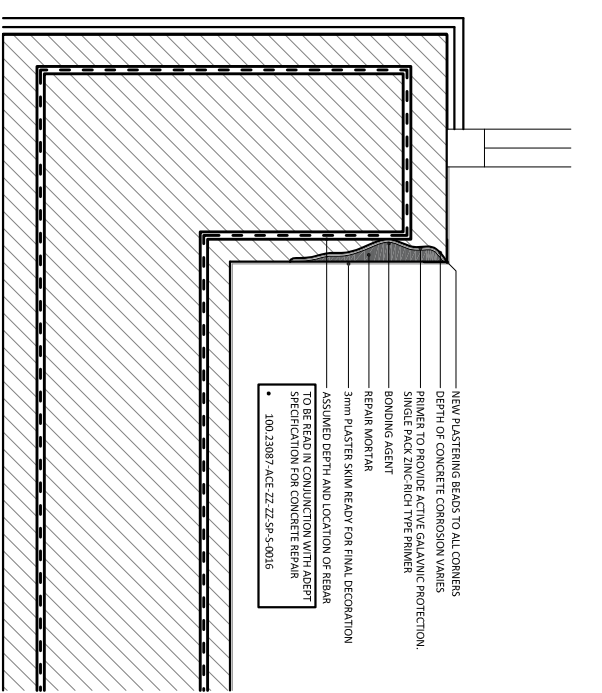
TYPICAL SPALLED CONCRETE REPAIR 1:10

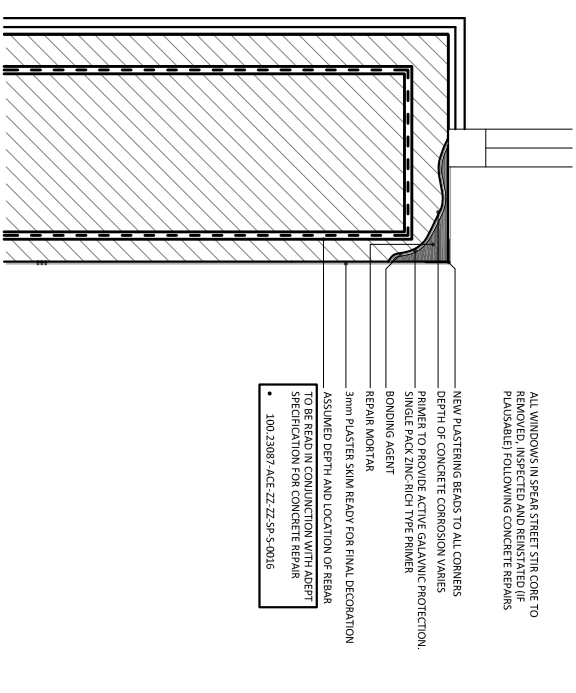
TYPICAL SPALLED CONCRETE CILL/JAMB/HEAD REPAIR 1:10

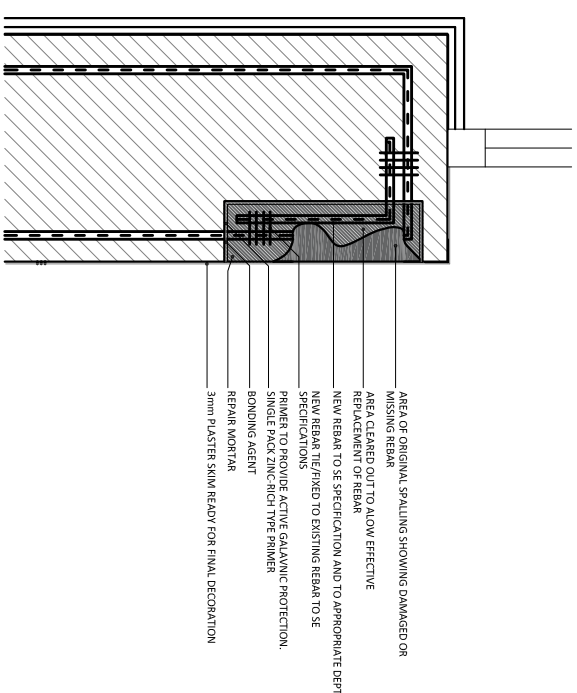
TYPICAL SPALLED CONCRETE WITH DAMAGED REBAR REPAIR 1:10

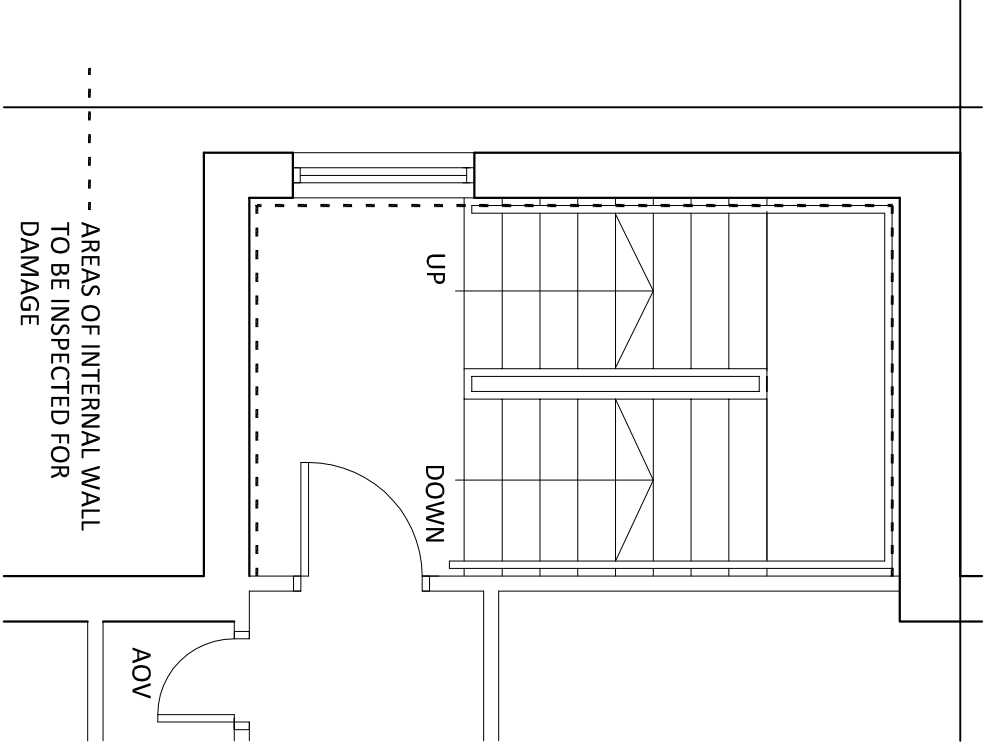
DAMAGED AREAS FOR INSPECTION 1:50

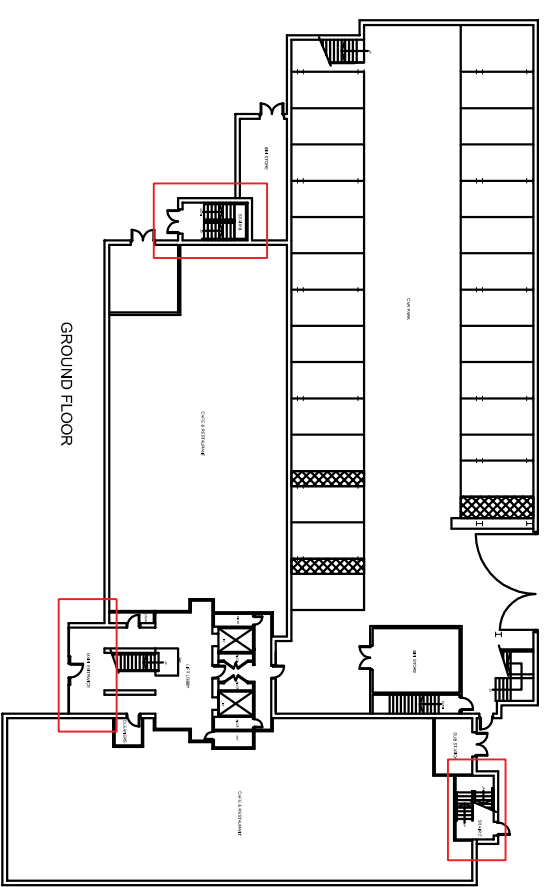
STAIR CORE LOCATIONS 1:50
