## 7.2 Appendix ii – 2024 morphological plan (following partial soft strip) by SLHA

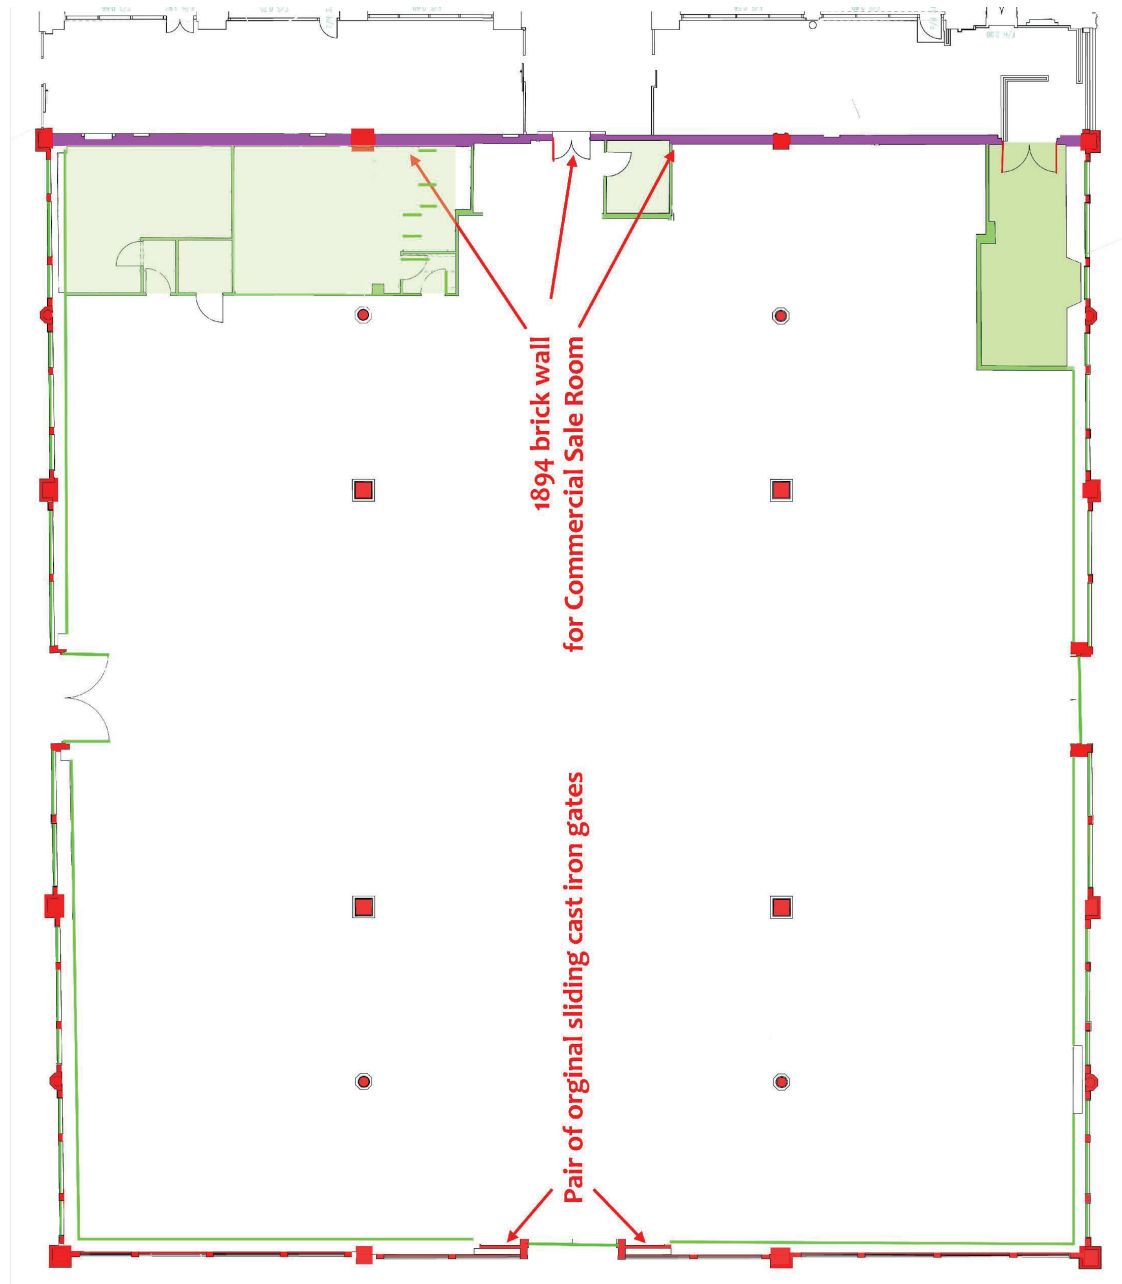
**Figure 102:** Ground floor morphological plan, illustrating areas and fabric dating to the c1980s highlighted **green**, and fabric dating to the original construction (and faithful reproduction of missing cast iron elements) highlighted **red**.
