33, Thomas Street,  
Manchester.

Structural Details  
Sheet 1.

J-22119-003 rev

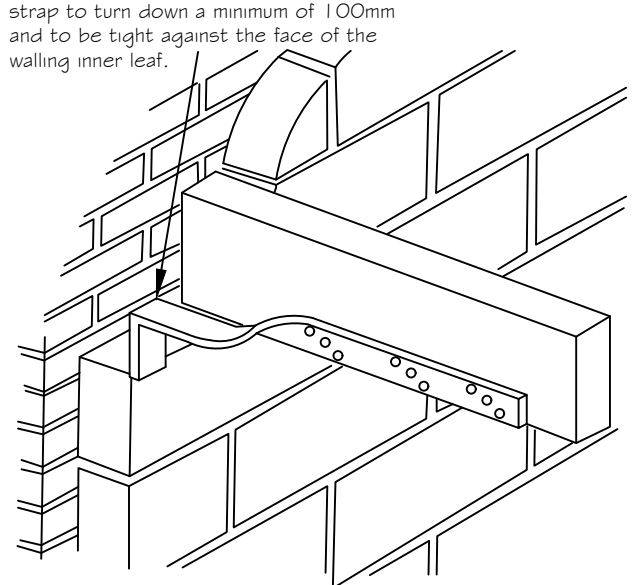
1:10 TYING OF TIMBER FLOOR BEARING ON TO WALL

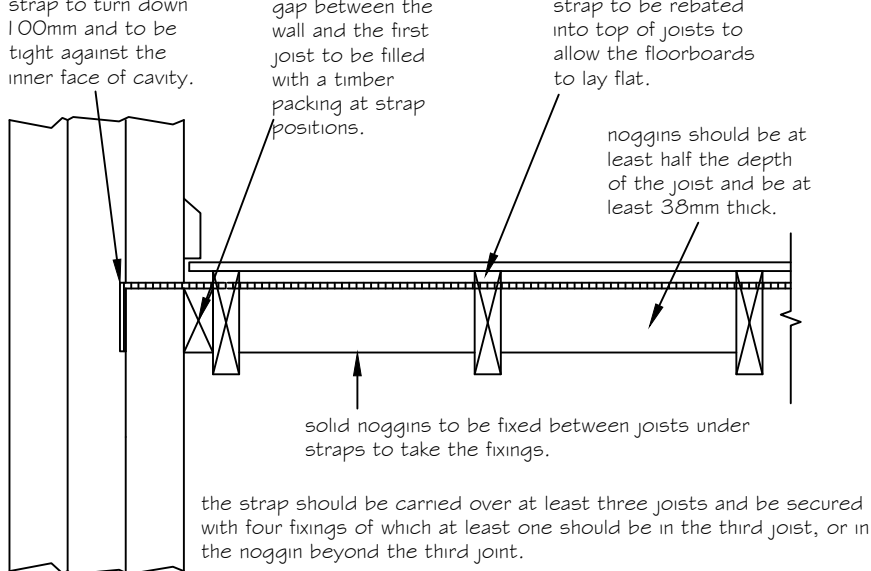
1:10 WALL RESTRAINT DETAIL WITH TIMBER FLOOR SPANNING PARALLEL

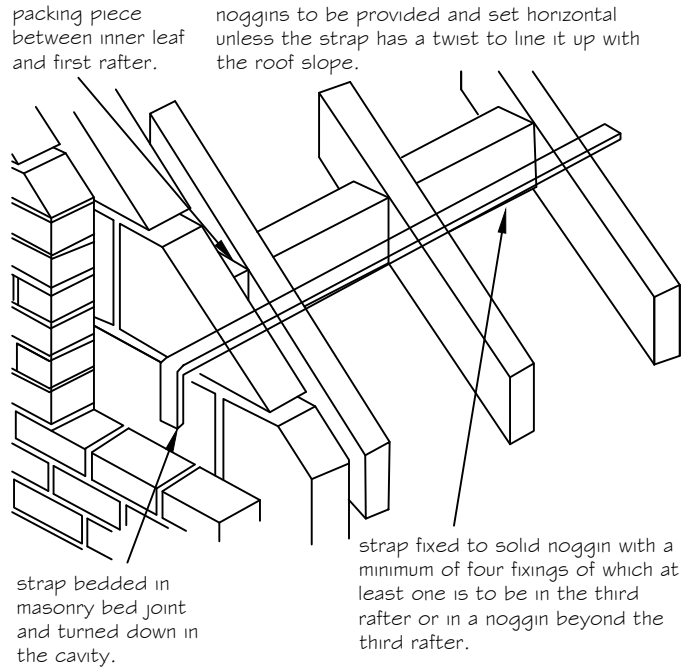
1:10 TYING OF PITCHED ROOFS TO GABLE WALLS

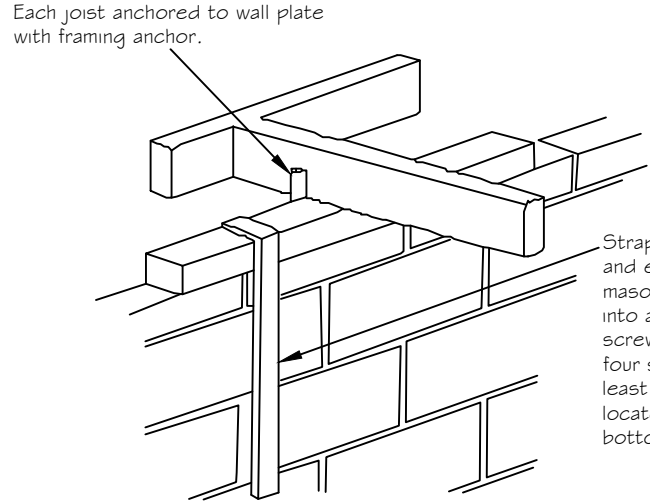
1:10 TYING OF TIMBER FLOOR BEARING ON TO WALL
