# A&H CONSTRUCTION & DEVELOPMENT PLC.

Lowry Park, Manchester

Remediation Validation Report

PH/C5470/12572

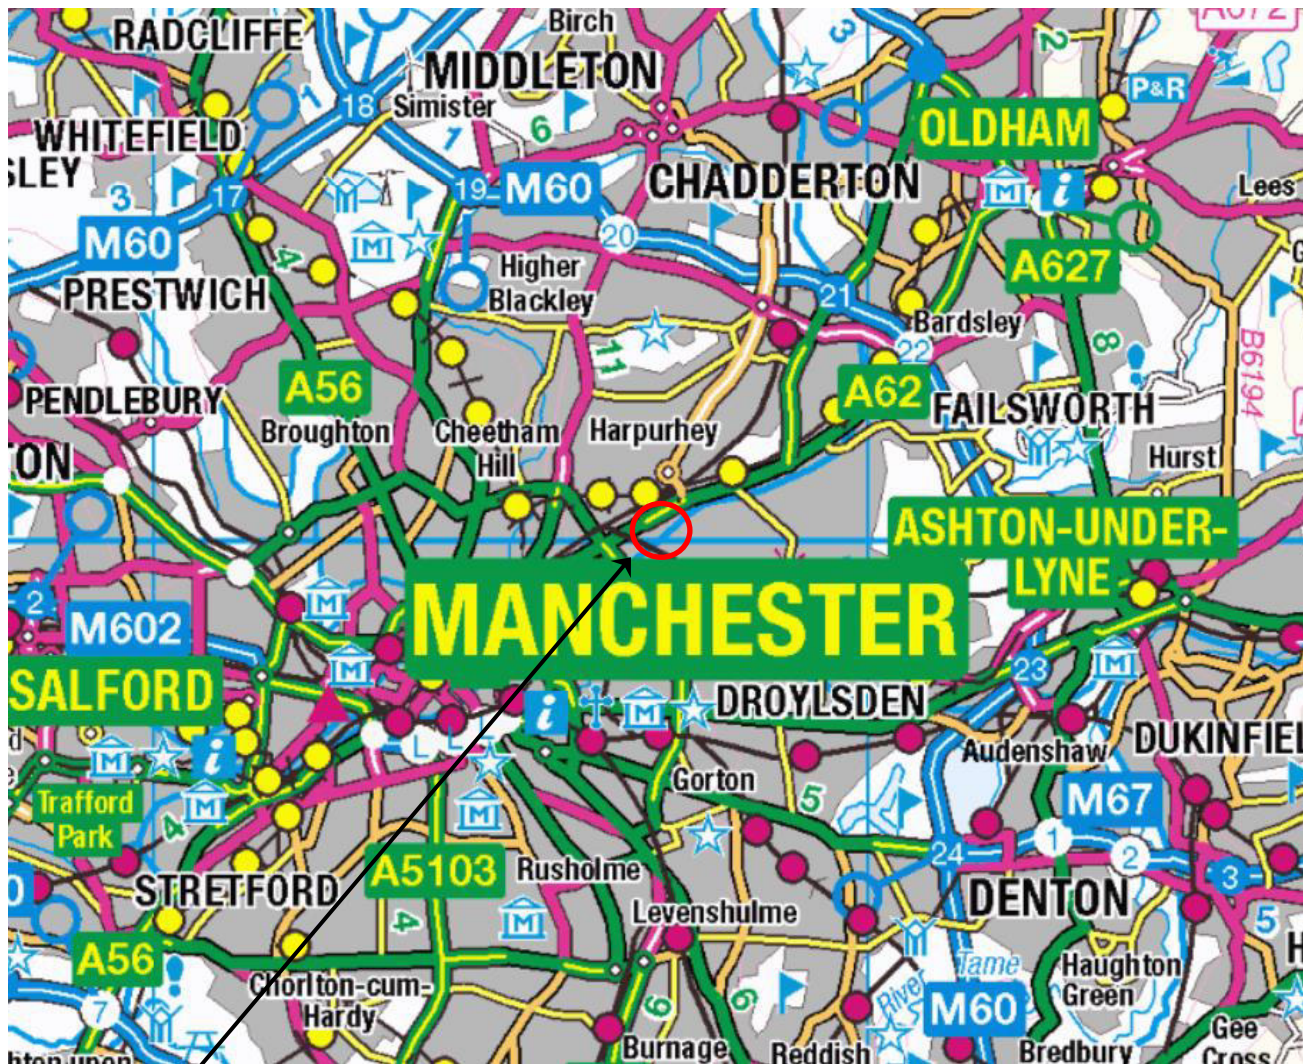
The proposed development is for a commercial end use comprising the redevelopment of three plots of land into commercial light industrial type units, with associated car parking and infrastructure as shown on the proposed site plan, Drawing No. PL-1003 provided to BSL by the client.

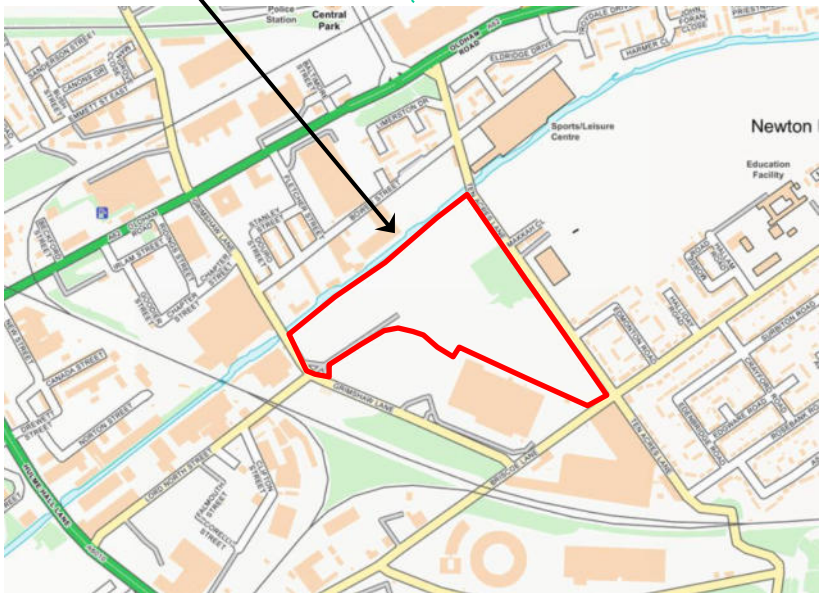
| REV | DATE | DESCRIPTION | BY | CKD |
|---|---|---|---|---|
| DRAWING No.<br><b>C5470/01</b> | REVISION<br><b>-</b> | SCALE<br><b>NTS</b> | DATE<br><b>12/07/23</b> | |

The site is located off Grimshaw Lane, Manchester, M40 2BA. It is situated approximately 3.60km north-east of Manchester City Centre, centred on National Grid Reference 387082, 400076 as shown on the Site Location Plan, Drawing No. C5470/01.
