| Project Name: Vine Street | Project No. 14944 | Co-ords: 389243.00 - 396948.00<br>Level: | Date<br>31/08/2021 |
| Location: Gorton, Manchester | | Dimensions (m):<br>Depth 2.90 | Scale<br>1:30 |
| Client: Ridge and Partners LLP | | | Logged<br>G. Calvert |

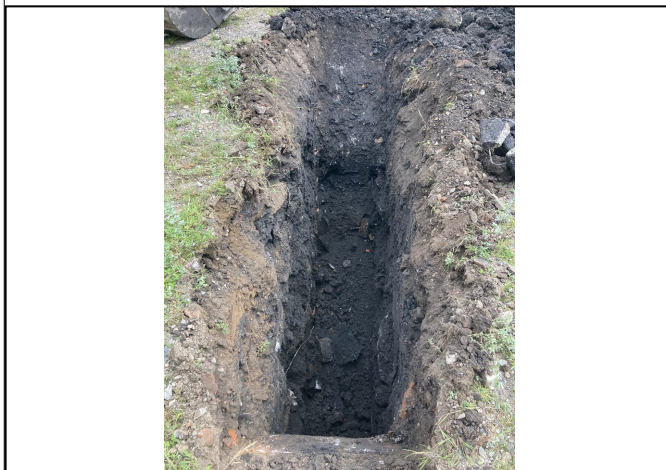
Trial Pit 101

| Water Strike | Samples & In Situ Testing | | | Depth (m) | Level (m) | Legend | Stratum Description | |
|---|---|---|---|---|---|---|---|---|
| | 2.10 | ES | | 2.90 | | | MADE GROUND: Dark brown slightly sandy clay with frequent rootlets. (Topsoil). Gravel is fine to coarse subangular to subrounded of brick, plastic, concrete, mudstone, geotextile, metal wire and timber. Cobbles are angular to subangular of brick and concrete. (Sweet hydrocarbon odour). | 1 |

Remarks: 1. Complete.

Stability: Stable.

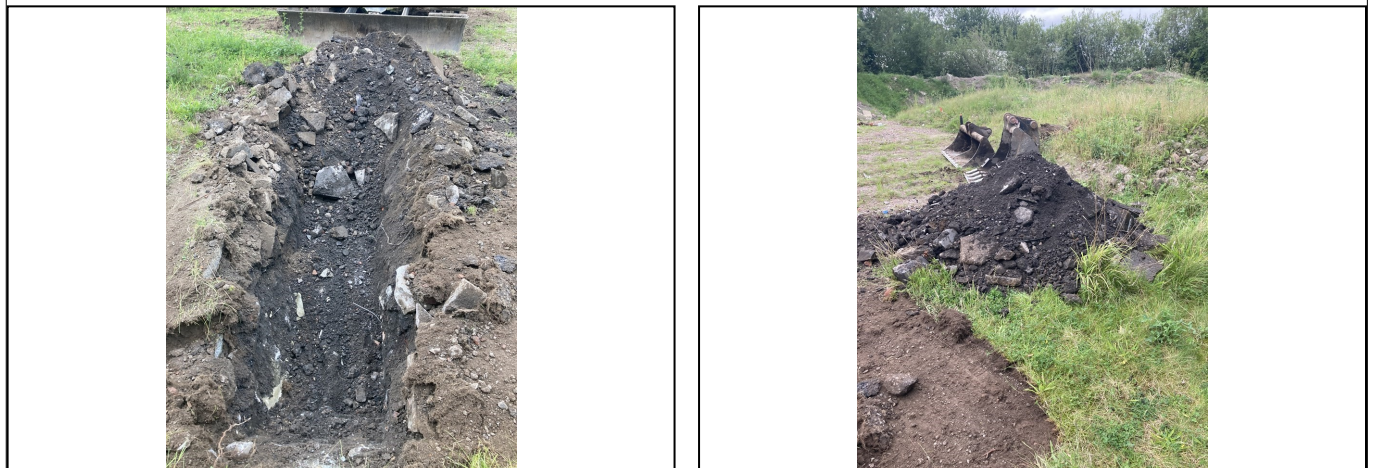
Trial Pit 102

| Water Strike | Samples & In Situ Testing | | | Depth (m) | Level (m) | Legend | Stratum Description | |
|---|---|---|---|---|---|---|---|---|
| | 0.40<br>0.50 | ES<br>L | | 0.70 | | | MADE GROUND: Dark brown slightly sandy gravel with occasional cobbles. Gravel is fine to coarse angular to subrounded of brick, concrete, metal, metal wire and plastic. Cobbles are angular of concrete, brick and paving stone. | |

Remarks: 1. Terminated due to concrete slab.

Stability: Stable.

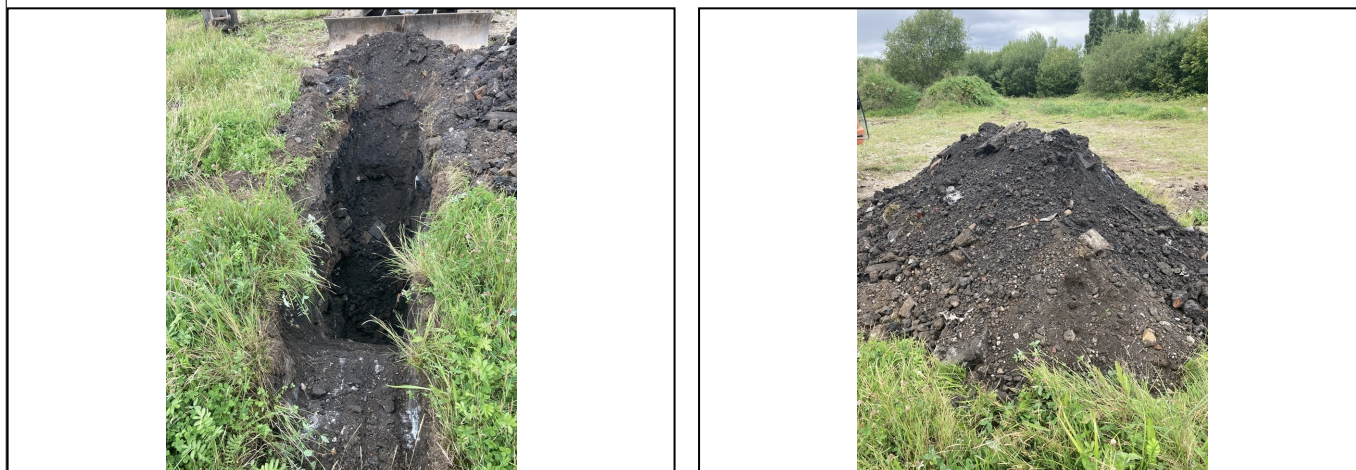
Trial Pit 103

| Water Strike | Samples & In Situ Testing | | | Depth (m) | Level (m) | Legend | Stratum Description | |
|---|---|---|---|---|---|---|---|---|
| | 0.80 | ES | | | | | MADE GROUND: Dark brown sandy gravel with occasional cobbles. Gravel is fine to coarse angular to subrounded of brick, plastic, concrete, mudstone, geotextile, plastic bottles and timber. Cobbles are angular of brick and concrete. | 1 |
| | 2.00 | ES | | | | | MADE GROUND: Black slightly clayey gravel with frequent cobbles. Gravel is fine to coarse angular to subrounded of brick, concrete and rag. Cobbles are angular of brick and concrete. (Strong sweet hydrocarbon odour) | 2 |

Remarks: 1. Complete.

Stability: Stable.

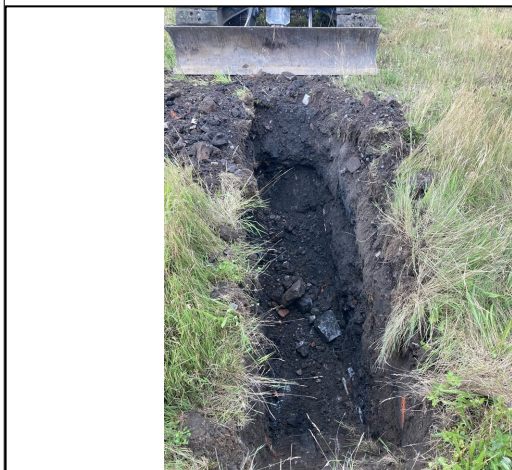
Trial Pit 104

| Water Strike | Samples & In Situ Testing | | | Depth (m) | Level (m) | Legend | Stratum Description | |
|---|---|---|---|---|---|---|---|---|
| | 0.70 | ES | | | | | MADE GROUND: Dark brown gravelly clayey fine to medium sand with rare cobbles. Gravel is fine to coarse angular to subrounded of brick, concrete, mudstone, timber, plastic bags, plastic, metal wire and glass. Cobbles are angular of brick and concrete. (Becoming more gravelly circa 1.50m bgl). | 1 |

Remarks: 1. Terminated due to concrete obstruction. 2. Water strike encountered at 1.20m bgl- slow ingress with an oily sheen. 3. Monitoring well installed. 4. Response zone 1.00-2.00m bgl.

Stability: Stable.

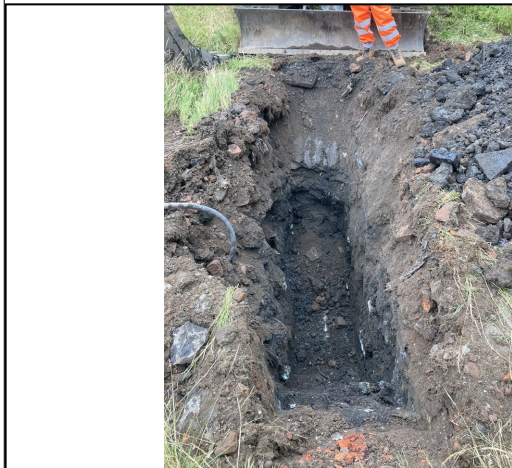
Trial Pit 105

| Water Strike | Samples & In Situ Testing | | | Depth (m) | Level (m) | Legend | Stratum Description | |
|---|---|---|---|---|---|---|---|---|
| | 1.60 | ES | | | | | MADE GROUND: Brown clayey gravelly fine to coarse sand with frequent cobbles. Gravel is fine to coarse angular to subrounded of brick, concrete, plastic, mudstone, sandstone, geotextile, hosepipe and rubber gloves. Cobbles are angular of brick and concrete. (Sweet hydrocarbon odour) | 1 |

Remarks: 1. Terminated due to concrete obstruction. 2. Water strike encountered at 1.80m bgl- see page.

Stability: Stable.

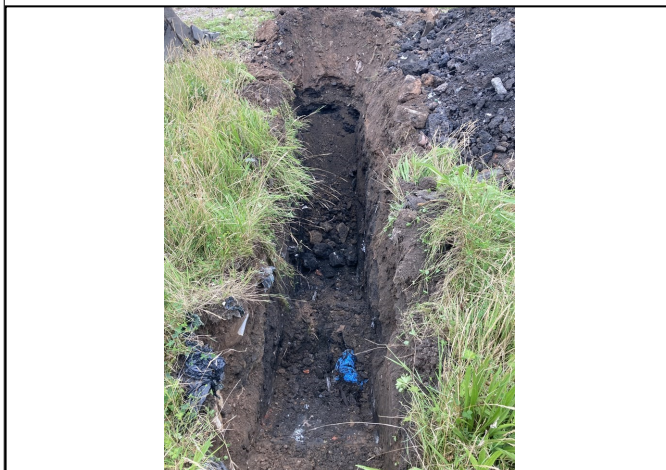
Trial Pit 106

| Water Strike | Samples & In Situ Testing | | | Depth (m) | Level (m) | Legend | Stratum Description | |
|---|---|---|---|---|---|---|---|---|
| | 1.00 | | | 1.00 | | | MADE GROUND: Black clayey slightly gravelly fine to coarse sand. Gravel is fine to coarse angular to subangular of brick, plastic bags, foam, metal wire, paper, concrete and cans. Cobbles are angular of brick and concrete. (Hydrocarbon odour). | 1 |

Remarks: 1. Terminated due to concrete obstruction.

Stability: Unstable.

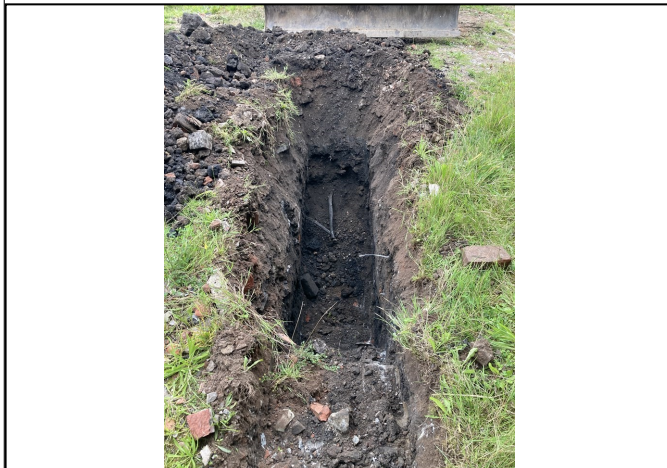
Trial Pit 107

| Water Strike | Samples & In Situ Testing | | | Depth (m) | Level (m) | Legend | Stratum Description | |
|---|---|---|---|---|---|---|---|---|
| | | | | 0.80 | | | MADE GROUND: Dark brown sandy gravel with frequent cobbles. Gravel is fine to coarse angular to subrounded of ceramic, concrete, brick, plastic and geotextile. Cobbles are angular of brick and concrete. | 1 |

Remarks: 1. Terminated due to concrete obstruction.

Stability: Stable.

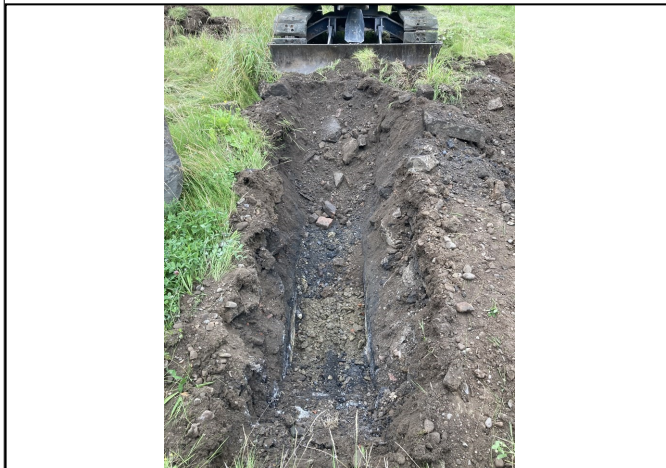
Trial Pit 108

| Water Strike | Samples & In Situ Testing | | | Depth (m) | Level (m) | Legend | Stratum Description | |
|---|---|---|---|---|---|---|---|---|
| | 0.50 | ES | | 0.10 | | | MADE GROUND: Brown slightly clayey gravelly medium to coarse sand. Gravel is fine to medium angular to subrounded of brick and mudstone with frequent rootlets. (Topsoil)<br>MADE GROUND: Dark brown very sandy gravel with occasional cobbles. Gravel is fine to coarse angular to subrounded of brick, mudstone, sandstone, clinker, ash, geotextile and plastic. Cobbles are angular of brick and concrete. | 1 |

Remarks: 1. Terminated due to concrete obstruction.

Stability: Stable.
