86 Princess St

Facade Repairs

Stone Repair Details

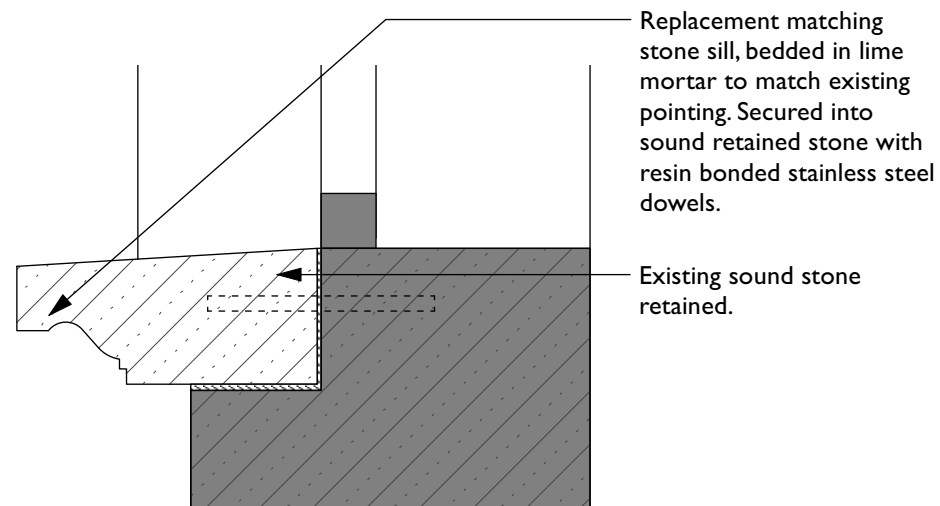
1 Typical Stone Reinstatement Detail  
Scale: 1:10

Replacement matching stone sill, bedded in lime mortar to match existing pointing. Secured into sound retained stone with resin bonded stainless steel dowels.

Existing sound stone retained.

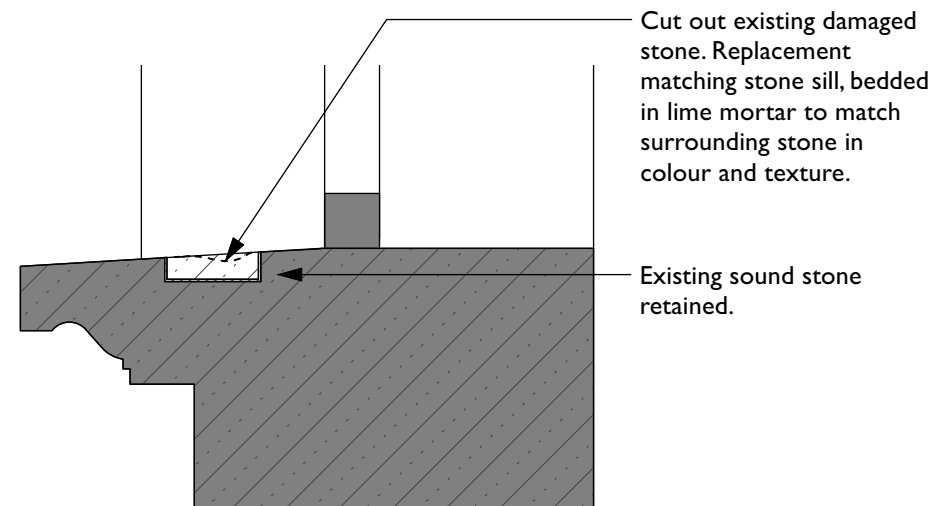
2 Typical Stone Reinstatement Detail  
Scale: 1:10

Cut out existing damaged stone. Replacement matching stone sill, bedded in lime mortar to match surrounding stone in colour and texture.

Existing sound stone retained.

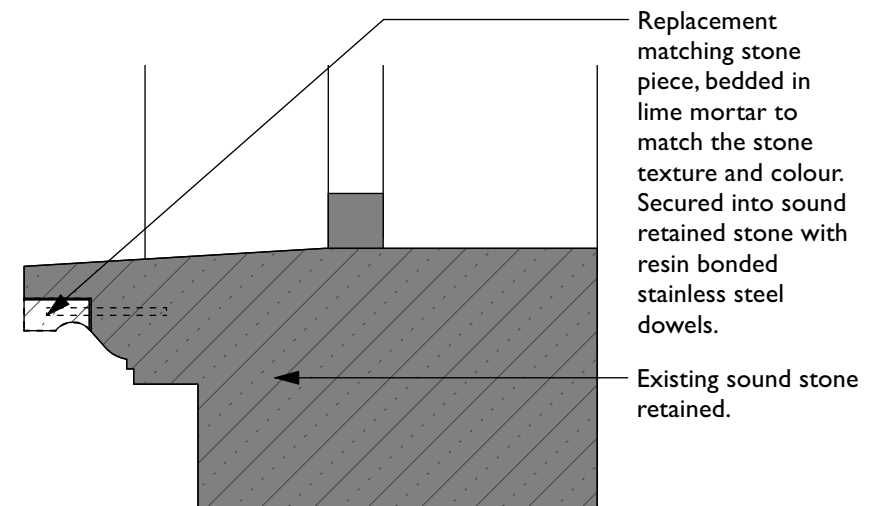
3 Typical Stone Reinstatement Detail  
Scale: 1:10

Replacement matching stone piece, bedded in lime mortar to match the stone texture and colour. Secured into sound retained stone with resin bonded stainless steel dowels.

Existing sound stone retained.
