## Victoria House

### Facade - Typical Bat and Bird box

22017-BWT-ZZ-XX-DR-Y-0073

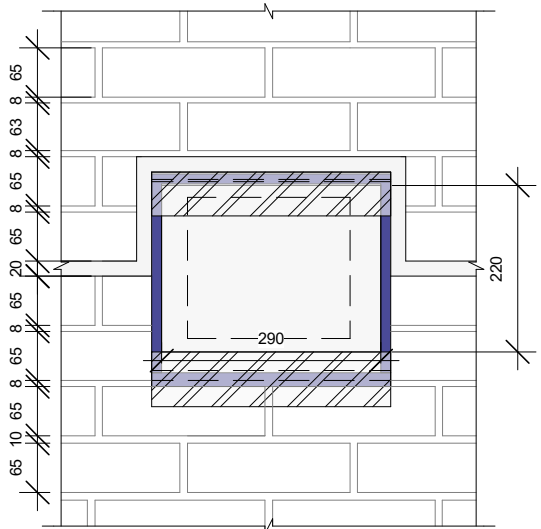
Typical Detail\_A\_Vertical  
1:5

- No cavities to be allowed during insulation installation
