# Pell Frischmann

Longhurst Road, Blackley

Geotechnical Interpretative Report

Report Ref: 106240-PEL-GEN-XX-RP-D-0002

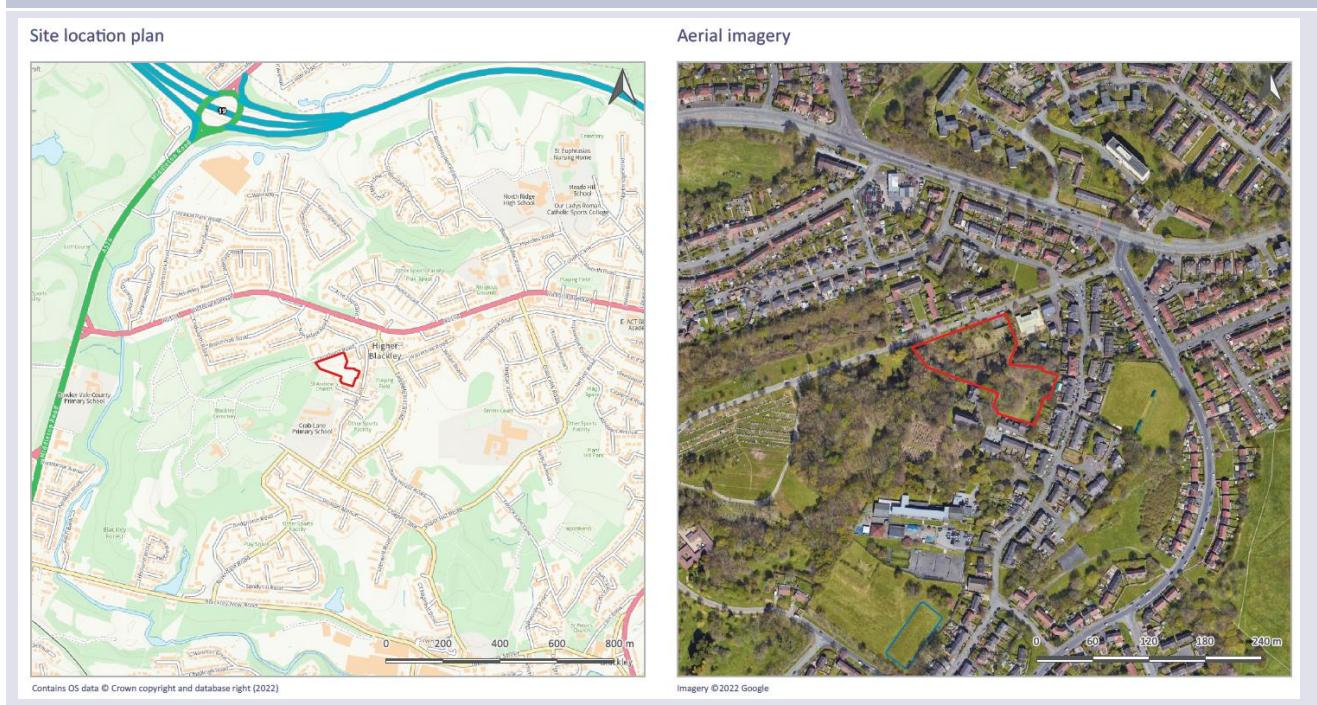
**Figure 1: Site Location Plan**

The site of the proposed development is located approximately 6.0km north of the Manchester City Centre along Longhurst Road, the site is currently unoccupied and located at approximate postal address M9 8NS. For this report, the bounds of the development area, hereafter referred to as 'site' are as shown in **Figure 1** below:

The site is irregular in shape, approximately 0.82 Ha and is located south of Longhurst Road, in Upper Blackley at grid references 384800, 403930. The site is level over the hardstanding area in the north eastern section, and then slopes from approx. 89.0mOD to 98.9mOD at the south eastern edge of the site. The north-eastern portion of the site comprises an area of level hardstanding bound by an existing concrete retaining wall (approx. 2.0m in height). The remainder of the site is currently grassed and undeveloped with medium to dense vegetation. The approximate locations of existing retaining walls on site are shown in **Figure 2**, the extents of these have been determined from survey information and aerial mapping, both walls are described as brick, the central wall (outlined in green) retains up to 1.5m in height, and the western boundary wall (outlined in blue) height was not determined as part of the topographic survey.

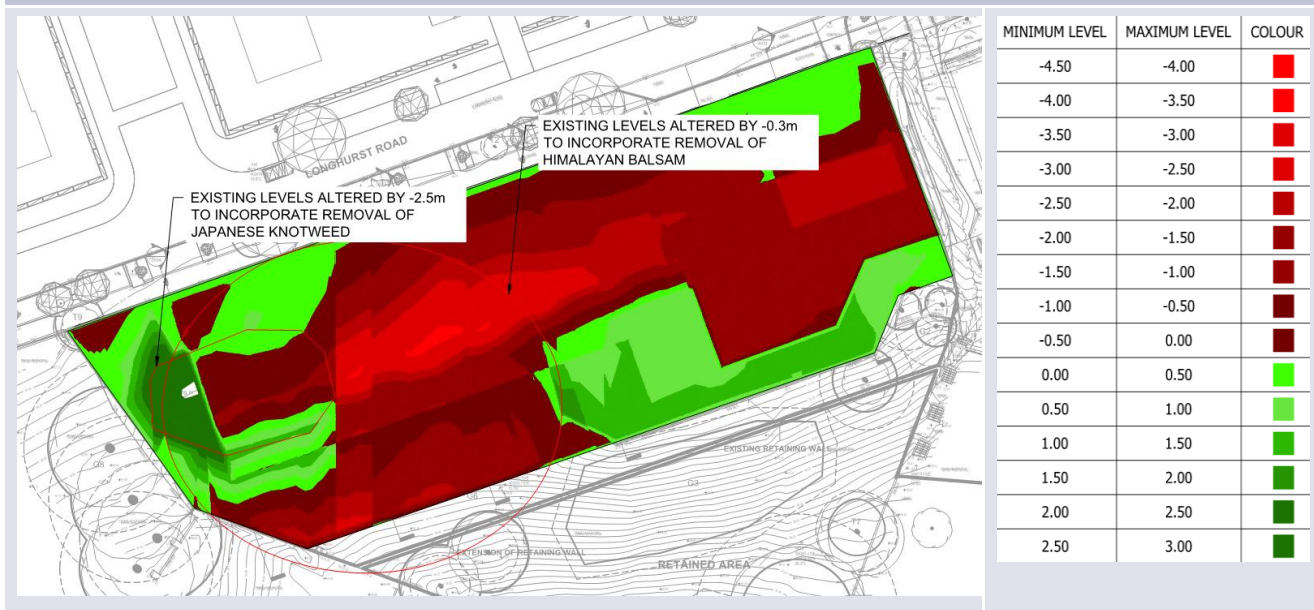
Figure 3: Proposed Cut and Fill

The proposed development comprises construction of 9 No. blocks of new residential dwellings which are up to three storeys in height built into the existing slope. To provide level platforms, the associated earthworks includes up to 4.5m of cut across the central portion of the site, and nominal filling (0.5m to 1.0m) across the central southern portion, the proposed cut and fill levels are shown in **Figure 3**.

The proposed site development comprises construction of a single level basement into the existing slope (refer **Figure 3**). This will require excavation of up to 4.5m in isolated areas, but generally 2.5m to 3.5m over the site. This excavation unloading will result in immediate heave as a result of elastic response to the unloading and will occur immediately during excavation and therefore will not affect the proposed structures. Long term heave will also occur in cohesive soil associated with the long term response of the soil to the change in effective stress. The shallow foundation design will need to consider the long term unloading pressure in the design of shallow footings to ensure ground movement (heave or settlement) does not affect the proposed structure significantly. Where the floor slabs are suspended over strip or pad foundations, void formers should be incorporated to prevent the effects of unloading heave on the floor slabs.

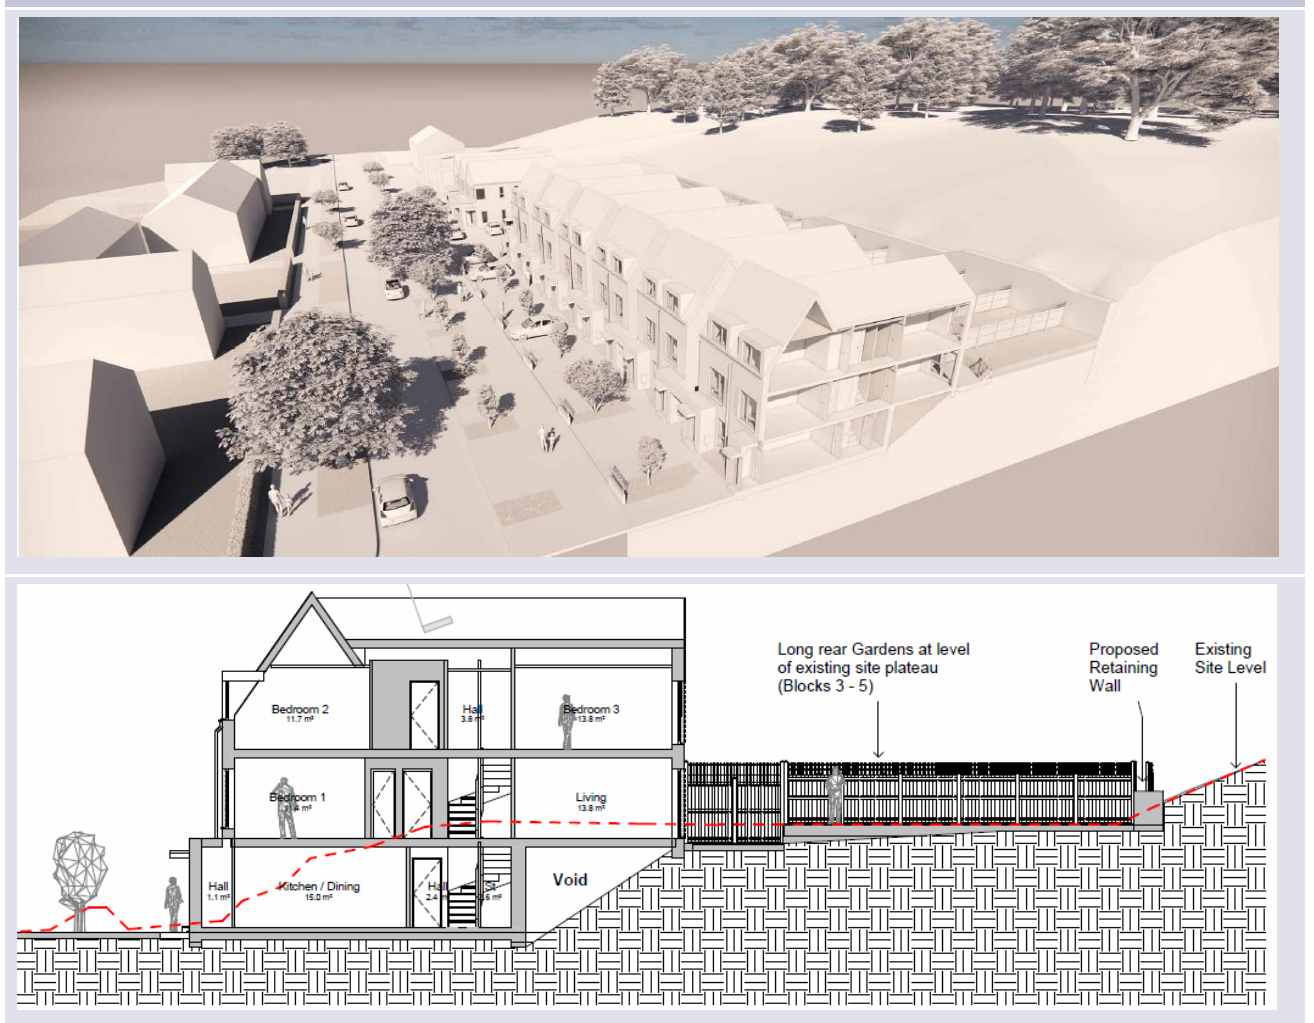
Figure 4: Architectural Render of Proposed Development (Bowker Sadler Architecture)

Architectural images of the proposed development are shown below in **Figure 4**, which shows how the structures are proposed to be constructed into the existing slope, no basement wall is shown instead a void with a permanent slope is proposed.

The upper level tiered area is proposed to be garden planting areas, and therefore is not anticipated to comprise anything that structurally will be affected by soil volume change. But as shown on **Figure 4**, the foundation for the upper section of blocks spanning over the void cut slope will be founded at the upper level, and therefore the foundation design will need to consider the minimum foundation depths as per **Table 13**, subject to detailed design of the foundations.

Cut slopes are proposed at the back of the housing units as shown in **Figure 4**, based on the lower floor levels of 86.5mOD and upper terrace levels of approximately 91.0mOD, the cut slope will be approximately 4.5m in height. Current proposals show this cut face at an angle of 1V:1H, which is unlikely to be stable long term, based on descriptions of soils strengths a cut slope angle of 1V:2.5H is recommended for long term with appropriate slope drainage as described below.

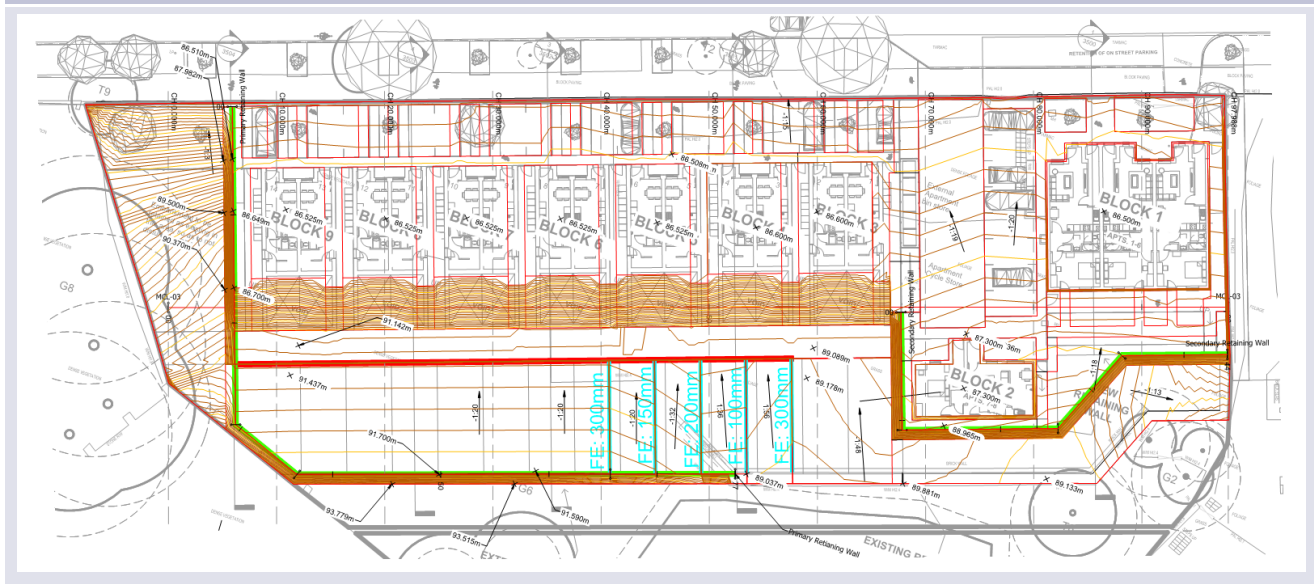
### Figure 5: Proposed Block Layouts

The finished floor level at Longhurst Road varies between 86.5mOD and 86.6mOD, with the 7 No. western blocks separated by a paved parking area in the north western portion of the site. Block 2 is situated on the upslope terrace at a finished floor elevation of 87.30mOD. The existing central retaining wall will be extended by a new retaining wall running further west to the site boundary (shown as *Primary Retaining Wall* in light green on **Figure 5**) which up to 2.10m of soil when running east to west, then returns back to the level of Longhurst Road, retaining up to 3.70m along this section where the existing soil is retained to avoid disturbing the Root Protection Area of adjacent trees. A secondary retaining wall runs from the eastern corner of the site to behind Block 2 (shown as *Secondary Retaining Wall* in light green) retaining up to 2.0m.

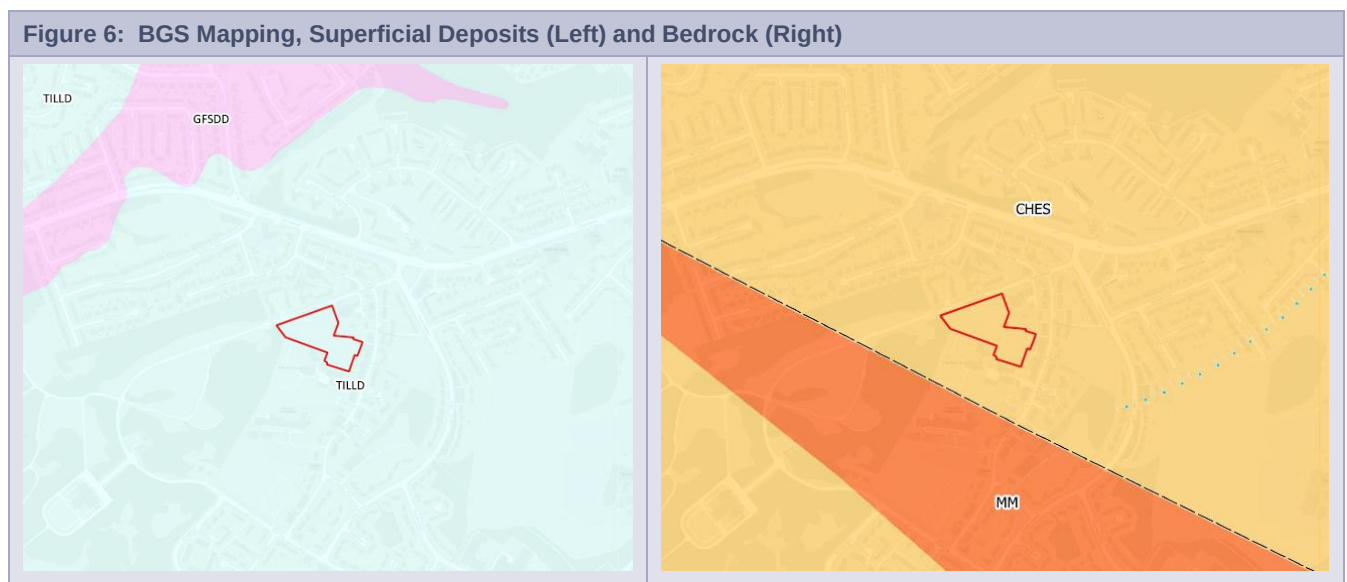
BGS mapping indicates the site is underlain by Glacial Till Deposits (TILLD) superficial deposits, and Chester Formation (CHES) bedrock as shown in **Figure 6**. Outside of the site extents mapped are Glaciofluvial Sheet Deposits (GFSD) and Manchester Marls Formation (MM).

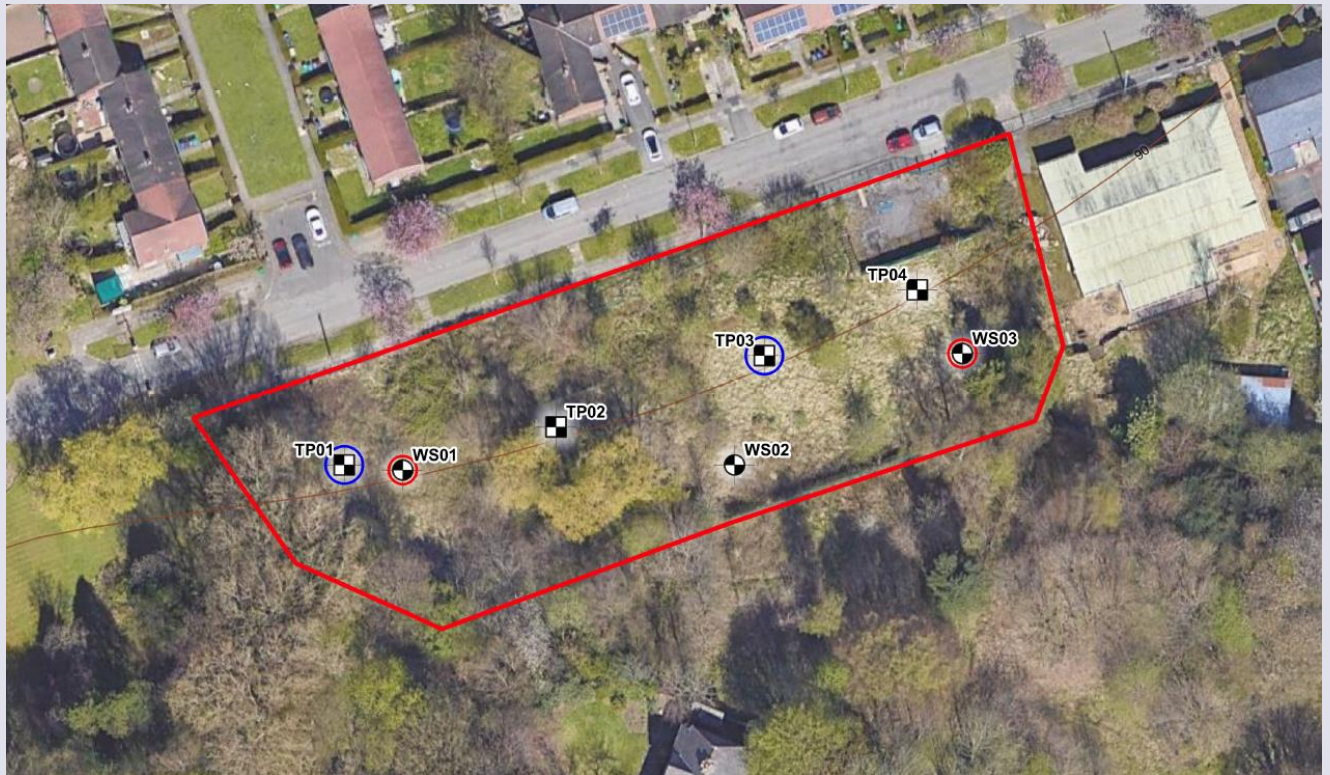
**Figure 7: Soiltechnics Exploratory Location Plan**

The locations of the completed exploratory holes are shown in **Figure 7** below.

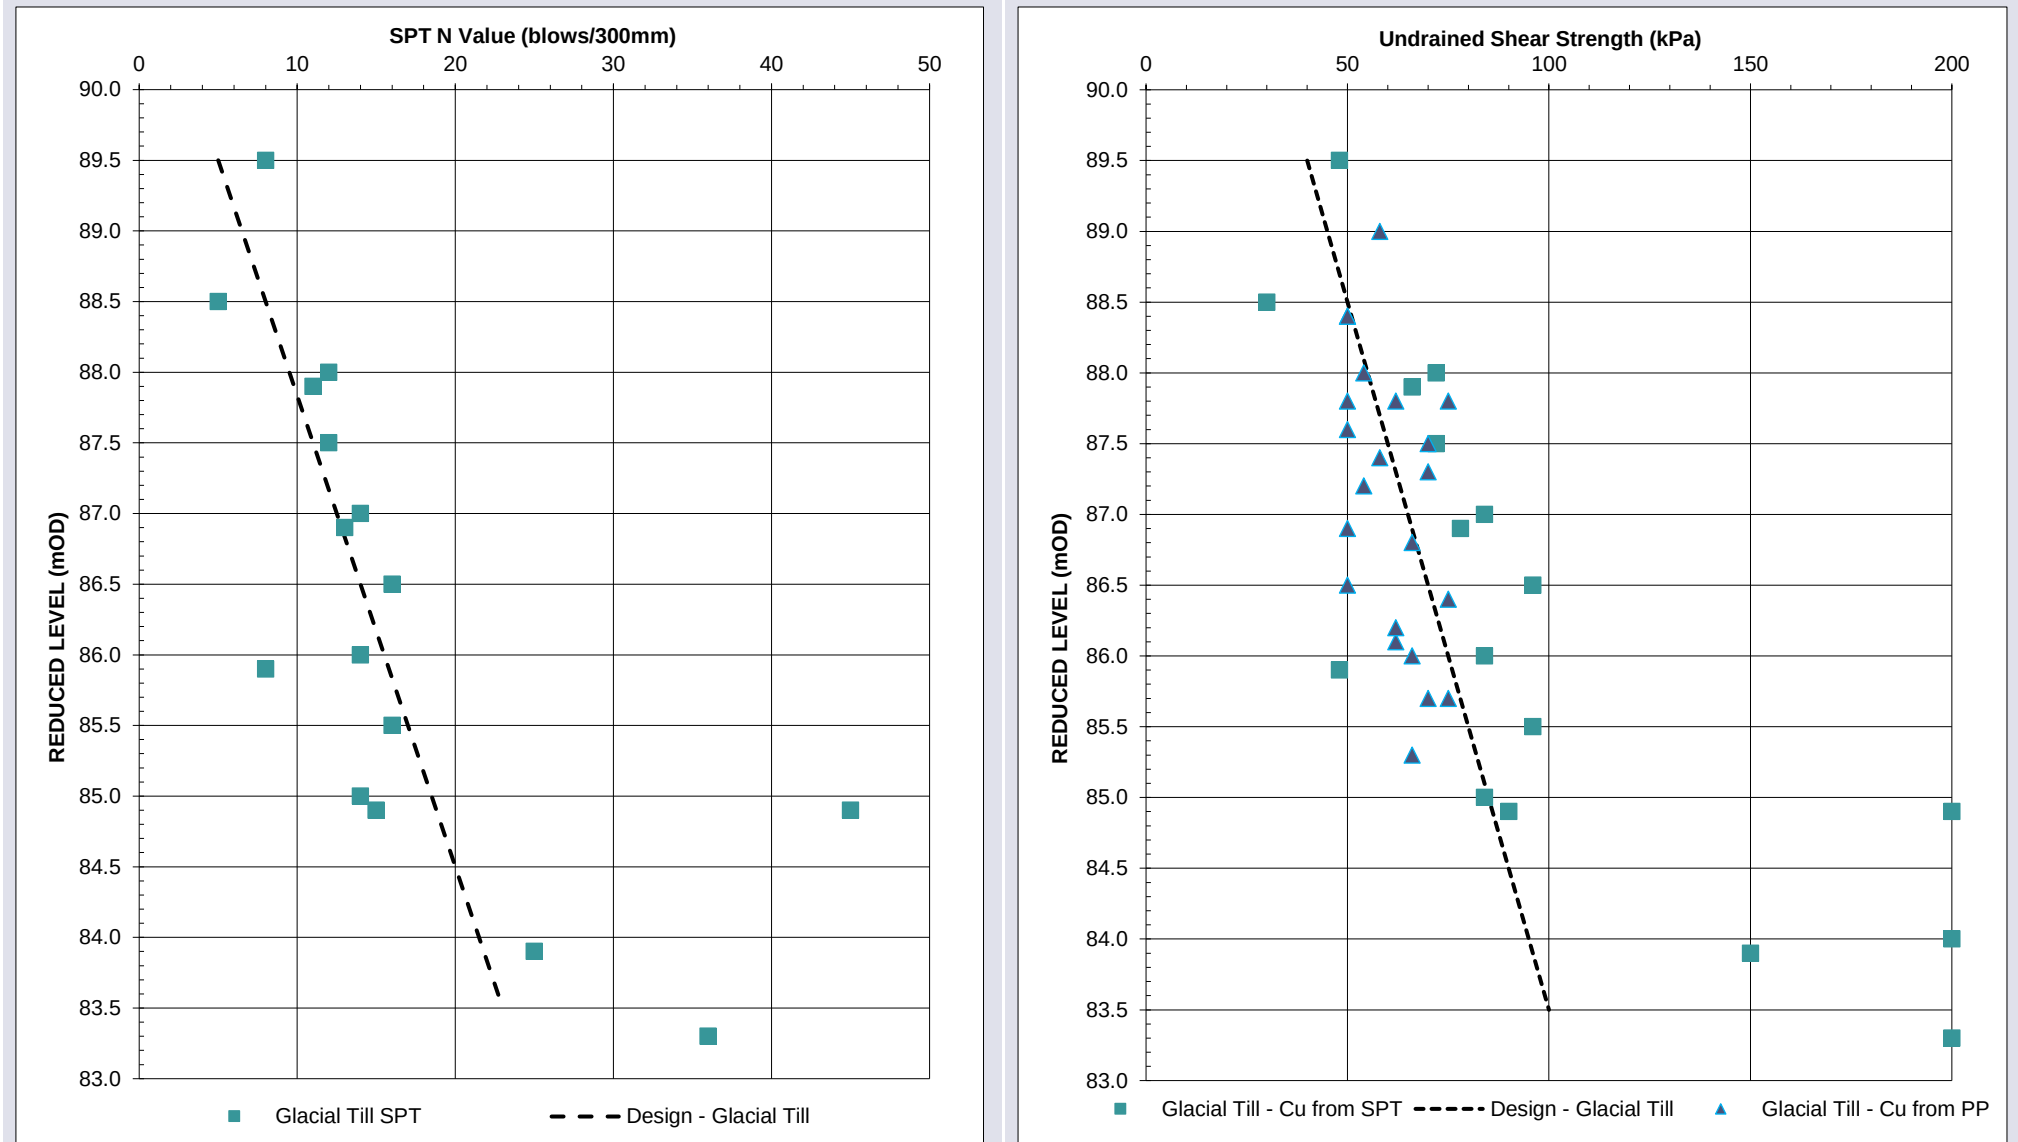
Figure 8: Glacial Till - SPT Test Results (Left) and Undrained Shear Strength (Right)

For low plasticity glacial tills, the undrained shear strength is closely related to the moisture content of the material (CIRIA 504). Strength testing of on remoulded specimens of Glacial Till at varying water contents predicted undrained shear strengths of approximately 100 kN/m<sup>2</sup> for a moisture content of 18 %, which is generally consistent with the undrained shear strength profiles derived from the in-situ testing.

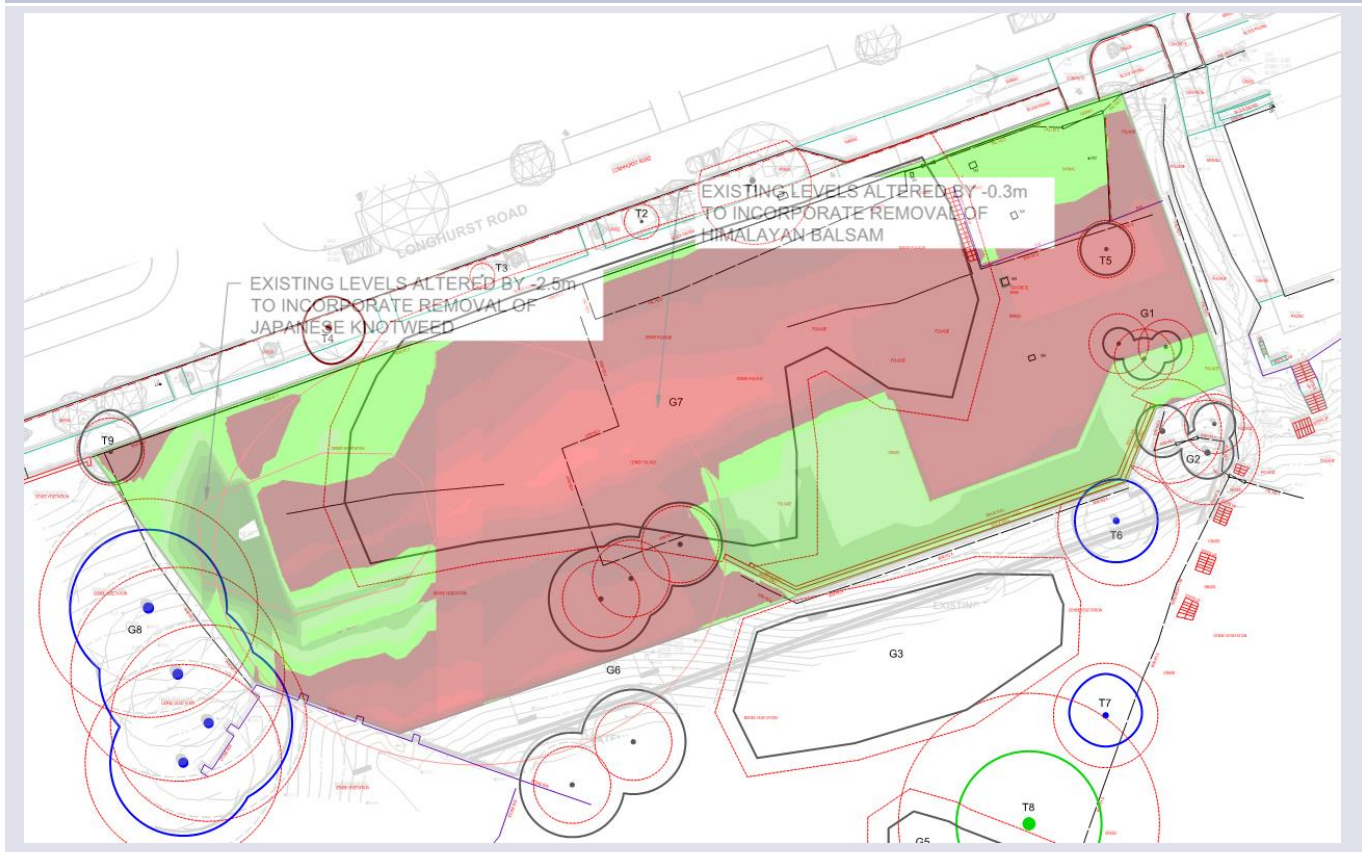
**Figure 9: Tree and Excavation Plan**

The existing vegetation will be removed as part of the site clearance, and therefore there is a risk of volume change occurring as a result of moisture change within the soil zones affected by the tree roots. As excavation is occurring across the site where the proposed floor slabs are located it is considered likely that the soil zone affected by the moisture change from the vegetation will be excavated and therefore will not affect the foundations. A tree survey was undertaken by Mulberry Tree Management (MTM), and the plan is shown on Drawing BS5837 and a snapshot shown below in **Figure 9** with the excavation and filling plan from **Figure 3** overlain.

This shows that within the footprint of the proposed structures, tree zones G1, G6, G7 and T5 will be present.

For the lower level of structural foundations (Longhurst Road level), the excavation levels shown in **Figure 9** indicates that the excavation is greater than the required minimum foundation depth as per **Table 13**, and therefore the affected soil zone will be excavated as part of the site works.

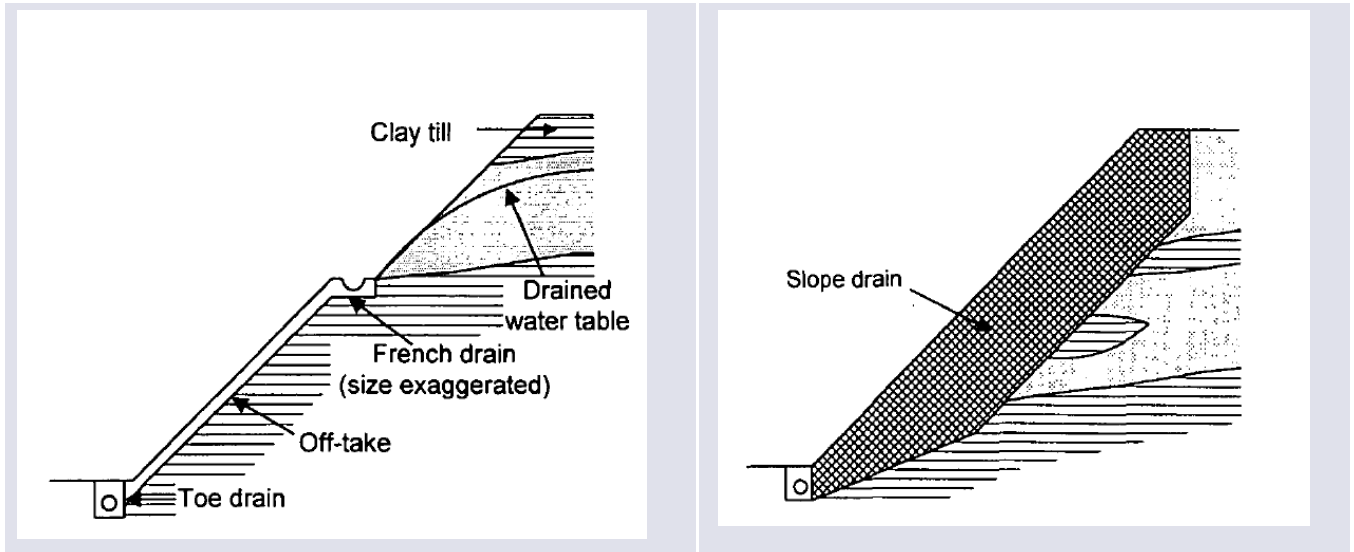
**Figure 10: Cut Slope Drainage in Glacial Till as per Ciria 504**

Glacial Tills can be a mixture of predominately cohesive material that is relatively impermeable, with layers of granular material (sands and gravels) that can be water bearing. Therefore, a key consideration of cut slopes is incorporating drainage into cut slopes where granular material is encountered to prevent shallow failures from occurring. The sketches below in **Figure 10** show possible drain layouts where granular till is encountered. Toe drainage should be provided at the toe of the cut slope in the void behind the houses to prevent water ponding.

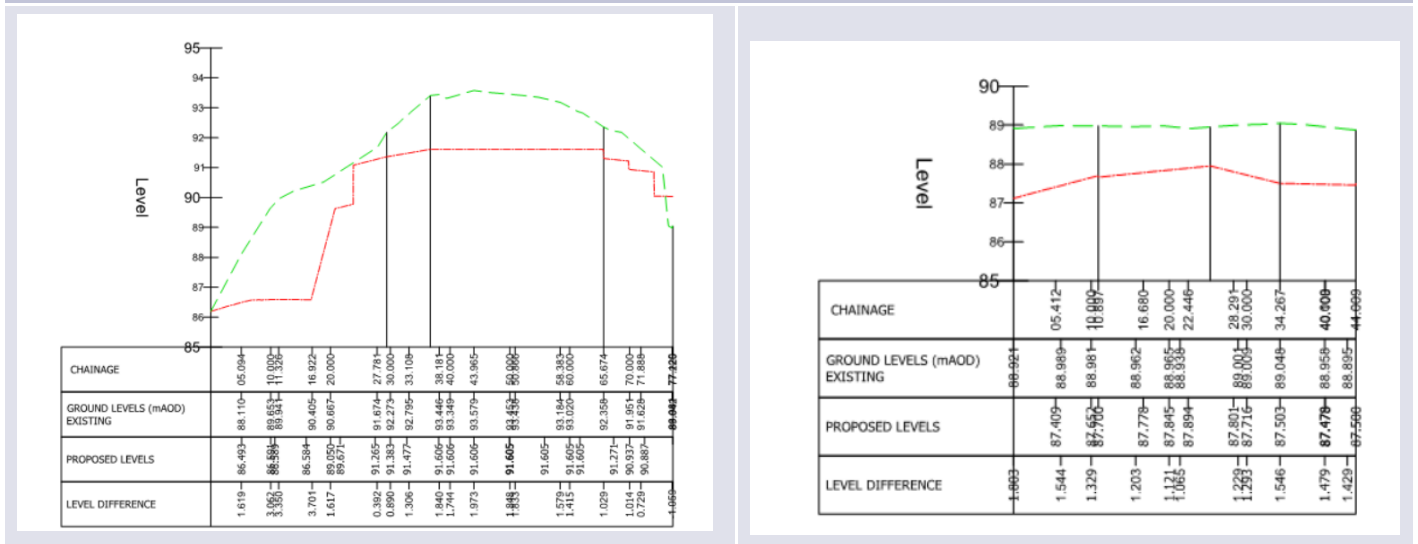
Figure 11: Proposed Retaining Wall Elevations, Primary (Left) and Secondary (Right)

- Maximum retained height of 3.70m, a total required pile length of 10.5m. As the highest retained height is over a relatively short section of wall, waler beams could be used to share the load to the shorter sections of wall and reduce the required post size and length.
- Maximum retained height of 2.50m, a total required pile length of 7.5m.
- Sheet Pile Wall: A sheet piled wall uses driven steel sheets to create a cantilevered retaining wall. The required embedment depth would be similar to that of a King Post Wall, but would be installed with pile driving equipment rather than a bored pile.
- Gravity Wall: A gravity wall constructed of reinforced concrete could be installed for heights up to 2.5m, however where the retained height exceeds 3.0m, a gravity wall base width required may make the wall uneconomical to construct.
