LIVERPOOL ROAD  
MANCHESTER

*LEVEL 03 PLAN*

LRH - REN - XX - 03 - DR - S - 01130 - P03

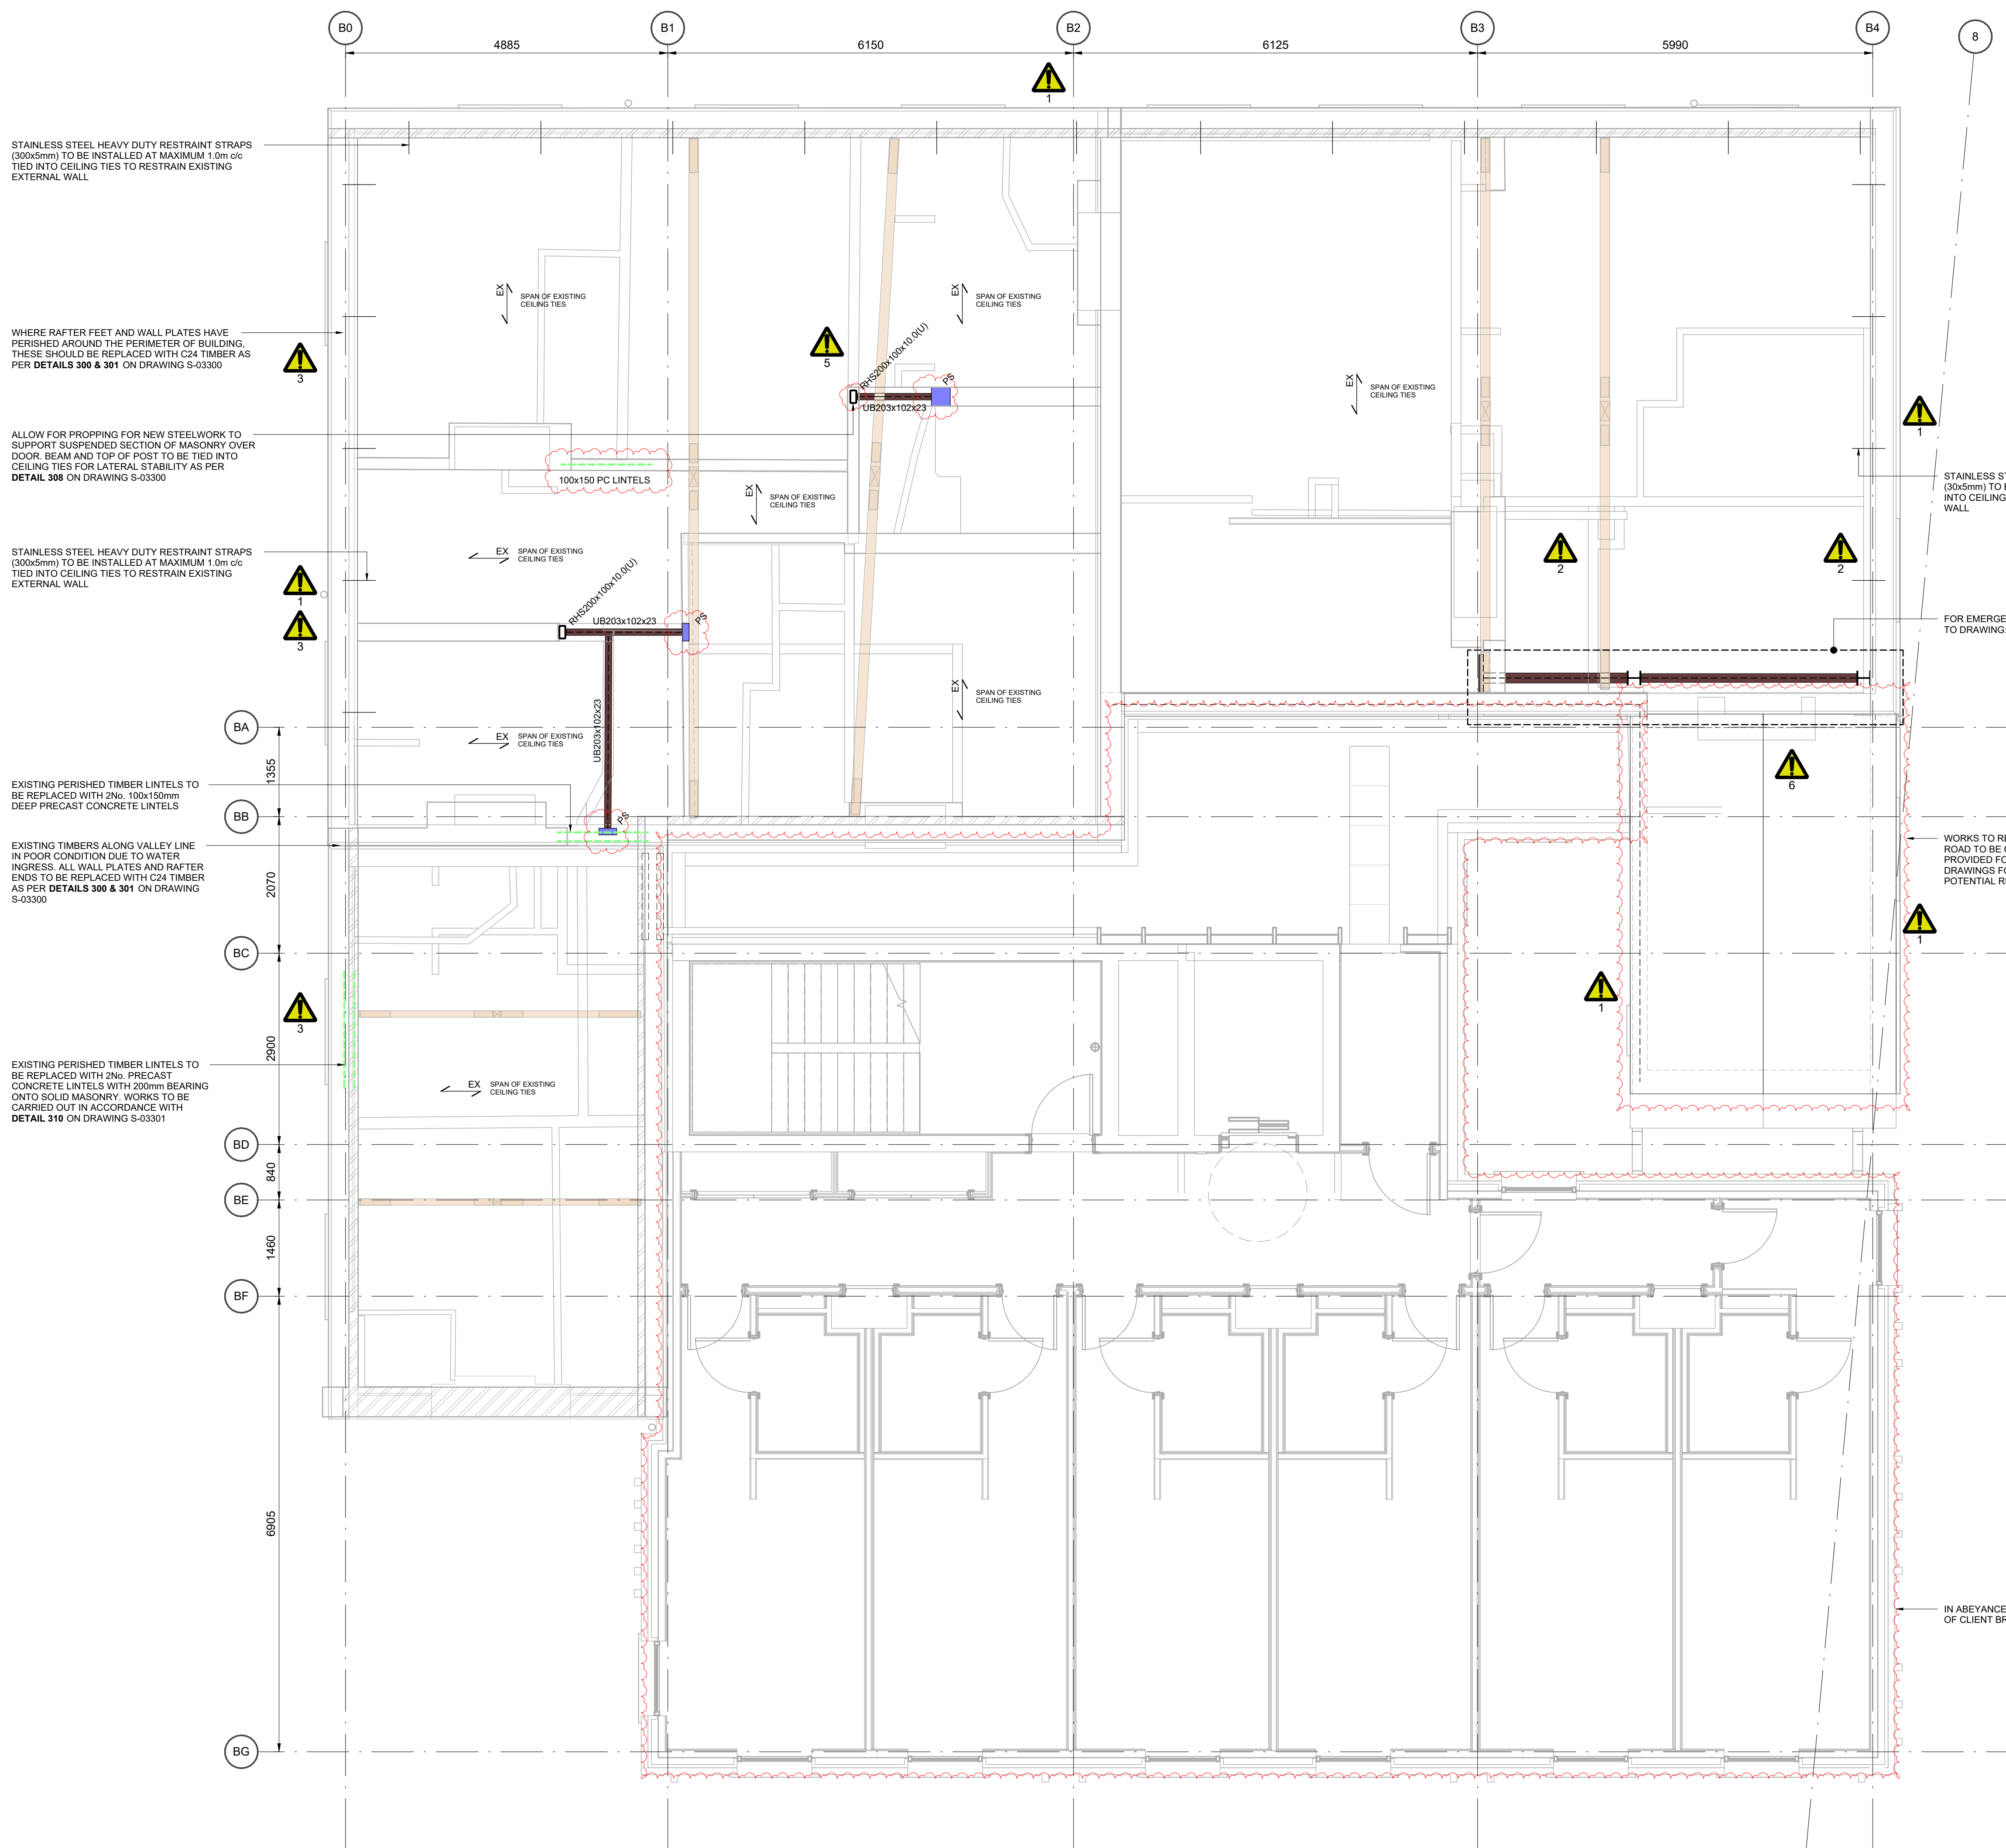
- 1 EXISTING PERIMETER WALLS MAY BECOME UNSTABLE DURING ROOF TIMBER REPAIR WORKS. THE MAIN CONTRACTOR IS TO ALLOW FOR TEMPORARY PROPPIING IF REQUIRED. CONSIDERING DESIGNING LCAFFING TO PROVIDE LATERAL SUPPORT TO THE TOP LEVEL OF WALLS IF REQUIRED.

- 2 EXISTING GABLE WALL TO NO 123 IS PARTIALLY UNRESTRAINED ALONG OLD MIDDLECOT STREET AND THE INTERNAL WALL TO STAIRS IS UNSTABLE. ALLOW FOR INSTALLATION OF EMERGENCY REMEDIAL WORKS PRIOR TO COMMENCING GENERAL REPAIR AND ALTERATION WORKS TO NO 123

- 3 EXISTING GABLE WALL TO NO 126 ALONG WODLAM PLACE IS BOWED AND RETAINED BY HISTORIC REMEDIAL TIES. INSTALLATION OF FLOOR STRENGTHENING WORKS, INCLUDING NEW TIES AND DIAPHRAGM FLOOR IS TO BE UNDERTAKEN ON A ROOM BY ROOM BASIS AND ONE FLOOR AT A TIME TO PREVENT DESTABILISING WALL

- 4 PERIMETER WALLS ARE STABILISED BY THE EXISTING FLOOR ACTING AS A DIAPHRAGM. TO PREVENT DESTABILISING EXISTING WALLS ALL FLOOR STRENGTHENING WORKS INCLUDING NEW TIES AND DIAPHRAGM FLOOR IS TO BE UNDERTAKEN ON A ROOM BY ROOM BASIS

- 5 LOAD BEARING INTERNAL WALL HAS BEEN HISTORICALLY ALTERED WITH WALL ABOVE SUPPORT ON DOOR FRAME AND POOR QUALITY POST. MAIN CONTRACTOR TO PROVIDE TEMPORARY PROPPIING AND RESTRAINT TO ALLOW INSTALLATION OF NEW SUPPORT FRAME

- 6 EXISTING OUTRIGGER TO REAR OF NO 123 IS IN A POOR STATE OF REPAIR WITH AREAS OF PARTIAL COLLAPSE AND TEMPORARY PROPPIING. FOLLOWING INSTALLATION OF EMERGENCY AND INFILTRATION WORKS TO REAR OF NO 123, MAIN CONTRACTOR IS TO ALLOW FOR INSPECTION TO DETERMINE REMEDIAL WORKS REQUIRED

| WP | INDICATES 150x150x15 RSA (33.9kg/m) WINDPOST TO BE INSTALLED PRIOR TO FORMING NEW OPENING. POSTS FIXED TO FLOOR JOISTS ABOVE AND BELOW. WALL TIED TO POST WITH M12 G8.8 STAINLESS A4 ANCHORS AT MAX 400c/c WITH MINIMUM 150mm EMBEDMENT INTO SOLID MASONRY AND FIXED WITH R-KEM II RESIN |
| PS | INDICATES 440mm LONG x 215mm DEEP (WIDTH TO SUIT EXISTING WALL) CONCRETE PADSTONE TO PROVIDE MINIMUM 100mm BEARING FOR NEW STEEL BEAMS |

EXISTING CEILING TIES TO BE SUPPORTED BY TIMBER BINDERS @  
MAXIMUM 1.4m SPACING HUNG FROM PURLINS WITH HANGERS @  
MAXIMUM 2.0m c/c THROUGHOUT EXISTING BUILDING. WHERE  
BINDERS OR HANGERS ARE MISSING, THESE SHOULD BE  
REINSTATED IN LINE WITH **DETAILS 305 TO 307** ON DRAWING LRH-  
REN-XX-XX-DR-S-03300
