University of Manchester  
Samuel Alexander Building, Oxford Road,  
M13 9PL – Sump pump enclosure

Heritage Statement Supporting an application for  
Planning Consent

Ref: PN8232.02

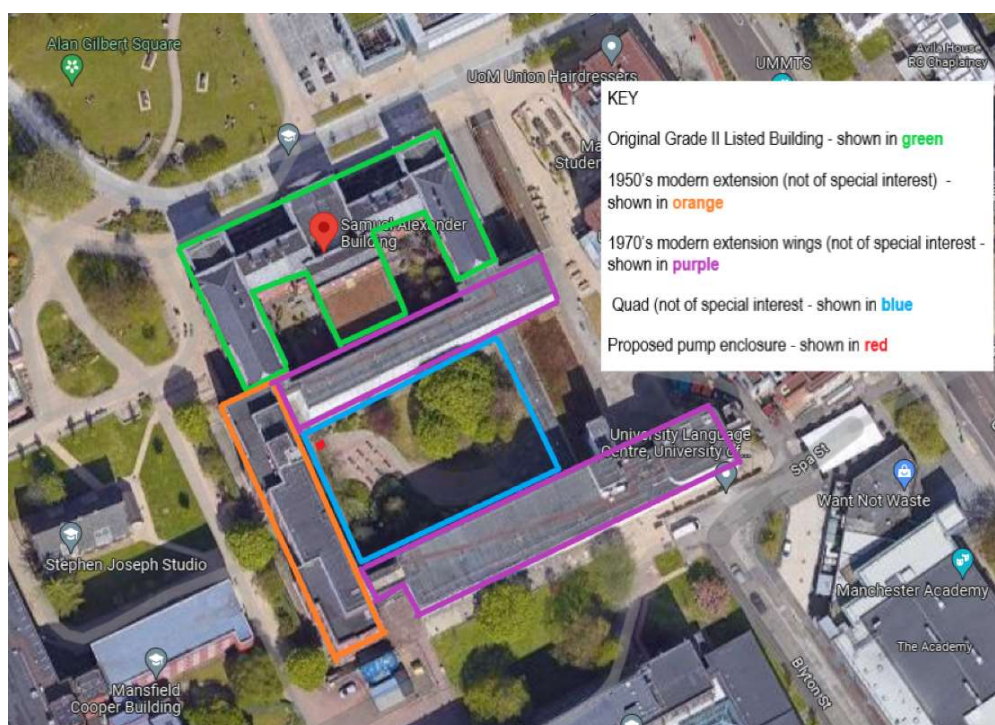
The current site layout of Samuel Alexander Building is illustrated below in Figure 1. The original Grade II Listed Building is shown in green, the 1950's modern extension (not of special interest) is shown in orange, the 1970's modern extension wings (not of special interest) are shown in purple, the quad is shown in blue, and the location of the proposed pump enclosure is shown in red.

Figure 1: Site plan showing parts of the building with heritage value and those which are 'not of special interest'.

The layout of Samuel Alexander Building is illustrated above in Figure 1. The original Grade II Listed Building is shown in green, the 1950's modern extension (not of special interest) is shown in orange, the 1970's modern extension wings (not of special interest) are shown in purple, the quad is shown in blue, and the location of the proposed pump enclosure is shown in red.

The proposed siting has the least impact to the setting and its immediate surroundings as it is surrounded by the modern extensions that are not of special interest according to Historic England. The modern extensions were later added in the 1950's and 1970's. The 1950's west extension is not of special interest. The two c.1970 ranges which run eastwards from the west extension and are linked on the east side by a covered corridor are also not of special interest. The modern extensions are what have formed and surround the quadrangle which is not of special interest. See Figure 1 for an annotated site plan which captures the original Grade II Listed Building shown in green, the 1950's modern extension (not of special interest) shown in orange, the 1970's modern extension wings (not of special interest) shown in purple, the quadrangle shown in blue, and the location of the proposed pump enclosure shown in red.
