86 Princess St

Water Ingress

Repair Proposals 1 of 2

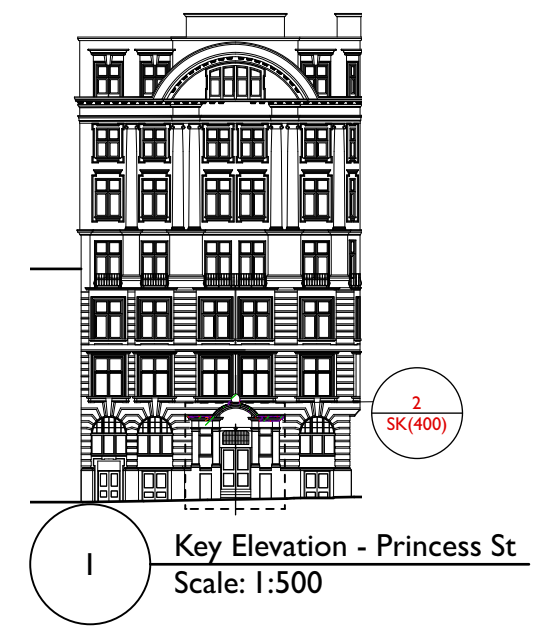
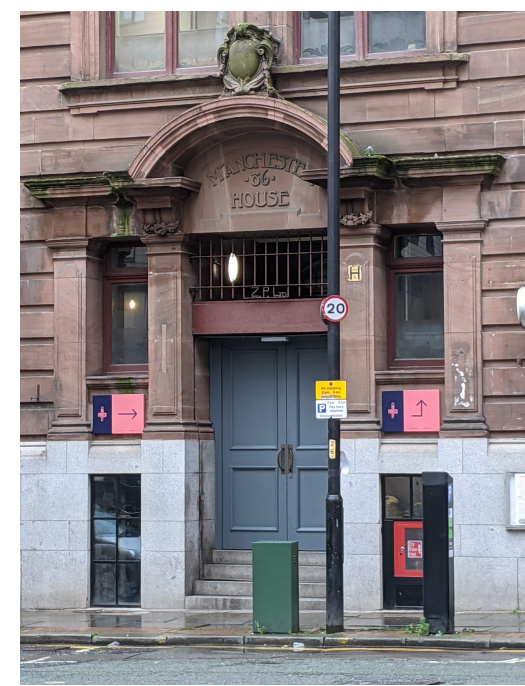
2 Localised Elevation - Doorway 1  
Scale: 1:50

- Localised redressing of loose and friable stone
- Replace 2 no. side pieces to cartouche plinth - take profile from un-eroded areas to ensure new profile matches the existing.
- New code 6 lead flashing - installed in accordance with LSTA recommendations, and where deviates as agreed with Conservation Officer on site, in accordance with specialist subcontract recommendations.
