# Renaker - Plot D

## Flood Risk Assessment and Drainage Strategy

Curtins Ref: 082430-CUR-XX-XX-RP-C-92000\_Plot D

Site Address: Plot D, Great Jackson Street, Manchester

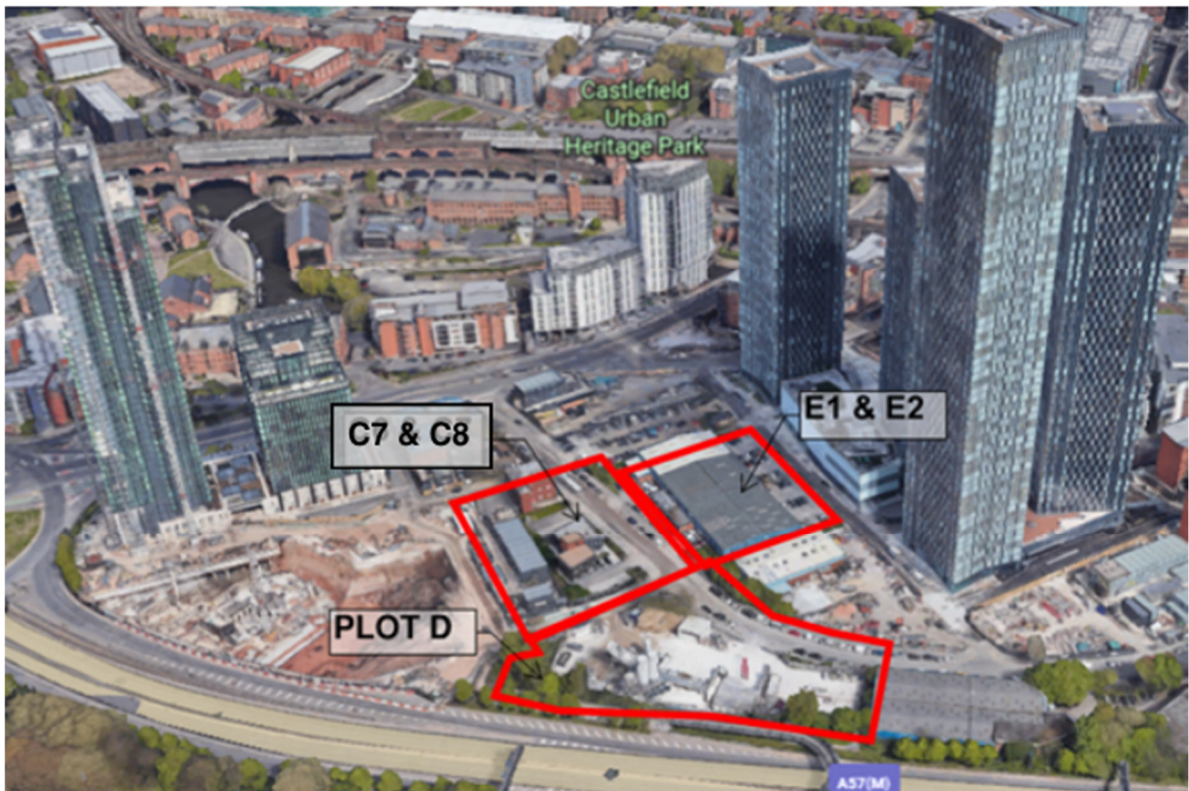
**Figure 1 - Google Earth image of the Site Location, 2022**

- 2.1.1 Within the general area adjacent to plot D Renaker are also proposing the development of Phase 3 of the Crown Street Development. The location of the Plot D development and the proximity of the Crown Street Phase 3 development are defined in Figures 1 and 2.

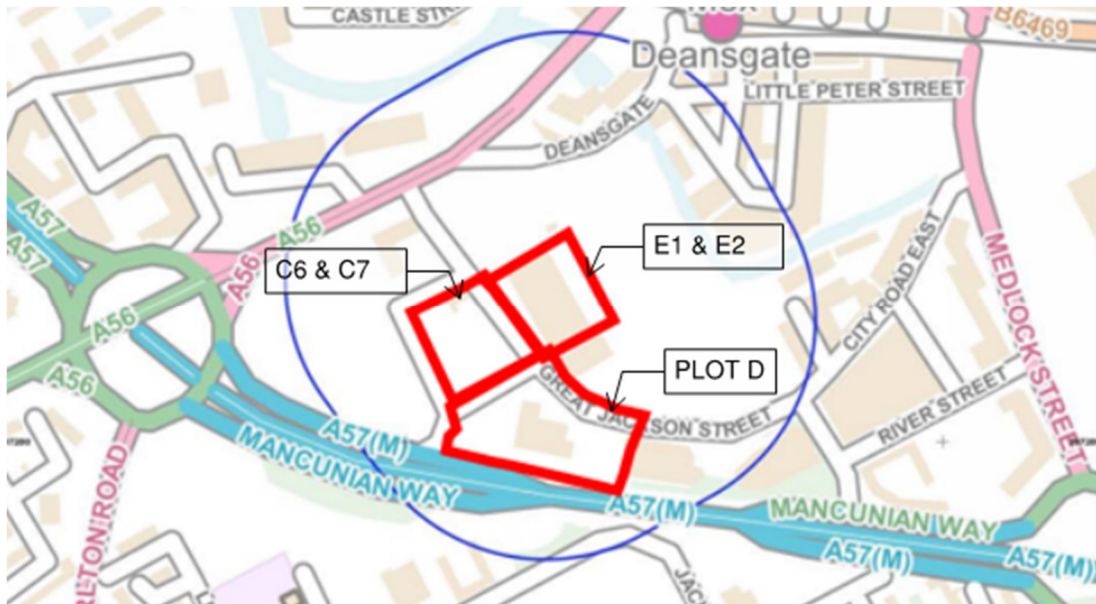
**Figure 2 – Site Location Map, Archaeological Services Mapping, 2022**

- 2.1.2 The approximate postcode of the application site is M15 4PA and the approximate Ordnance Survey grid reference of the site is SJ832972, with eastings and northings 383291, 397265.
- 2.1.3 Plot D is currently occupied as a construction compound for the Deansgate Square development.
- 2.1.4 The Site is currently accessed from GJS, Mancunian Way, Silvercroft Street or Melbourne Street.
- 2.1.5 GJS runs adjacent to the north-east boundary of Plot D. Melbourne Street bounds the site to the north, and the Mancunian Way bounds the site to the south.

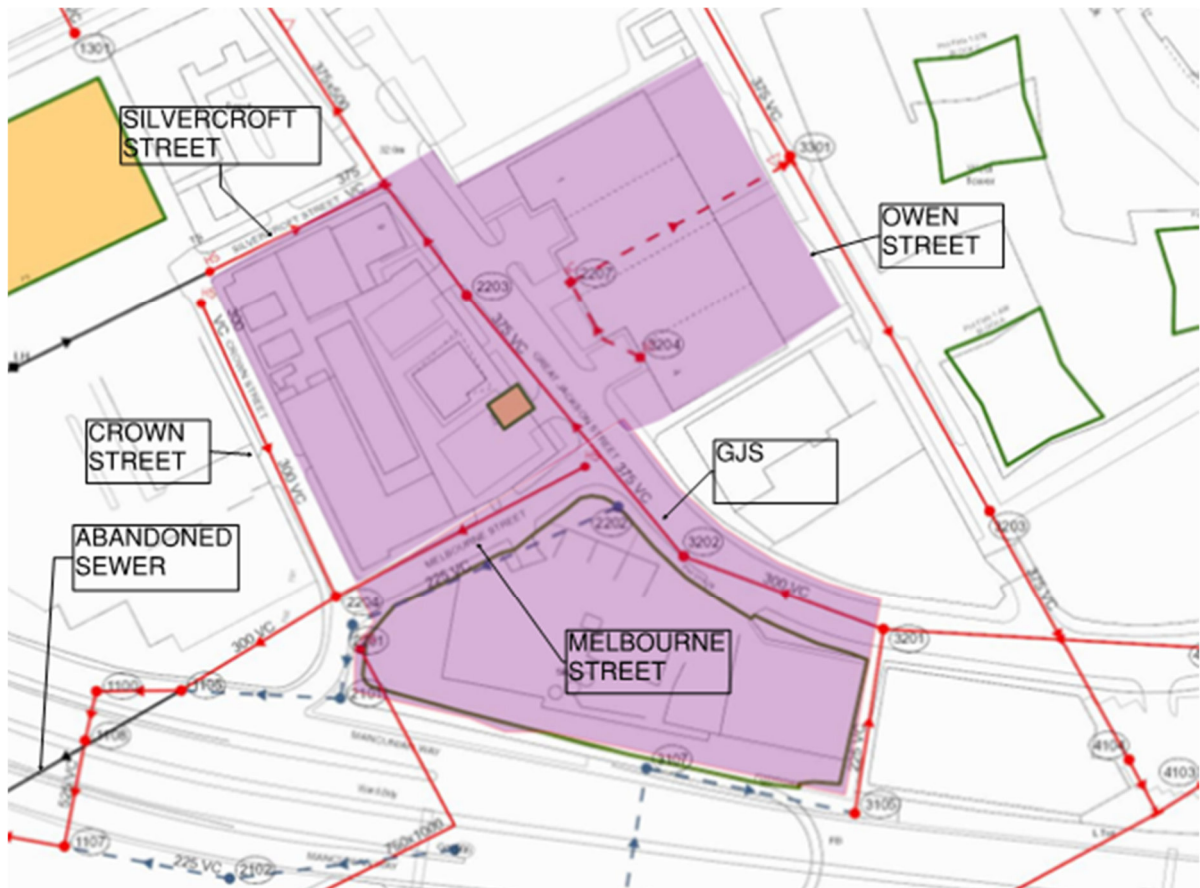
2.4.1 An extract from the United Utilities public sewer records has been obtained for the development site and is shown in Figure 3 below. The full records can be found in *Appendix B*.

the development site the proposed basement has been reduced to ensure that the development doesn't cross the historic alignment of the sewer.

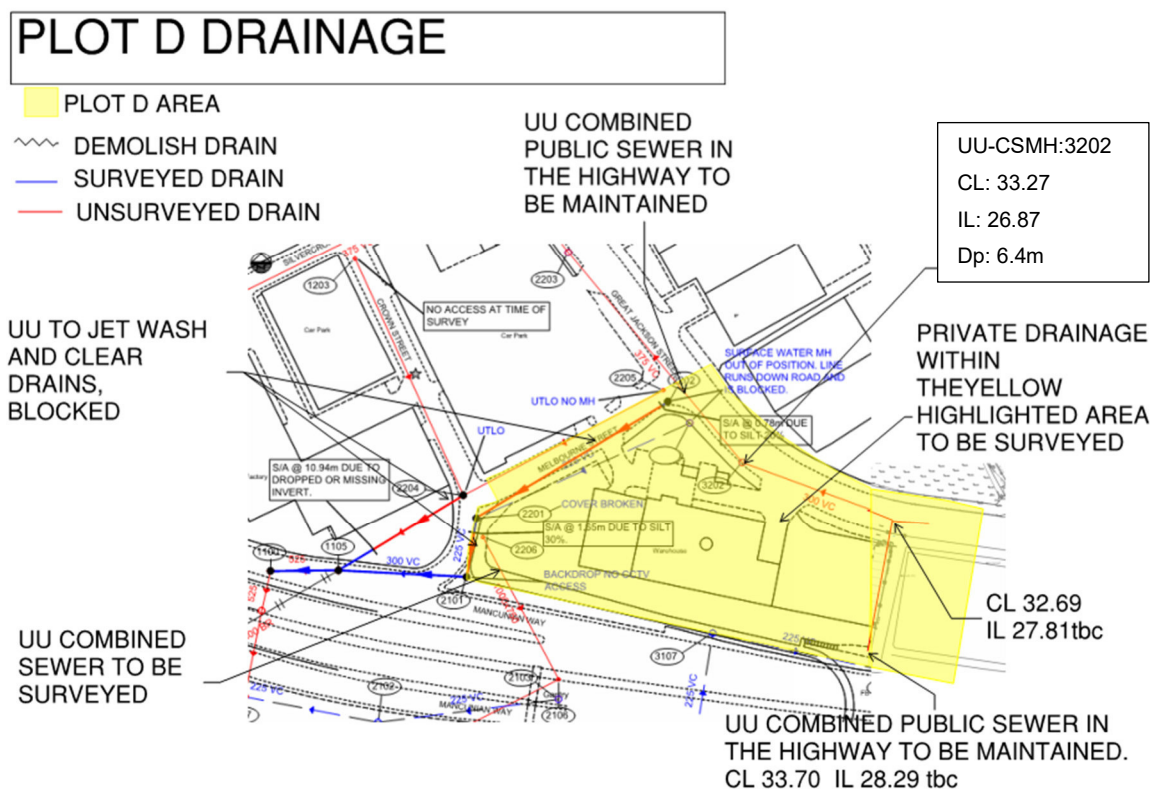
**Figure 4 – CCTV drainage survey summary findings – Plot D**

2.4.8 The findings from the surveys associated with plot D are summarised in Figures 4. Additional CCTV drainage surveys will be conducted at the detailed design stages, when connection locations are confirmed.

- 5.2.1 While the risk of flooding from infrastructure failure is considered low, CCTV drainage surveys have identified that some of the UU infrastructure close to the site is heavily silted.
- 5.2.2 UU have been notified, as these drains should be jetted and cleared. As part of the detailed design stages, further CCTV drainage surveys will be commissioned. Drains will be high pressure jetted, if required.
- 5.2.3 The above mitigation measures will reduce the risk of flooding from infrastructure failure, post development.

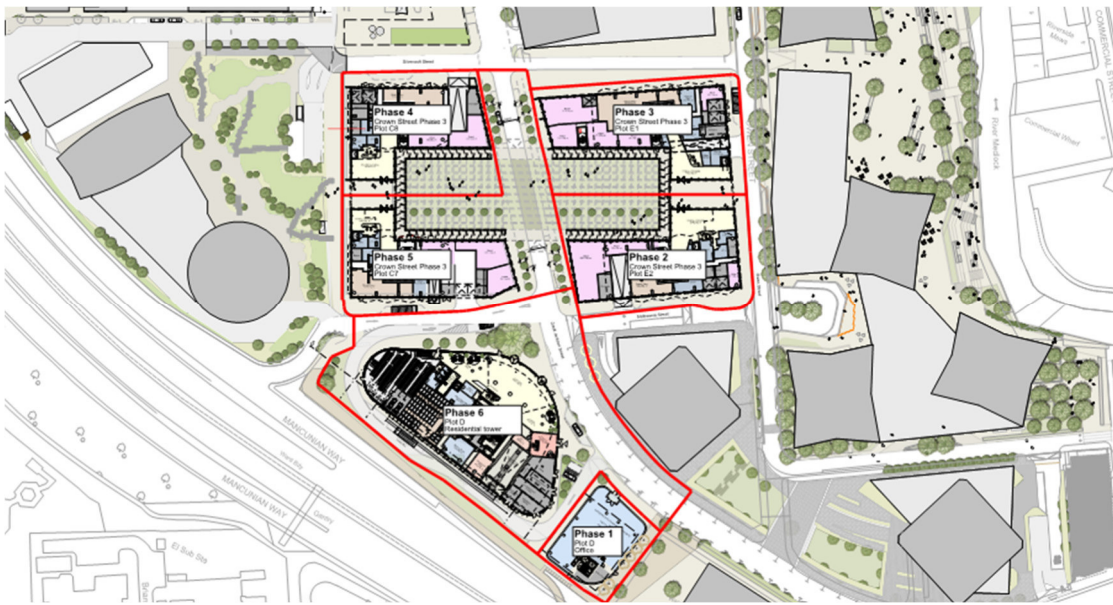
**Figure 5 SimpsonHaugh Architects, 2022**

The development proposals can be seen in Figure 5 below and full plans can be found in *Appendix A*, along with the documents submitted with this planning application.

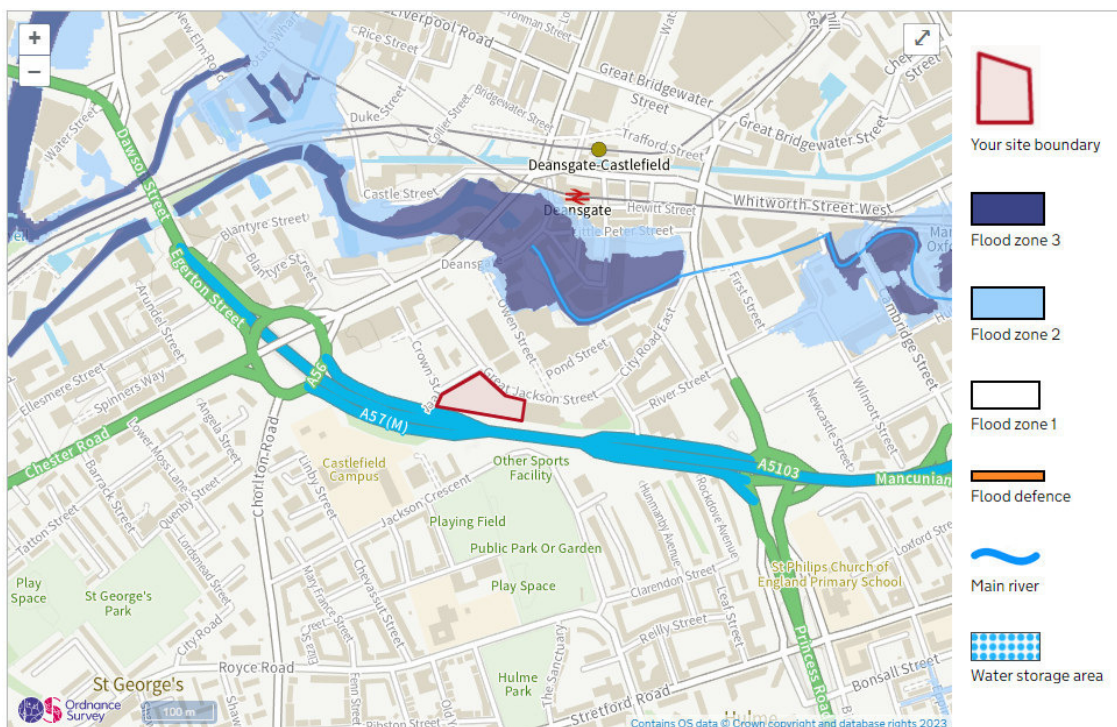
**Figure 6 EA Flood Map for Planning Extract, EA 2022**

4.2.1 The EA's Indicative Flood Map for Planning shows the site is situated in Flood Zone 1, an area at low risk of flooding from rivers and the sea. Developments in this zone do not have any restrictions, provided they do not increase flood risk elsewhere. This can be seen in Figure 6 below.

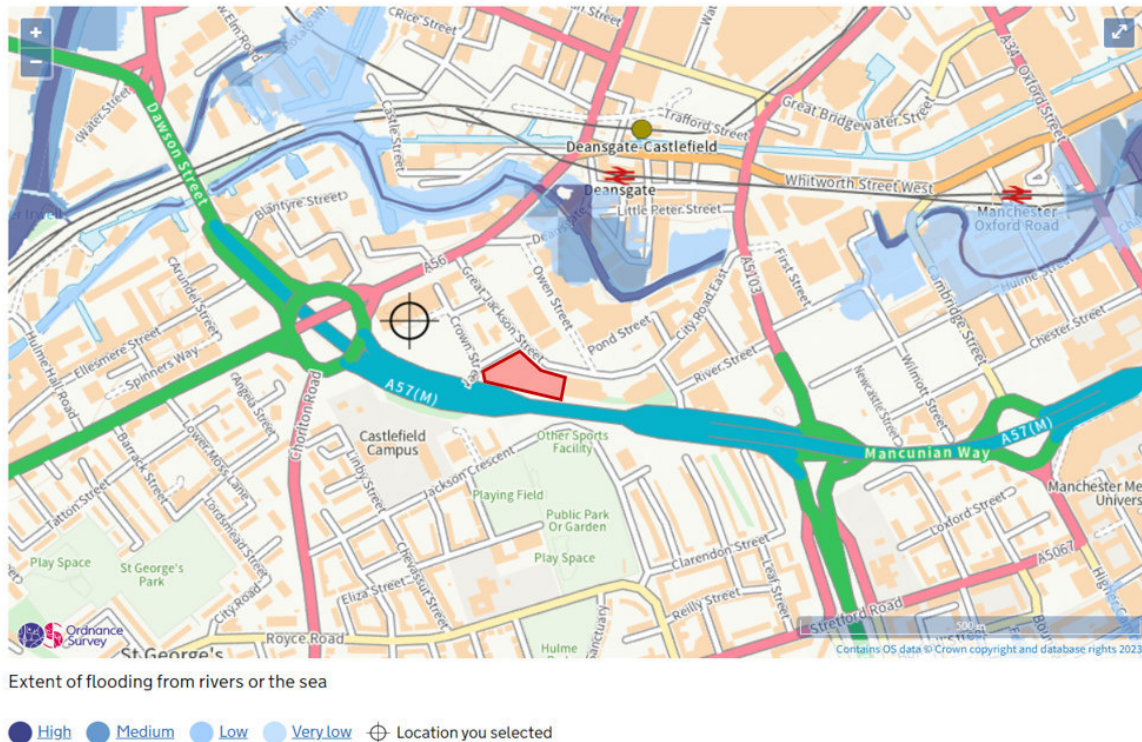
**Figure 7 Long Term Flood Risk Service, Extent of Flooding, 2022**

4.2.2 The web based 'Long Term Flood Risk Assessment for Locations in England' has also been reviewed; this can be seen in Figure 7. This shows the site, considering long term risk, is at extremely low risk of flooding from rivers and the sea (the site area is not identified as very low risk).

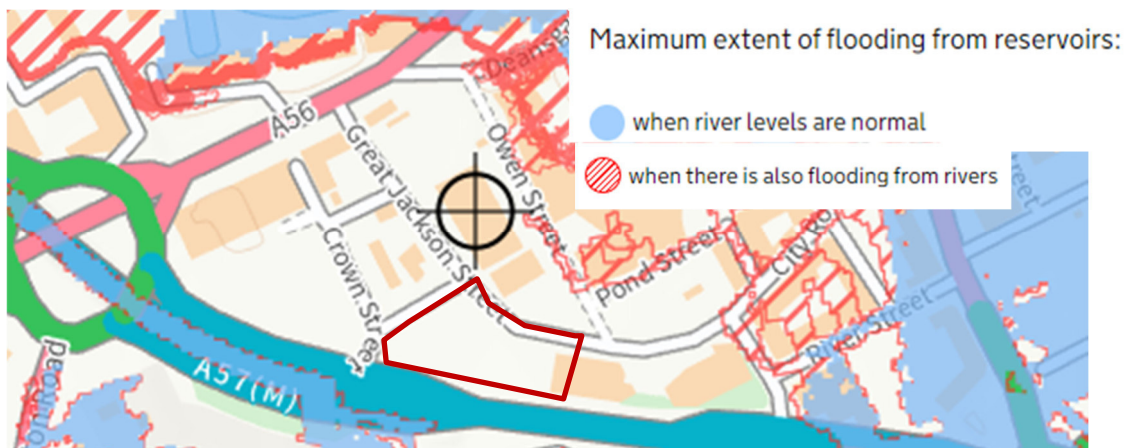
**Figure 8 Long Term Flood Risk Assessment Map – Flood Risk from Reservoirs**

4.3.1 Reservoir flooding is unlikely to happen and there has been no loss of life in the UK from reservoir flooding since 1925. The Environment Agency is the enforcement authority and ensures that reservoirs are inspected regularly, and essential safety work is carried out. The Long-Term Flood Risk Assessment (Flood Risk from Reservoirs) map represents the worst-case scenario and this map can be seen below in Figure 8. This shows the site is at low risk of reservoir flooding.

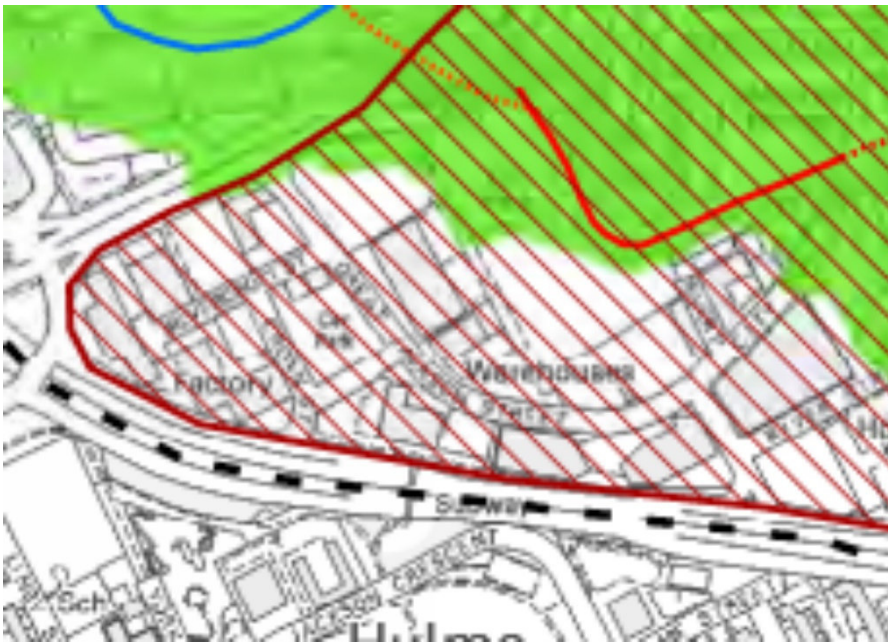
**Figure 9 MCC SFRA Canal Hazard Zones Map MM\_3.1 Extract, 2011**

4.4.2 An extract of The MCC SFRA references 'Map MM\_3.1 – Canal Hazard Zones' which identifies the potential extents of flooding cause by overland flows from the Canal is provided below in Figure 9.

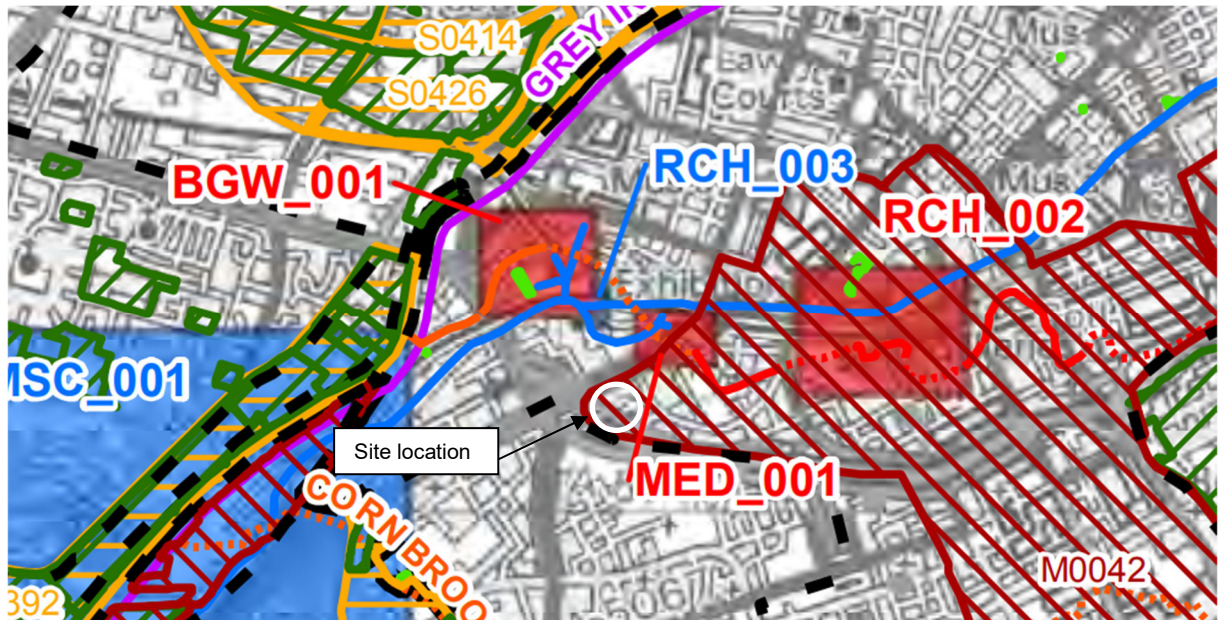
*Figure 10 MCC SFRA Hydraulic Interactions Map HI\_5.1 Extract, 2011*

accumulated flood risk is also considered low. This is reaffirmed by the SFRA Hydraulic Interactions Map HI\_5.1, shown in Figure 10 below. The site is not identified as being at risk from hydraulic interactions.

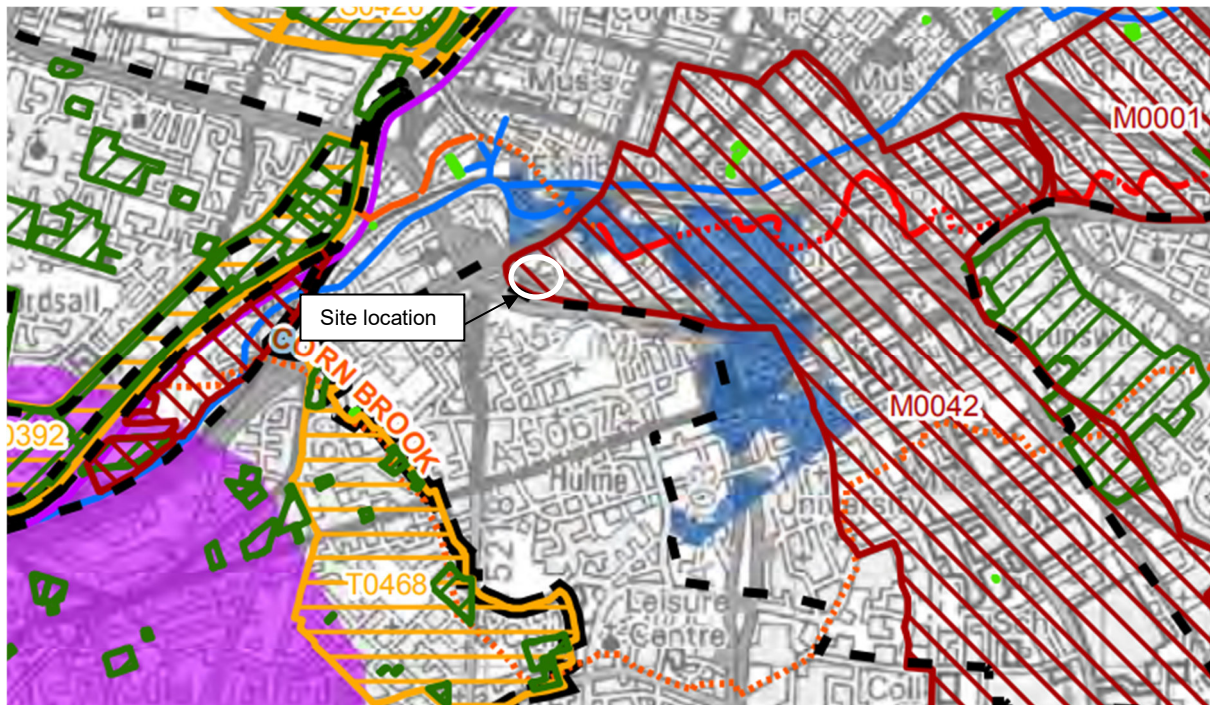
**Figure 11 MCC SFRA Groundwater Flooding Map GW\_2.1 Extract, 2011**

4.5.3 The site is not shown to be within an area at risk of groundwater flooding according to the Groundwater Flooding Map shown within the MCC SFRA. This is shown in Figure 11 below.

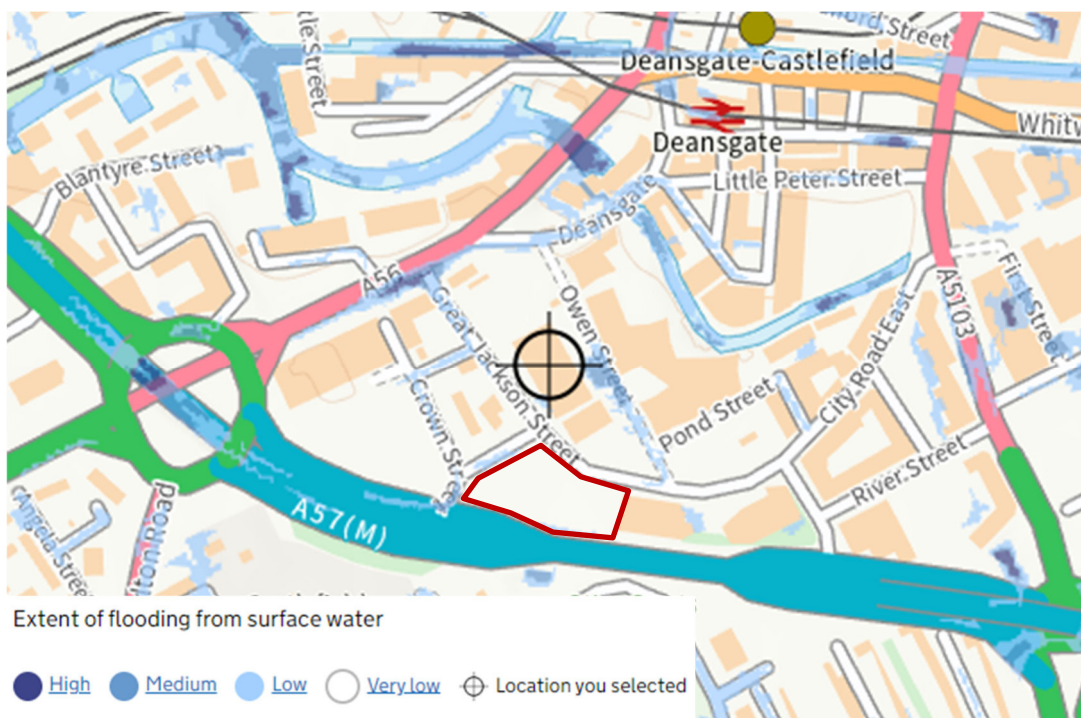
**Figure 12 Long Term Flood Risk Service Map, 2022**

- 4.7.1 Surface water flooding occurs when intense rainfall is unable to soak into the ground or enter a drainage system due to blockages or the capacity of the system being exceeded. Overland flows can also be generated by burst water mains, failed dams and any failure in a system storing or transferring water.
- 4.7.2 The Long Term Flood Risk Maps represent the worst case scenario and can be seen below in Figure 12. This shows that there is 'low risk' surface water flood risk along Melbourne Street which abuts the northern boundary of Plot D. The flooding is confined to the roads, where levels are lower. Therefore, Plot D is considered to be at a very low surface water flood risk.

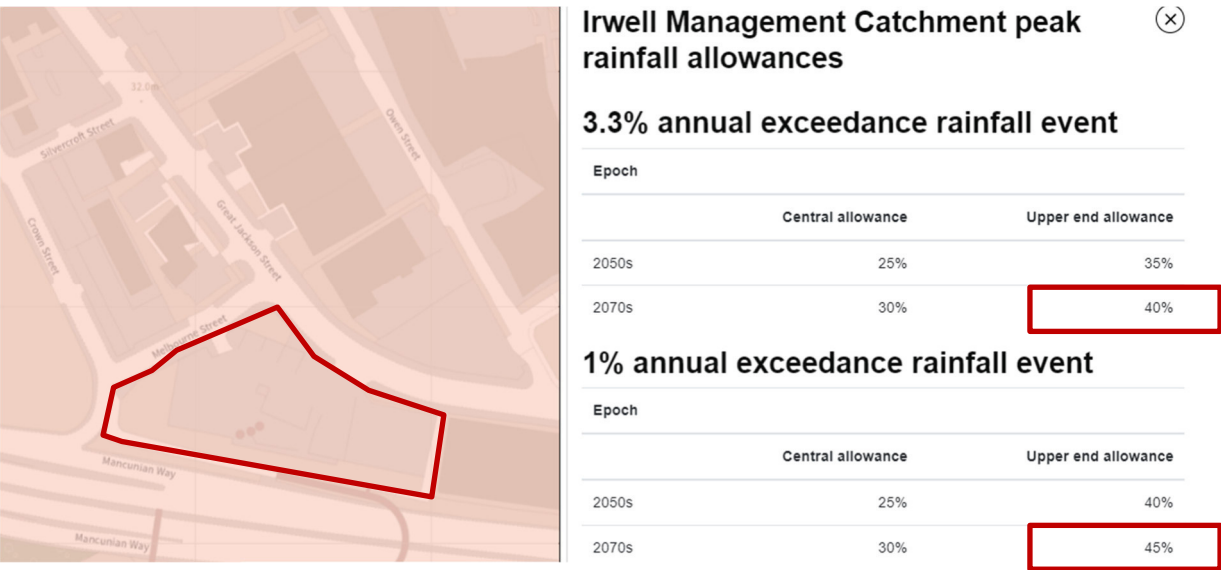
**Figure 13 Defra Data Services Platform, Climate Change Allowances, Peak Rainfall Allowances Map, 2022**

5.4.2 In May 2022, the EA updated climate change allowances for peak rainfall intensities which should be applied to new developments. Figure 13 below shows this.

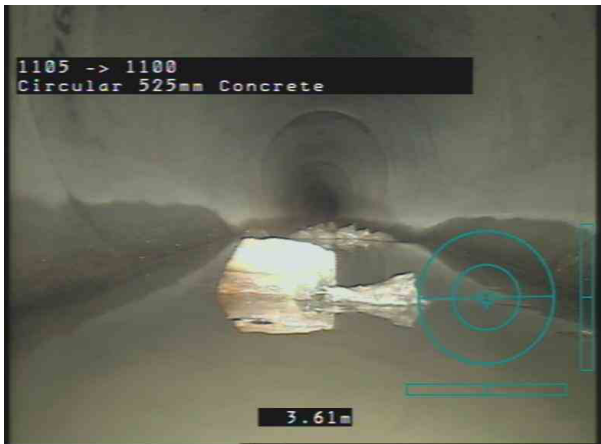
1105X\_e58a2646-c911-4907-860f-02568851a08a\_20191218\_213155\_710.jpg, 00:03:32, 3.61 m  
Other obstacles, brick or masonry in invert from 6 o'clock to 7 o'clock, 10% cross-sectional area loss

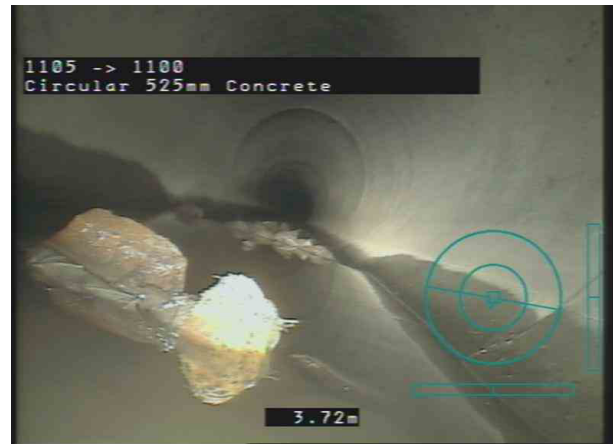
1105X\_3996a299-04be-4035-bd44-1a8446a09a23\_20191218\_213009\_115.jpg, 00:01:47, 3.72 m  
Settled deposits, coarse, 15% cross-sectional area loss, start

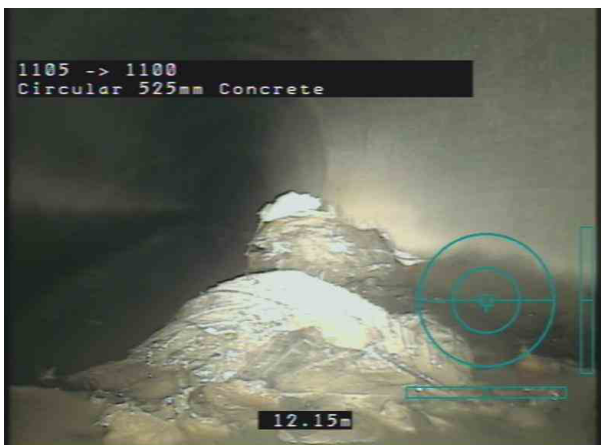
1105X\_04d7ba1b-8c45-4777-839c-1492a72d1db0\_20191218\_213804\_994.jpg, 00:09:04, 12.15 m  
Other obstacles, brick or masonry in invert from 4 o'clock to 7 o'clock, 20% cross-sectional area loss

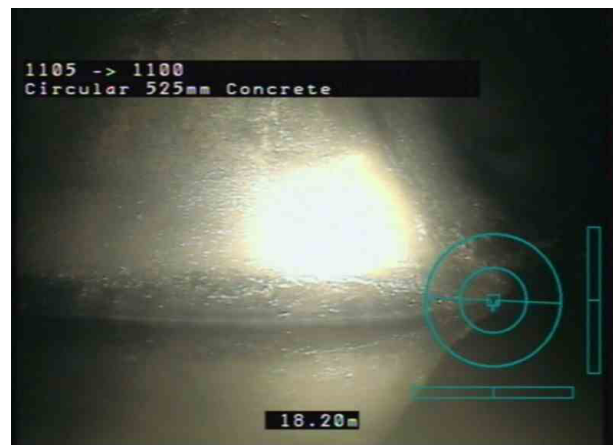
1105X\_b4718763-4329-4ae5-8267-61e07a194c70\_20200109\_082429\_832.jpg, 00:11:56, 18.20 m  
Settled deposits, coarse, 15% cross-sectional area loss, finish

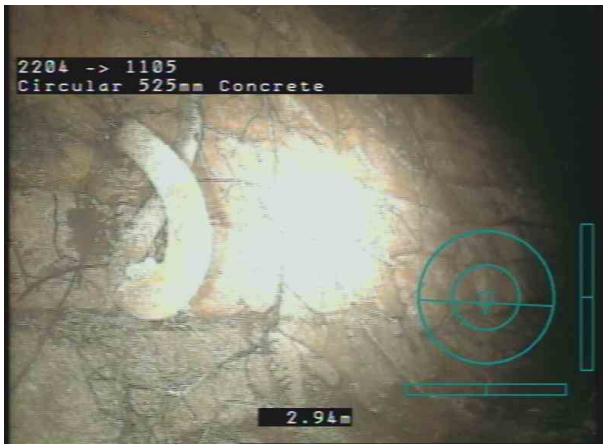
2204X\_dced5df7-3818-4aeb-a04b-da4ec2573895\_20191218\_220723\_457.jpg, 00:05:51, 2.94 m  
Roots, tap

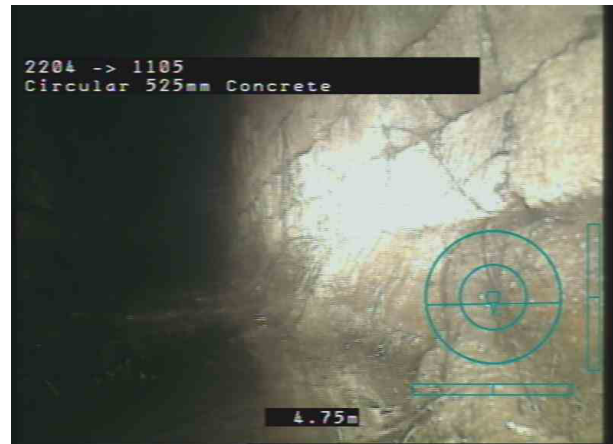
2204X\_f012e500-f0fc-481b-b5e8-7461bc6394bf\_20191218\_220904\_498.jpg, 00:07:33, 4.75 m  
Roots, tap

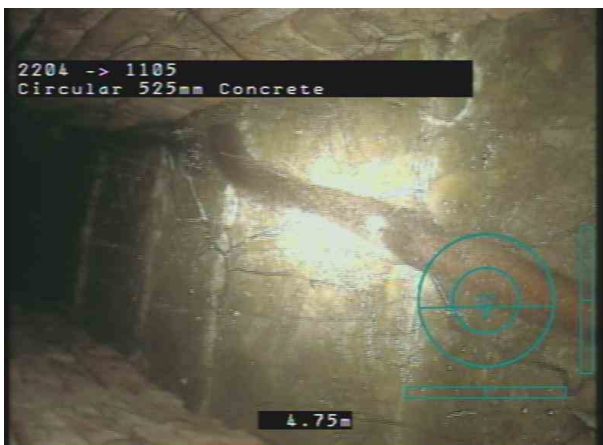
2204X\_e5c0bd09-637c-4e47-992c-48e38db5ee44\_20191218\_220928\_242.jpg, 00:07:33, 4.75 m  
Roots, tap

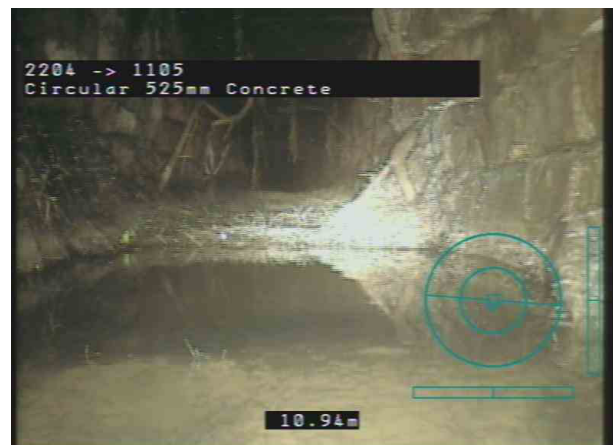
2204X\_e5699ea4-ddc3-40d9-9bc6-c4ec7cdbcfff\_20191218\_221433\_046.jpg, 00:11:40, 10.94 m  
Dropped invert, gap: 300mm from 5 o'clock to 7 o'clock

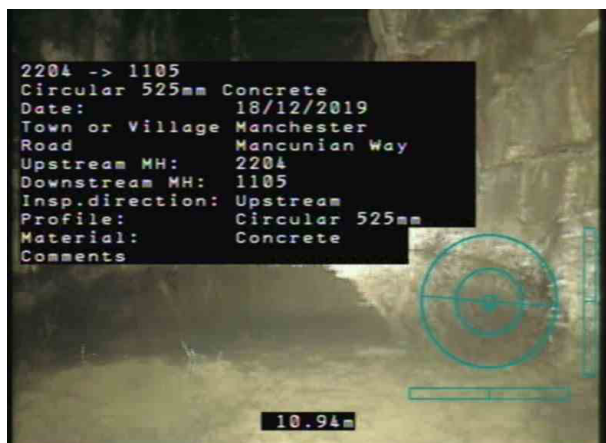
2204X\_2a3c3330-cb34-4f44-a61b-ee1bfe9f7a4a\_20200109\_0  
82526\_030.jpg, 00:11:40, 10.94 m  
Roots, fine, finish

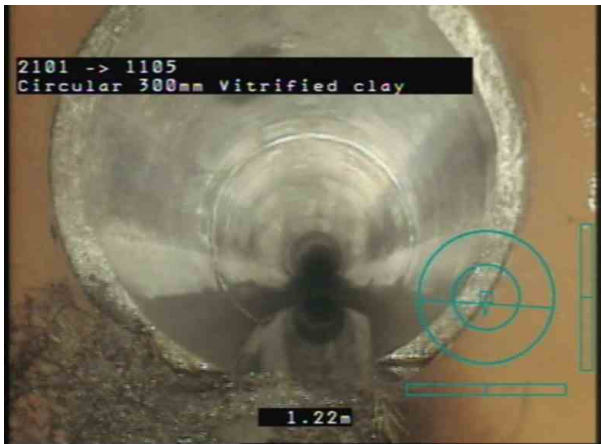
2101X\_30833b35-4960-4fdf-87b4-f3dfb2c9e443\_20200109\_082820\_479.jpg, 00:00:55, 1.22 m  
Roots, fine at joint

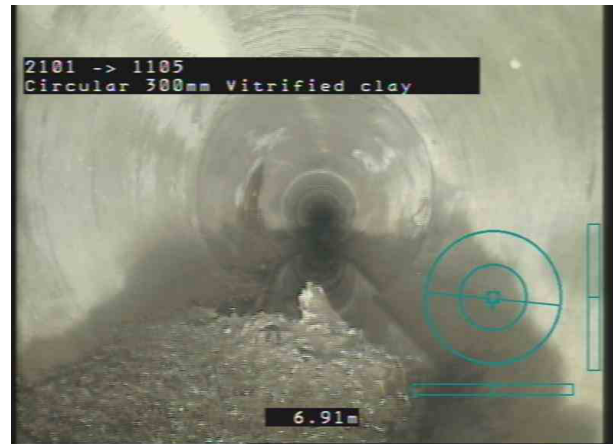
2101X\_85f62e90-ec19-4acf-bf4b-1e2a8c9373ba\_20191218\_23414\_189.jpg, 00:04:15, 6.91 m  
Roots, mass, 15% cross-sectional area loss

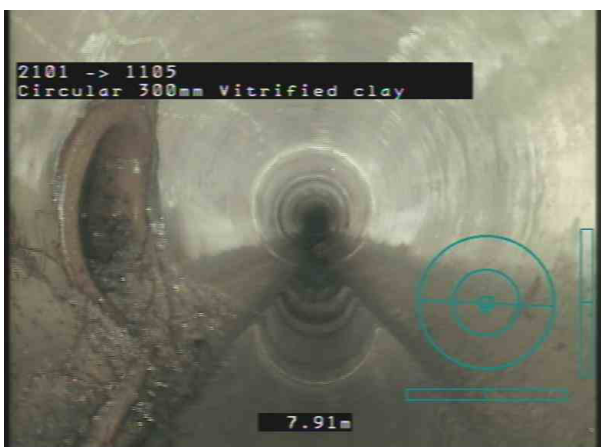
2101X\_ba195ac0-e5d4-4fbc-bb1f-bffe23014324\_20191218\_23431\_754.jpg, 00:04:33, 7.91 m  
Roots, tap

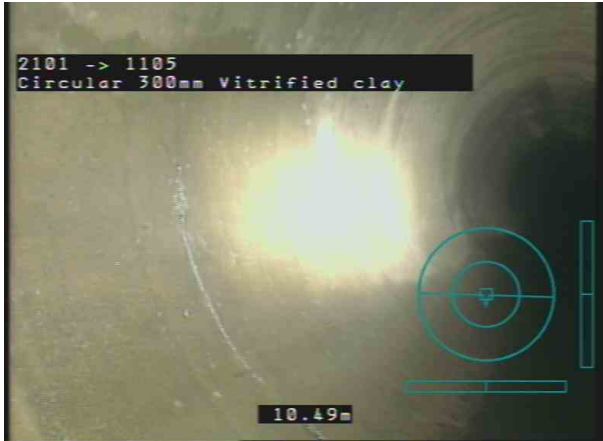
2101X\_e43a32e1-e7bb-4540-a1a8-16d7c8271d61\_20191218\_223652\_030.jpg, 00:06:45, 10.49 m  
Fracture, circumferential from 2 o'clock to 10 o'clock

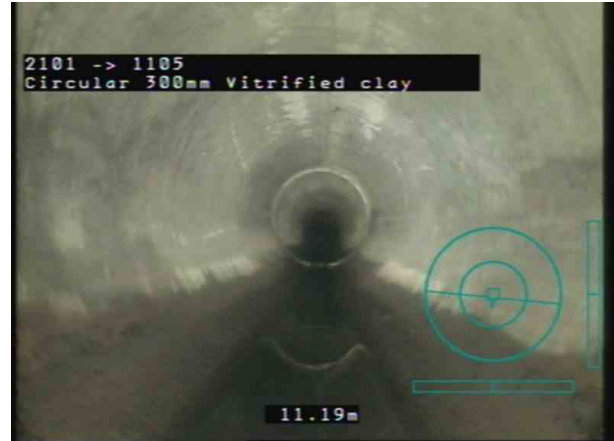
2101X\_09cd2e99-ddea-4d5f-996f-3bdd47d71097\_20200109\_082838\_512.jpg, 00:07:11, 11.19 m  
Roots, fine at joint

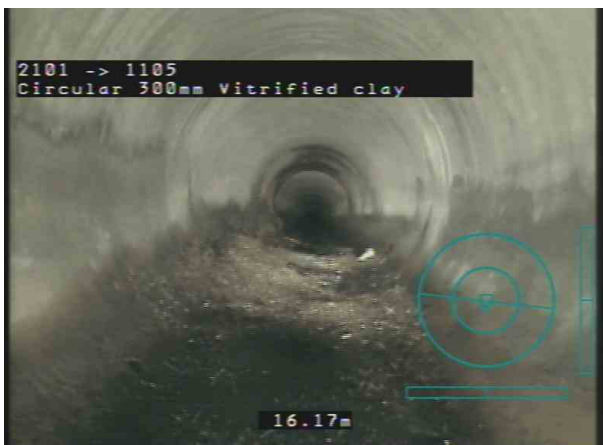
2101X\_462ddc81-c59d-43a3-88b2-0b74bcc11d12\_20191218\_223753\_042.jpg, 00:07:54, 16.17 m  
Roots, mass, 20% cross-sectional area loss, start

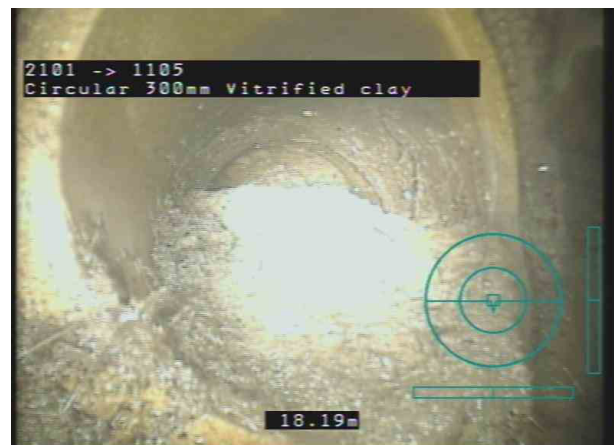
2101X\_9fe4bb4f-b1f3-436e-af08-a8c4b31ad9c4\_20191218\_223833\_574.jpg, 00:08:34, 18.19 m  
Connection defective, connecting pipe is blocked at 10 o'clock, diameter: 150mm

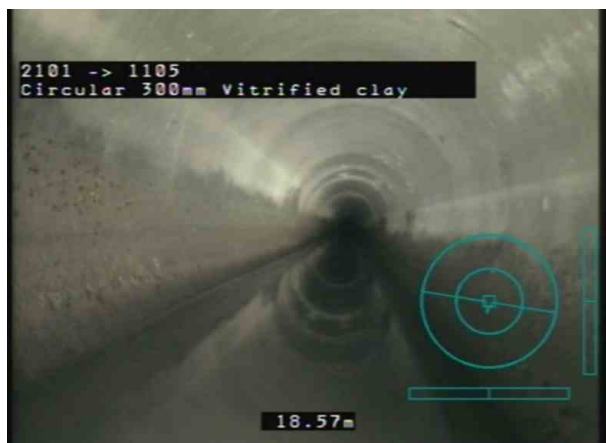
2101X\_25967ed6-0ff3-4572-8178-528241cc09ad\_20200109\_082843\_723.jpg, 00:09:05, 18.57 m  
Roots, mass, 20% cross-sectional area loss, finish

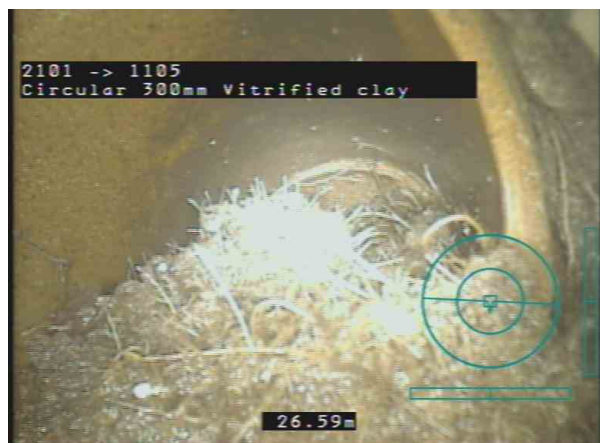
2101X\_aff6f31d-438d-49fc-9cb5-d164974ebd40\_20191218\_24120\_287.jpg, 00:10:39, 26.59 m  
Connection defective, connecting pipe is blocked at 10 o'clock, diameter: 150mm

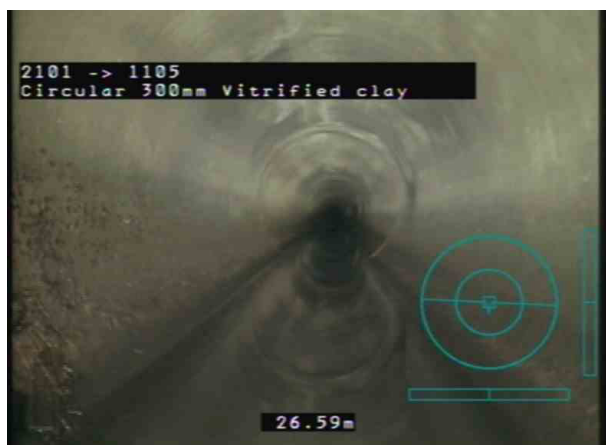
2101X\_69d52bde-462e-4bab-beca-9a86779e0b75\_20200109\_082856\_179.jpg, 00:11:34, 26.59 m  
Roots, fine

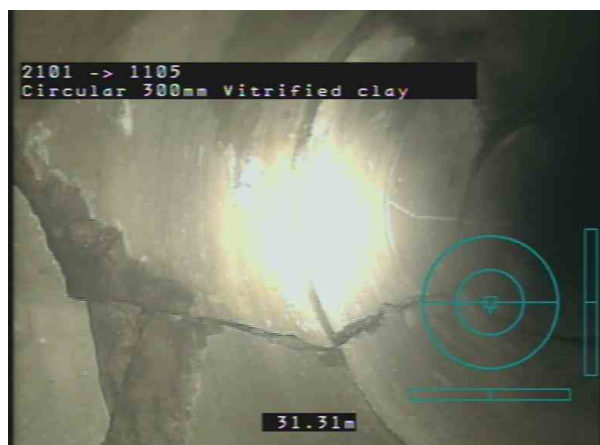
2101X\_02ef41d3-5402-44b2-b7ed-a30fa3ddc12a\_20191218\_224405\_257.jpg, 00:14:04, 31.31 m  
Fractures, multiple from 7 o'clock to 5 o'clock

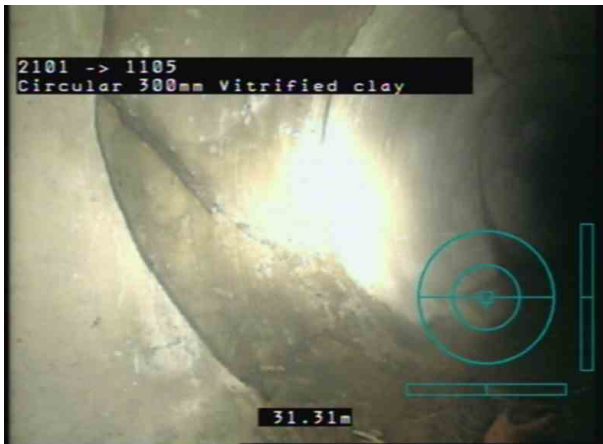
2101X\_02b31859-62bb-4581-8431-ace2bb5bf4cd\_20200109\_082900\_567.jpg, 00:14:31, 31.31 m  
Roots, fine

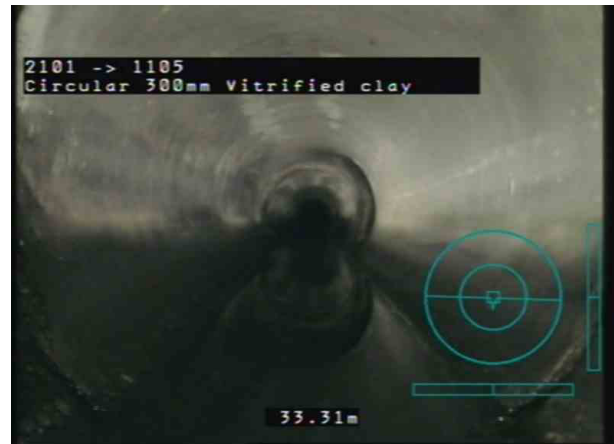
2101X\_df33cf18-b4ab-4f51-898c-c87bf54343cf\_20200109\_082904\_272.jpg, 00:15:31, 33.31 m  
Roots, fine at joint

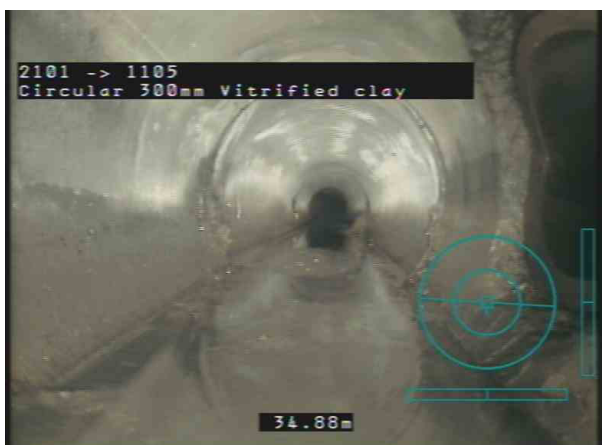
2101X\_65f33adf-bb8d-4c29-96e1-156203d14962\_20191218\_224821\_145.jpg, 00:17:51, 34.88 m  
Settled deposits, fine, 20% cross-sectional area loss, start

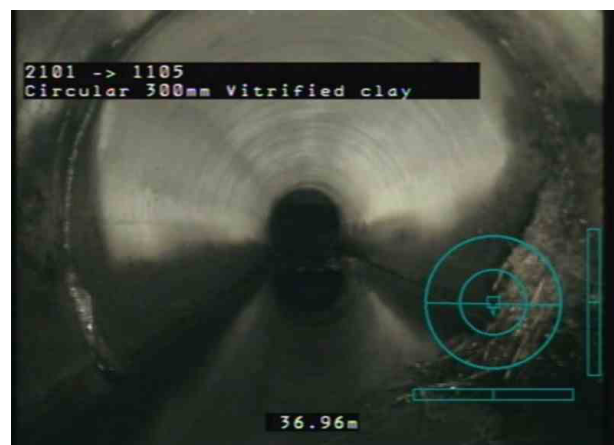
2101X\_f35292fb-46e6-4677-ab75-0143026b05cf\_20200109\_082912\_167.jpg, 00:21:47, 36.96 m  
Roots, fine at joint

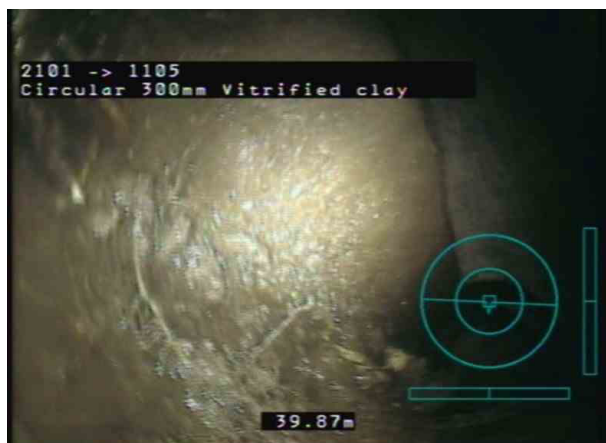
2101X\_5e7de495-03ec-47ae-972a-e7e7f12164f7\_20200109\_082915\_999.jpg, 00:23:03, 39.87 m

Settled deposits, fine, 20% cross-sectional area loss, finish

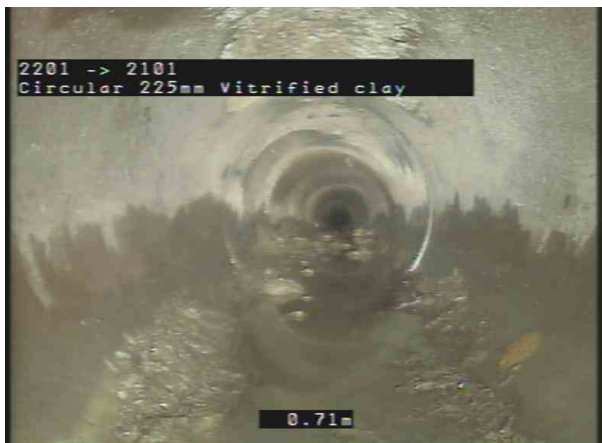
2201X\_c32e63fd-8186-41f6-893a-d2db77e82397\_20191219\_010729\_212.jpg, 00:01:27, 0.71 m  
Settled deposits, fine, 20% cross-sectional area loss, start

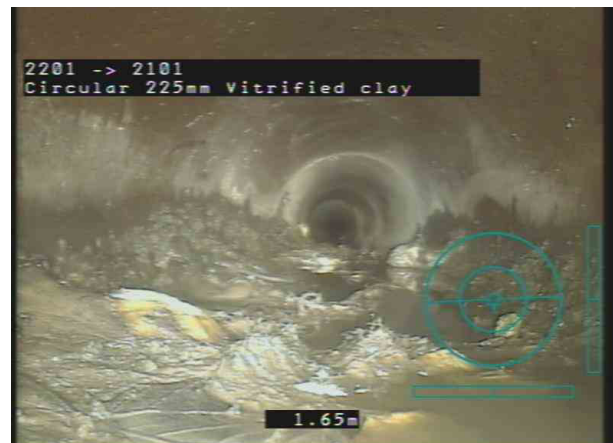
2201X\_d7eb6c7f-19ab-49e2-82a2-fbdbc84d65fa\_20191219\_011003\_390.jpg, 00:04:01, 1.65 m  
Settled deposits, fine, 30% cross-sectional area loss

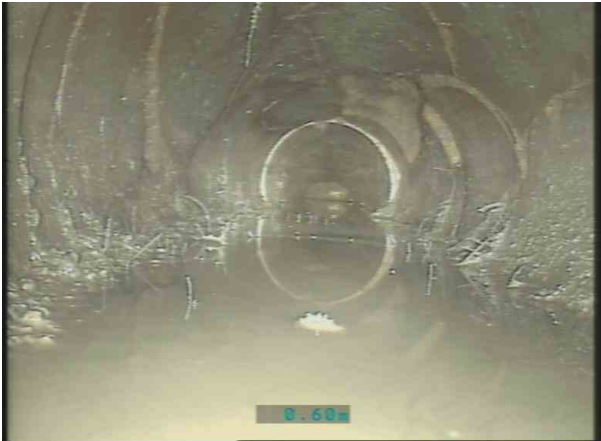
2202X\_faa5824c-328f-4b59-8d4a-b95a0af8fc36\_20191219\_202346\_967.jpg, 00:00:37, 0.60 m  
Fractures, multiple from 7 o'clock to 5 o'clock

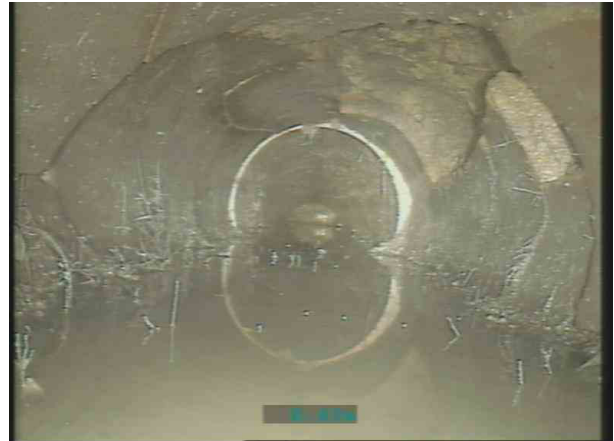
2202X\_9e74917b-78b7-4495-8c04-d6319efe82de\_20191219\_202430\_818.jpg, 00:01:18, 0.69 m  
Settled deposits, fine, 20% cross-sectional area loss

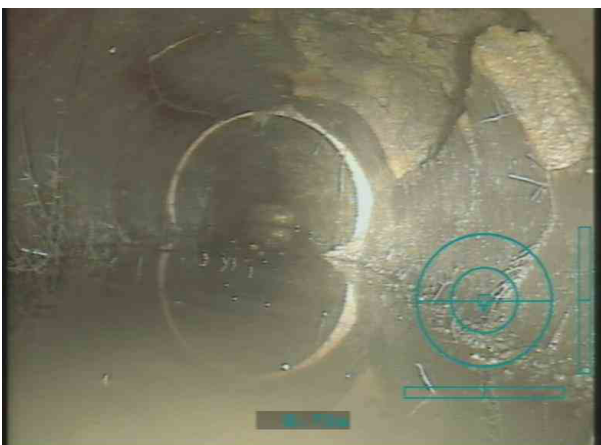
2202X\_b55a91f6-0b21-421b-91b1-69a9cd8ff5c3\_20191219\_202515\_216.jpg, 00:02:05, 0.78 m  
Hole in drain or sewer from 12 o'clock to 2 o'clock

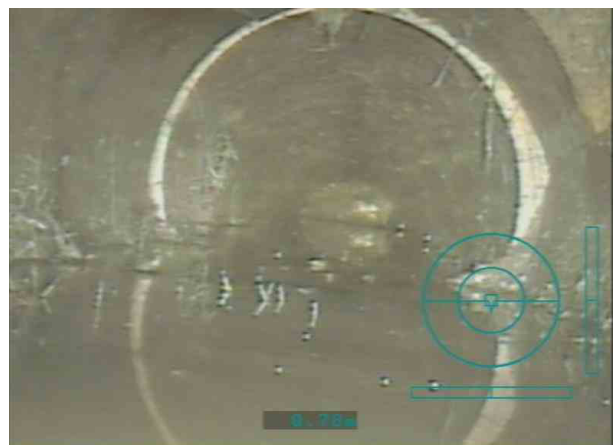
2202X\_fa760428-c13d-4e09-a836-50c0f9278e12\_20191219\_202556\_946.jpg, 00:02:29, 0.78 m  
General remark, blockage visible in distance possible roots

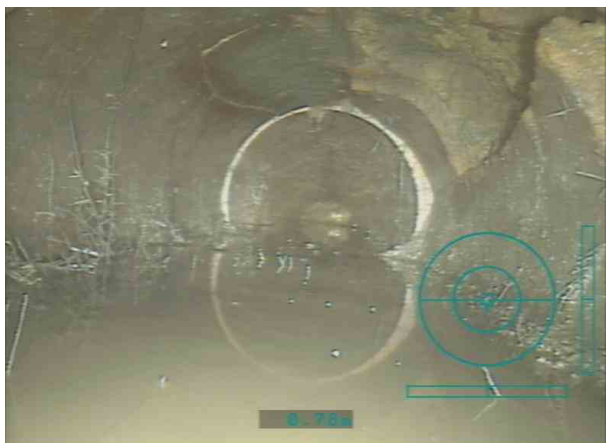
2202X\_3c85dc51-271d-4ecb-8ab4-7ba6f2264d26\_20191219\_202629\_924.jpg, 00:03:17, 0.78 m  
Survey abandoned, Due to amount of silt
