# Renaker - Plot D

## Flood Risk Assessment and Drainage Strategy

Curtins Ref: 082430-CUR-XX-XX-RP-C-92000\_Plot D

Site Address: Plot D, Great Jackson Street, Manchester

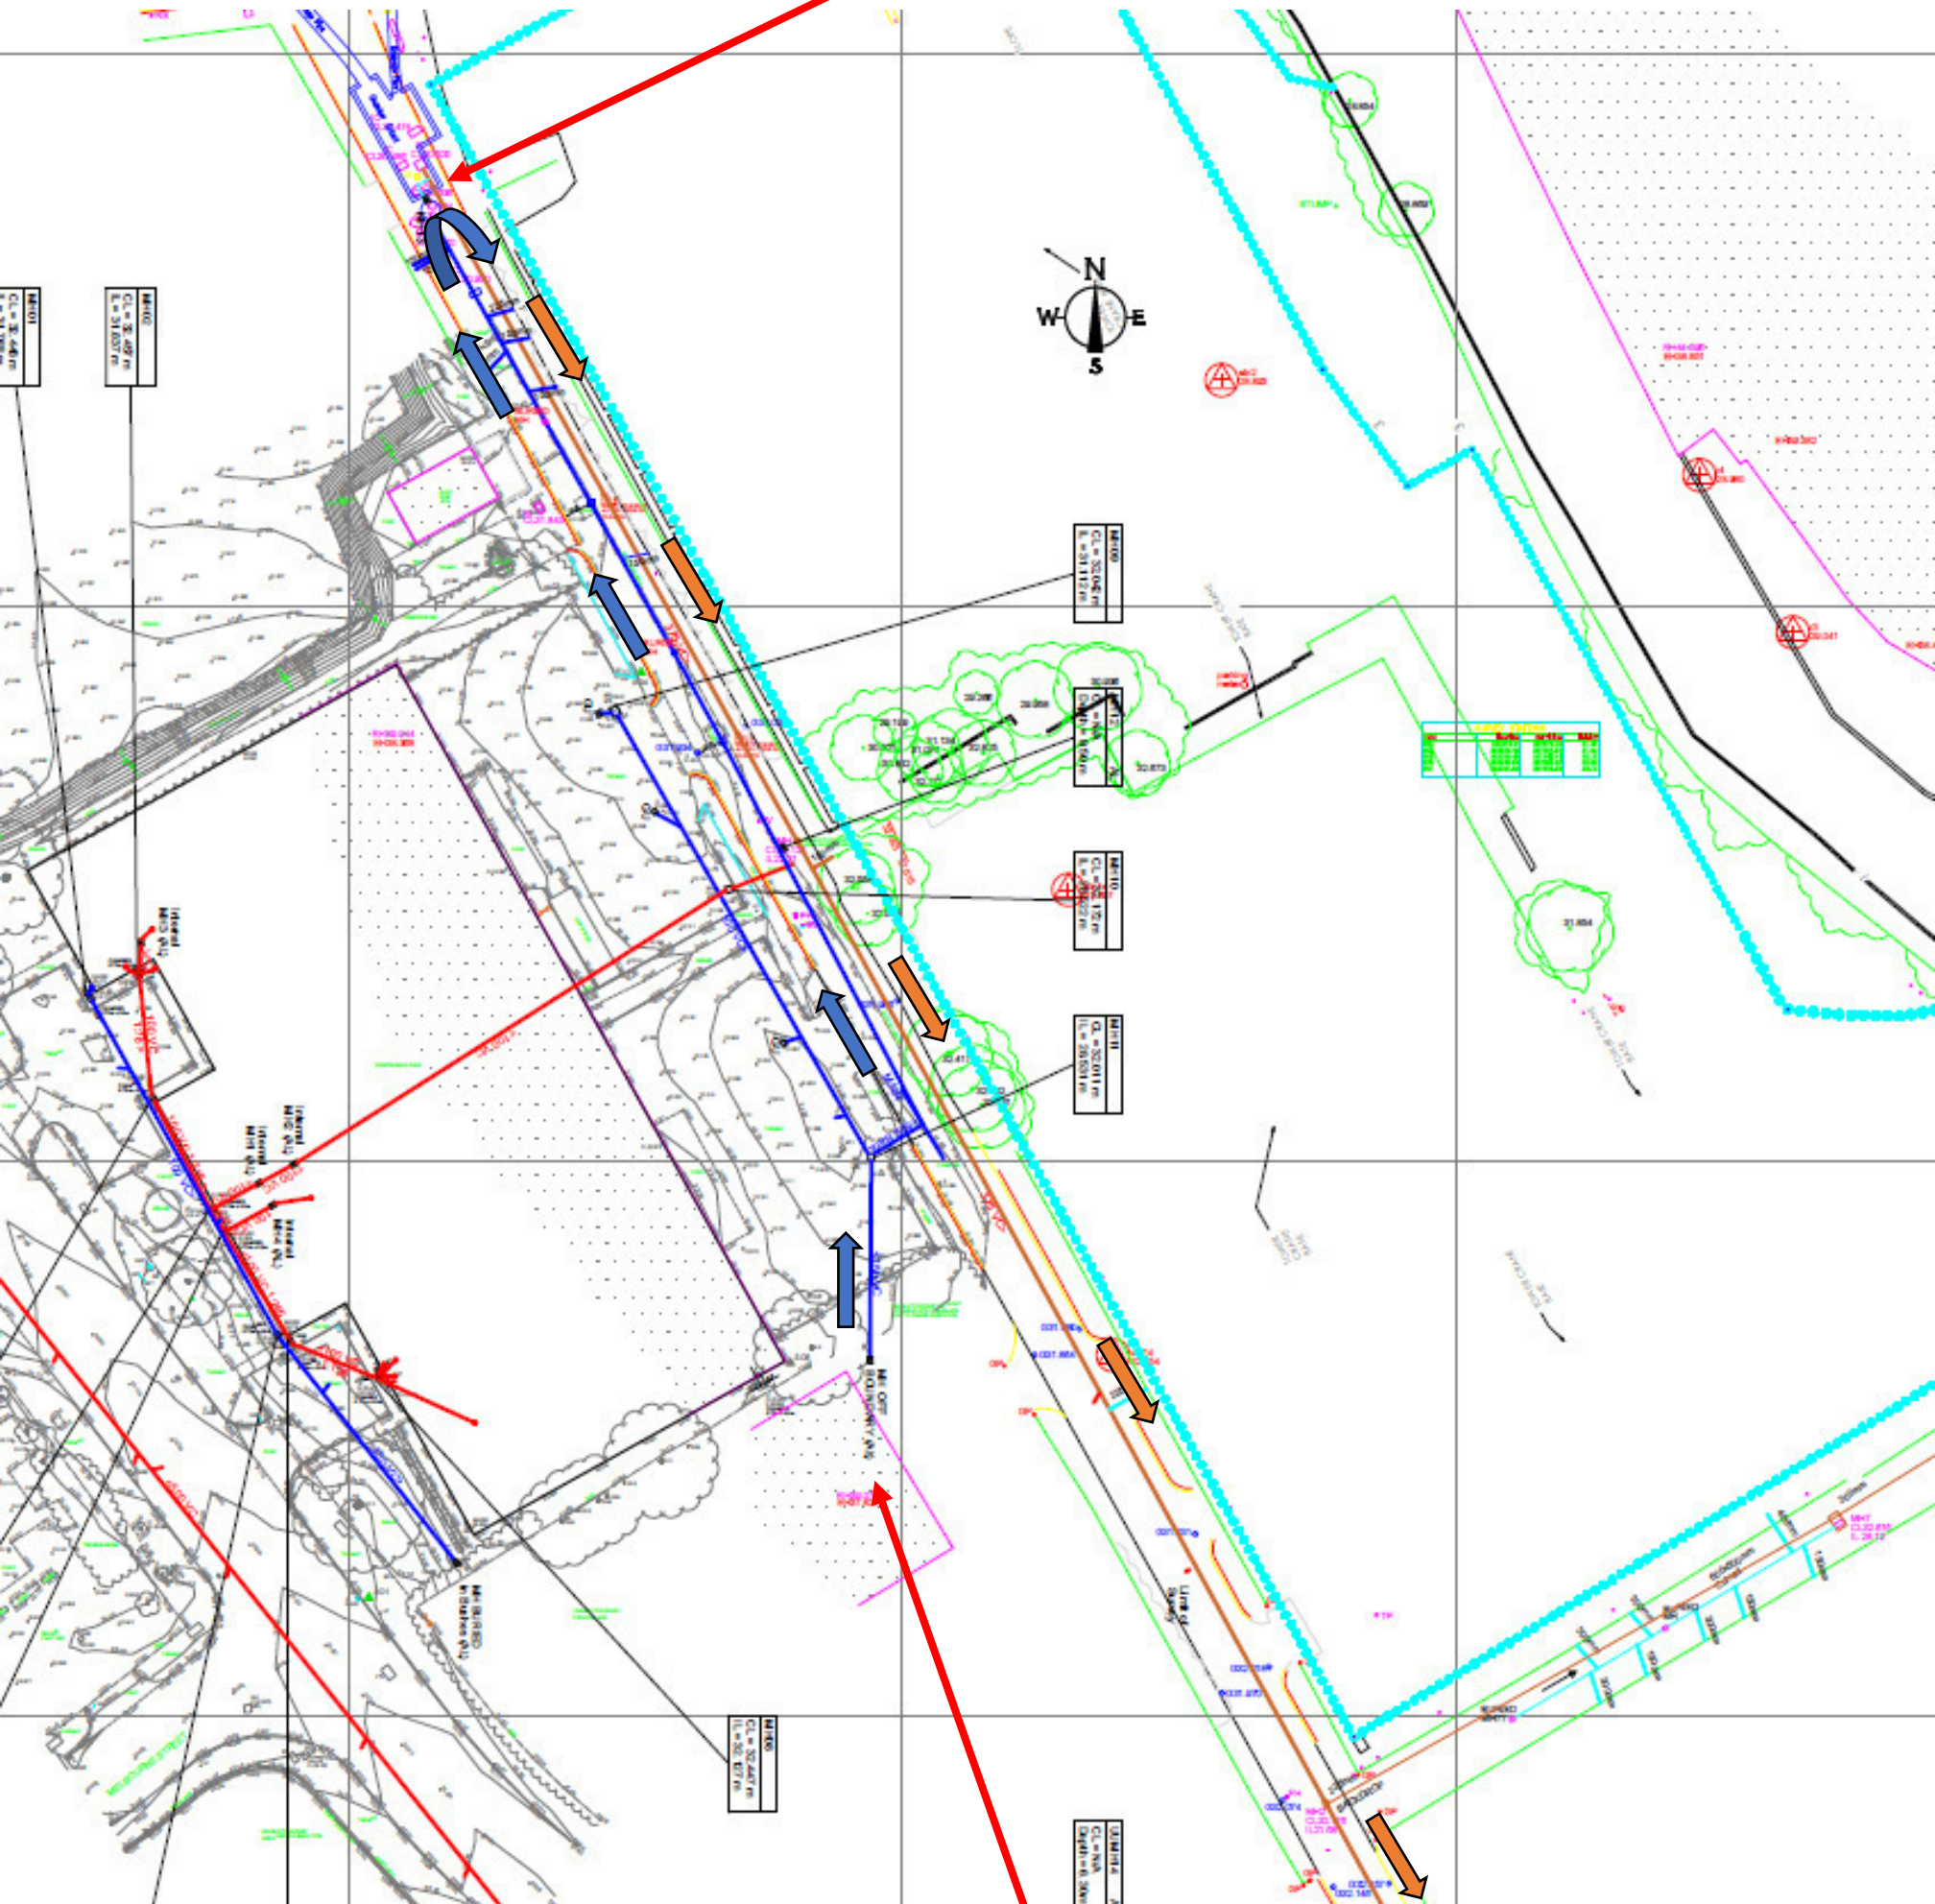
There is a 150mm line into 4m deep MH on DeTrafford plot which then runs north to CSO chamber on Owen Street

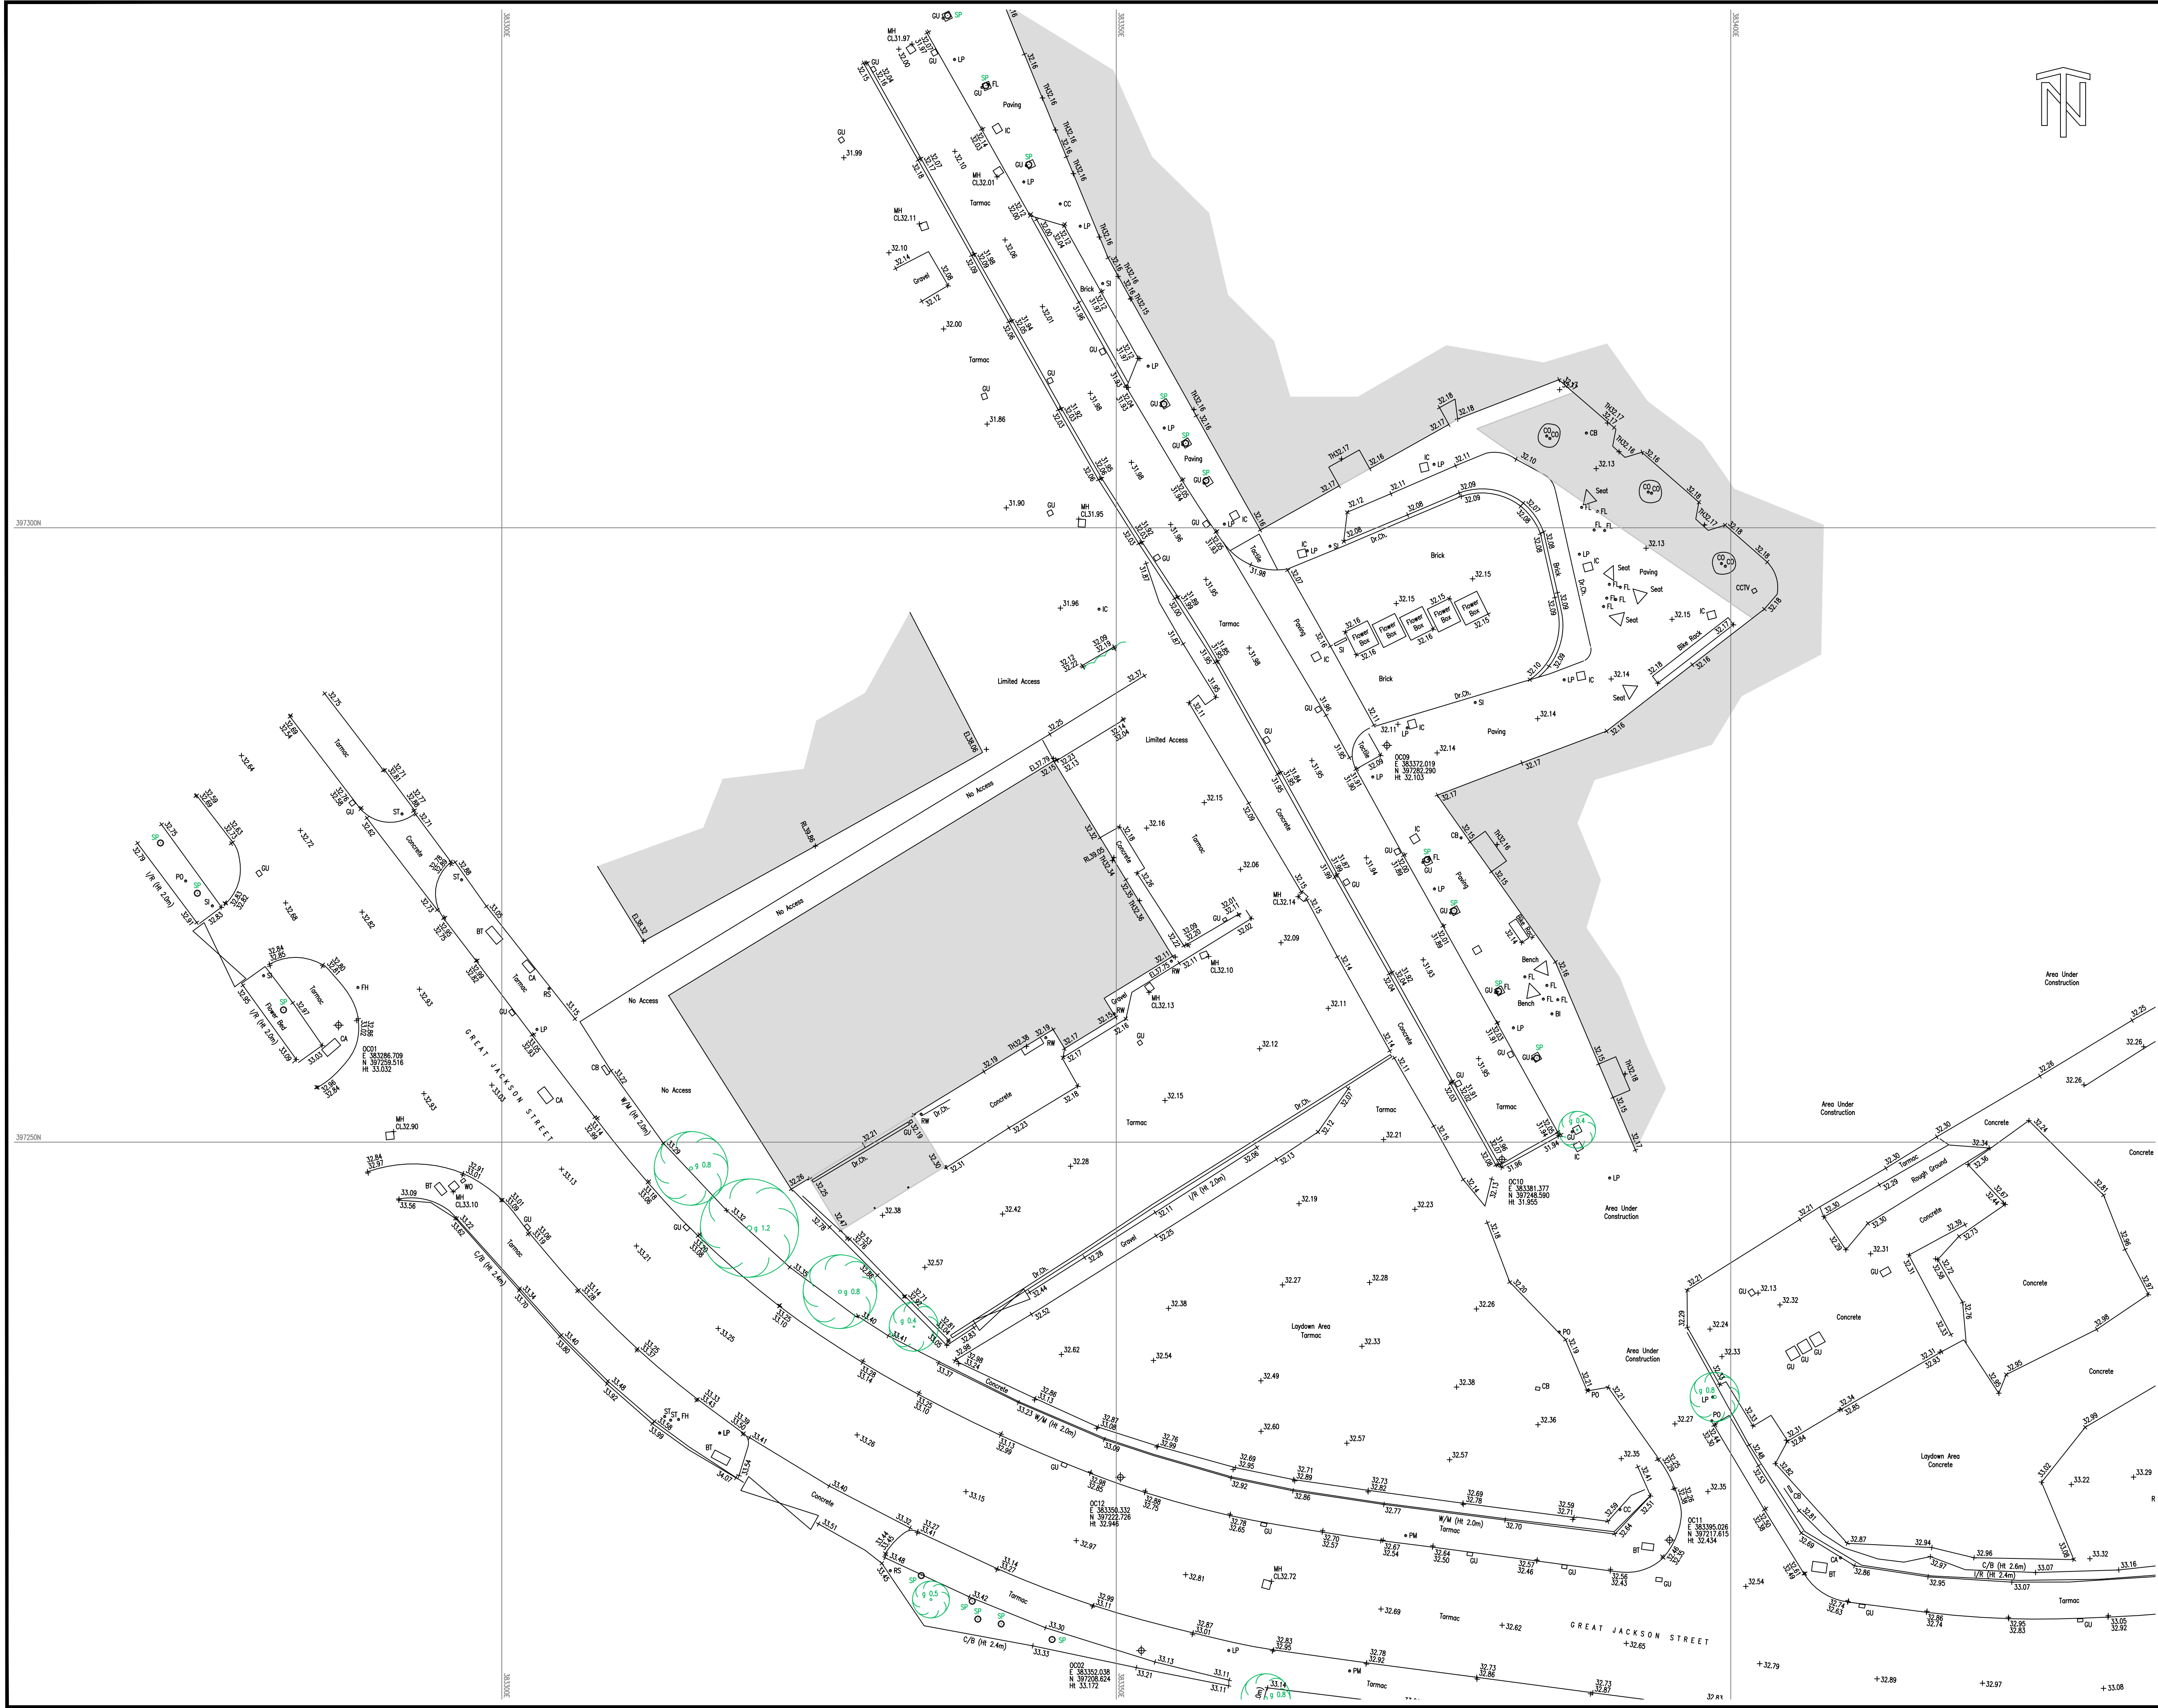
| Drawing No | 11072 / 001 / 1 | | | | 0 |

**KEY**  
Grid & Datum - Local Plane Grid related to OS National Grid & Datum  
By GNSS RTK Observations
