# MANCHESTER GRAMMAR SCHOOL, MANCHESTER

## PHASE 1: PRELIMINARY RISK ASSESSMENT

**Job Number:** LKC 23 1086  
**Date:** March 2023  
**Client:** The Manchester Grammar School

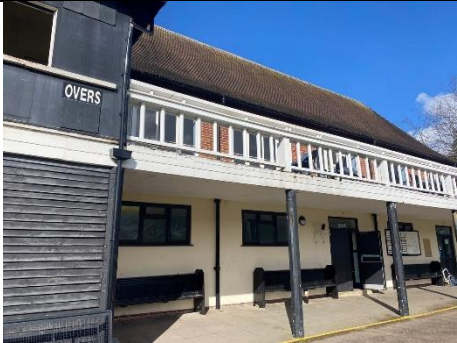
| <p><b>Photograph 1:</b> View of site from S.</p> | <p><b>Photograph 2:</b> View of site from N.</p> |

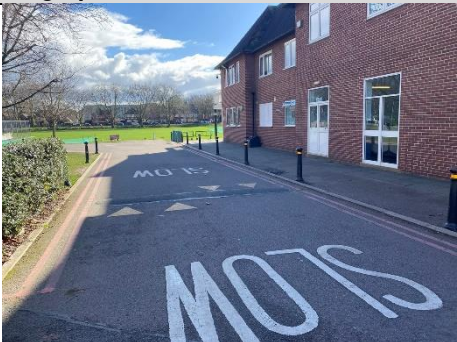
| <p><b>Photograph 3:</b> Vehicle access on eastern boundary</p> | <p><b>Photograph 4:</b> View of sloping ground to the south of site.</p> |

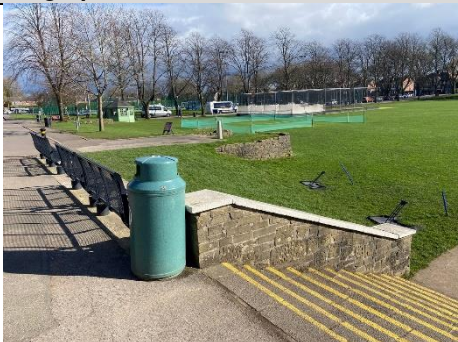
| <b>Slope Stability</b> | Site is relatively flat, however slope identified adjacent south and west of the proposed building.<br>No visible evidence of topsoil slippage and no evidence of movement or external fractures in the current onsite building. No further assessment required. |

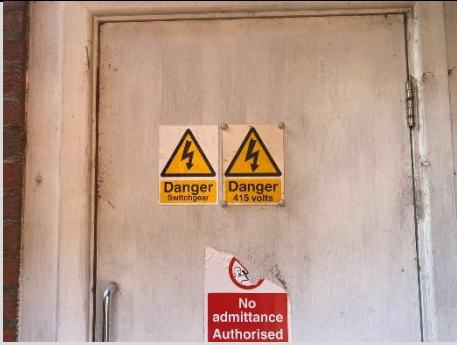
| <p><b>Photograph 5:</b> services noted within current onsite building (to be demolished).</p> | <p><b>Photograph 6:</b> services noted within proposed footprint of building.</p> |
