VALLEY GUTTER: PROPOSED WORKS TO TYPICAL DETAIL OVER VALLEY BEAM 1:5 @ A1 / 1:10 @ A3

| JOB TITLE<br>Essential Repair 1830 Warehouse,<br>Science & Industry Museum. M3 4FP | JOB NO.<br>275 | DRWG. TITLE<br>Valley Gutter: Proposed works<br>to Typical Detail over Valley<br>Beam | STATUS<br>Planning |
| DRWG. NO.<br>275 / PD / 321<br>(A1 ORIGINAL FORMAT) | REV:<br>JP | SCALE:<br>1:5@A1<br>1:10@A3 | DATE:<br>16/02/23 |

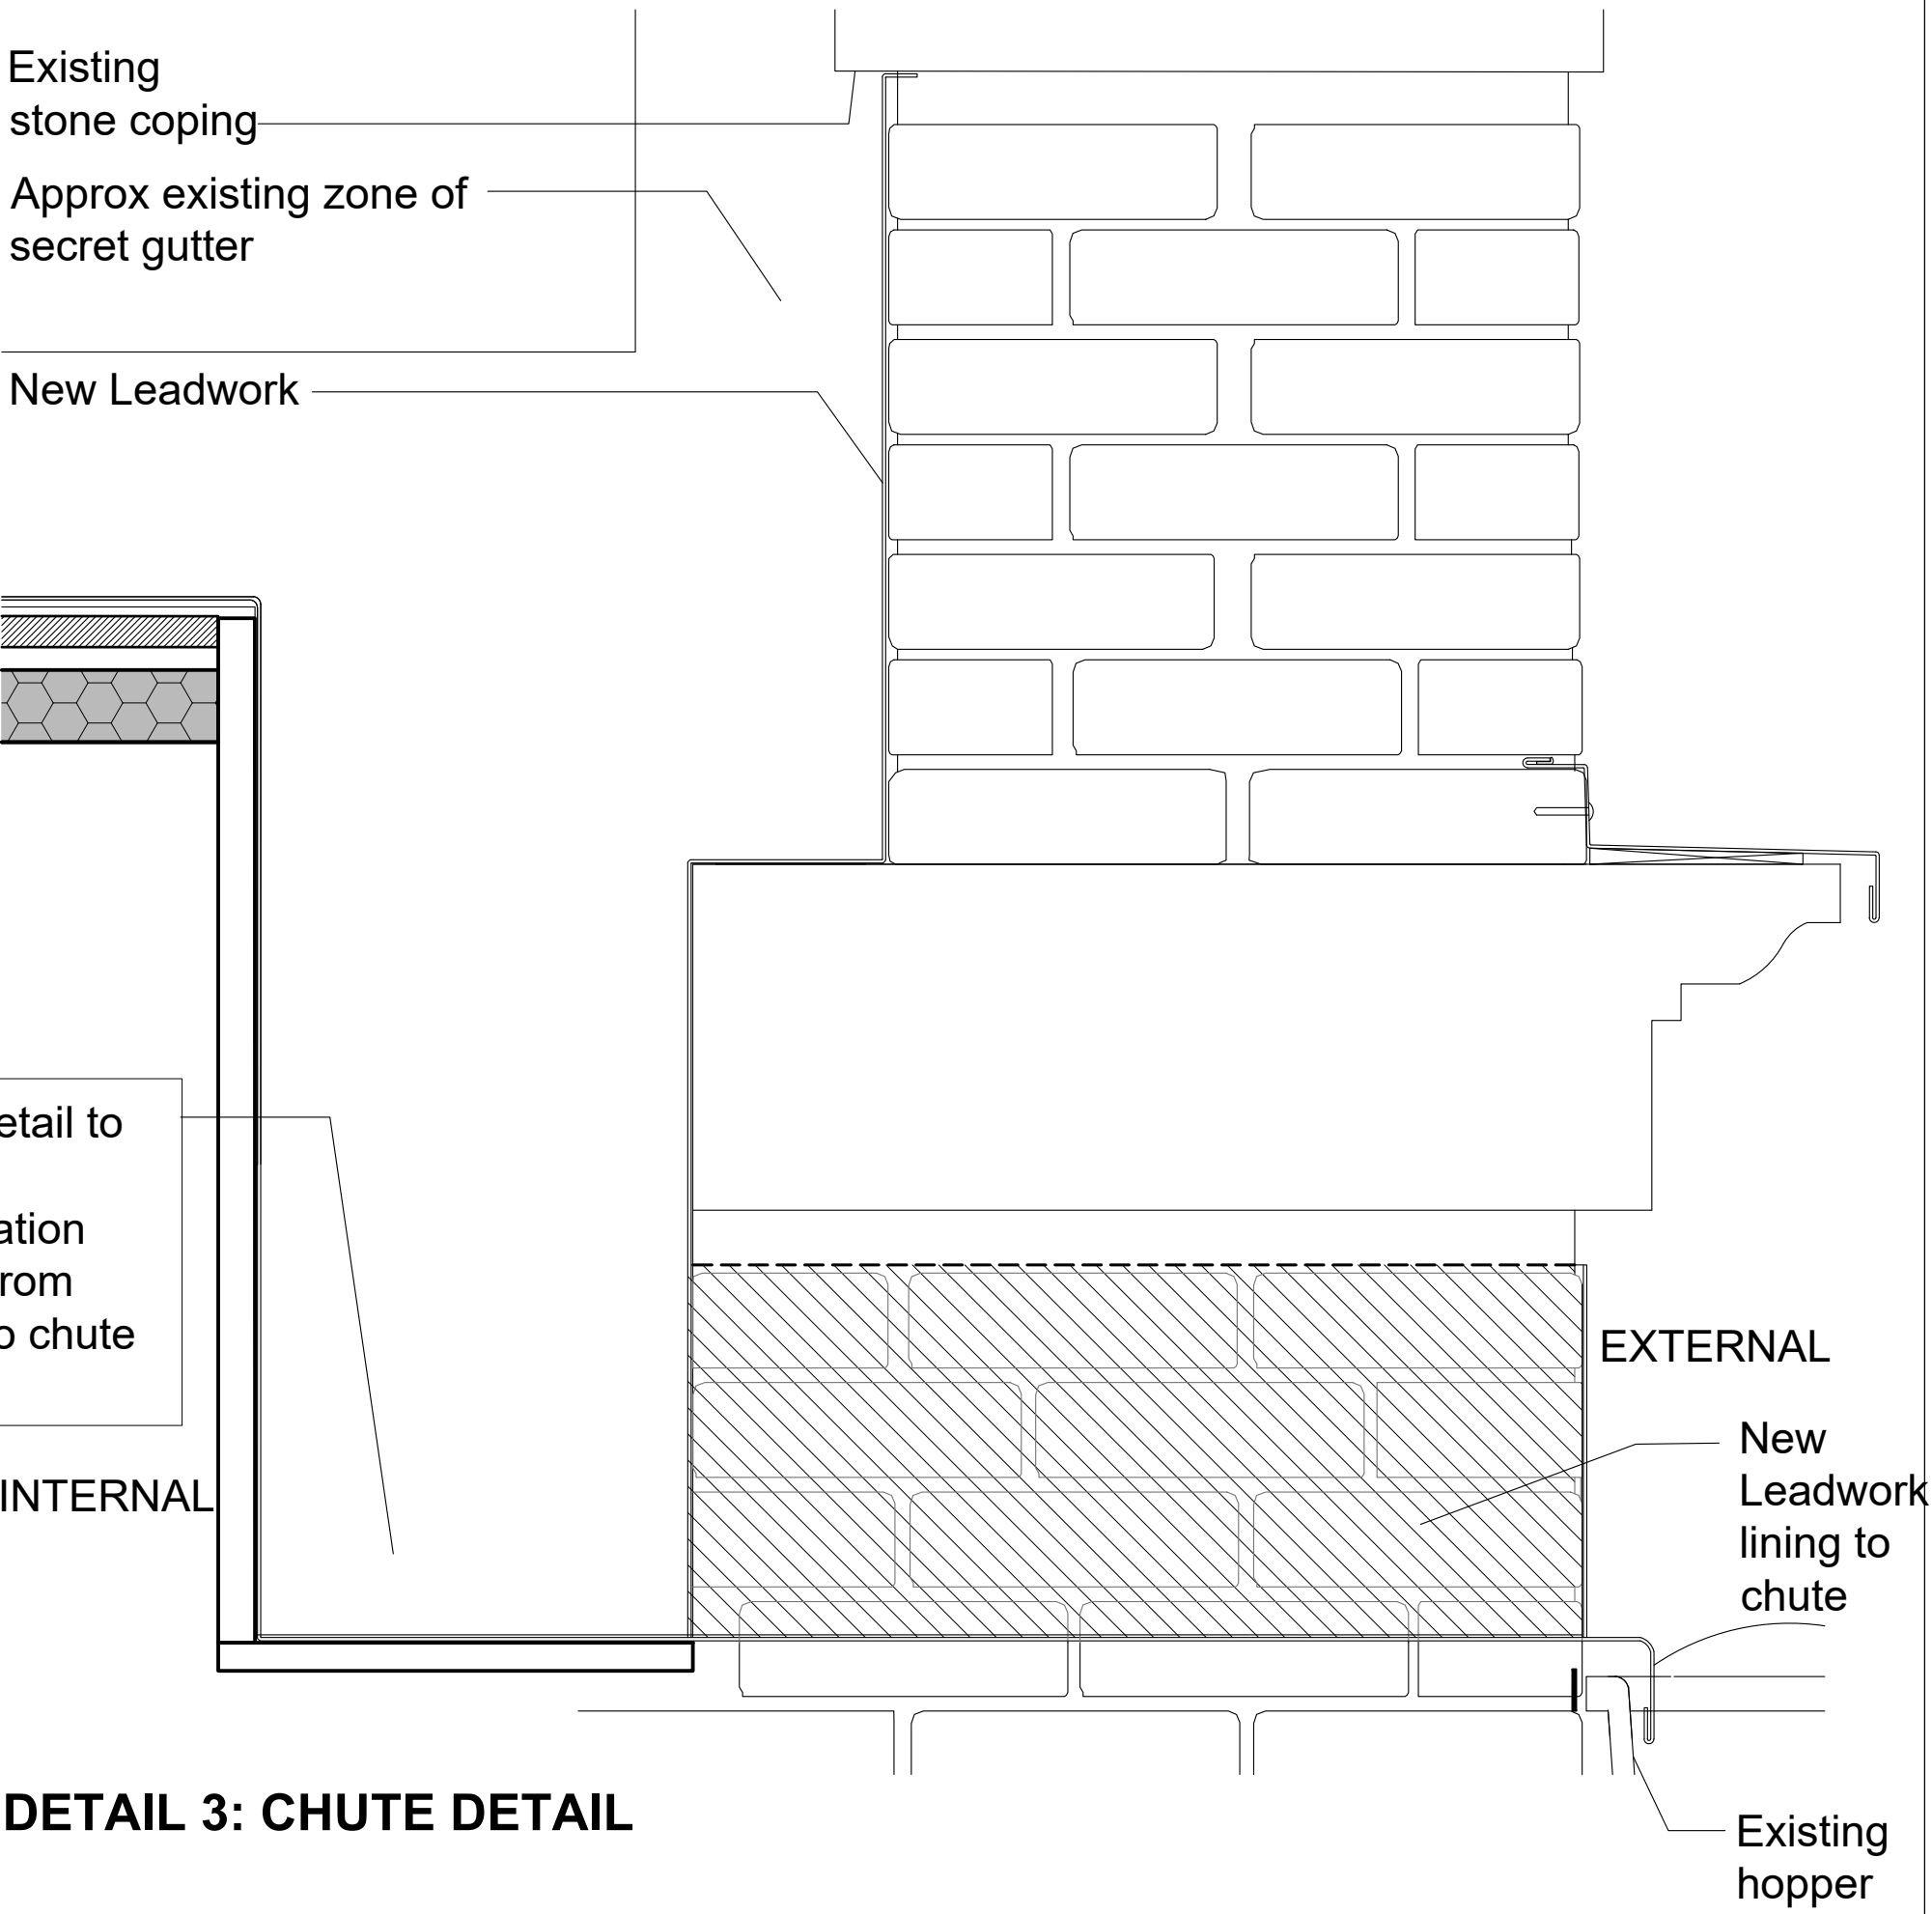
DETAIL 3: CHUTE DETAIL

MC to survey and verify detail to chute outlet on site and to complete design of installation detail with new leadwork from valley gutter via catchpit to chute in each case.
