## 358 Security fencing specification for Treetop Trek facility – Heaton Park

358 Security fencing to enclose the accessible areas of the Treetop Trek and Treetop Nets course in Heaton Park.

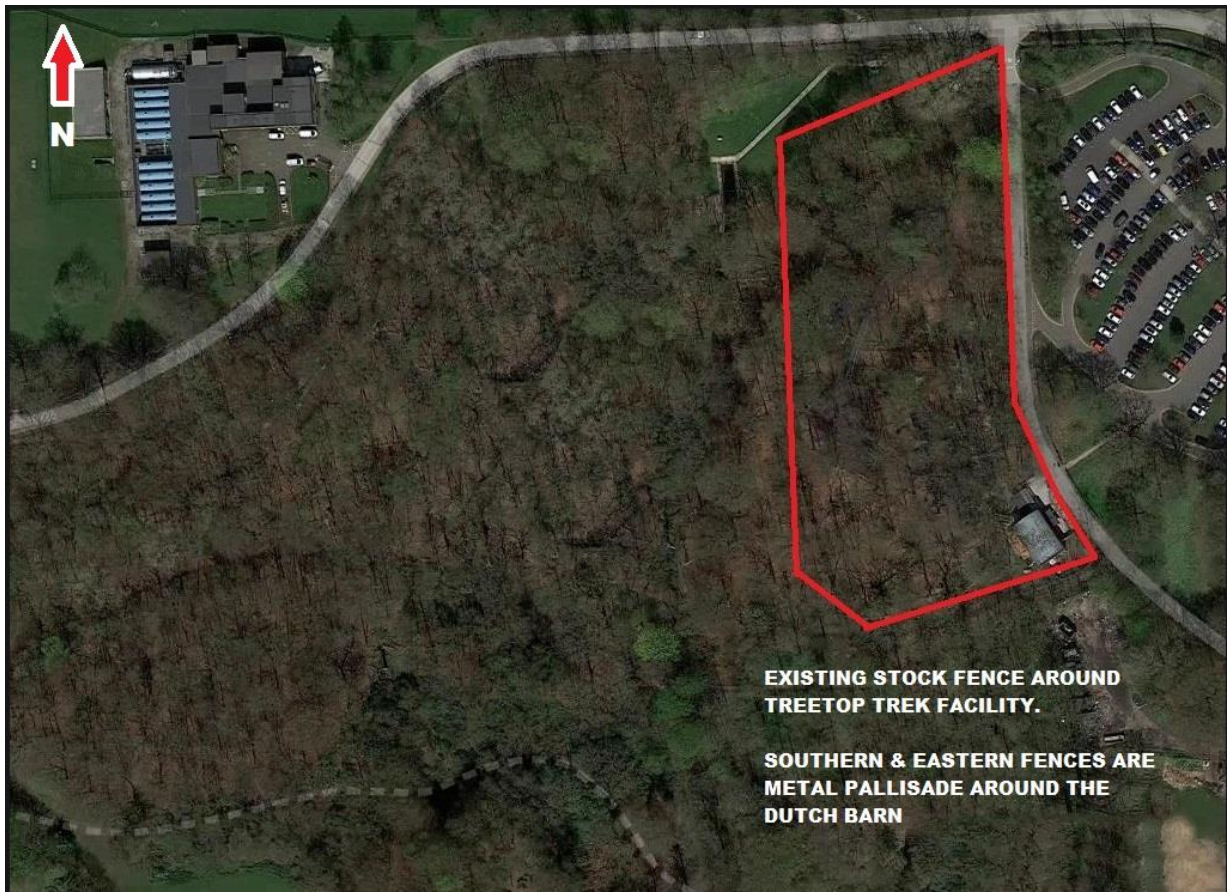
The two sets of maintenance gates to the complex will remain in the same position as the existing gates. Please see map below with red line illustrating the current location of the stock fencing. Maintenance gates will be situated, North East corner and South East corner by the Dutch Barn.

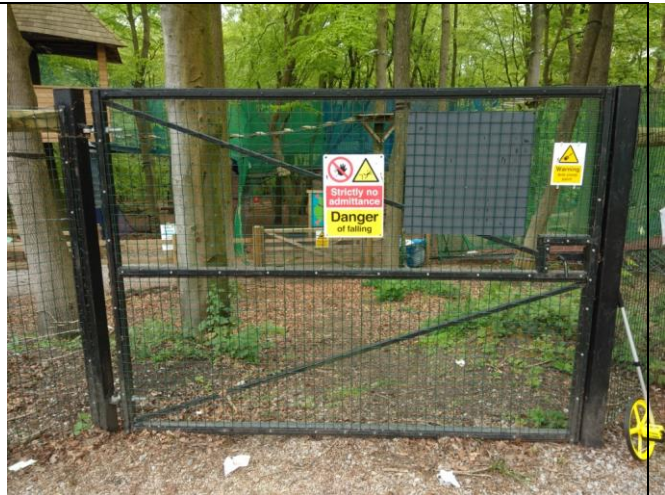
- Removal of existing 2.5m maintenance gate.

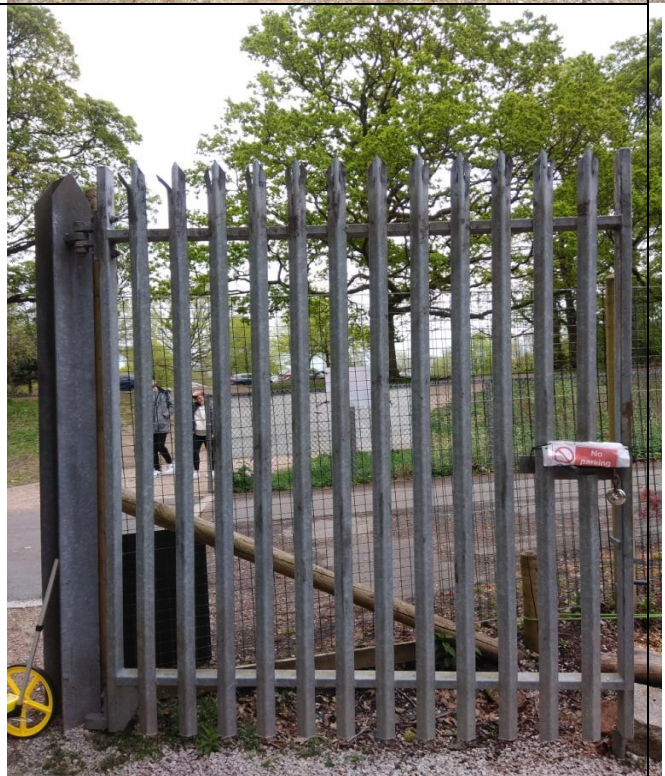
- Removal of existing 4.4m double palisade entrance gates.

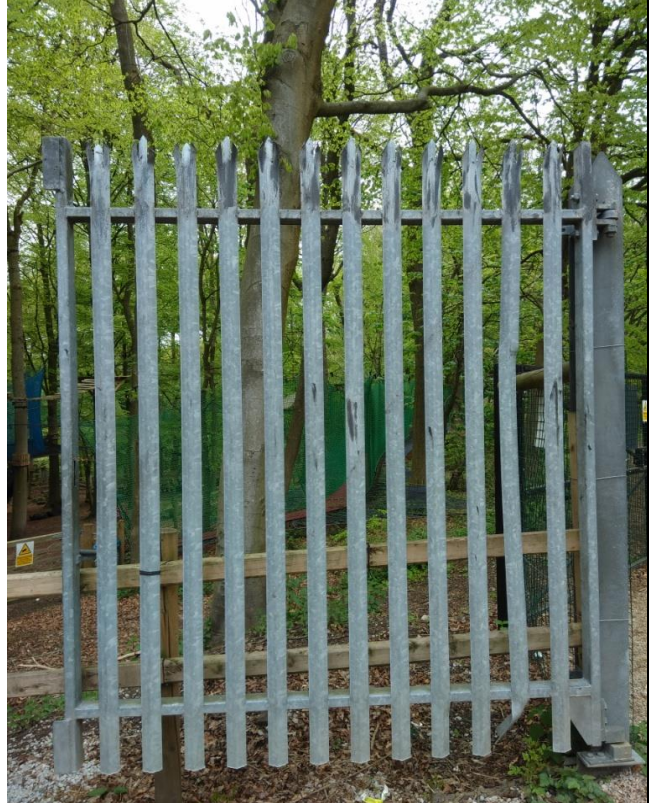
- Removal of existing 6m double palisade rear gates.
- Also removal of existing remainder of palisade fencing at rear of compound approximately 30m.

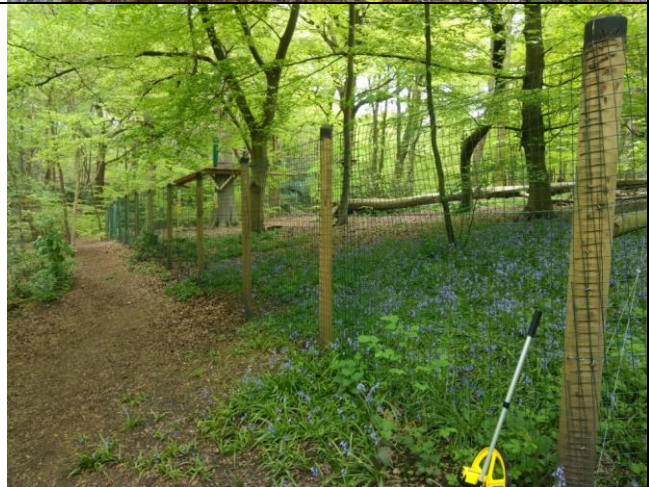
- Removal of existing stock fencing from around perimeter of Treetop Nets.
- Including removal of existing 1.2m pedestrian gate.

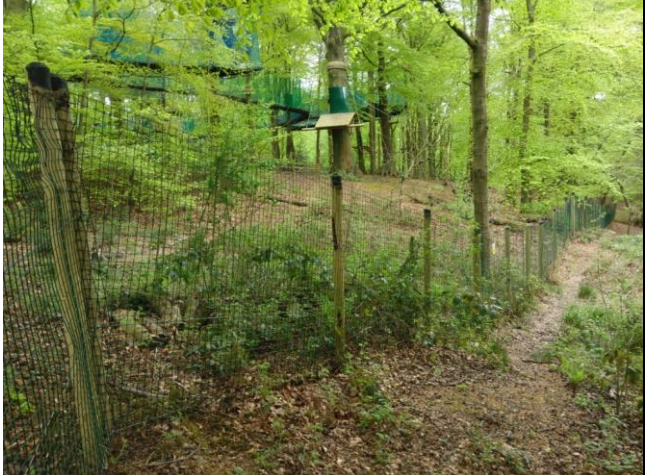
| <ul style="list-style-type: none"> <li>• Woodland location with some sloping areas.</li> </ul> | |

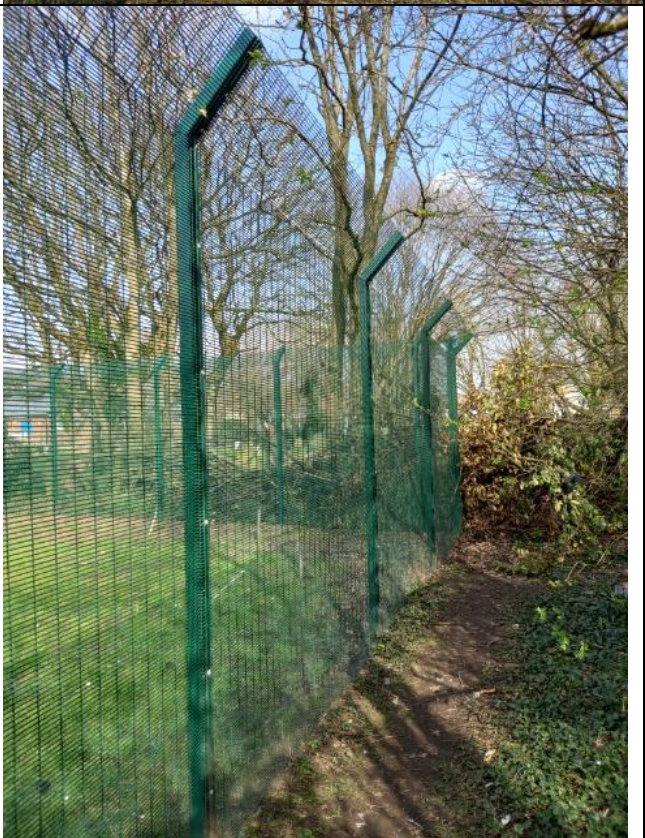
| <ul style="list-style-type: none"> <li>• To enclose the accessible area of the Treetop Trek course and enclose the Treetop Nets course;</li> </ul> <p>Including provision of new gates;</p> <ul style="list-style-type: none"> <li>• 2.4m maintenance gate</li> <li>• 4.4m double entrance gates</li> <li>• 6m double rear gates</li> <li>• 1.2m pedestrian gate</li> </ul> | |

| <p>Comments:</p> <ul style="list-style-type: none"> <li>• There is restricted access to some of the work areas.</li> <li>• Additional posts and 358 security mesh pannels cut in half on sloping areas of site.</li> <li>• Locking mechanisms for gates need to be sympathetically positioned at a low level so as not to provide a foot hole for persons attempting to climb the fence / over the gates.</li> </ul> | |

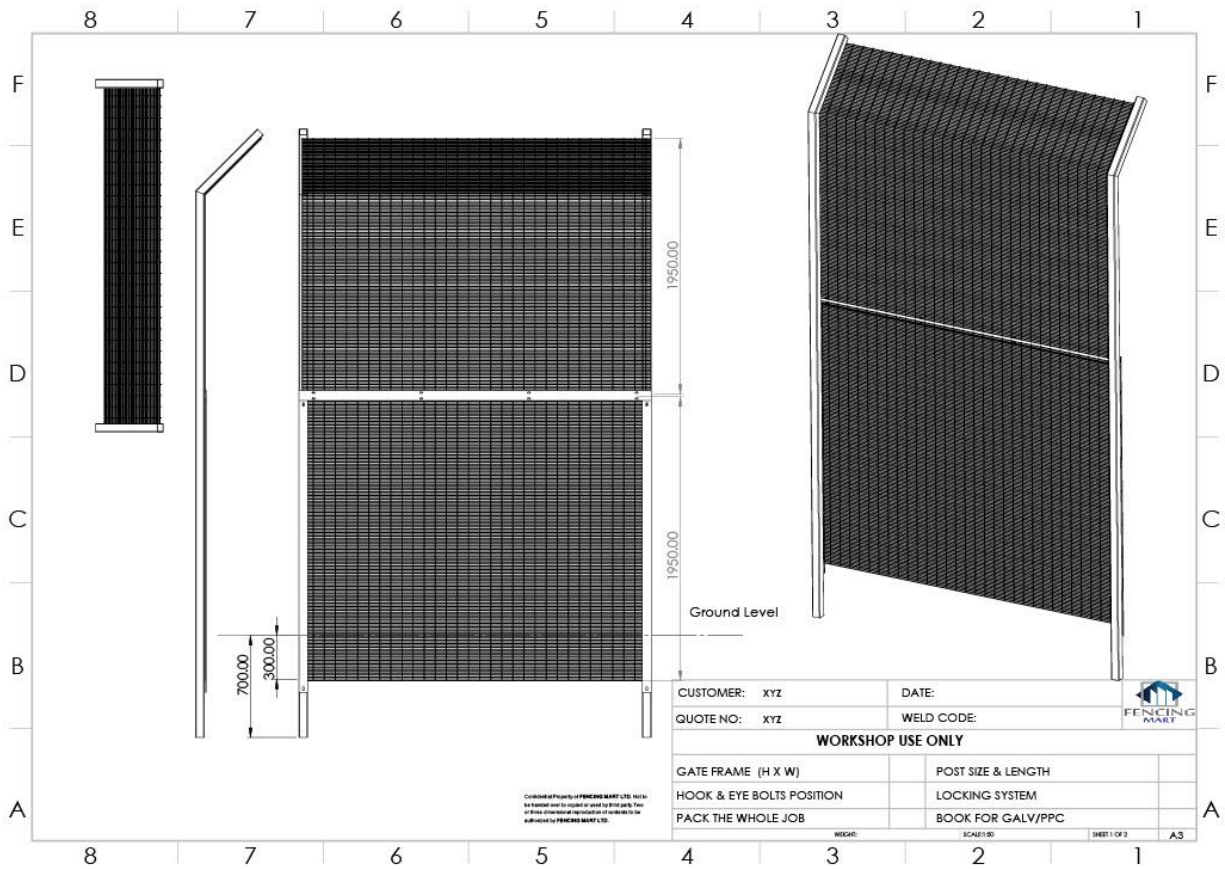
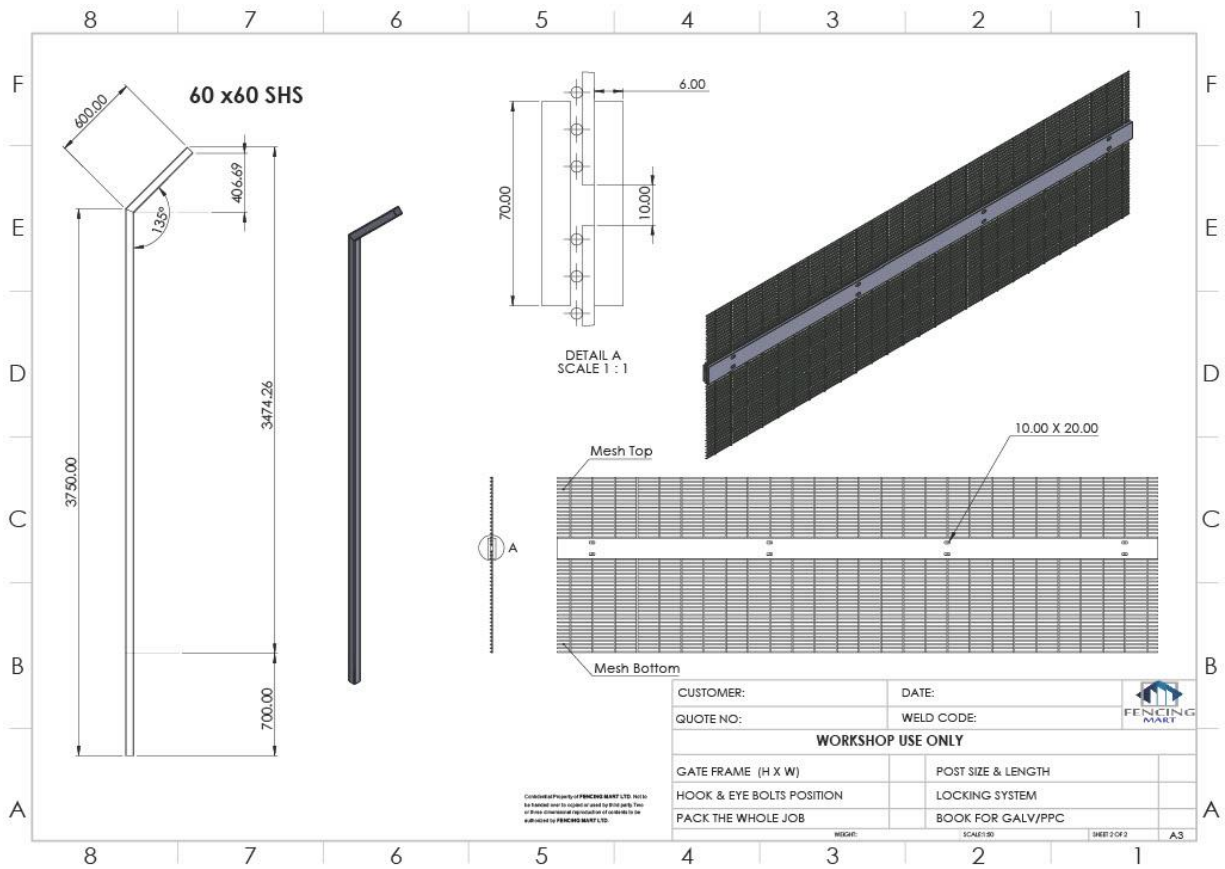
Images of 358 securi-mesh fencing -

- Install 3m high 358 securi-mesh with a 300mm 45-degree cranked section top on 80 x 80mm box section posts with cranked tops approx. 322m in length, manufactured from pre-galvanised steel and powder coated in dark green - RAL 6005.

- 358 securi-mesh fencing panels contain wires which are 4mm in thickness and have openings of 76.2mm x 12.7mm. The wires are welded at each intersection and the narrow apertures make the mesh difficult to climb, vandalise or cut through using conventional tools.
