VALLEY GUTTER: PROPOSED TYPICAL DETAIL OVER CROSS WALL 1:5 @ A1 / 1:10 @ A3

| BASED ON MEASURED SURVEY BY "SITECH SURVEYING SERVICES" | | | | |
|---|---|---|---|---|
| JOB TITLE<br>Essential Repair 1830 Warehouse,<br>Science & Industry Museum, M3 4FP | JOB NO.<br>275 | DRWG. TITLE<br>Valley Gutter: Proposed Works<br>to Typical Detail over Brick<br>Cross Wall | STATUS<br>Planning | |
| | | DRWG. NO.<br>275 / PD / 322<br>(A1 ORIGINAL FORMAT) | REV:<br>JP | SCALE:<br>1:5@A1<br>1:10@A3 |

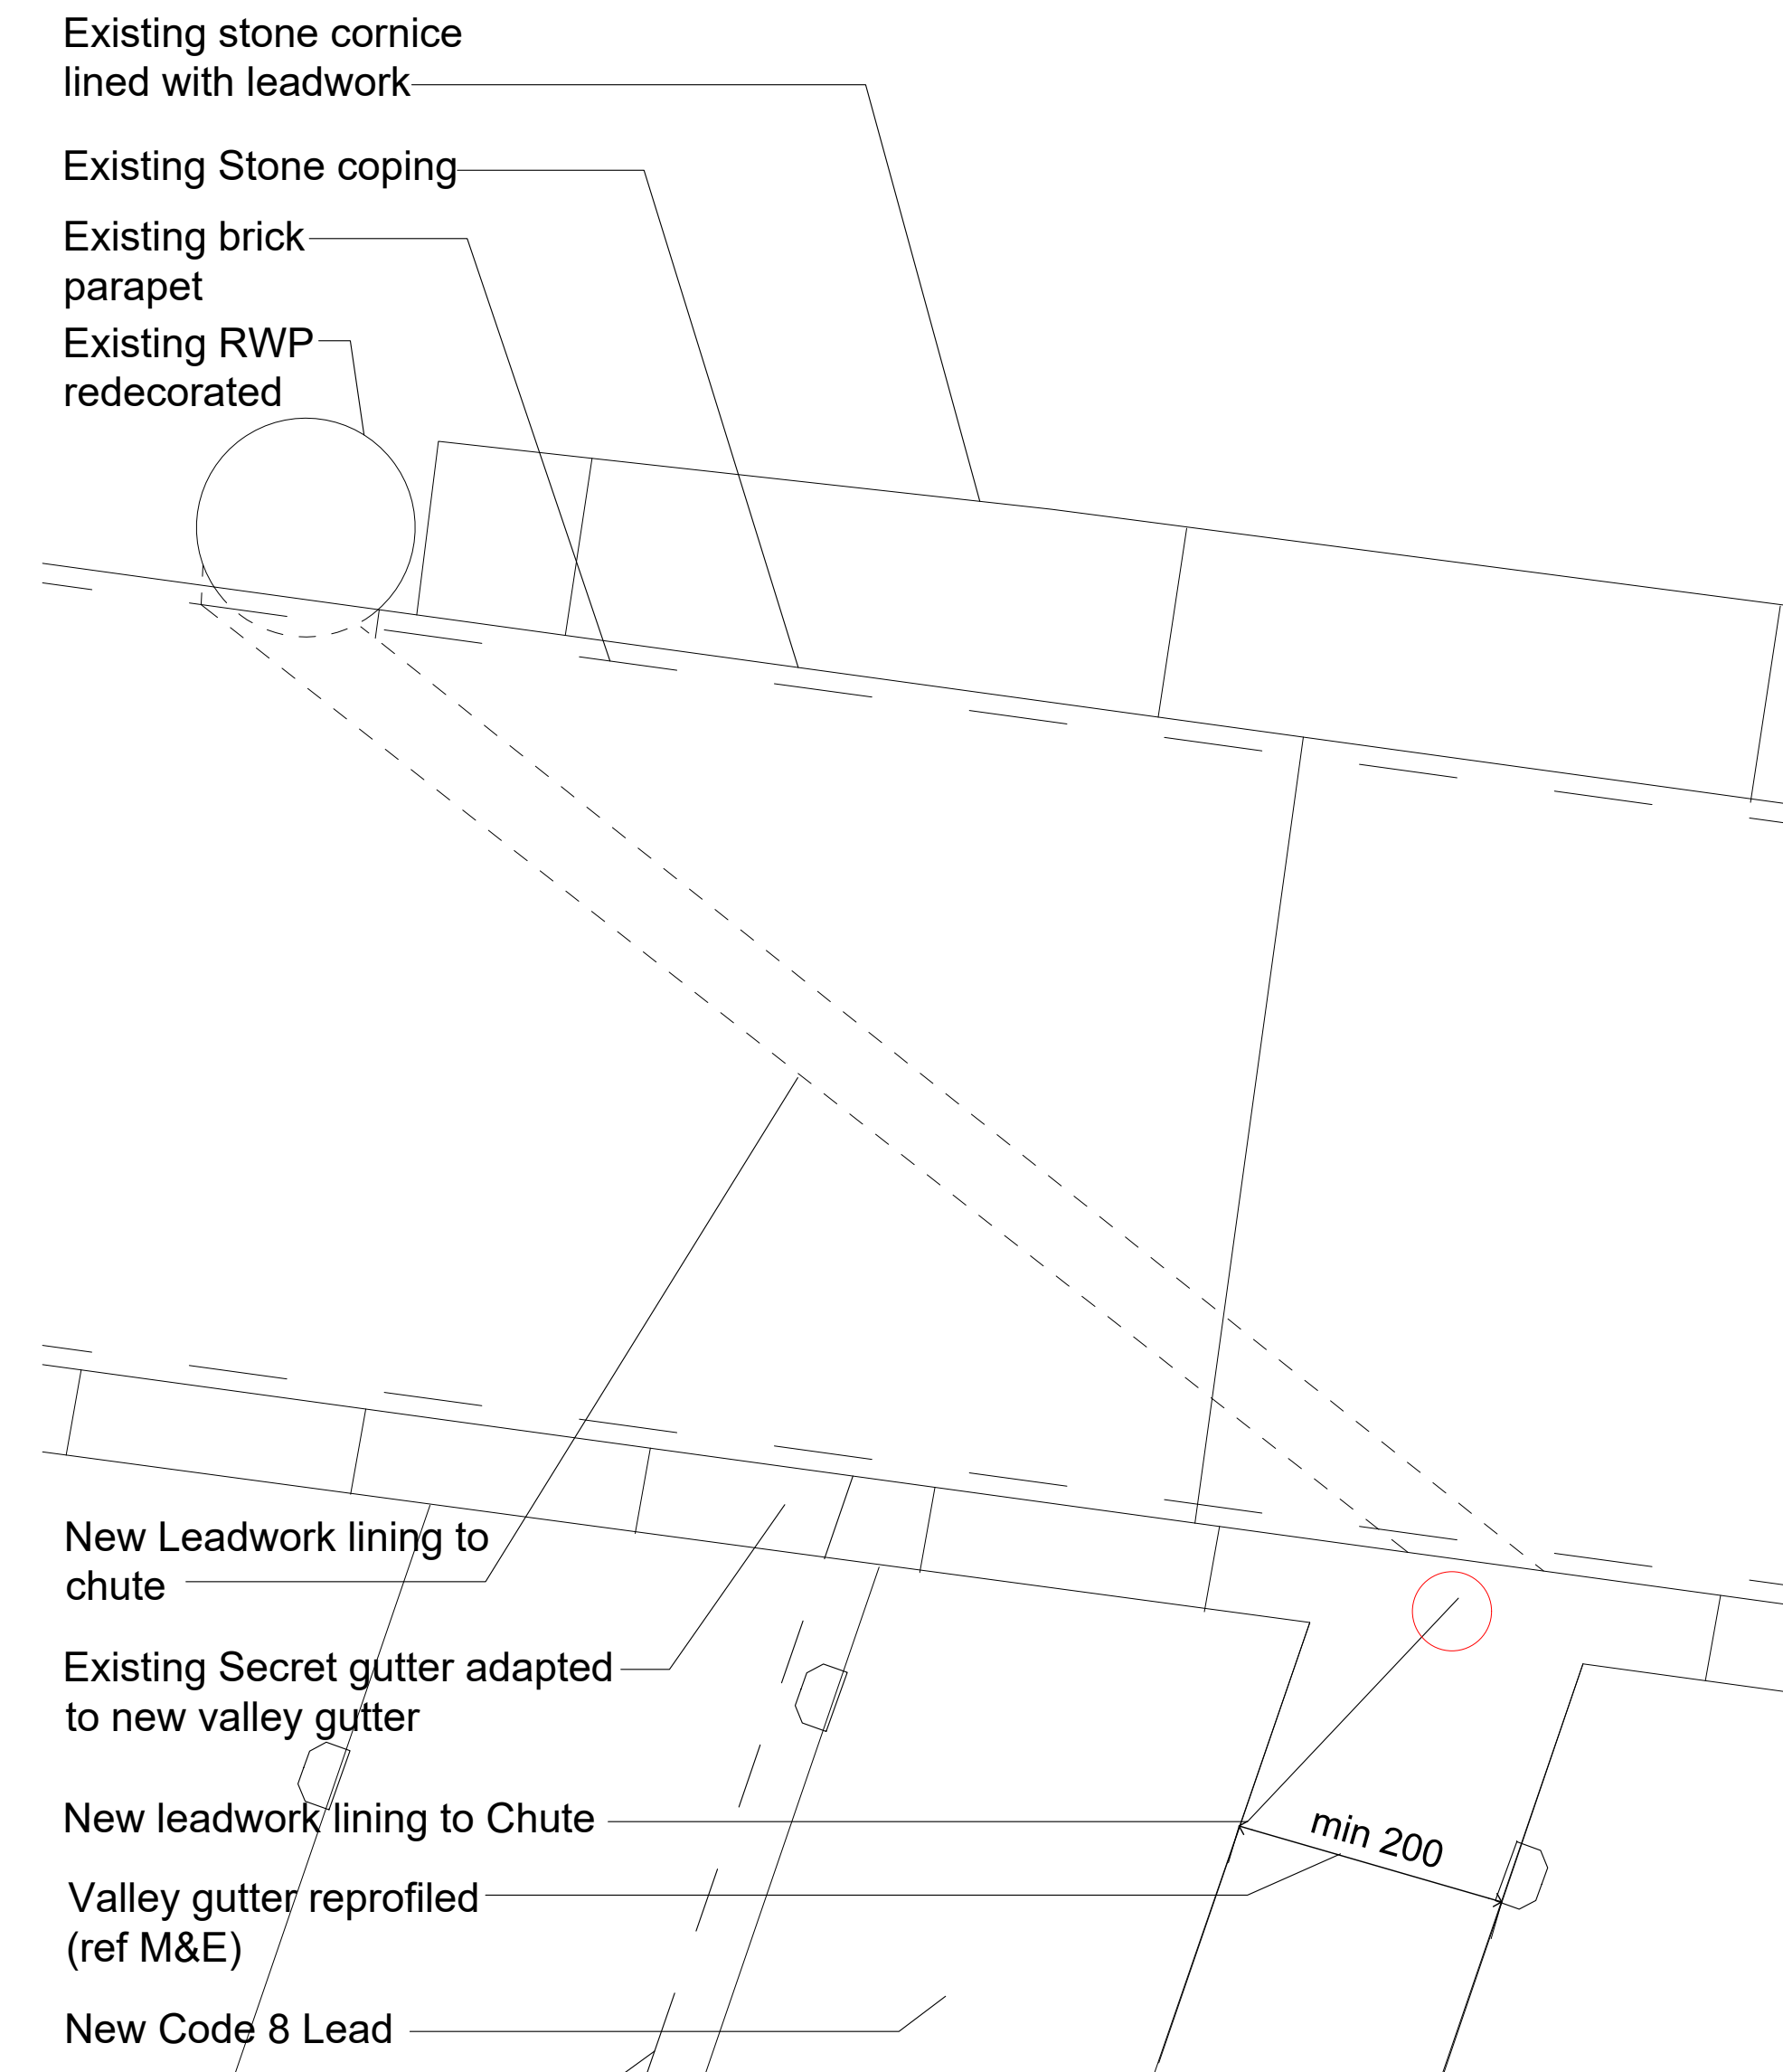
DETAIL 3: ROOF PLAN

KEY PLAN  
(Roof plan)
