**Design and Access Statement and Heritage Impact Assessment Proposed Fire  
Exit Door**

**Manchester Cathedral Visitor Centre**

**10 Cateaton St, Manchester M3 1SQ**

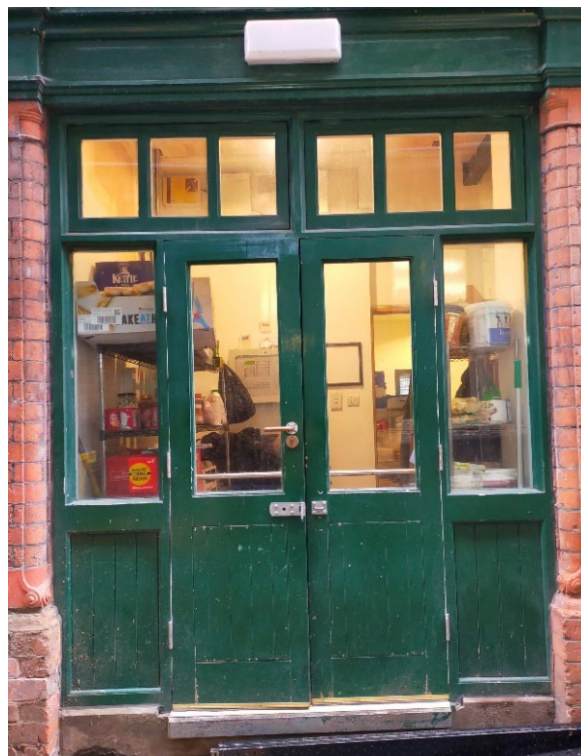
The proposed works relate to fire exit door to the east elevation of the building. The existing double doors are timber panelled with glazed upper lights. It is assumed that the existing fire exit door and windows in the building were installed as part of the refurbishment works carried out in 2002. The door is a fire exit and as such has panic bolt ironmongery internally. It opens into the alleyway enclosed between 10 Cateaton St. and 6 Cateaton St. This alleyway has access from the North and South side through metal gates which are ideally supposed to be locked. Due to the Southern gate, which approaches from the Cateaton St., remaining unlocked there have been incidents in the past where the fire exit door has been tampered from the exterior and thus poses a safety threat to the building. The specific weak point is the point at which the double doors meet.

Existing fire exit door - Exterior

To replace the existing double timber and glazed fire exit doors with a new single timber and glazed fire exit door with an outside access device for enhanced security.

The repairs proposed to the fire exit door have been carefully planned so that works result in the least possible harm to the existing building and retain as much historic fabric as possible. The repairs are essential for the long-term care and safety management of the building. The main impact on the building will be its aesthetic value which has been maintained to a large extent by matching the design and material of the new door to the existing fixed timber and glazed panels on either side of it. The new fire exit door will also be painted to match the existing fixed timber and glazed windows on the east facade of the building. The new locking mechanism on the door will maintain a safe exit route to the alleyway in case of a fire while increasing the required security of the door from the exterior which was the main security concern with the existing door.
