**RE: PLOT 10A DEVELOPMENT, FIRST STREET, MANCHESTER,  
GROUND CONTAMINATION RISK ASSESSMENT**

Ramboll UK Limited has been appointed by First Street Development Limited to provide a range of services which include contaminated land consultancy for the proposed development of Plot 10a, First Street, Manchester ('the Site').

This letter has been prepared to accompany the planning application for the proposed development of Plot 10a, First Street, Manchester. The letter outlines the previous work completed at the site and provides a ground contamination risk assessment summary for Plot 10a based on the proposed commercial end-use.

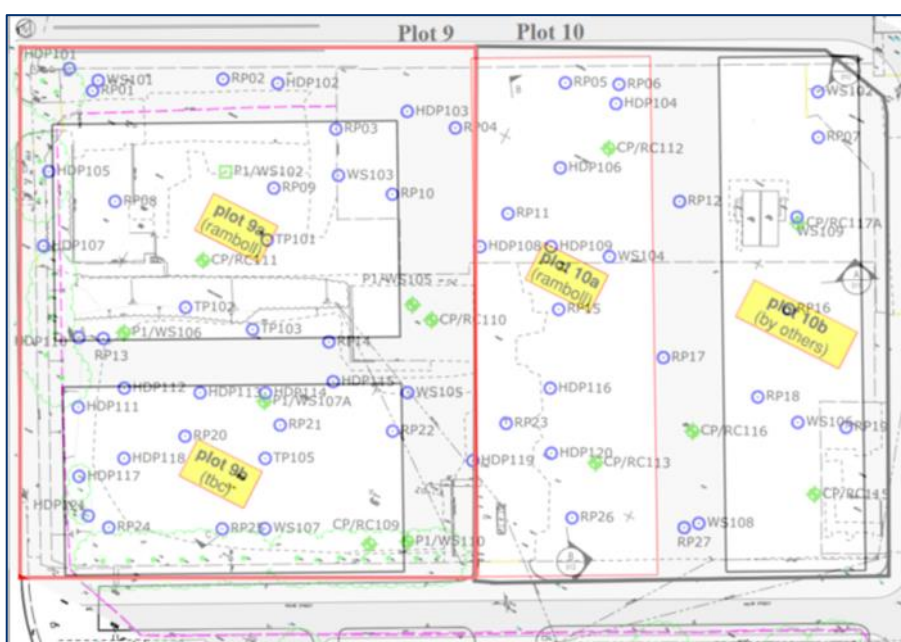
**Figure 2 Plot 10a in the context of the wider plots 9&10 investigation areas**

A site location plan is provided as Figure 1 below. A site plan showing the site boundary of Plot 10a in context of the wider site area referenced in the previous reports is provided as Figure 2. The red line boundary for Plot 10a proposed development is illustrated more accurately on Figure 3 along with the proposed development layout.

Plot 10a is approximately 0.3 Ha (hectares) in area, and rectangular in shape. Plot 10a is bounded by Plot 10b to the immediate east; Plot 9 to the immediate west, River Street to the north and Hulme Street to the south.
