Manox

Zone 5 and Zone 7  
Remediation Issues Plan

Zone 5 and Zone 7 Human  
Health Exceedances Plan

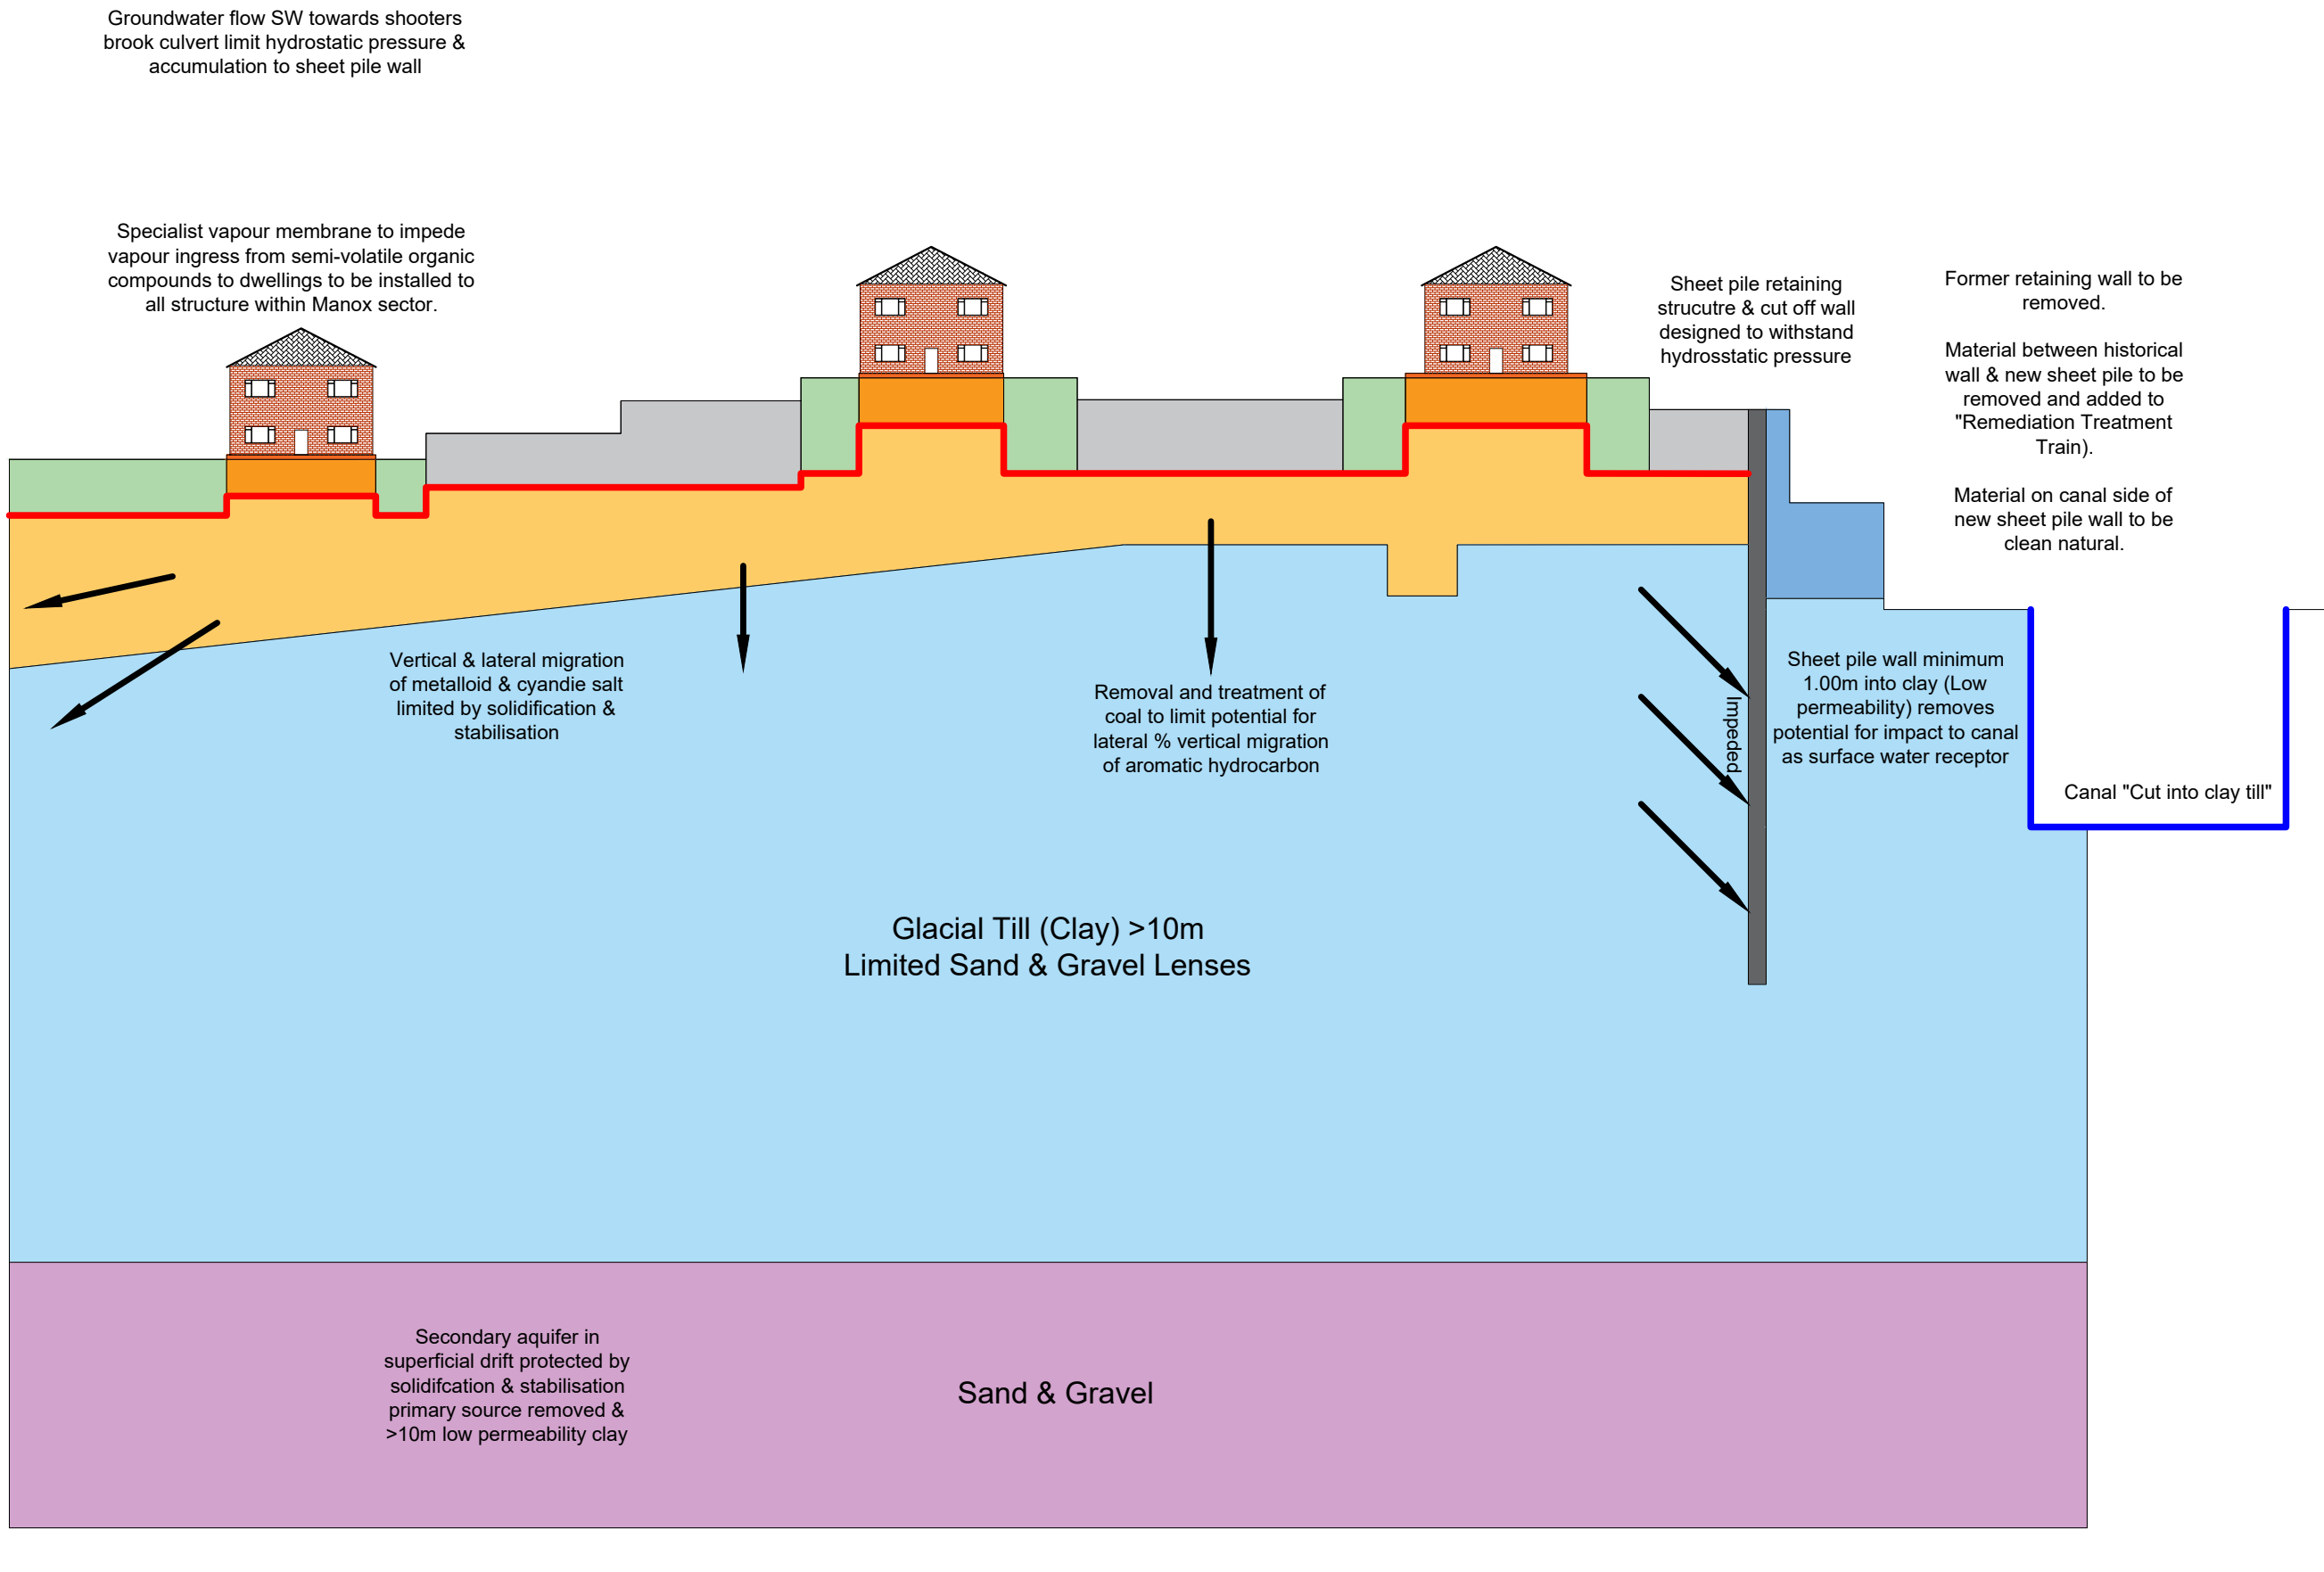
| <div>CSM Features</div> <div><div></div>Inert import &amp; Sub-Structure</div> <div><div></div>Inert import &amp; Highways &amp; Driveways</div> <div><div></div>1000mm clean cover to garden / Landscaping to remove direct exposure</div> <div><div></div>Full depth excavation of made ground across Manox site. All material enters "Remediation Train" prior to treatment, analysis &amp; Re-use</div> <div><div></div>Glacial Till (Clay)</div> <div><div></div>Sand &amp; Gravel</div> <div><div></div>Subformation or "Remediation platform level"</div> <div>Gardens 1000mm / Roads / Drives &amp; Plots - 750mm</div> |

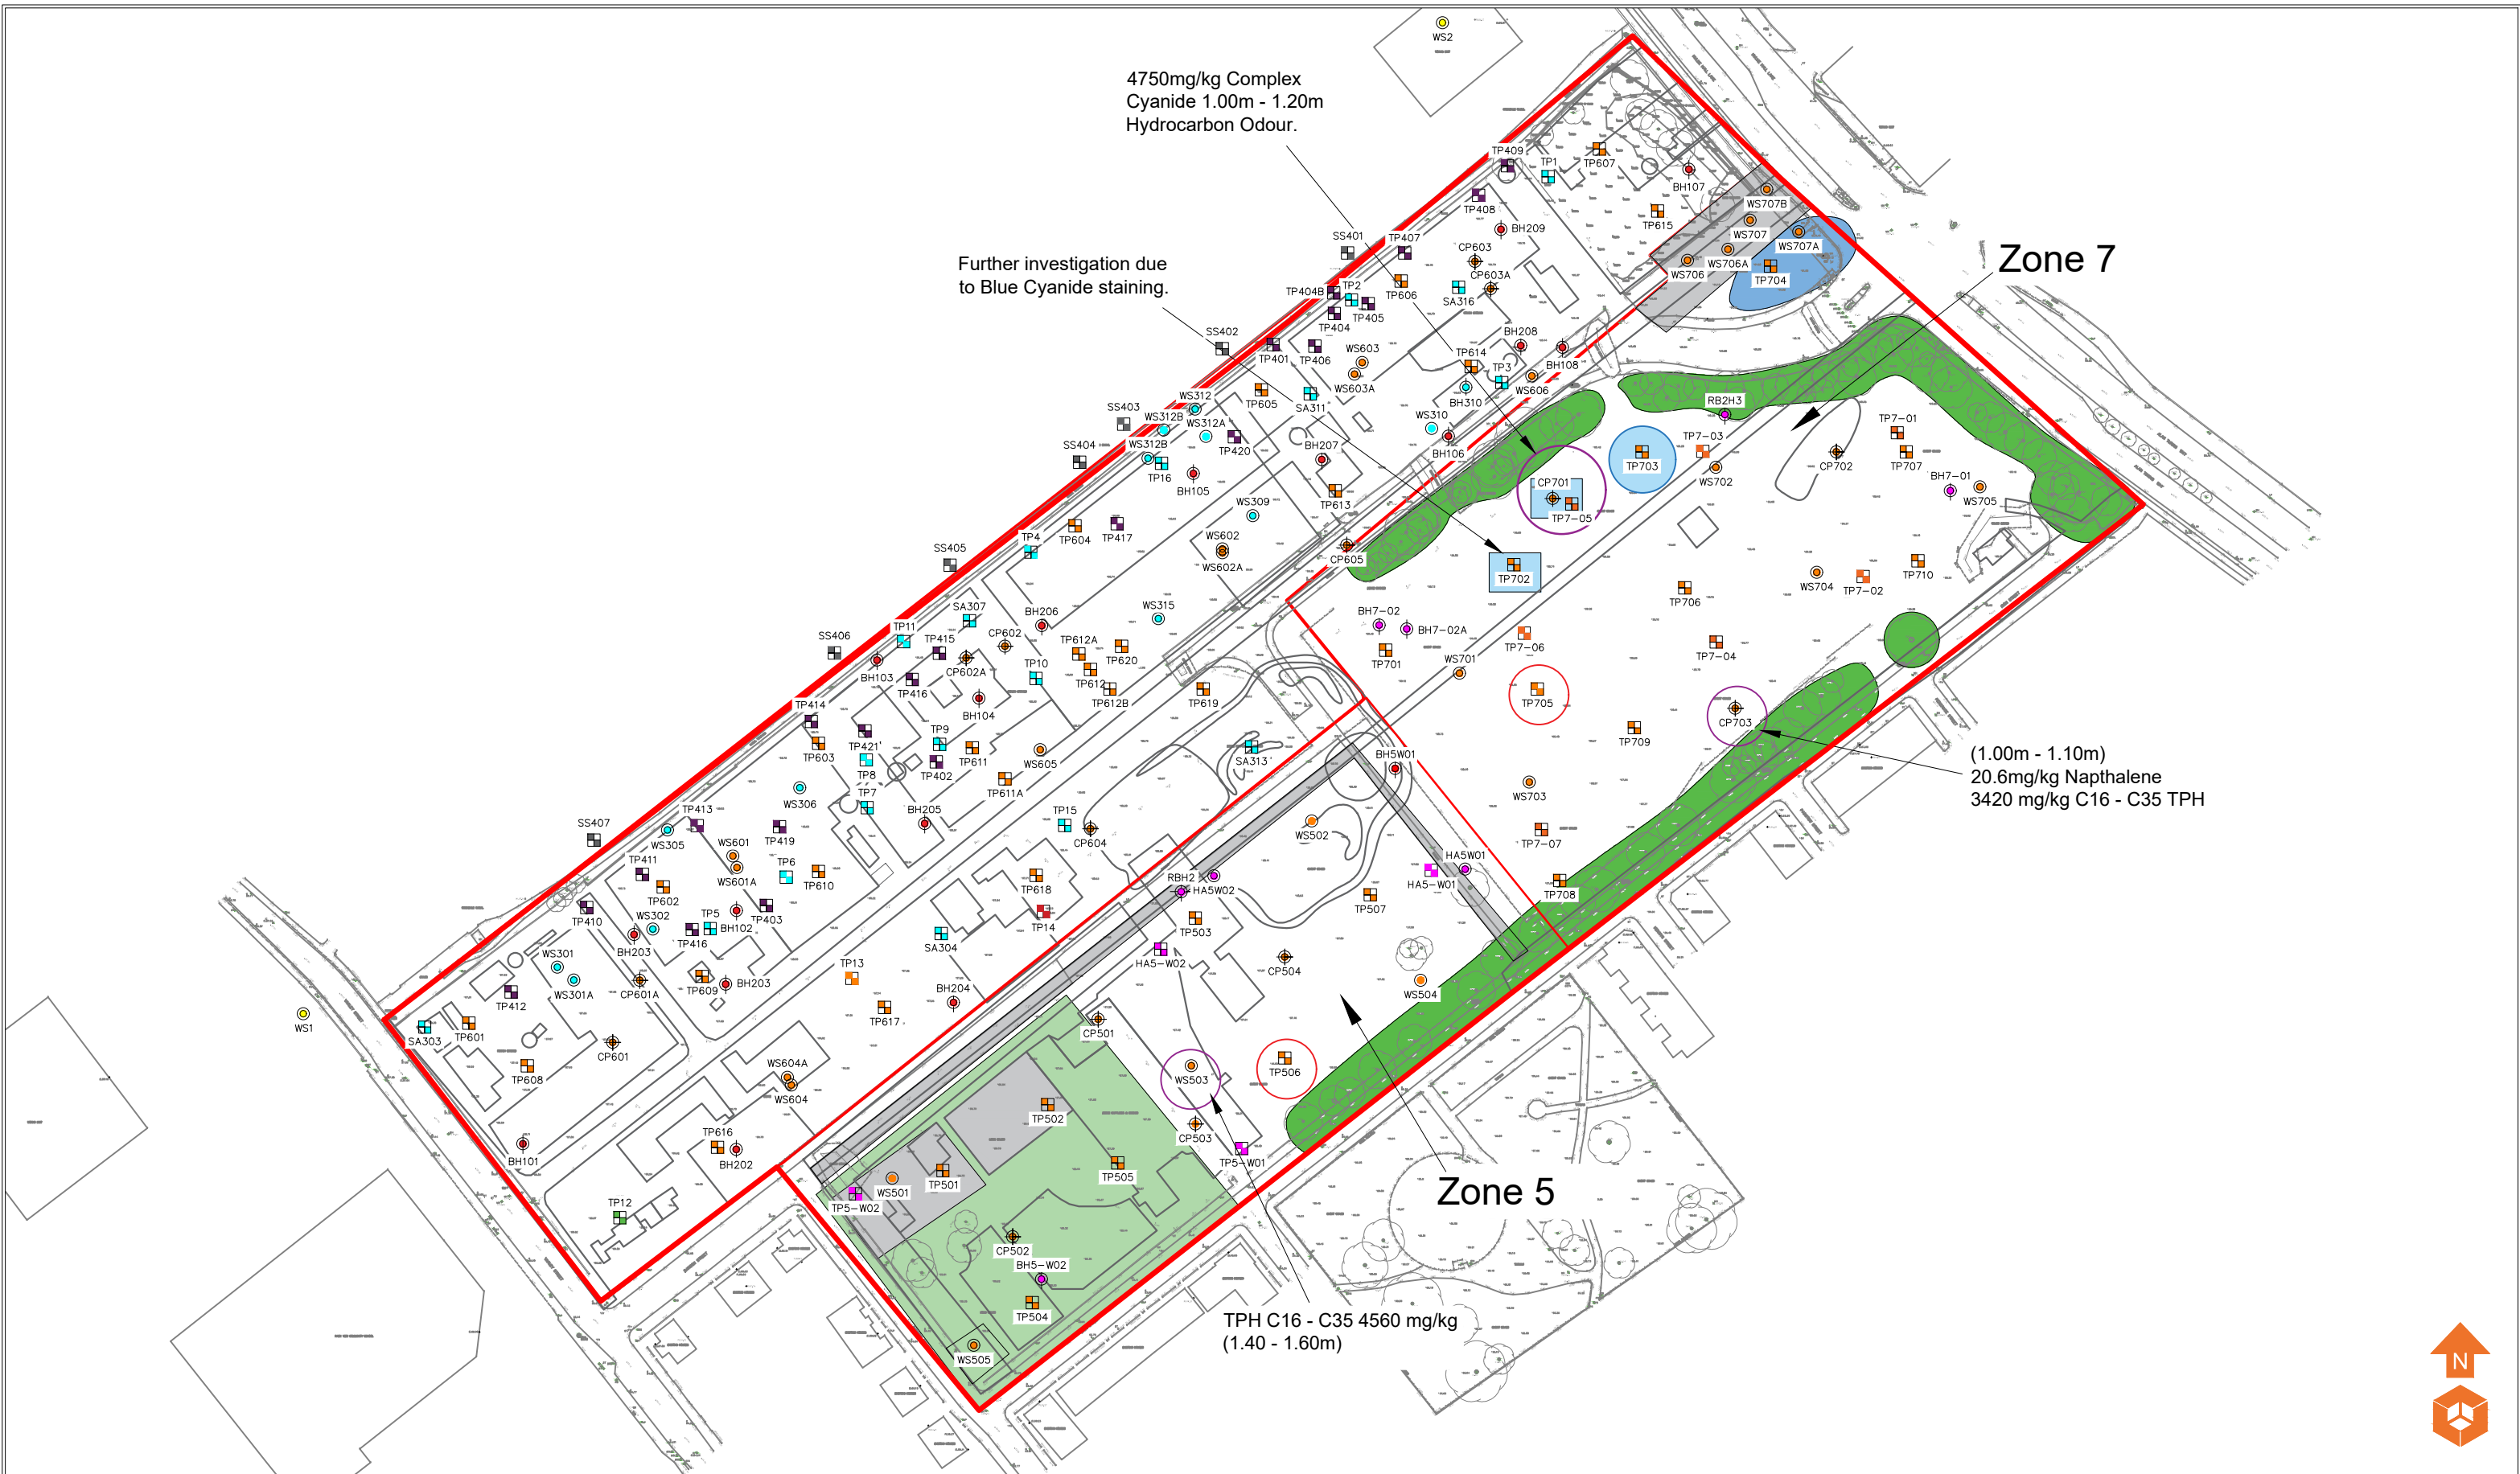
034

- Remediation Issues**
- Hardstanding / Obstruction
  - Soft / Loose natural ground
  - Dense Vegetation
  - Semi - mature Trees
  - Carbon Disulphide detected, removal required between 1.50 - 1.60m
  - Visual / Olfactory Contamination
  - Human health exceedance requiring removal

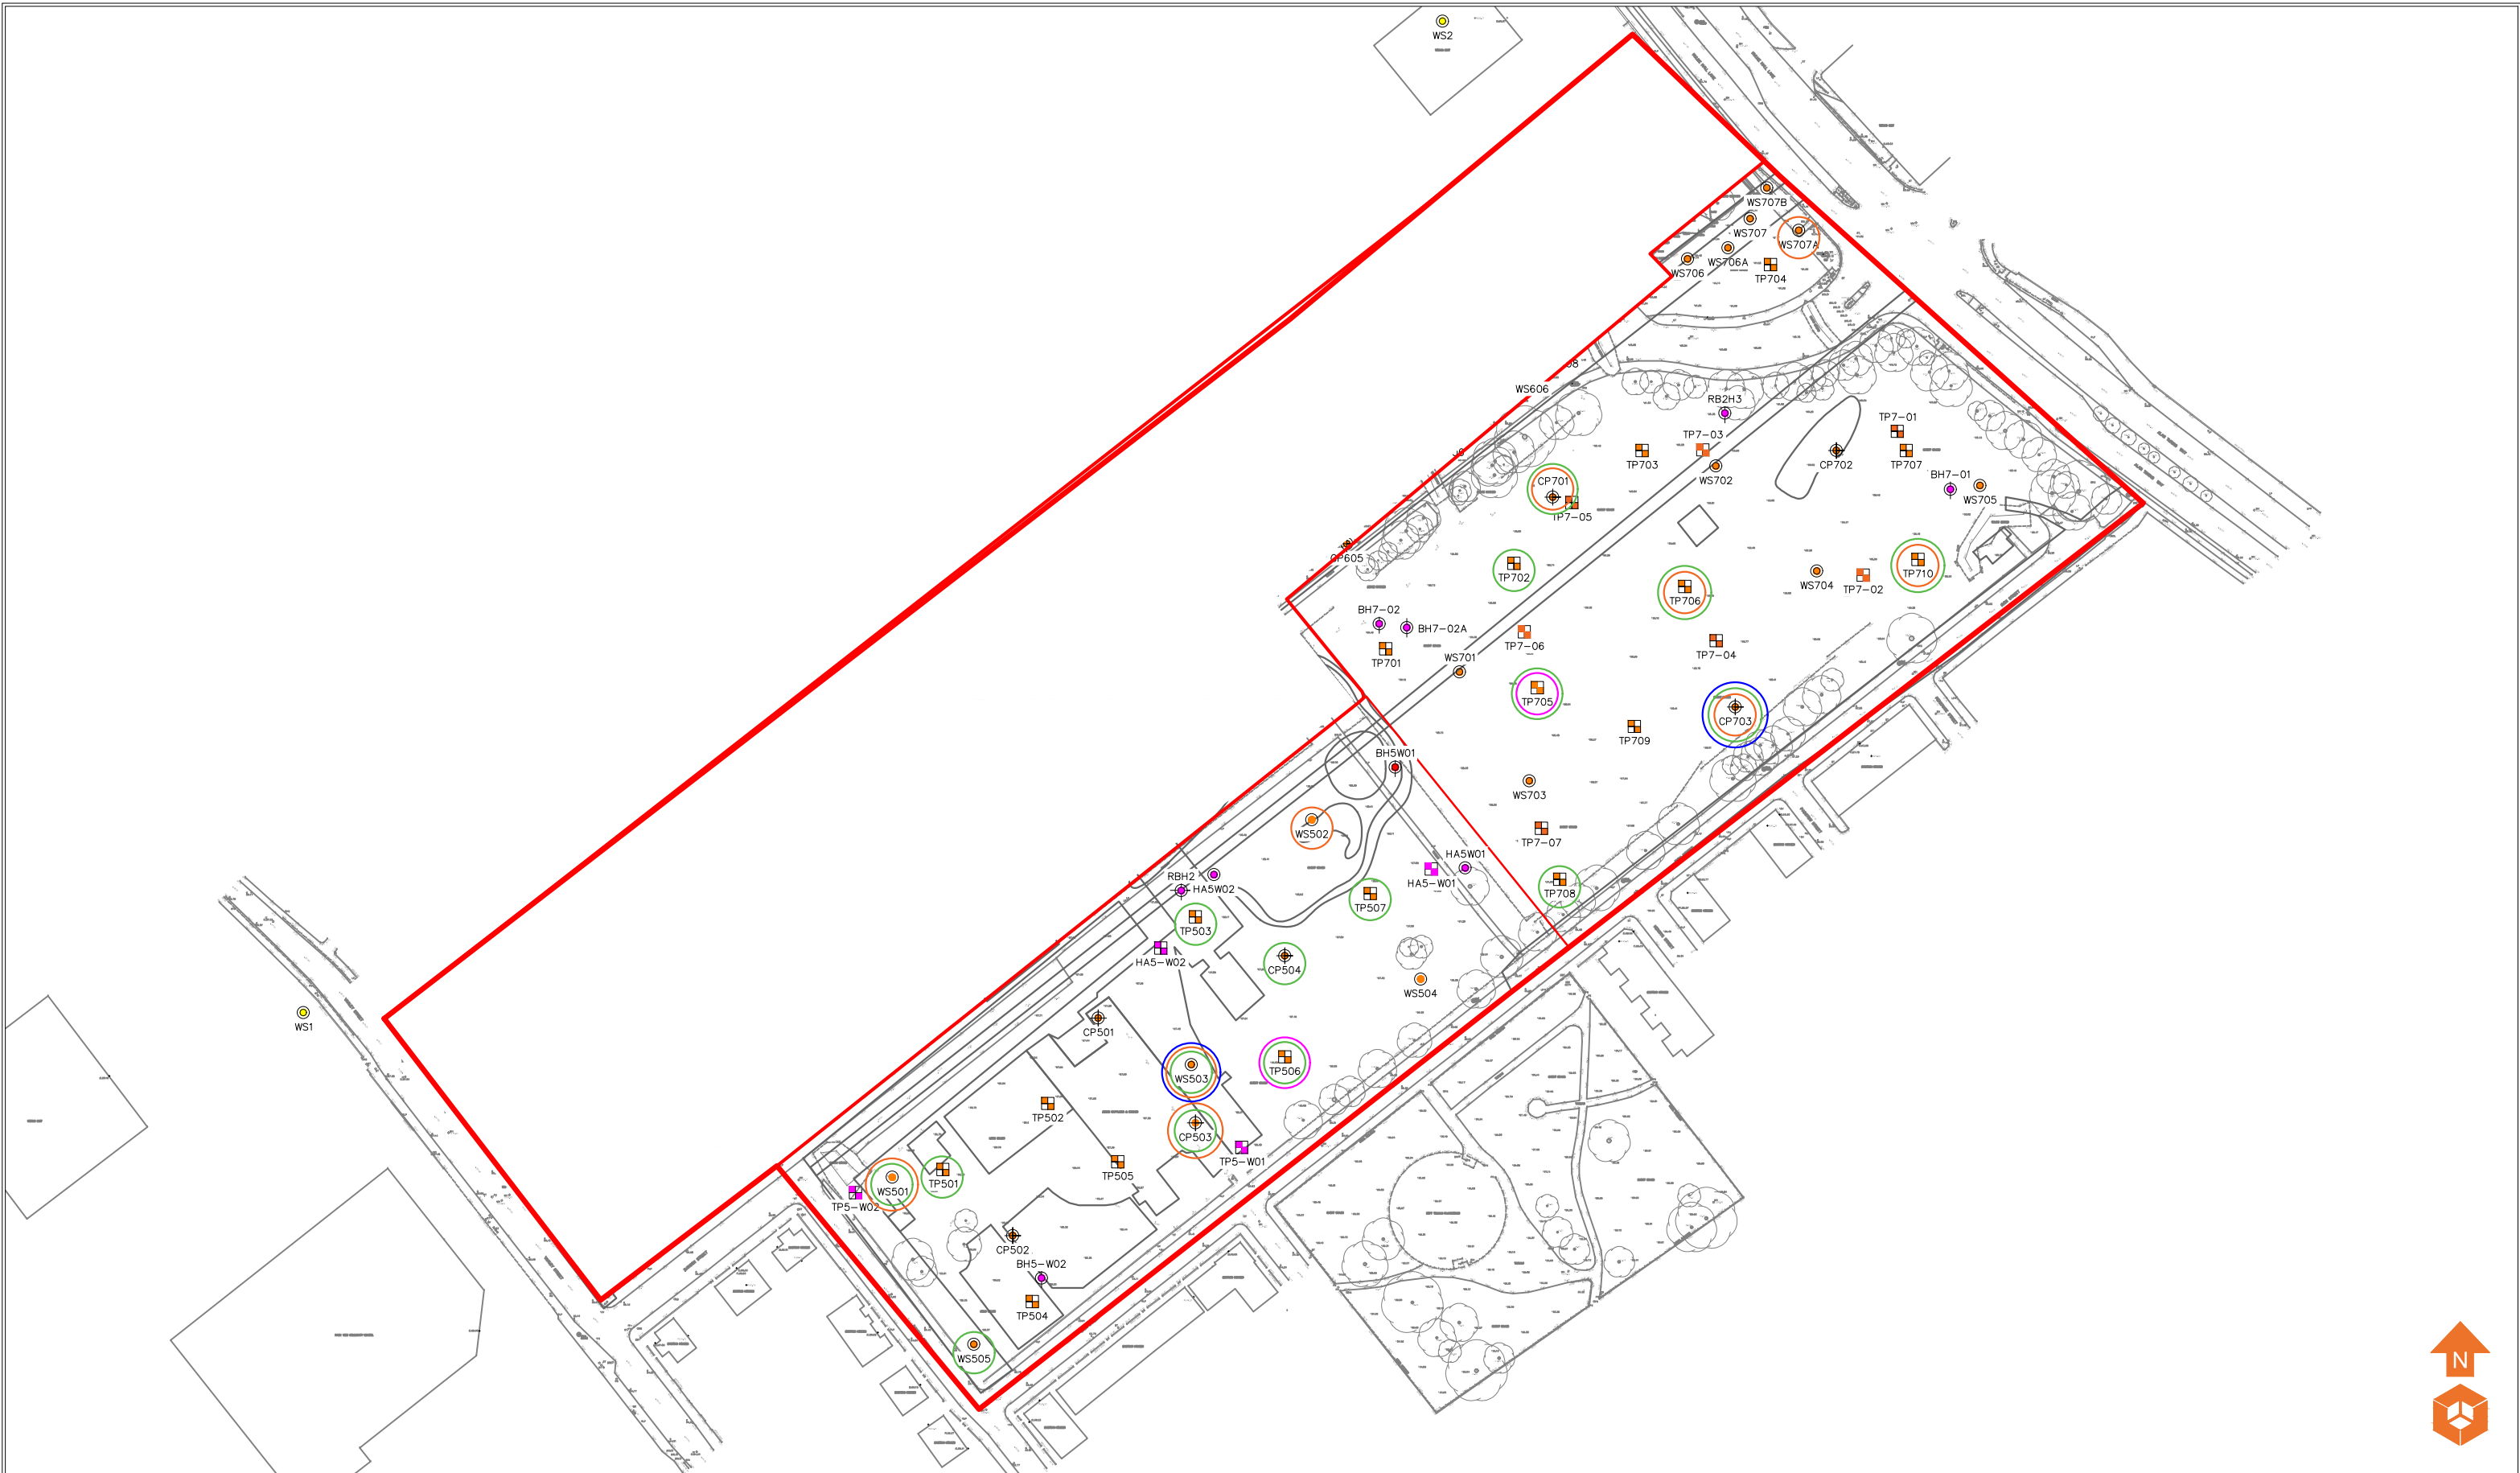
035

Contamination Exceedances

- PAH
- TPH
- Carbon Dioxide
- Heavy Metals
