| CLIENT | Historic England |
| PROJECT | Baguley Hall |
| TITLE | Valley Gutter Detail B&C |
| NUMBER | BGH-SEV-XX-ZZ-DR-A-4101 |

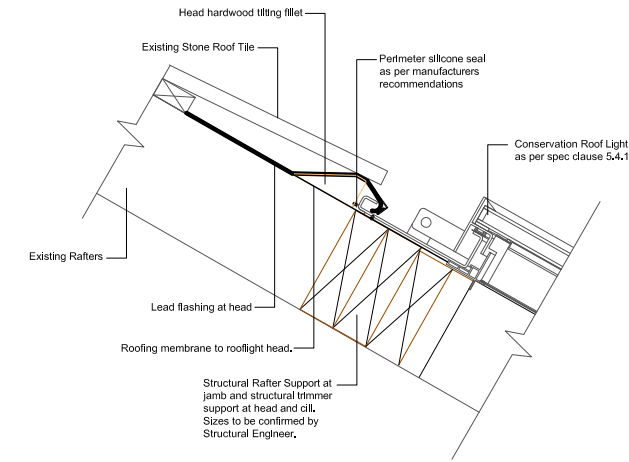
DETAIL B: Access hatch 1:5

NOTE: These sectional details are provided as an installation suggestion. Due to the differing nature of installations we strongly advise consultation with your rooflight installer to verify fitness for purpose. Sufficiency of structural supports to be checked by rooflight purchaser's structural consultant.
