Phase II Geoenvironmental Site Assessment  
Ancoats Green, Jersey Green and Prussia Street  
Arm Greenway Public Realm Improvements

Reference:15-798-R2-1  
Date: January 2023

## PHASE II GEOENVIRONMENTAL SITE ASSESSMENT

Ancoats Green, Jersey Green and Prussia Street Arm Greenway Public  
Realm Improvements

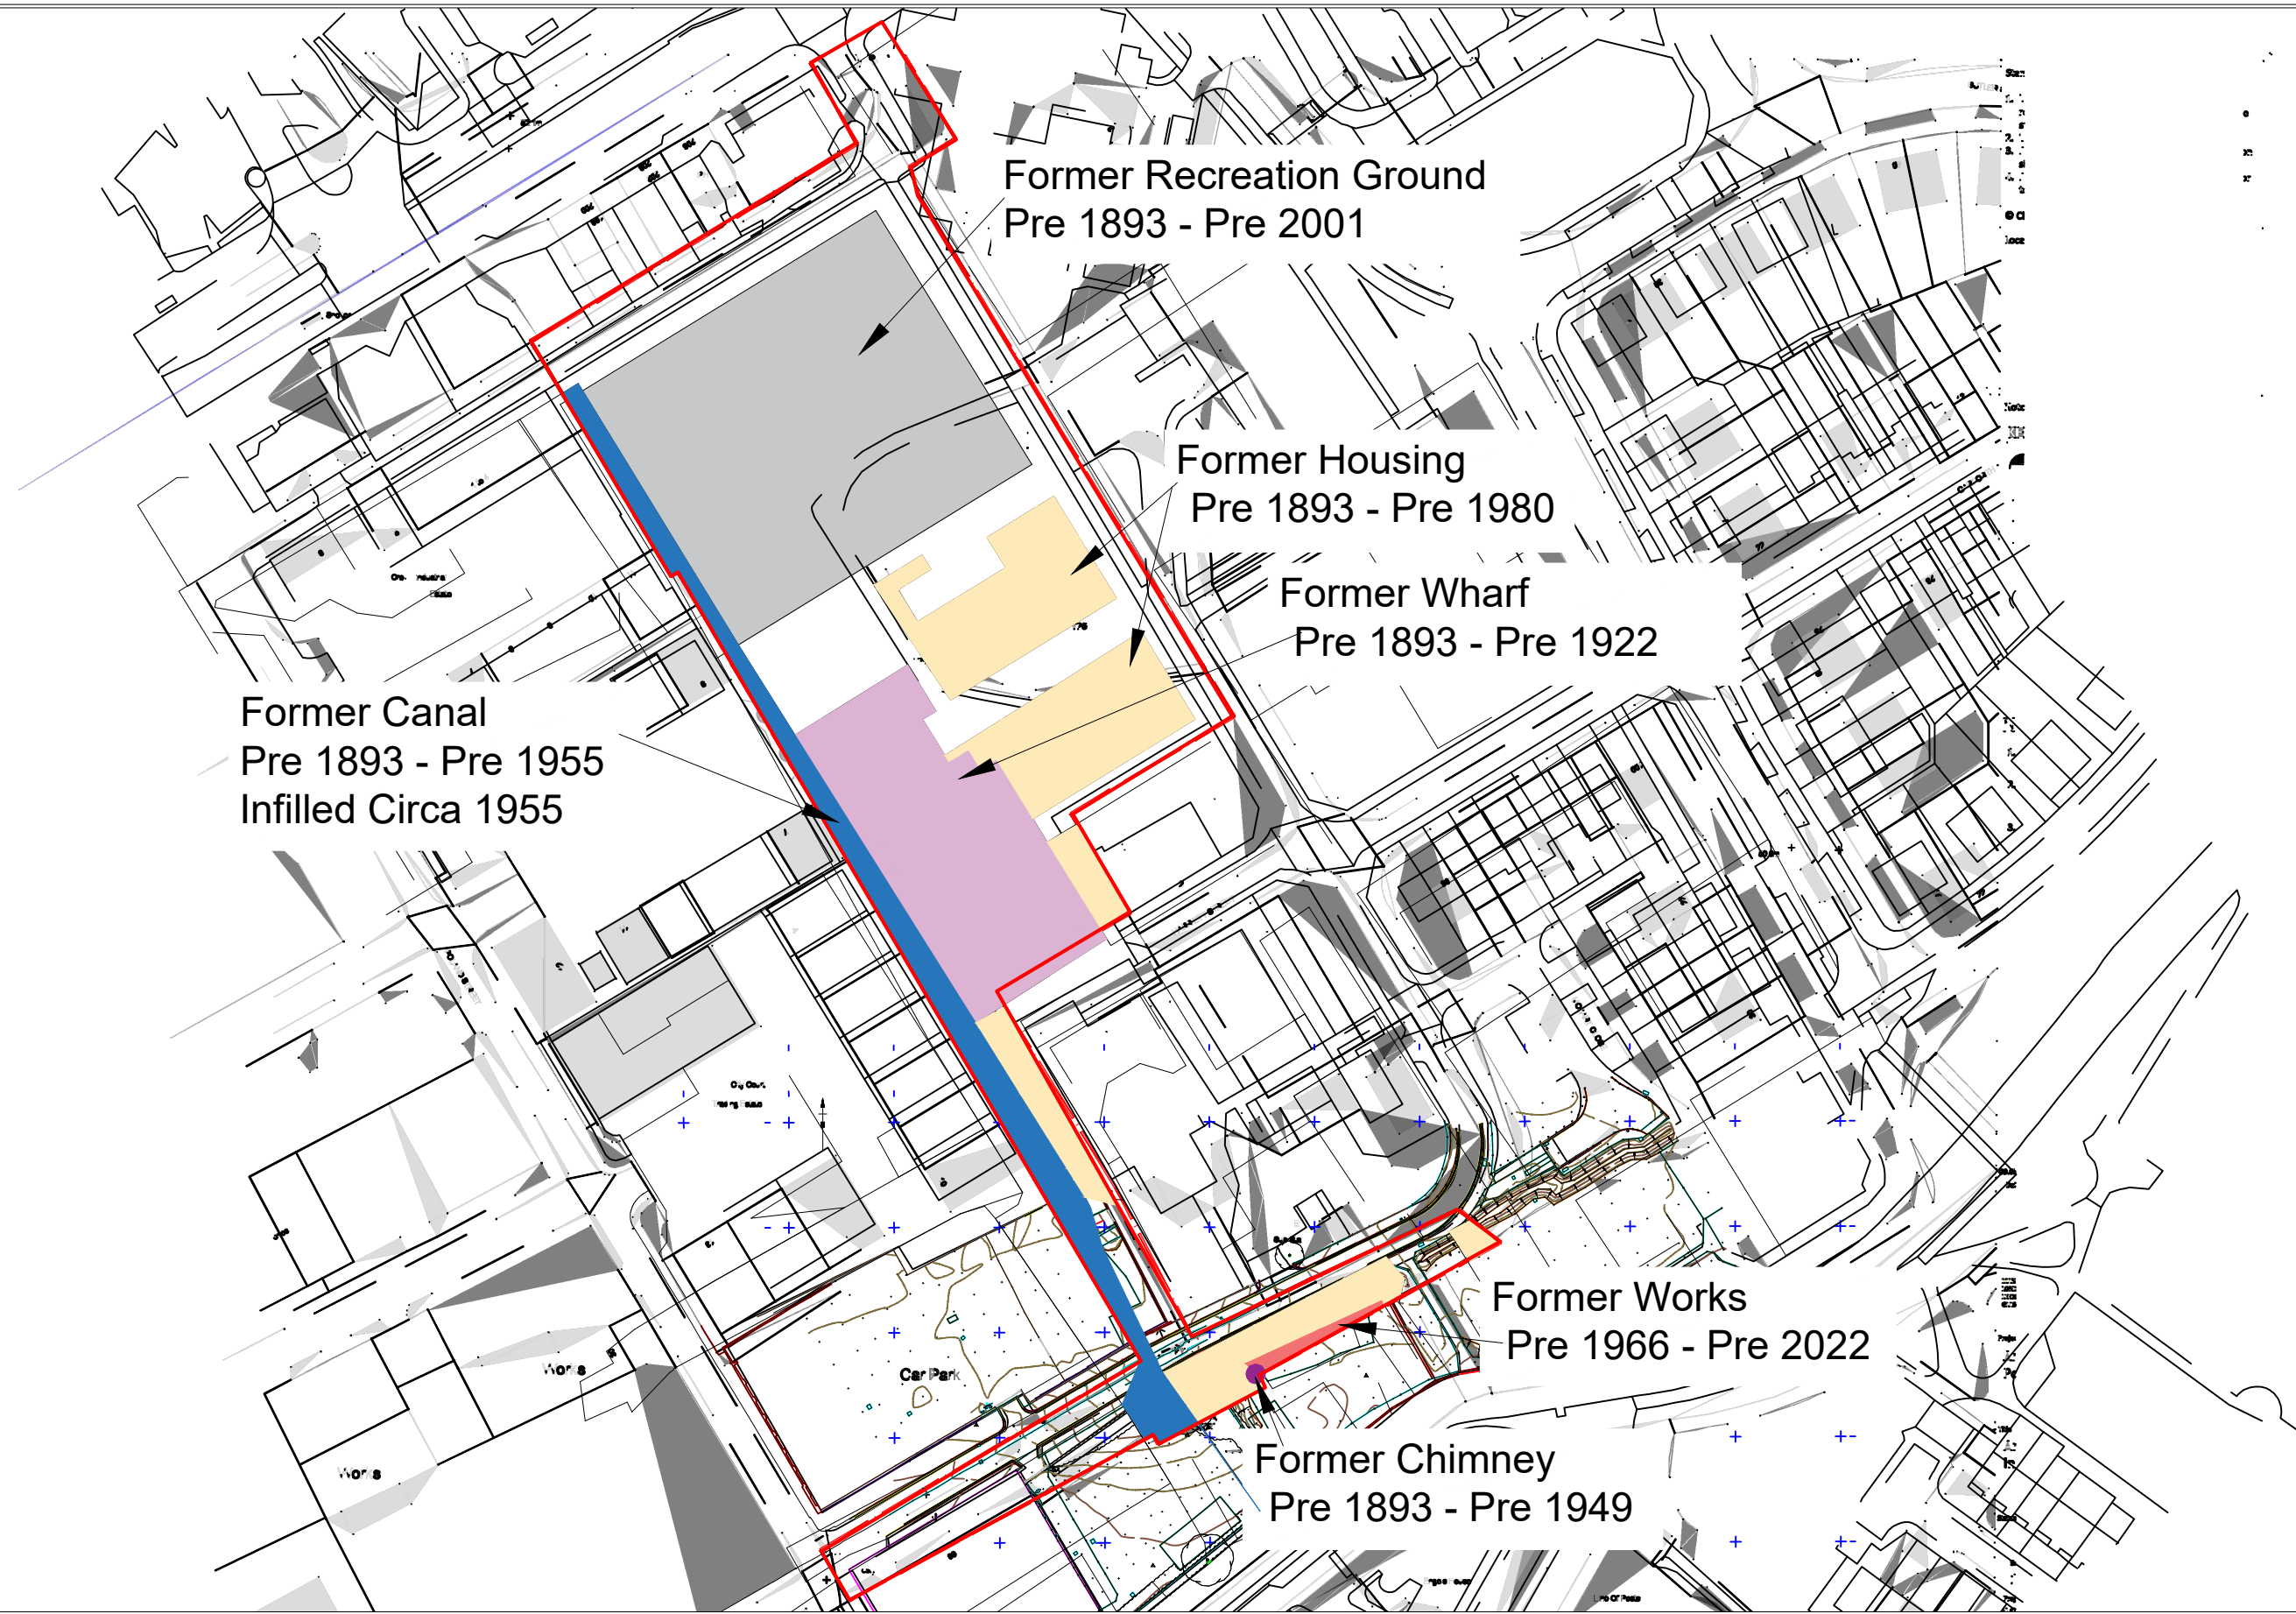
Site Features

- Former Canal
- Former Recreation Ground
- Former Chimney
- Former Housing
- Former Warf

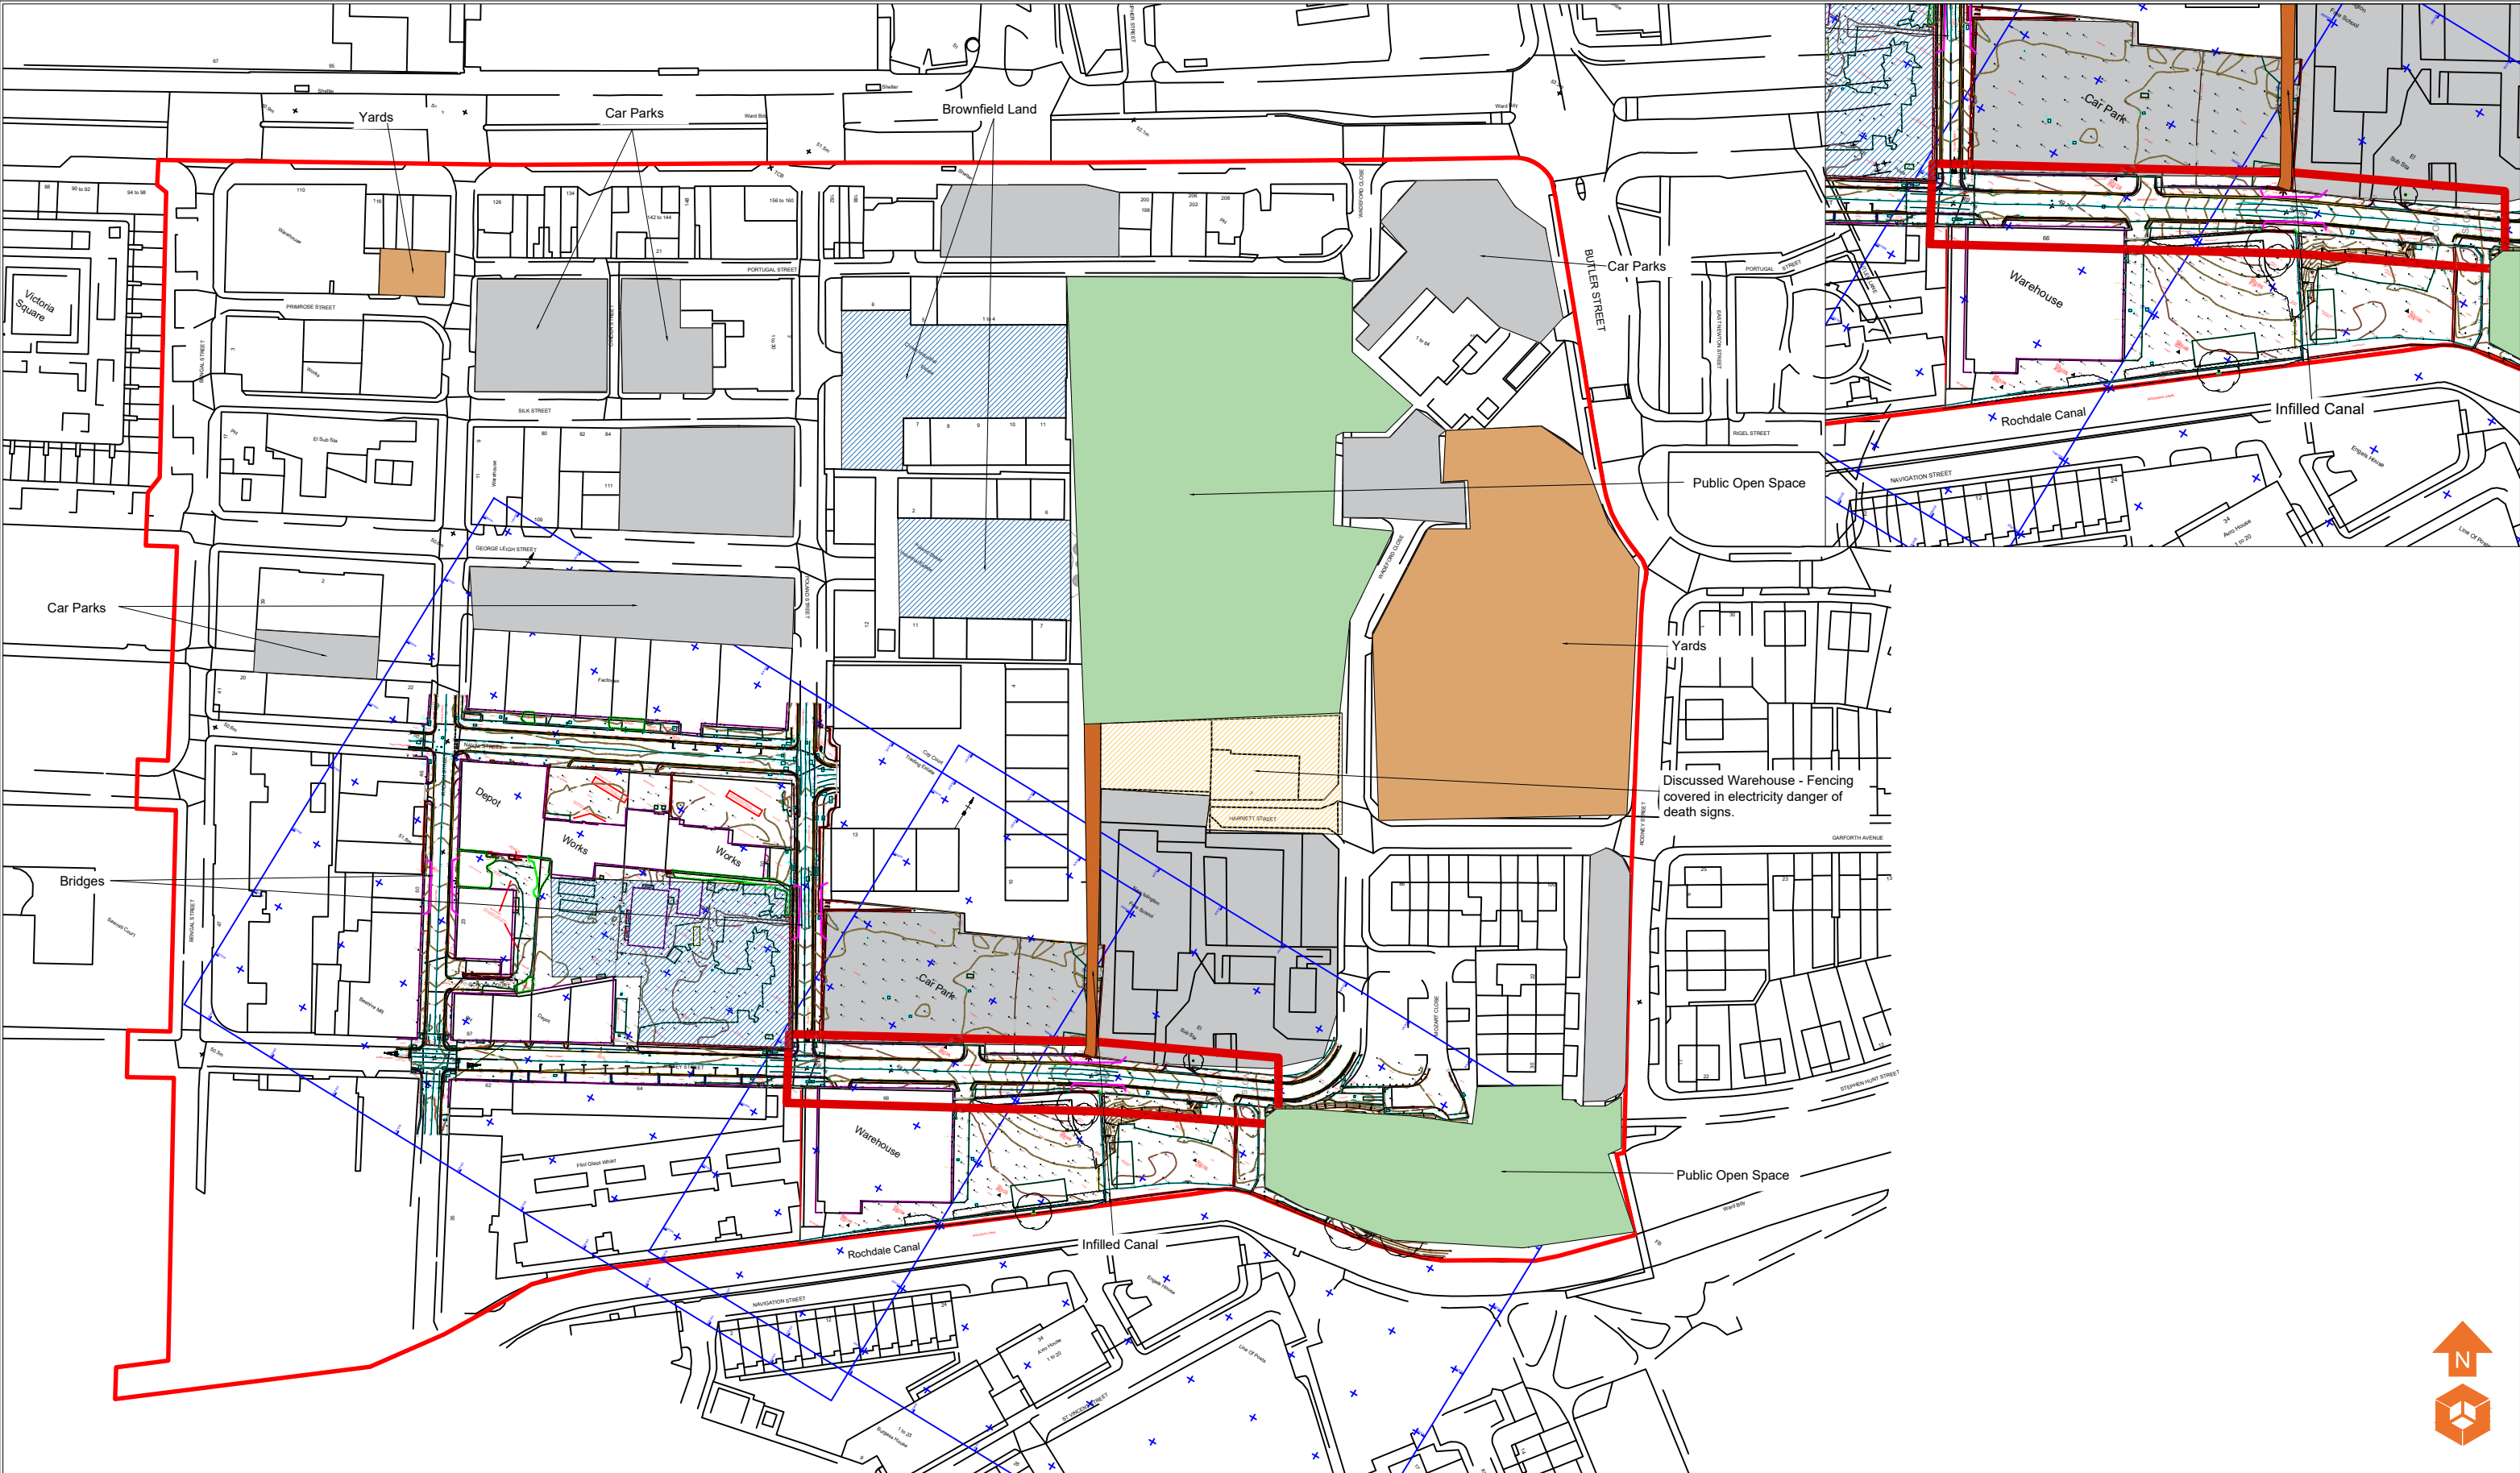
Site Features

- Infilled Canal
- Car Parking
- Public Open Space
- Yards
- Brownfield Land
- Discussed Warehouse

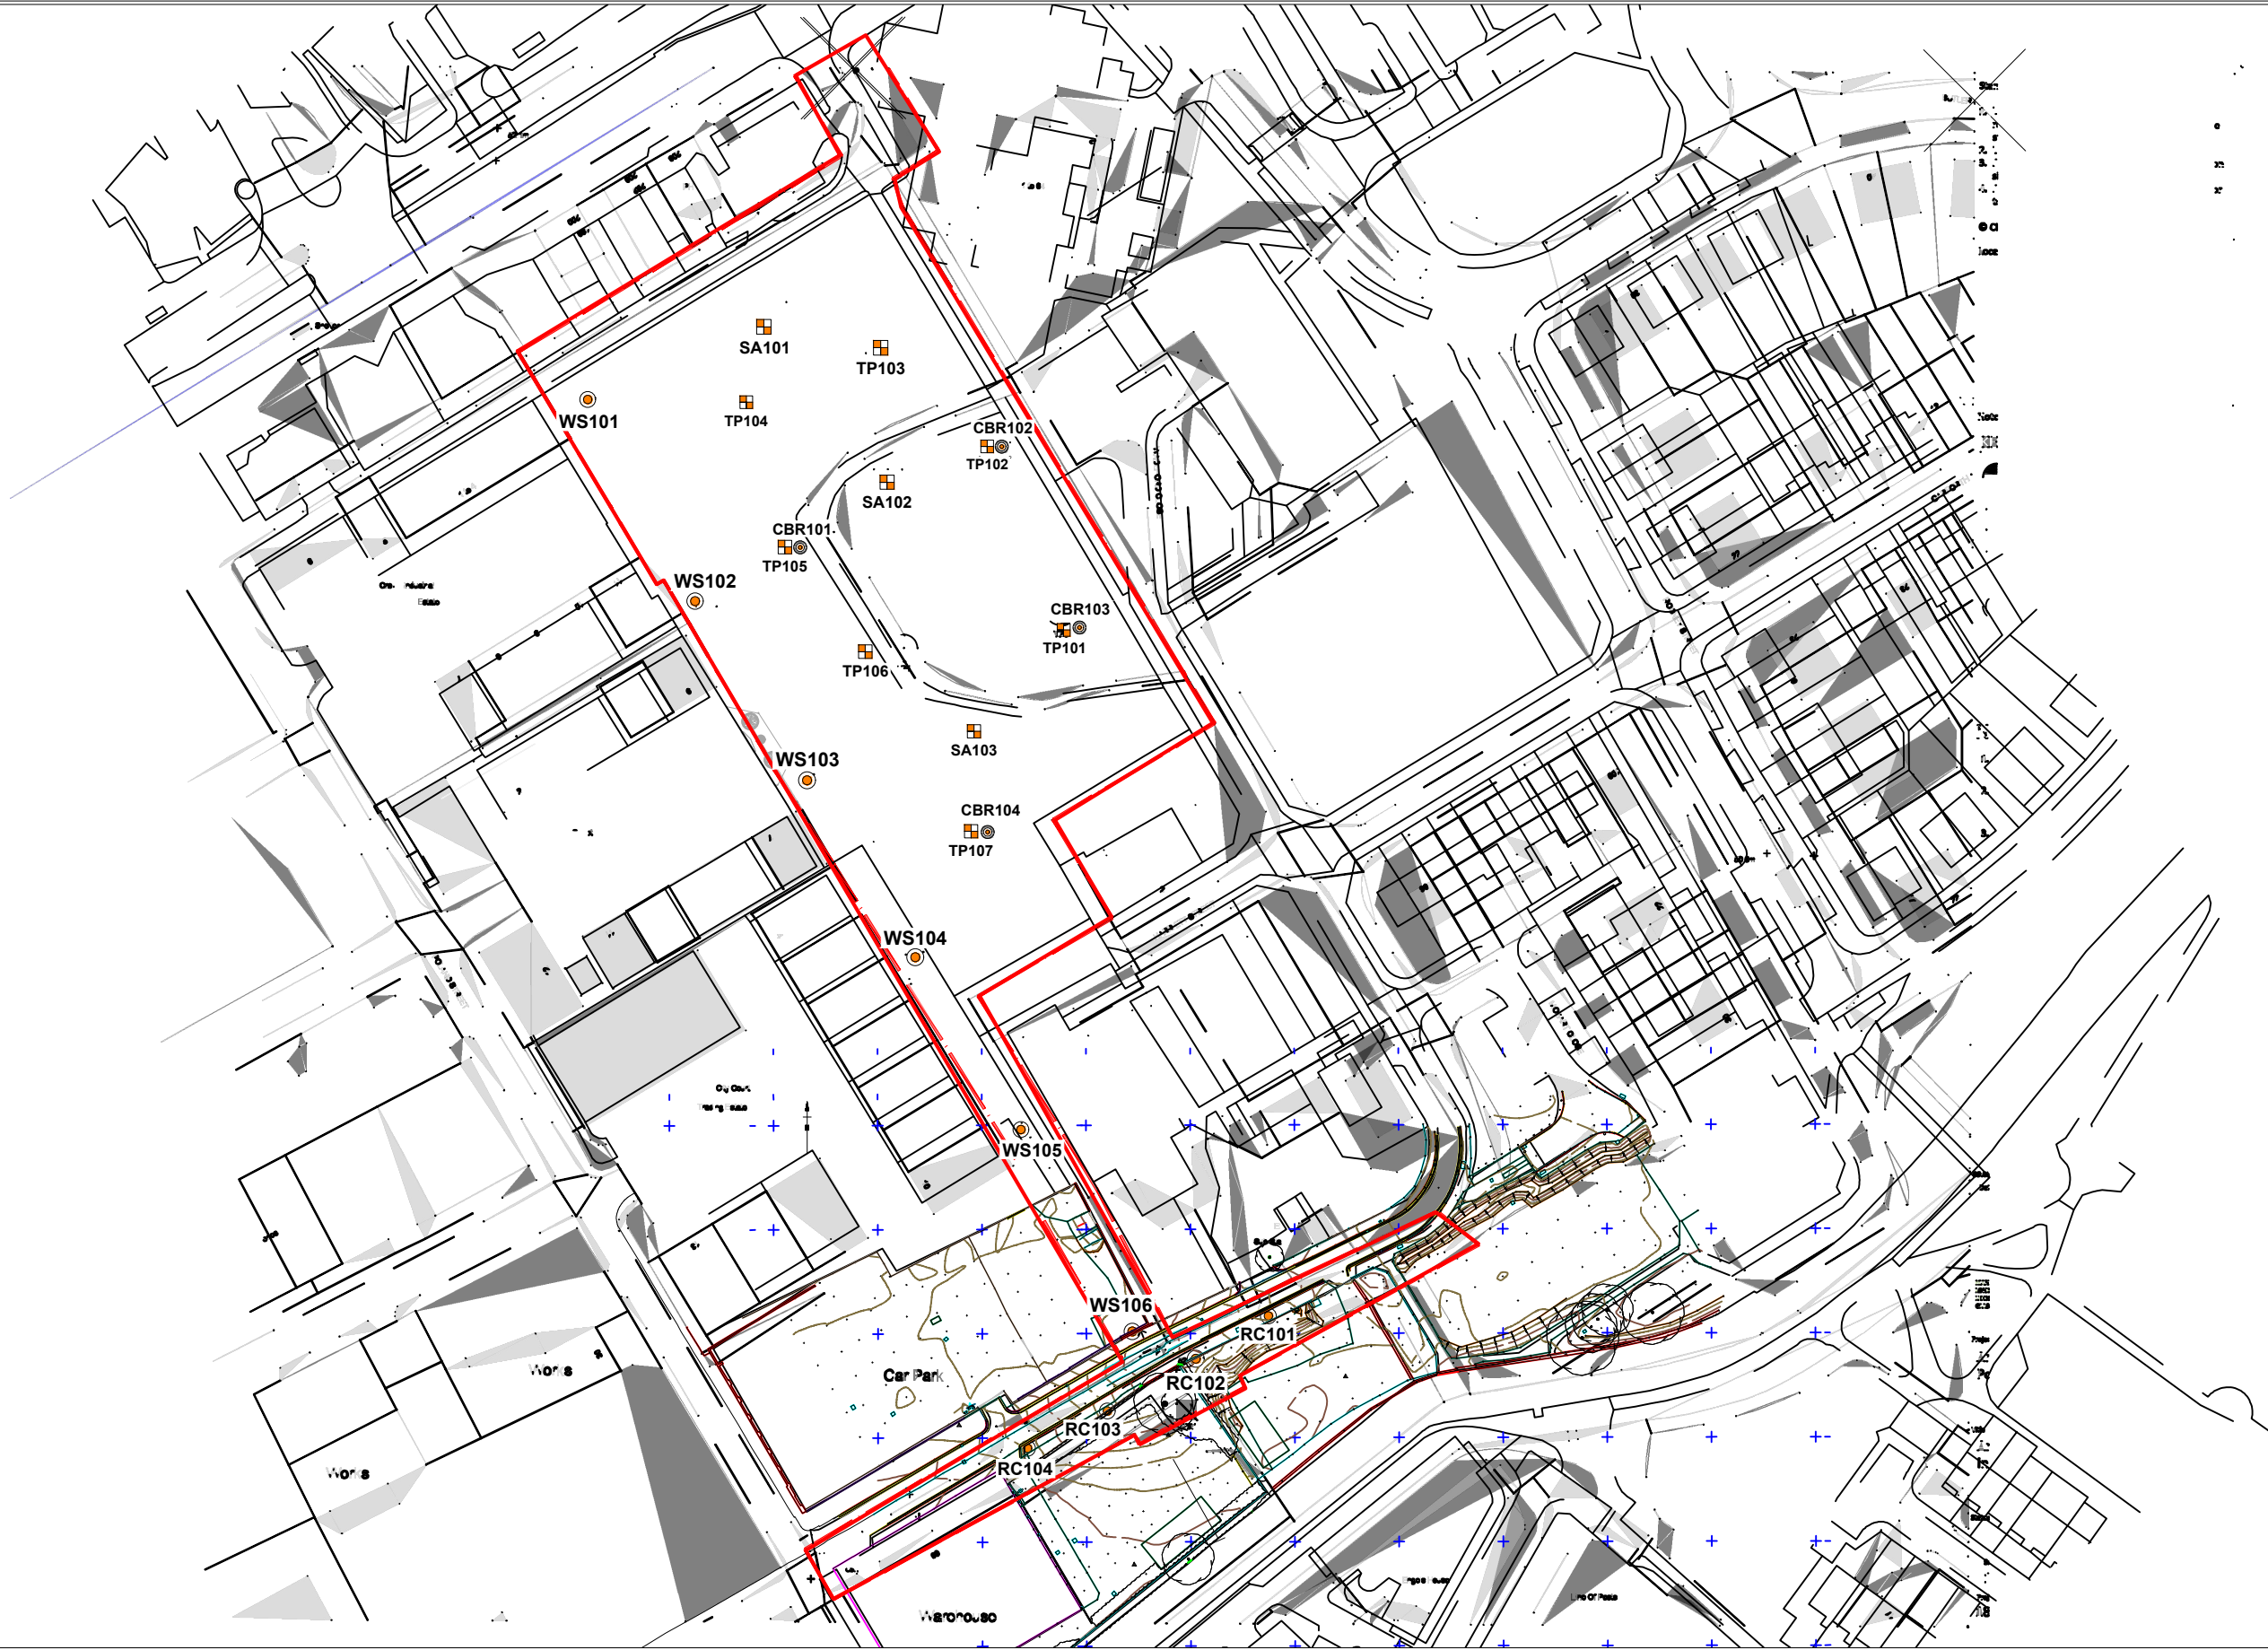
- Location Symbols
- WS101 Approximate Window Sample Probehole Location
  - TP103 Approximate Trial Pit Location
  - SA101 Approximate Soakaway Test Location
  - RC101 Approximate Rotary Borehole Location
  - CBR101 Approximate California Bearing Ratio Test Location

The sampling locations are illustrated in Drawing 15-798-004 (Appendix III). The ground conditions encountered are indicated on the logs, which are provided in Appendix V.

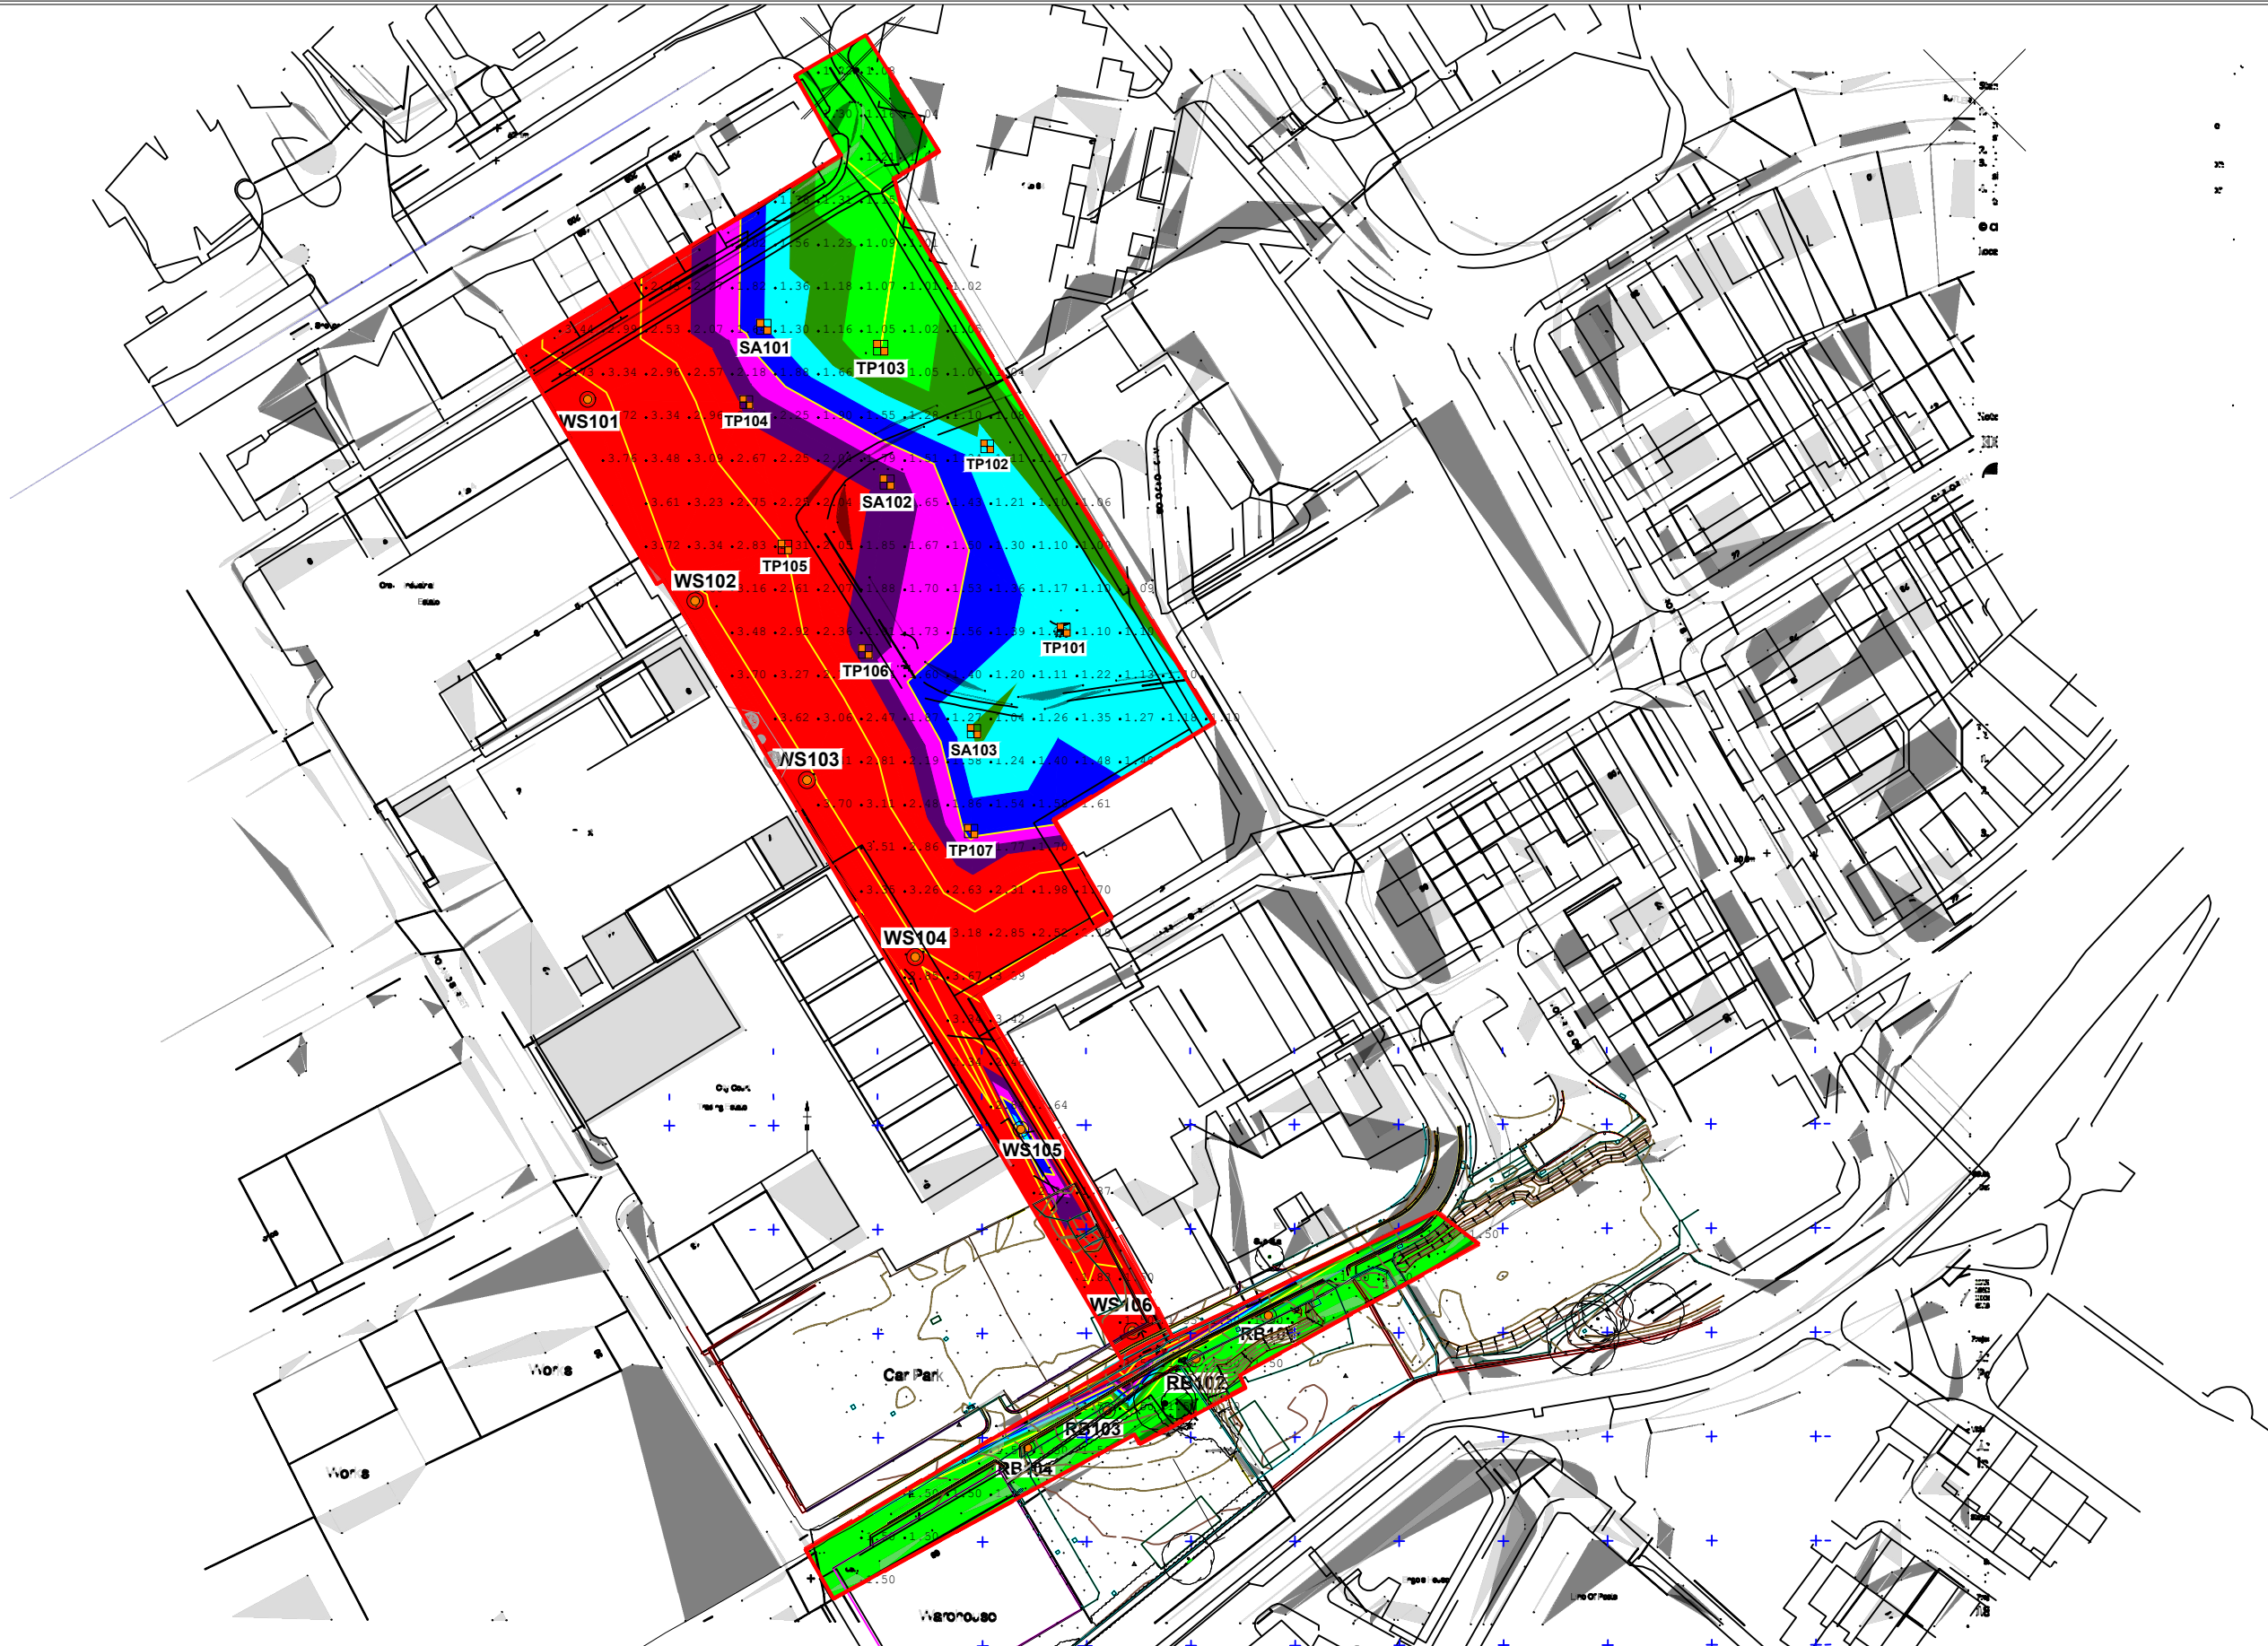
- Shallow Spread Footings**
- Depth to Founding Strata 0.00 - 1.24m
  - Depth to Founding Strata 1.25 - 1.49m
- Mass Trench Fill Footings**
- Depth to Founding Strata 1.50 - 1.74m
  - Depth to Founding Strata 1.75 - 1.99m
  - Depth to Founding Strata 2.00 - 2.24m
- Engineered Footings**
- Depth to Founding Strata 2.25 - 2.49m
  - Depth to Founding Strata >2.50m

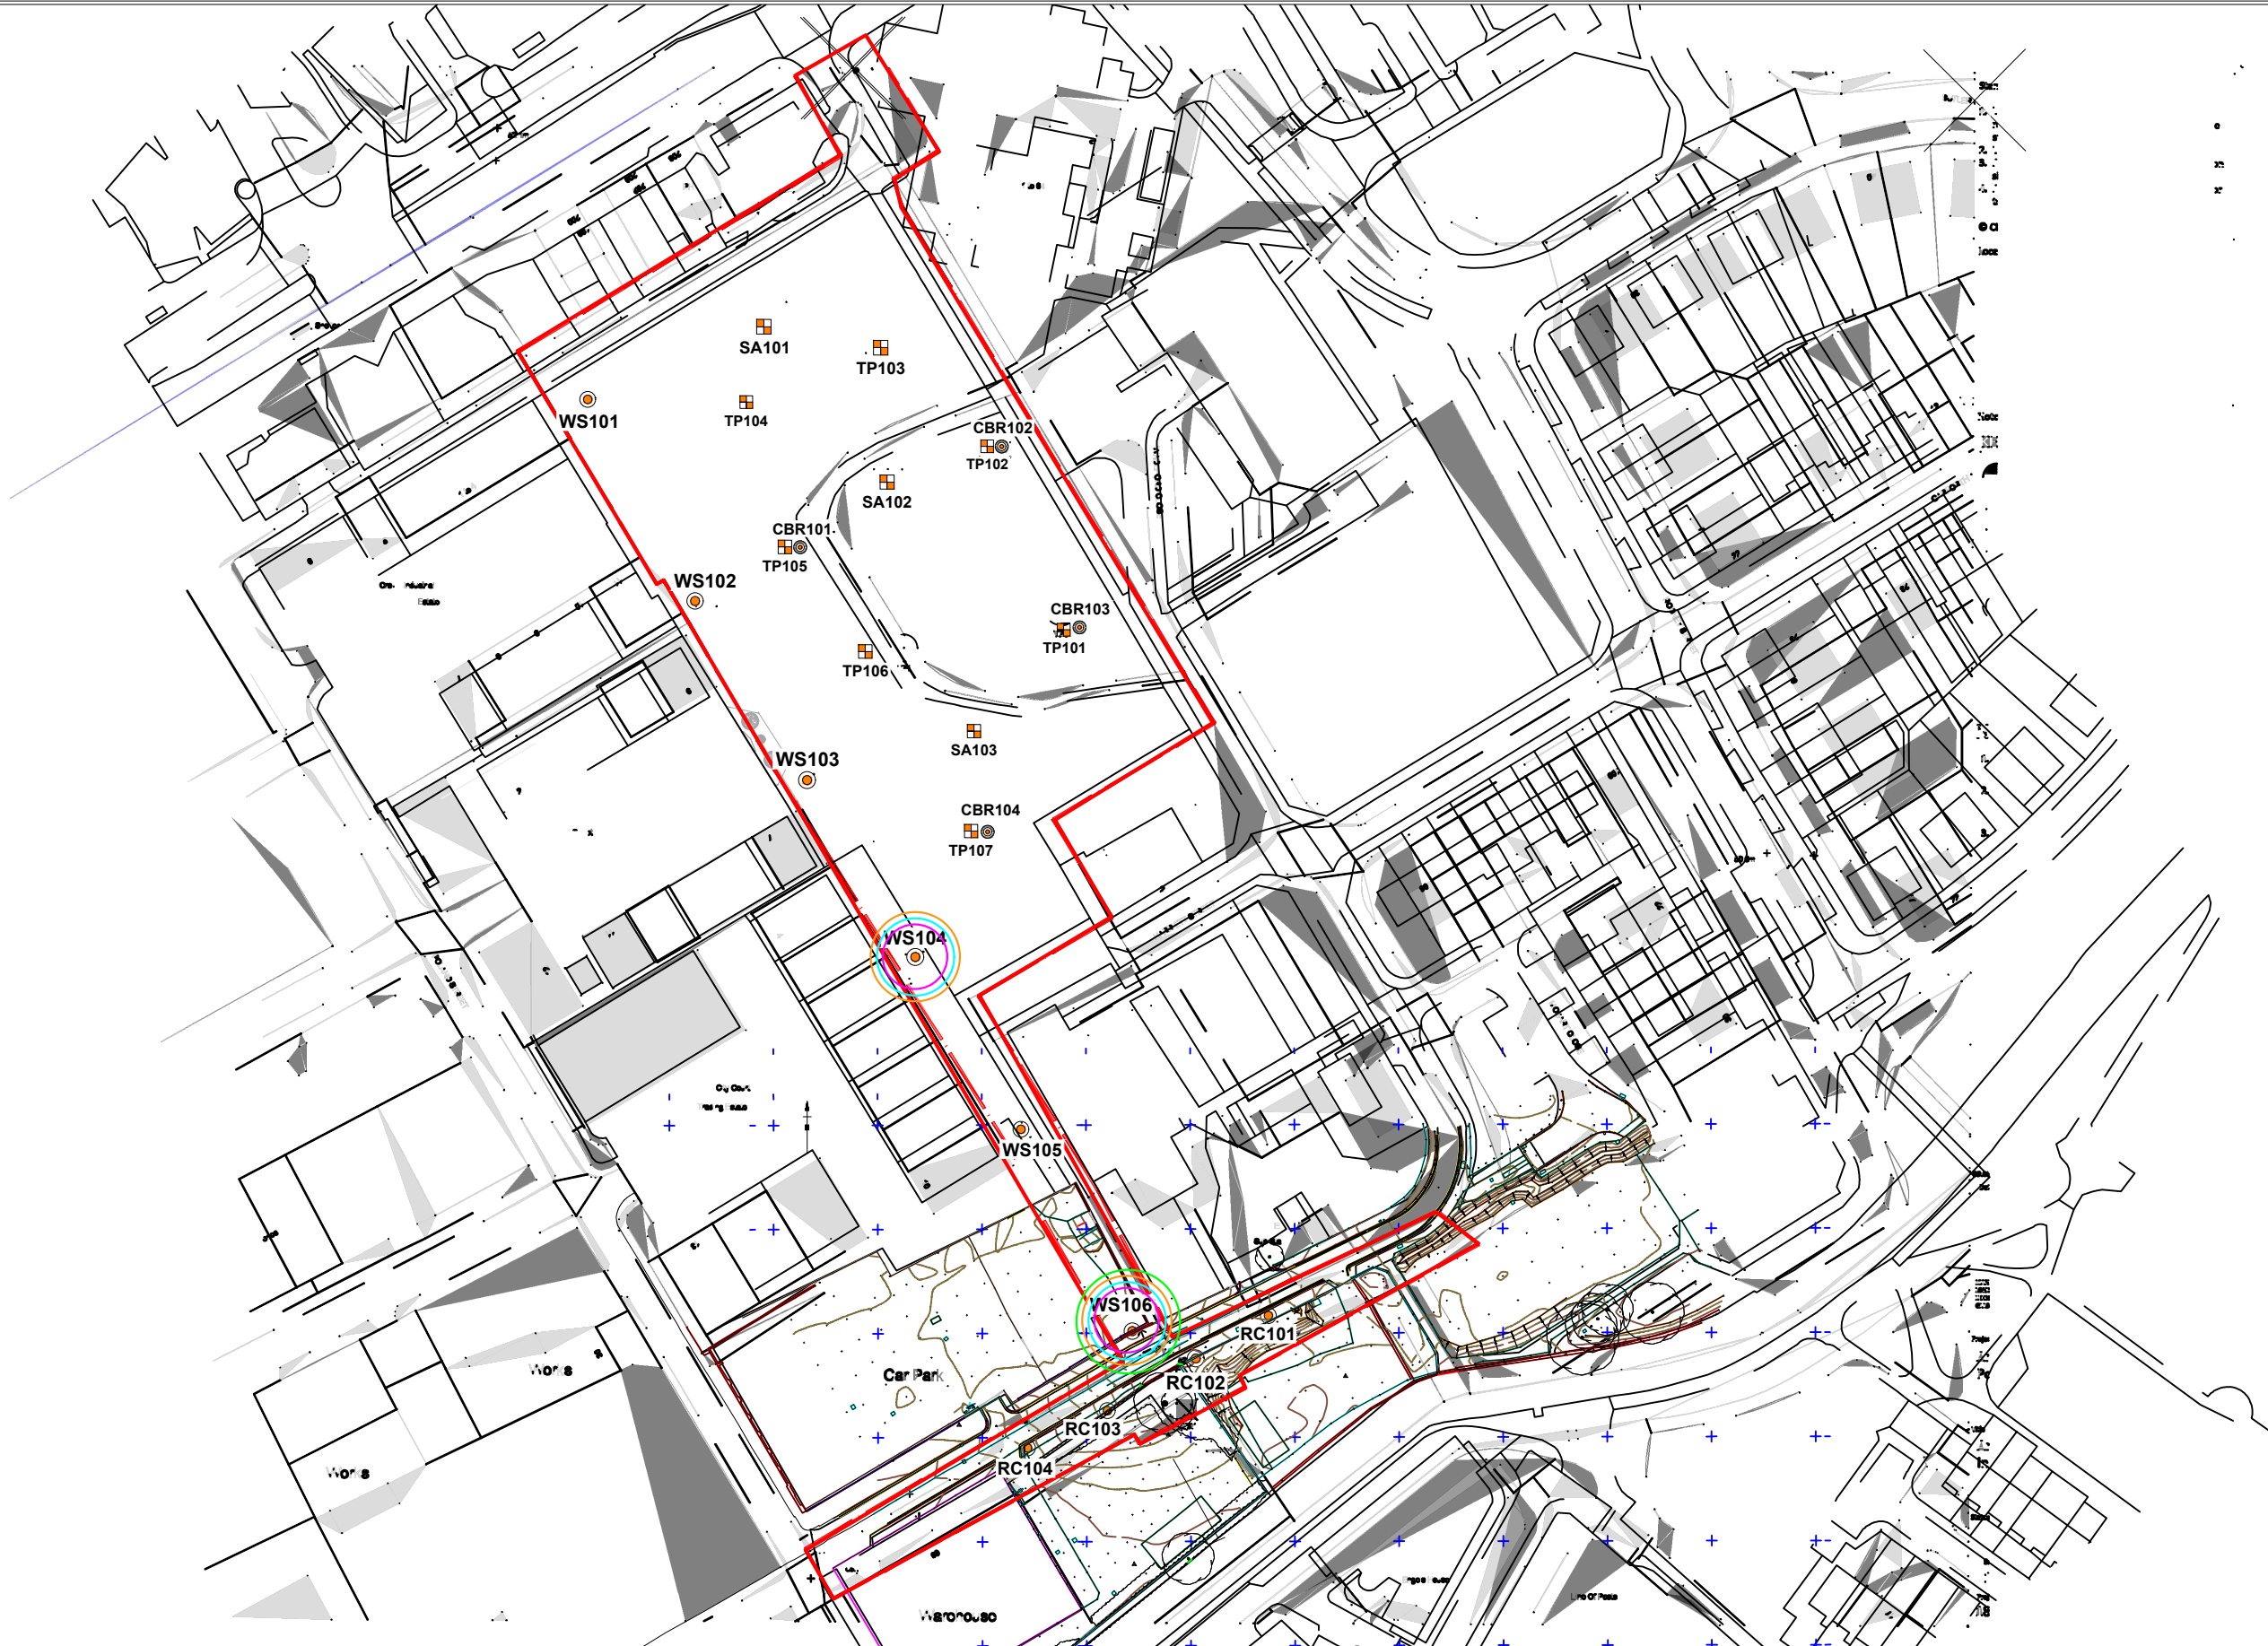
- Contamination Issues - Controlled Waters
- Heavy Metals
  - PAH
  - TPH (Aromatic)
  - TPH (Aliphatic)

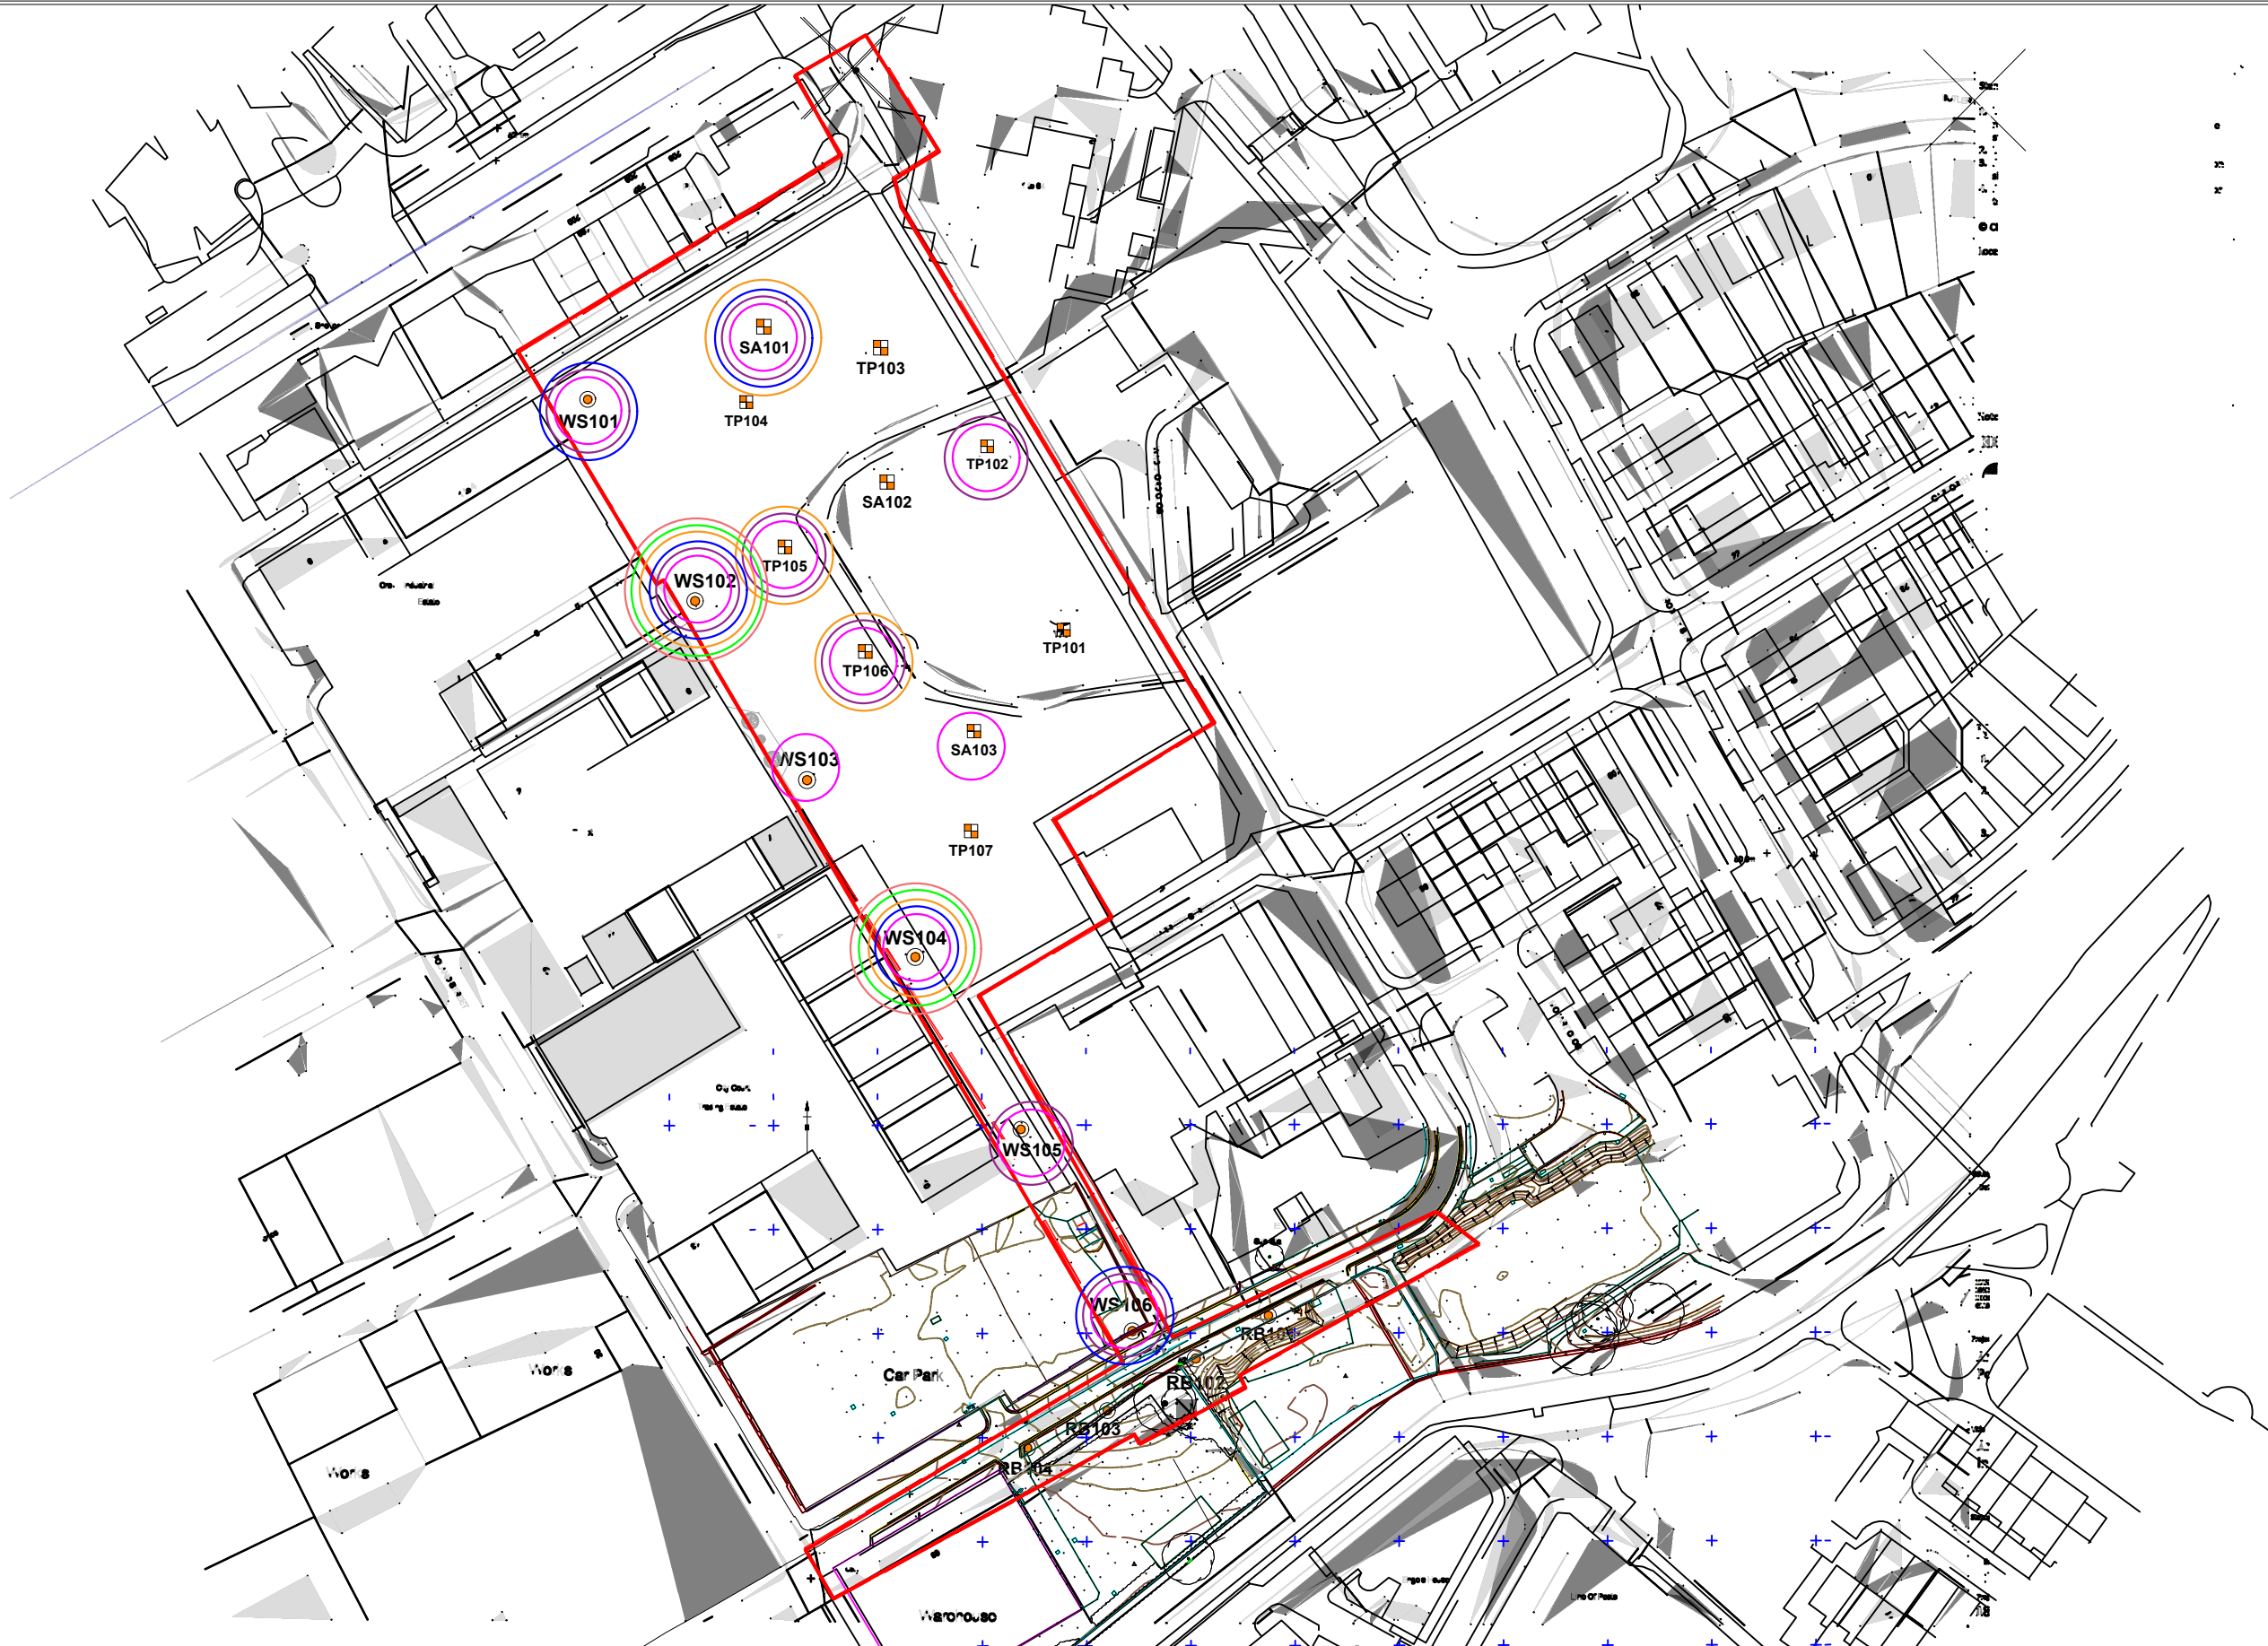
- Development Constraints**
- Heavy Metals
  - PAH
  - TPH
  - Napthalene
  - VOCs
  - SVOCs
