Phase II Geoenvironmental Site Assessment  
Ancoats Green, Jersey Green and Prussia Street  
Arm Greenway Public Realm Improvements

Reference:15-798-R2-1  
Date: January 2023

## PHASE II GEOENVIRONMENTAL SITE ASSESSMENT

Ancoats Green, Jersey Green and Prussia Street Arm Greenway Public  
Realm Improvements

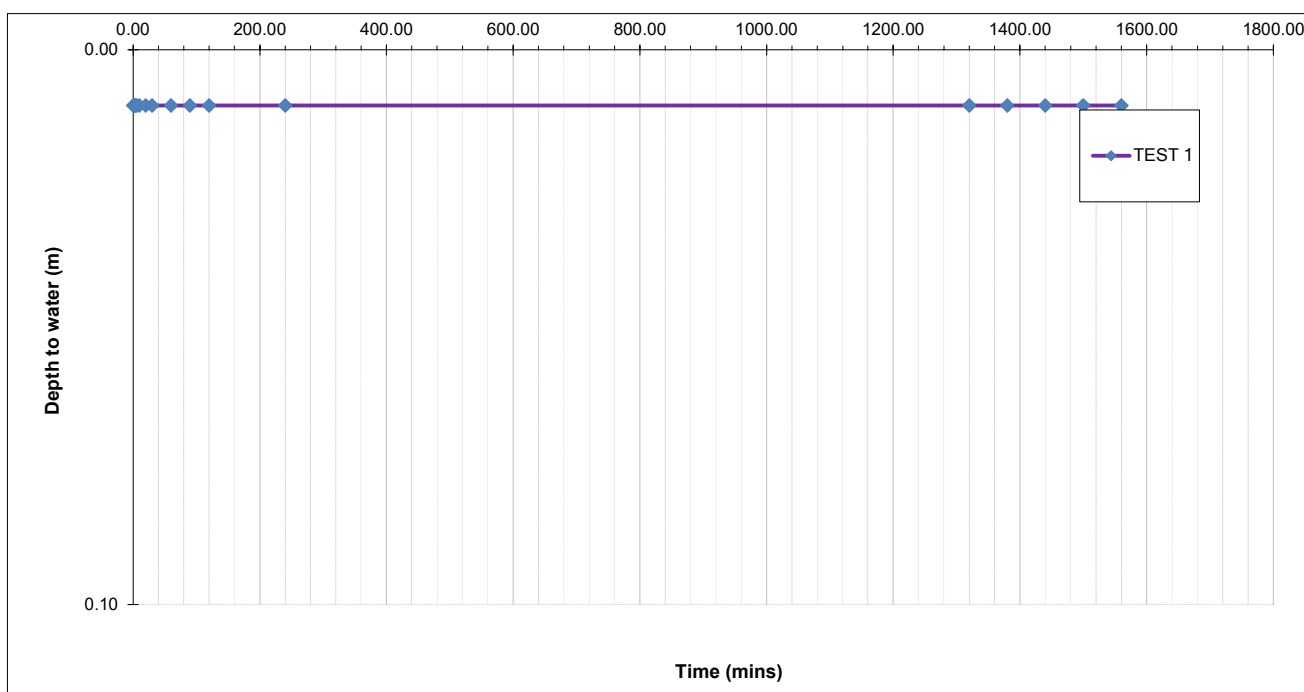
| | | <b>Site:</b> Jersey Street<br><b>Job Number:</b> 15-798<br><b>Date of Test:</b> 13/12/2022 | | <b>Trial Pit Number:</b> TP102<br><b>Length:</b> 2.00 m<br><b>Width:</b> 0.50 m<br><b>Depth:</b> 2.40 m<br><b>Groundwater Level:</b> m | | |
| Remarks - Test terminated due to lack of infiltration and the test did not reach 25% effective depth. | TEST 1 | | TEST 2 | | TEST 3 | |

The tests taken out within the trial pits did not reach the 25% adequate storage depth. Therefore, the tests have failed; this is due to the cohesive deposits on-site.

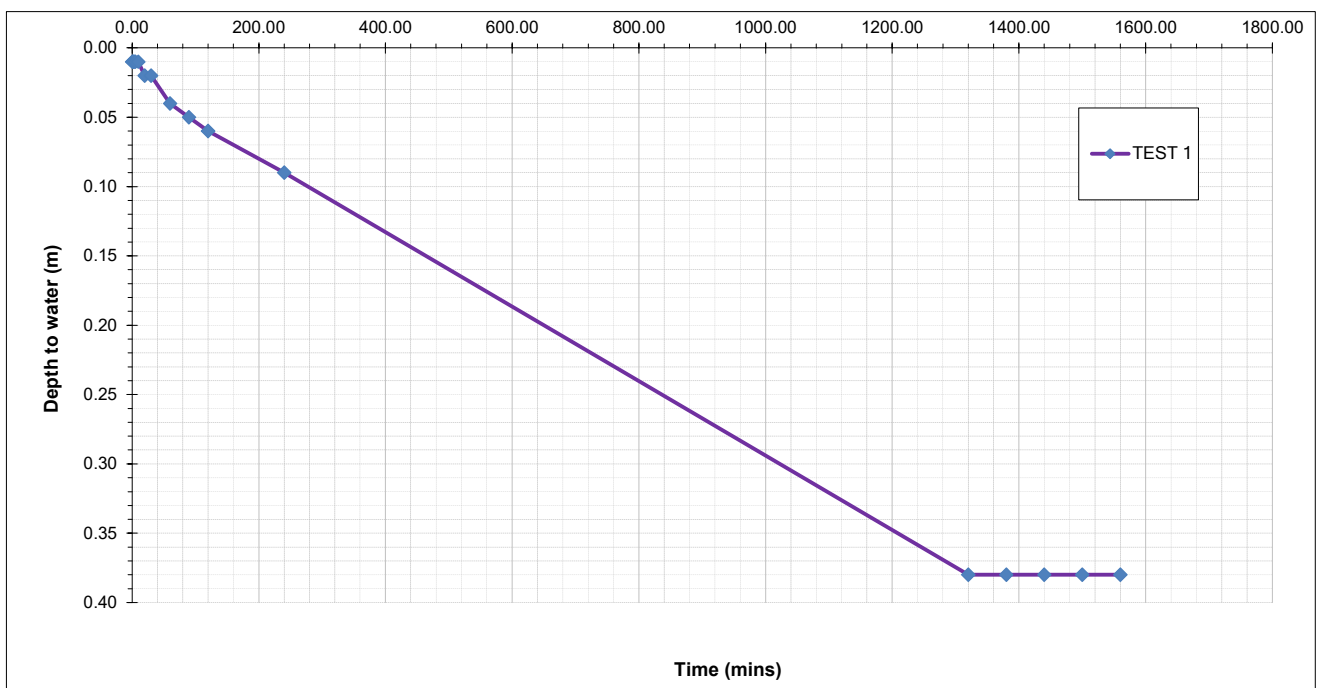
| | | <b>Site:</b> Jersey Street<br><b>Job Number:</b> 15-798<br><b>Date of Test:</b> 13/12/2022 | | <b>Trial Pit Number:</b> SA103<br><b>Length:</b> 2.00 m<br><b>Width:</b> 0.80 m<br><b>Depth:</b> 2.00 m<br><b>Groundwater Level:</b> m | | |
| Remarks - Test terminated due to lack of infiltration and the test did not reach 25% effective depth. | TEST 1 | | TEST 2 | | TEST 3 | |

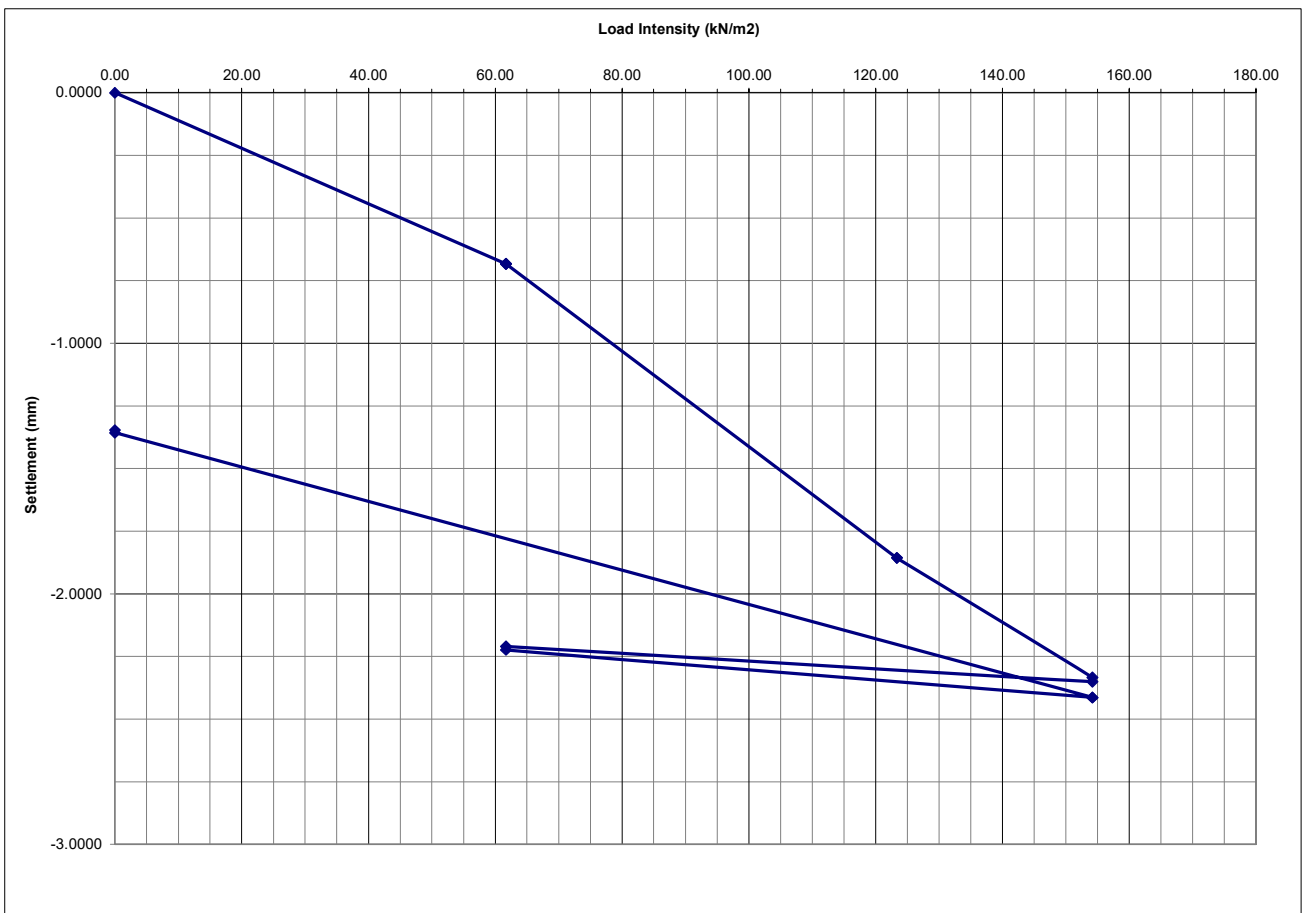
### Equivalent CBR Value of 8%

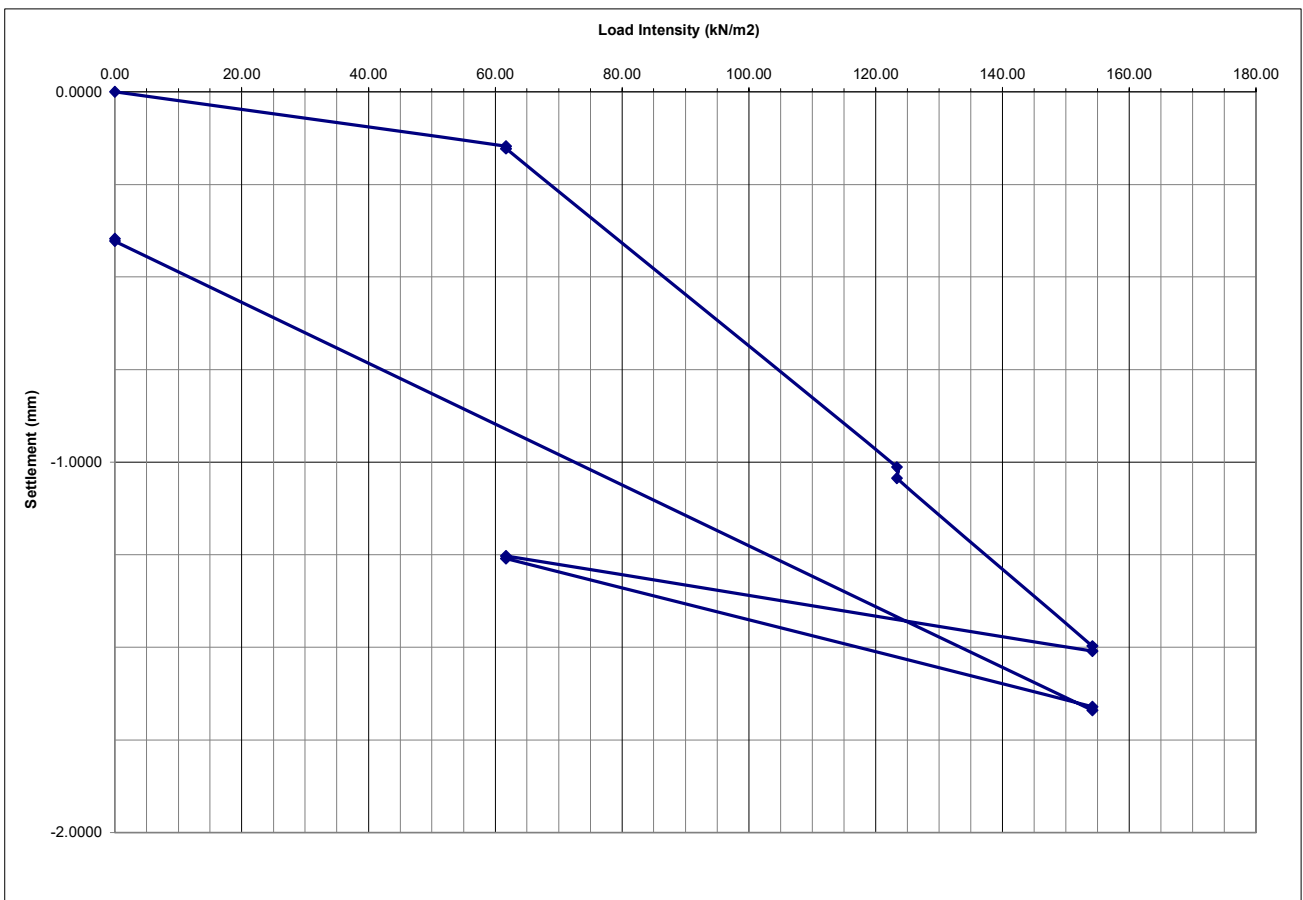
## Equivalent CBR Value of 15%

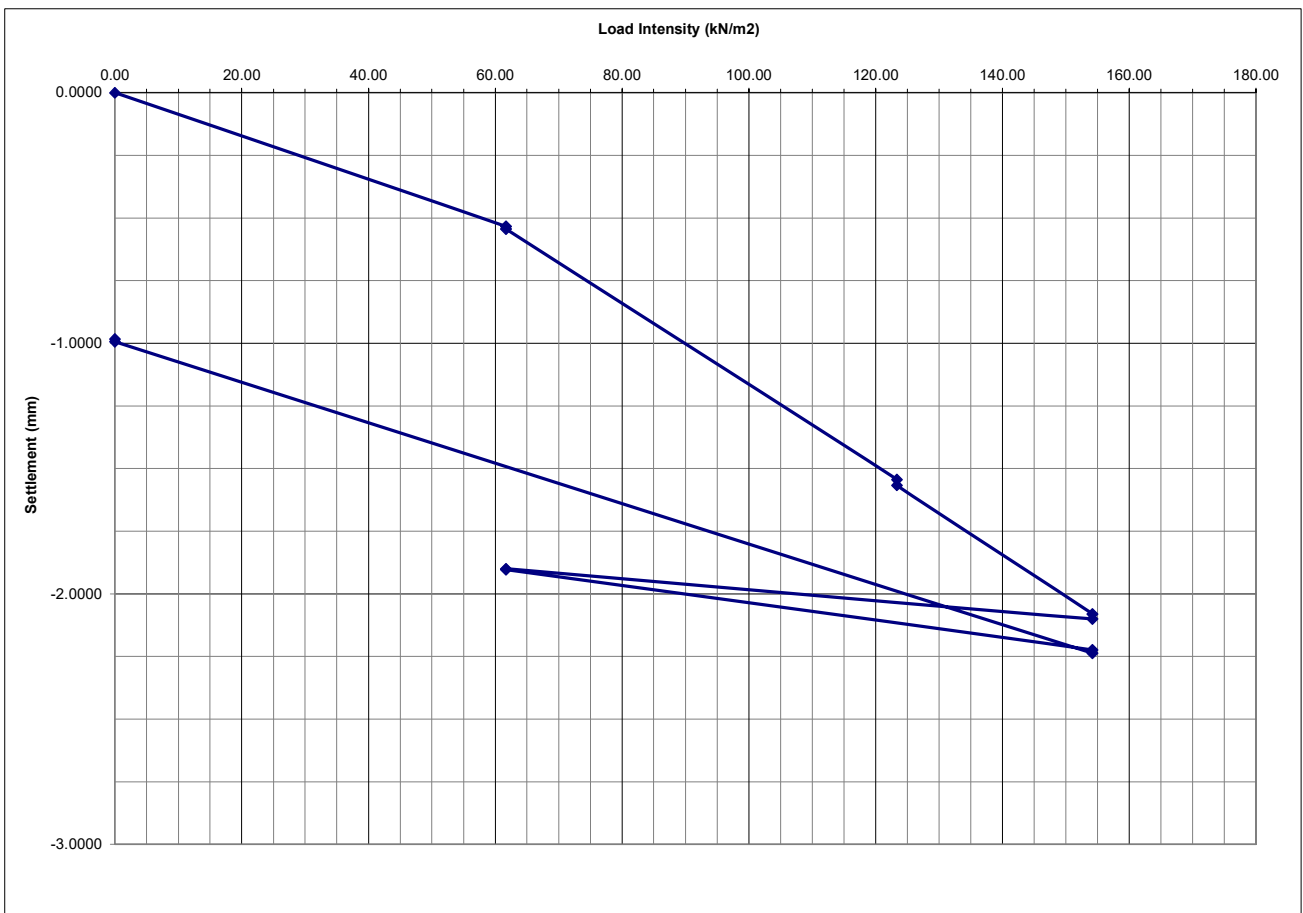
## Equivalent CBR Value of 10%

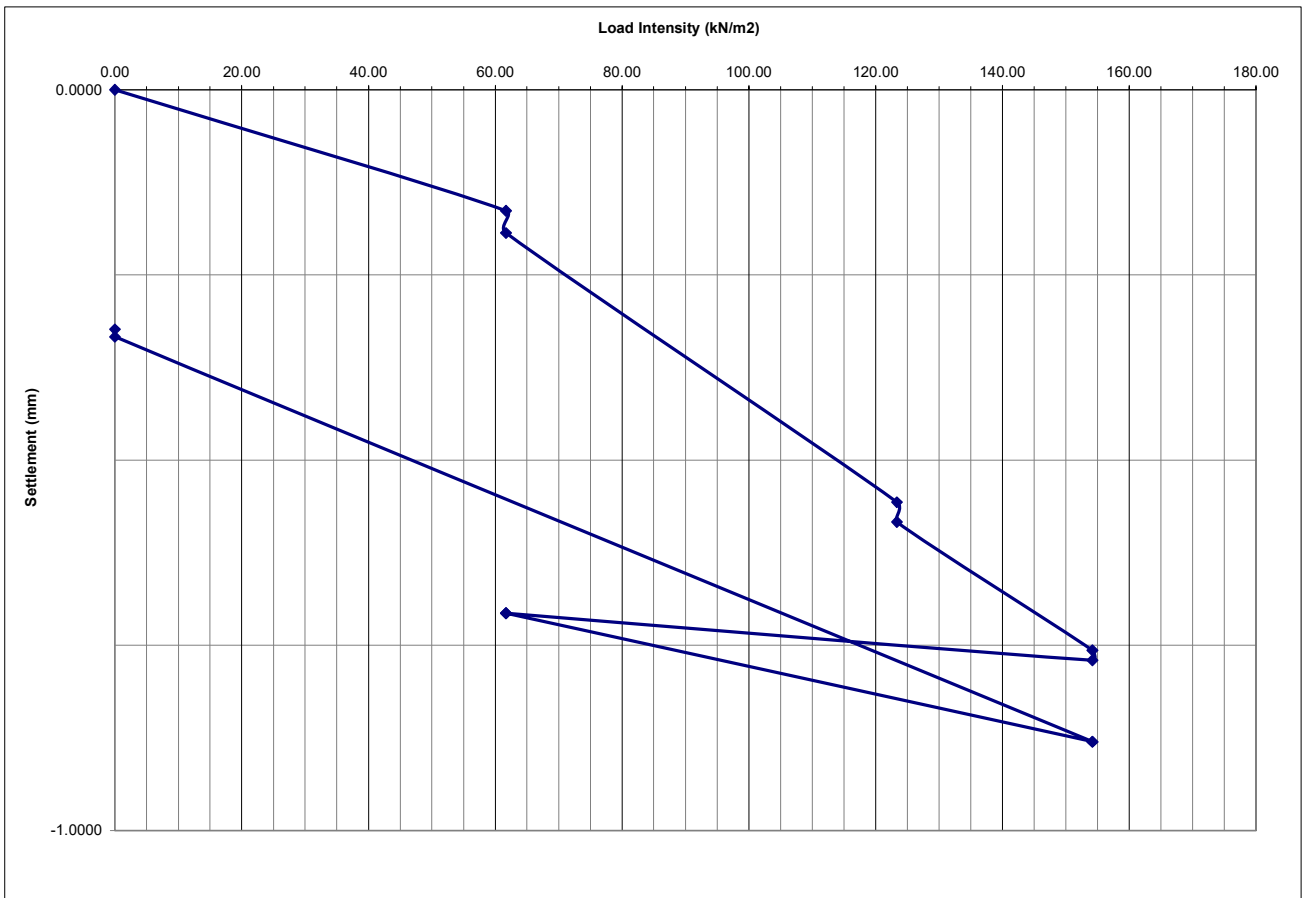
### Equivalent CBR Value in excess of 19%
