Phase I Geoenvironmental Site Assessment  
Manchester Life Phase 3

Reference:13-729-R1  
Date: February 2020

# PHASE I GEOENVIRONMENTAL SITE ASSESSMENT

Manchester Life Phase 3  
Land to the north and south of Jersey Street,  
Manchester,  
M4 6JW

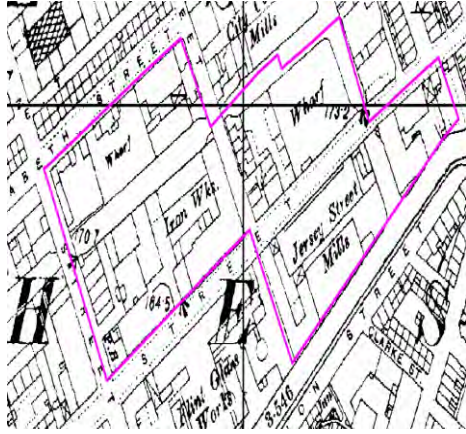
| MAP EDITION | HISTORICAL LAND USE | HISTORICAL MAP EXCERPT |
|---|---|---|
| 1893<br>1:2500 | <p><b>Parcel A</b><br/>Parcel A is entirely surfaced by buildings and intersected by a canal in the center. An Iron Works is present in the south east and a canal Wharf is located in the north off Bengal Arm.</p> <p><b>Parcel B</b><br/>The Parcel comprises a large Wharf in the eastern portion and numerous smaller buildings located to the east. The canal branch runs along the north and east.</p> <p><b>Parcel C</b><br/>The parcel comprises a number of large structures referred to as Jersey Street Mills.</p> | |

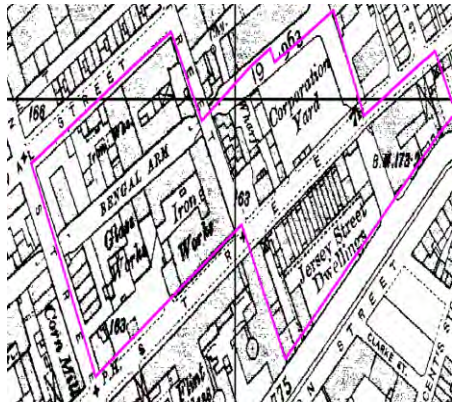
| MAP EDITION | HISTORICAL LAND USE | HISTORICAL MAP EXCERPT |
|---|---|---|
| 1908<br>1:2500 | <p><b>Parcel A</b><br/>The canal intersecting parcel A is referred to as Bengal Arm. The Wharf in the north of the site has been infilled and divided into a number of smaller buildings referred to as Iron Works. The buildings in the south west of the site are now referred to as a Glass Works.</p> <p><b>Parcel B</b><br/>The Wharf in this parcel has also been infilled and is now referred to as a Corporation Yard.</p> <p><b>Parcel C</b><br/>The Jersey Street Mill building to the west is now referred to as Jersey Street Dwellings and the north of the structure has been sub divided into a number of smaller structures.</p> | |

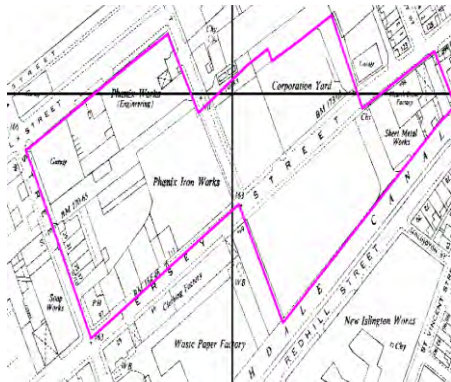
| <p><b>1952-1955</b><br/><b>1:2500</b></p> | <p><b>Parcel A</b></p> <p>The Iron Works located to the south east is now referred to as Phoenix Iron Works. The structures located in north east is also referred to as Phoenix Works (engineering). A garage is now present in the north west. The canal is no longer present.</p> <p><b>Parcel B</b></p> <p>The structures previously noted in the west are no longer present. The canal is no longer present.</p> <p><b>Parcel C</b></p> <p>All buildings in the west have been demolished. A chimney is present in the north east. A sheet metal works is present in the east in addition to a factory.</p> | |

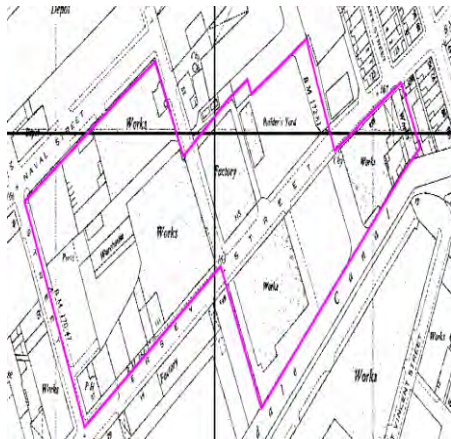
| <p><b>1958-1982</b><br/><b>1:1250</b></p> | <p><b>Parcel A</b></p> <p>The rectangular building present in the center is now referred to as a warehouse and the parcel no longer appears to be intersected by a canal.</p> <p><b>Parcel B</b></p> <p>The Corporation Yard present in the east is referred to as a builders yard. A structure has been developed to the west referred to as a factory. The canal is no longer present.</p> <p><b>Parcel C</b></p> <p>A works building has now been developed in the east of the site. The canal is no longer present.</p> | |

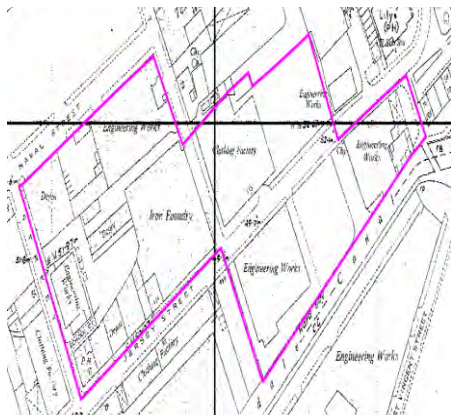
| <p><b>1958-1985</b><br/><b>1:1250</b></p> | <p><b>Parcel A</b></p> <p>The garage located to the north west and the warehouse located in the center are now referred to as depots. There is also an additional depot located to the south. An engineering works building is now present in the central western sector.</p> <p><b>Parcel B</b></p> <p>The factory located to the west is now specified as a clothing factory.</p> <p><b>Parcel C</b></p> <p>There have been no significant changes in parcel C.</p> | |

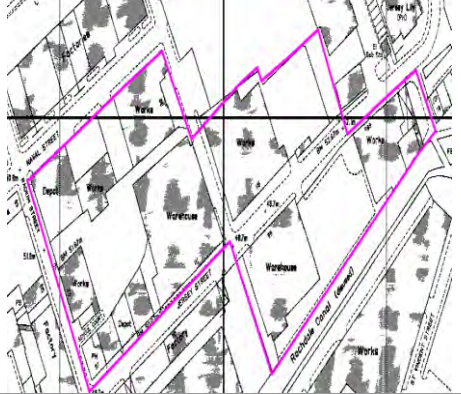
| <b>1988-1989</b><br><b>1:1250</b> | <p><b>Parcel A</b><br/>The structure in the south east is now referred to as a warehouse.</p> <p><b>Parcel B</b><br/>There have been no significant changes in parcel B.</p> <p><b>Parcel C</b><br/>The structure in the west is now referred to as a warehouse.</p> | |

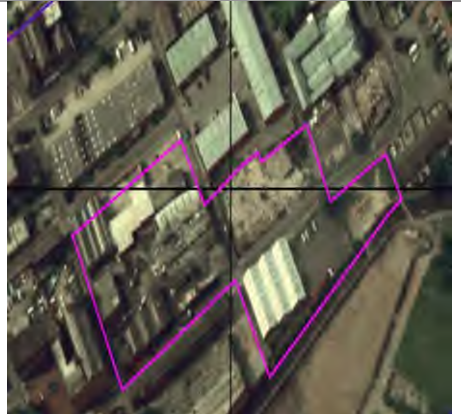
| <b>Envirocheck satellite image</b><br><b>2000</b> | <p><b>Parcel A</b><br/>There have been no significant changes.</p> <p><b>Parcel B</b><br/>The works building to the east has been demolished. The parcel appears to be vacant and surfaced by hardstanding.</p> <p><b>Parcel C</b><br/>The works building located to the east has been demolished.</p> | |

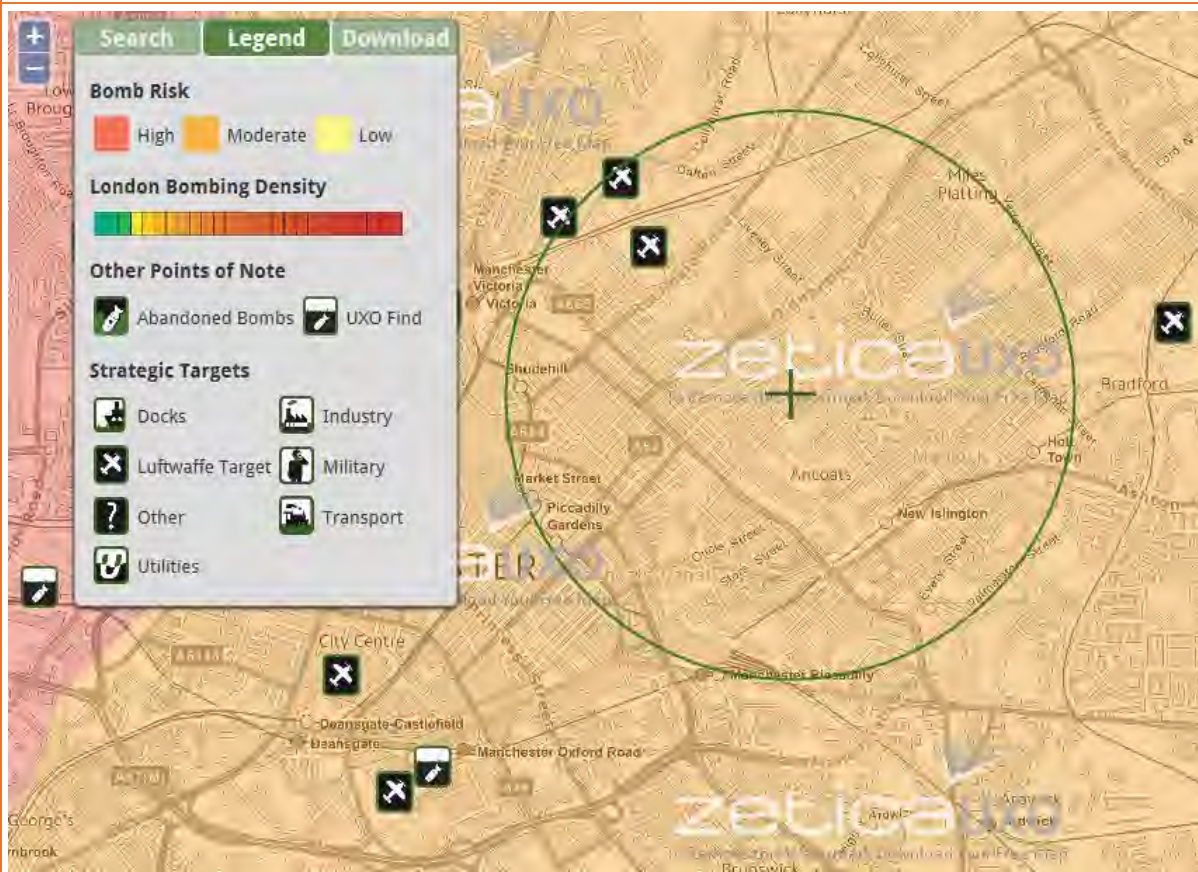
FIGURE 4.2 ZETICA UXO RISKS MAP

As the site is within the high-risk area, it is recommended that further detailed assessments are carried out to establish the level of risk and the potential need for mitigation.

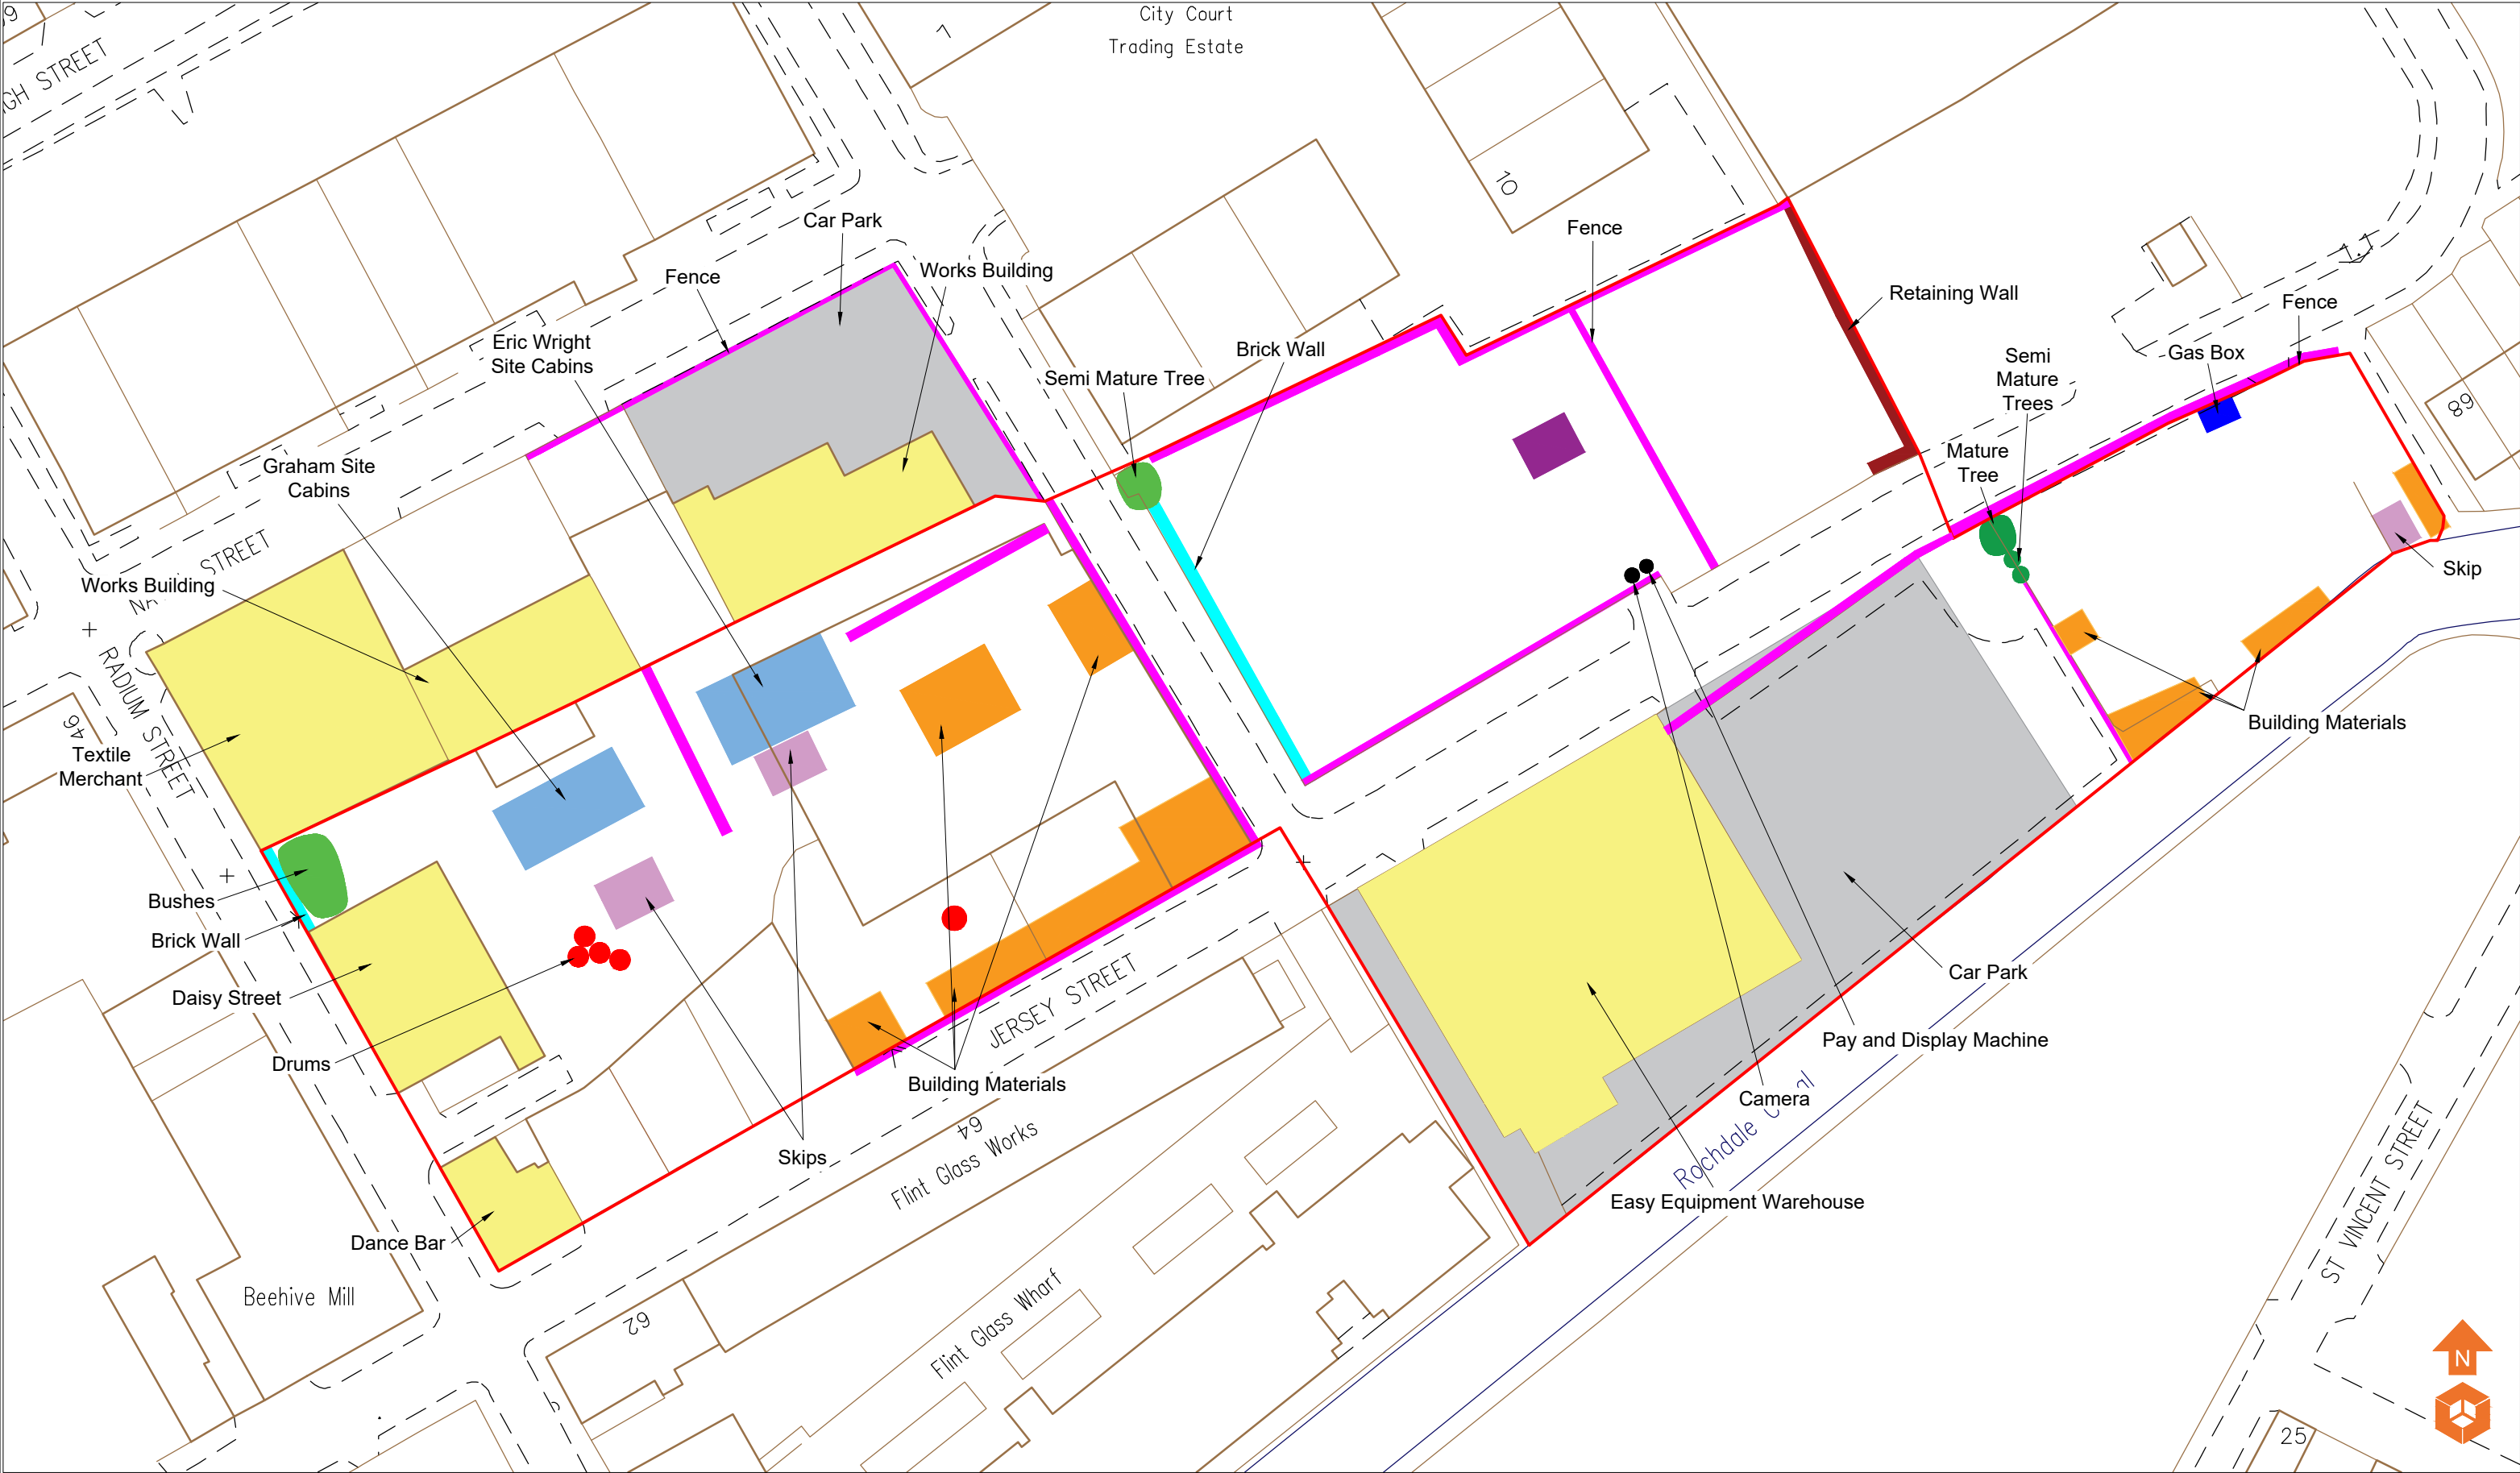
| <div>Current Site Features</div> <div><div><div>Skips</div><div>Existing Commercial Buildings</div><div>Trees/Bushes</div><div>Site Cabins</div><div>Gas Box</div><div>Building Materials</div><div>Retaining Wall</div><div>Car Park</div><div>Drums</div></div><div><div>Brick Wall</div><div>Fence</div><div>Camera/Pay and Display Machine</div></div></div> | | | | | | <div>Notes:</div> | | | | | | <div>Client:</div> <div>Manchester Life</div> | | <div>Job No:</div> <div>13-729</div> | | <div>Date:</div> <div>02.12.2019</div> | | <div><div></div><div>Environmental Engineering Partnerships Ltd<br/>City Heliport &amp; Business Centre<br/>Eccles, Manchester, M30 7RU<br/>Tel: 0161 707 9612<br/>E-mail: info@e3p.co.uk<br/>Website: www.e3p.co.uk</div></div> | |

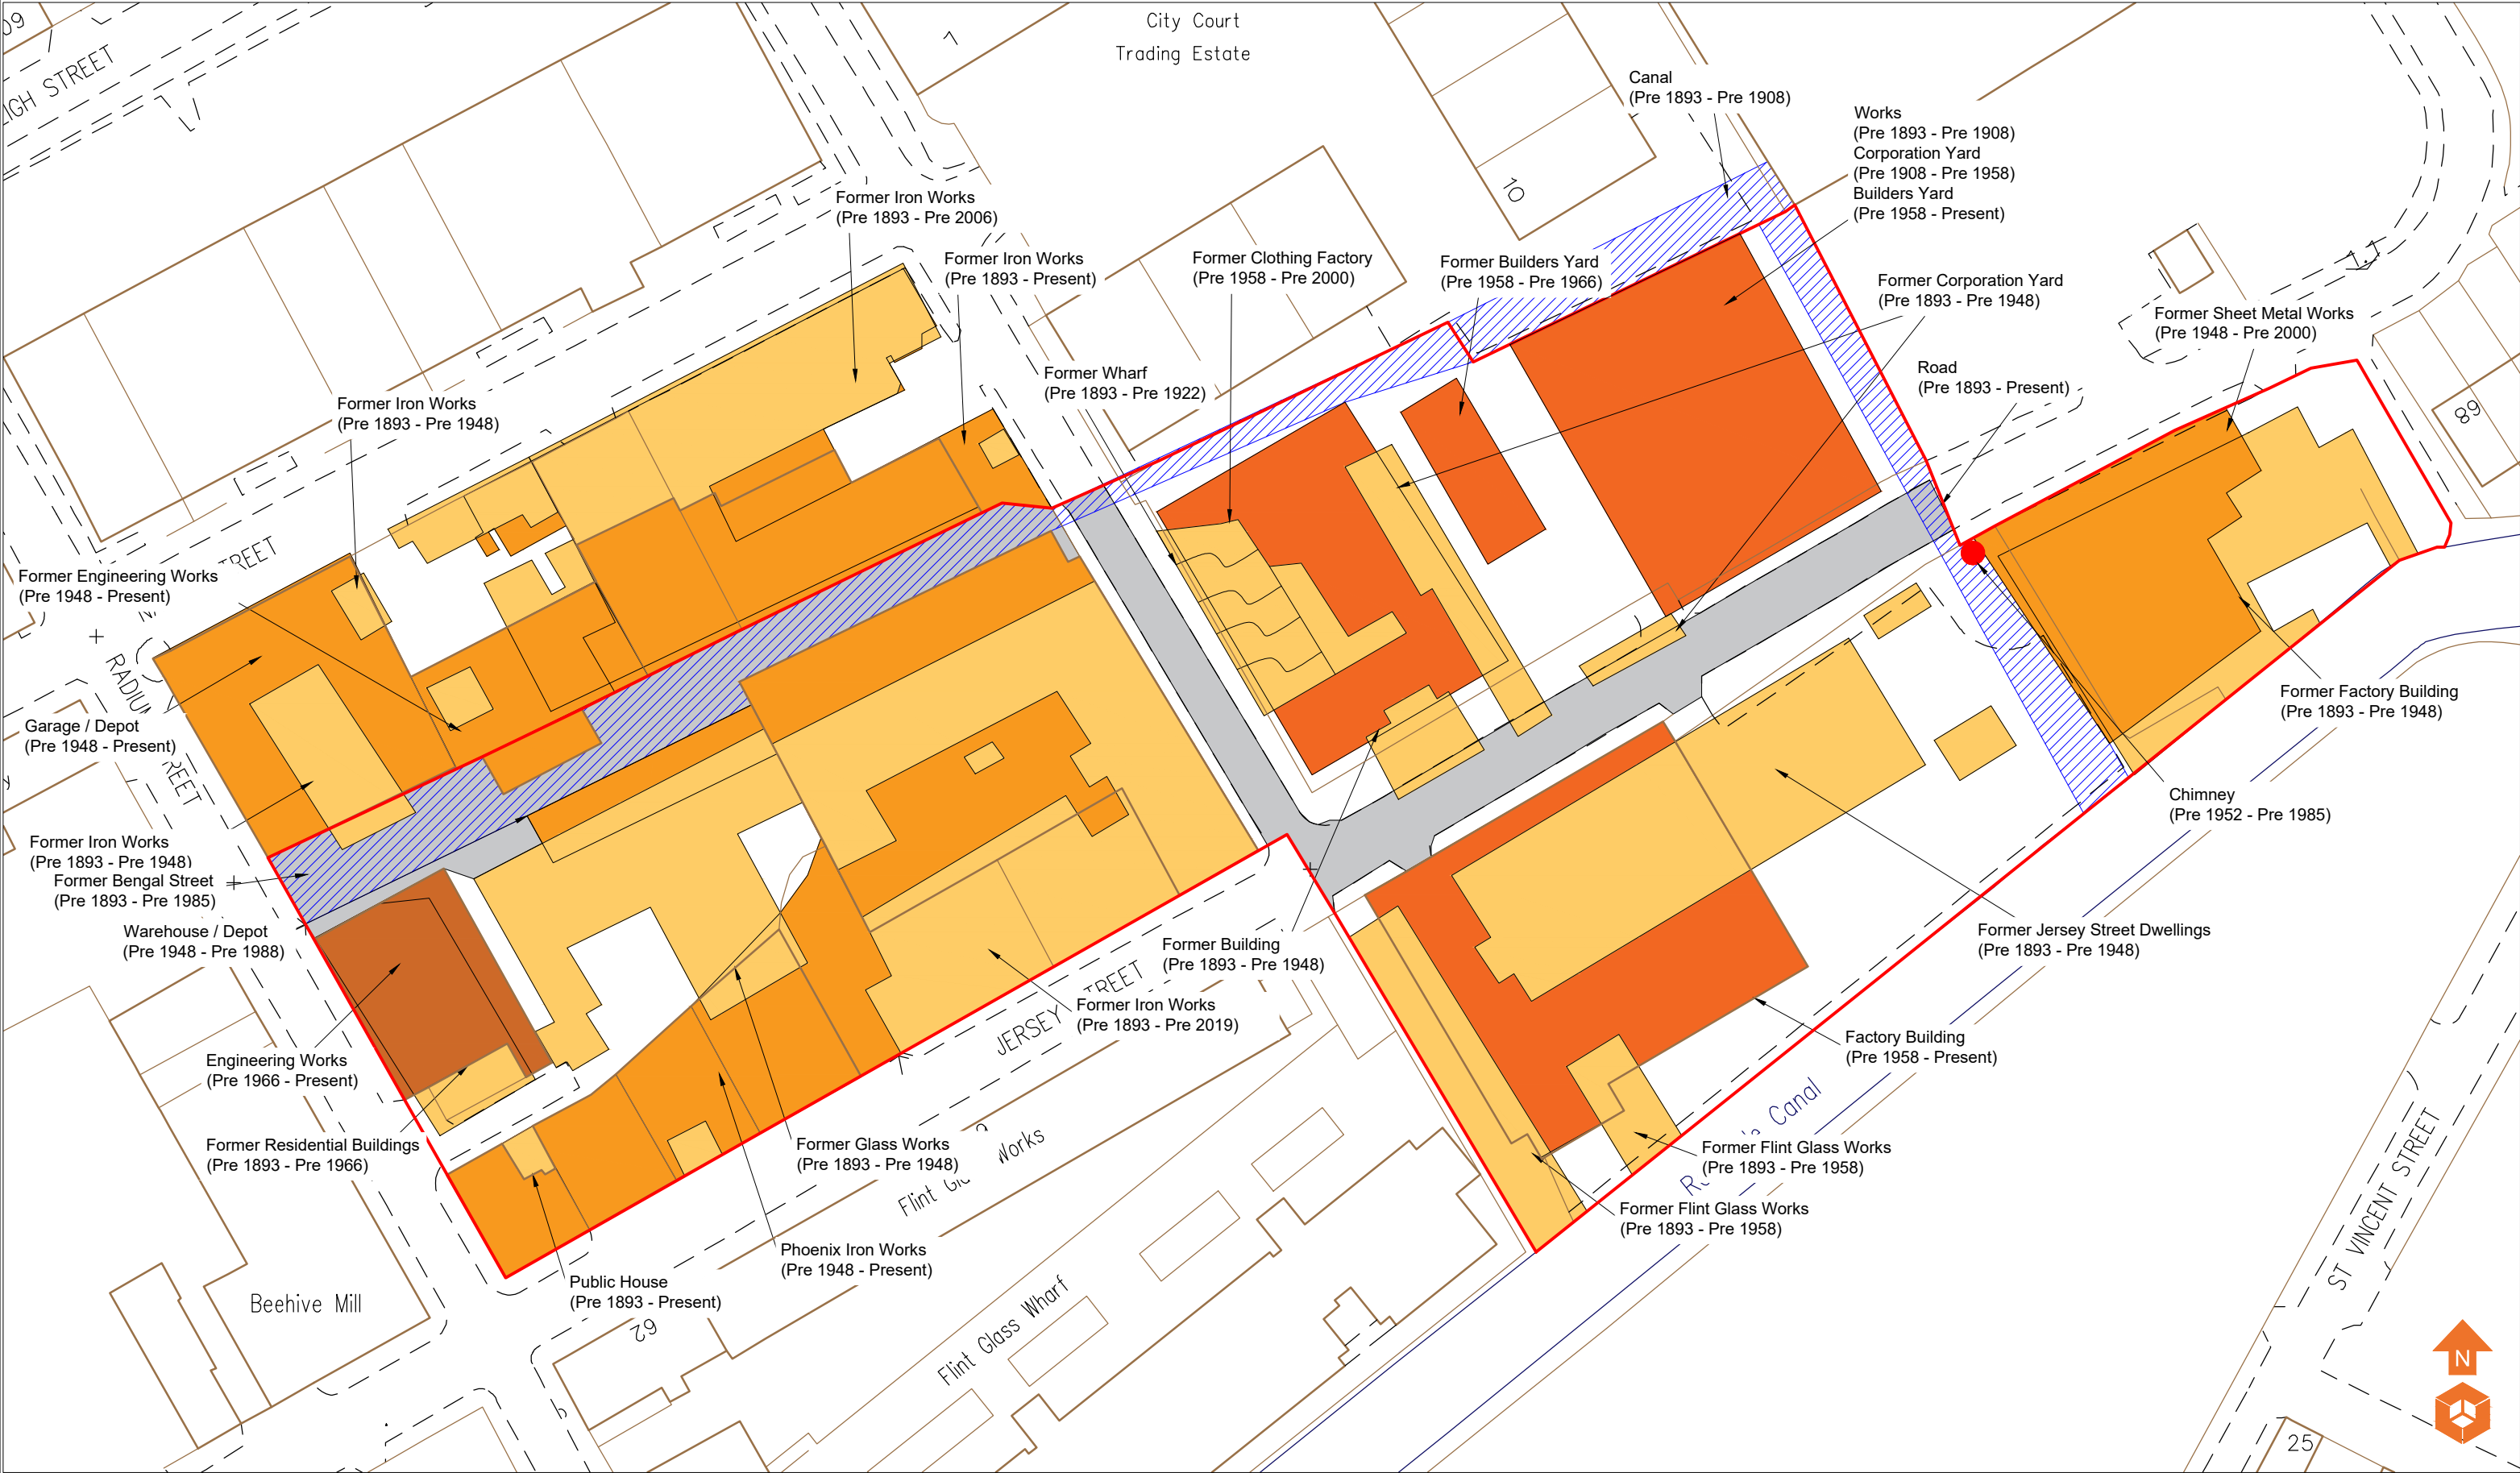
| <div>Historical Features</div> <div><div></div>Former Canal</div> <div><div></div>Former Chimney</div> <div><div></div>Former Works Building</div> <div><div></div>Former Works Building</div> <div><div></div>Former Works Building</div> | <div>Notes:</div> | | | | | | <div>Client:</div> <div>Manchester Life</div> | | <div>Job No:</div> <div>13-729</div> | <div>Date:</div> <div>01.11.2019</div> | <div><div></div><div>Environmental Engineering Partnerships Ltd<br/>City Heliport &amp; Business Centre<br/>Eccles, Manchester, M30 7RU<br/>Tel: 0161 707 9612<br/>E-mail: info@e3p.co.uk<br/>Website: www.e3p.co.uk</div></div> |

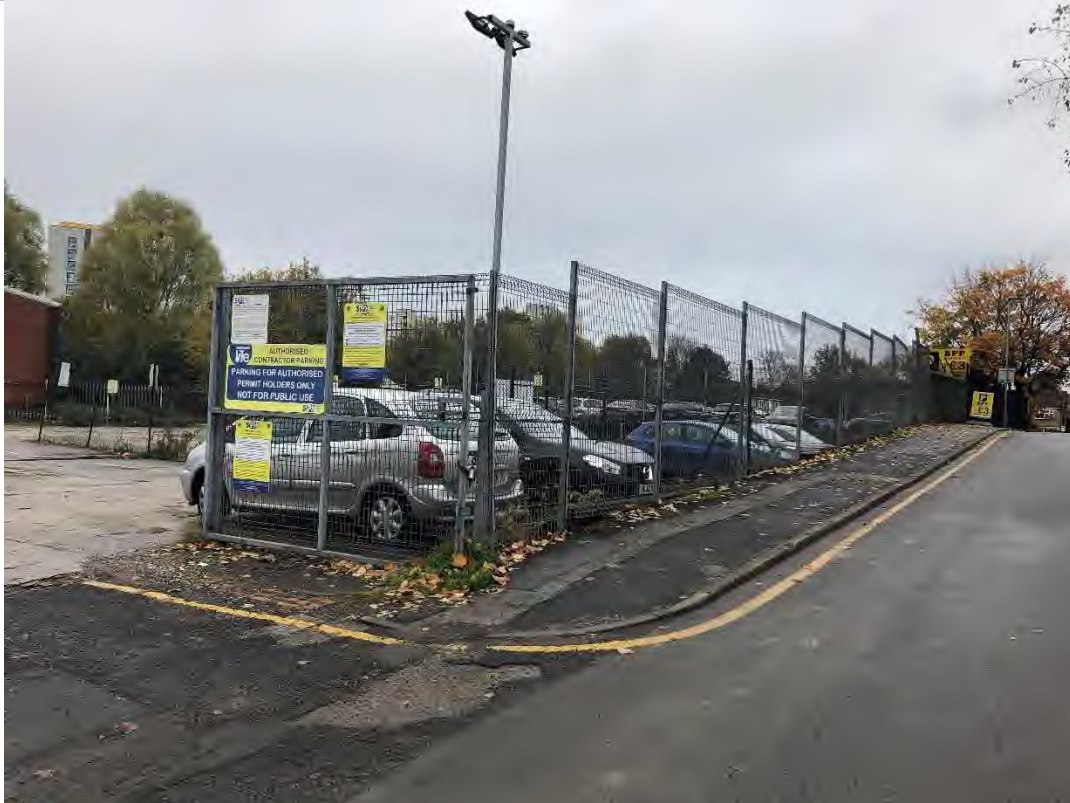
PLATE 3 PARCEL B LEVEL DIFFERENCE OVER CANAL BRIDGE

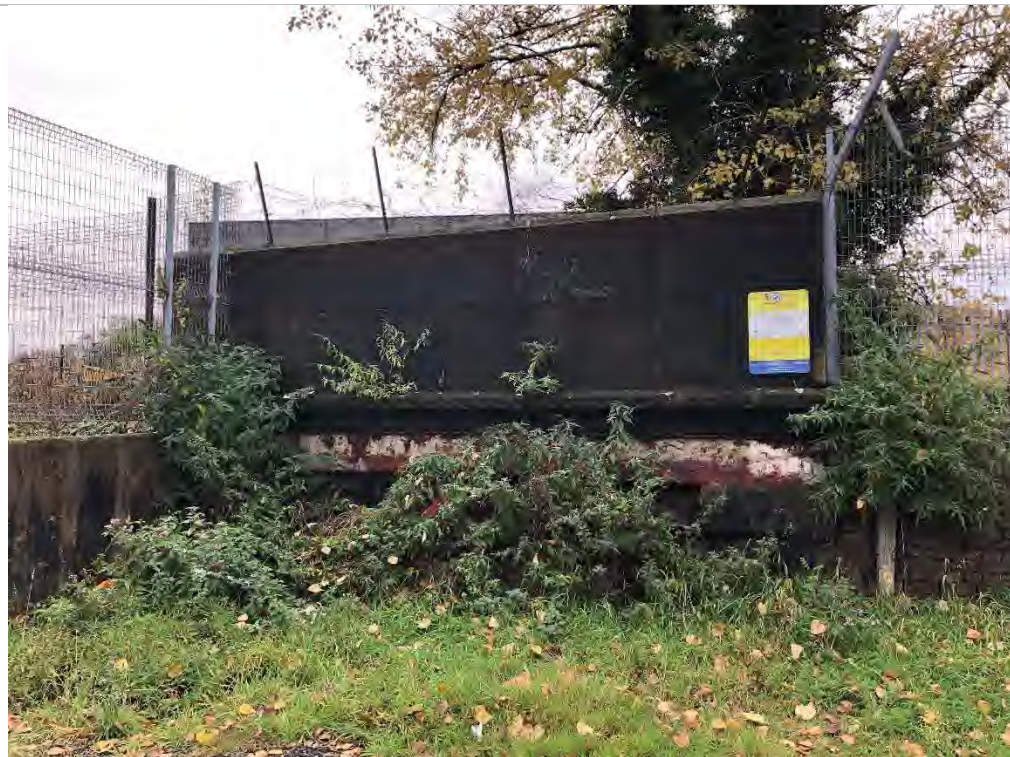
PLATE 6      EVIDENCE OF FORMER CANAL BRIDGE.
